**NORWAY/UNITED STATES DESIGN PROTECTIVE  
AIRCRAFT SHELTER (PAS) QUANTITY-DISTANCE  
PROGRAM 1/3-SCALE TEST SERIES**

**Volume I of V  
PAS 1-4 Summary**

**August 1993**

**Final Report**

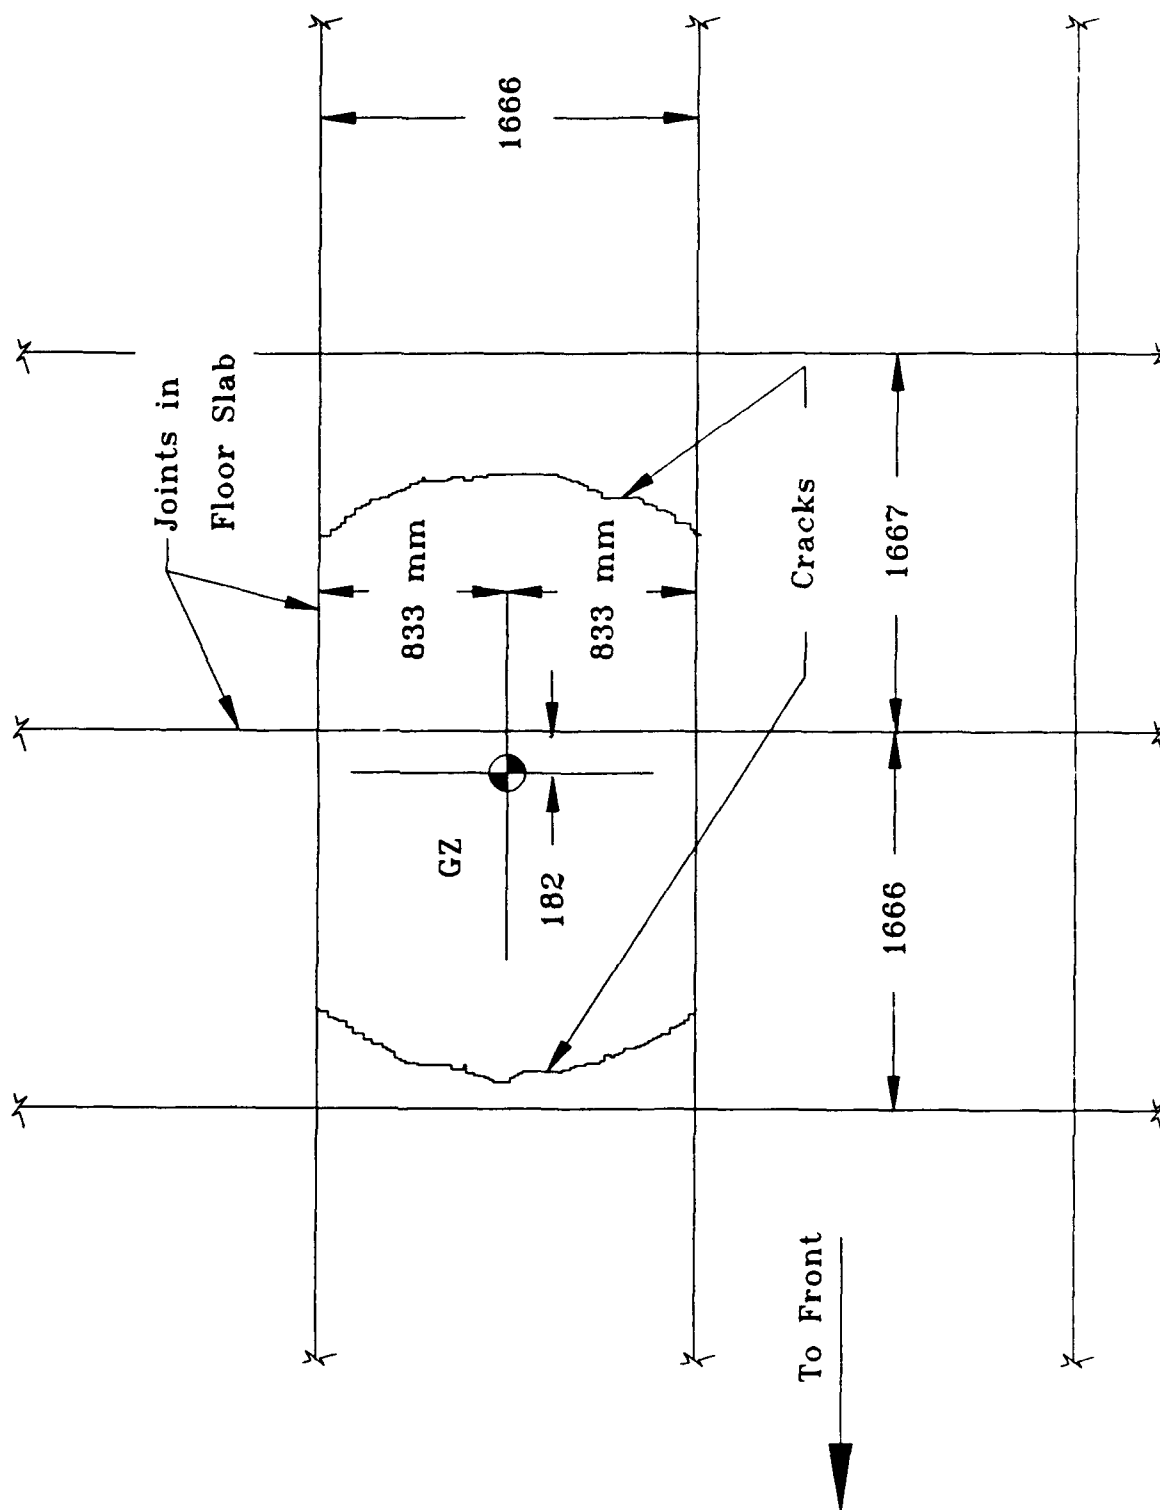
The pattern of hairline cracks shown in Figure 20 was observed in the floor slab around the surface GZ. Within these cracks, and the construction joints, the floor slab was "dished" downward to 18 mm at the GZ.

Figure 20. Crack pattern in floor slab, around GZ, PAS-1.

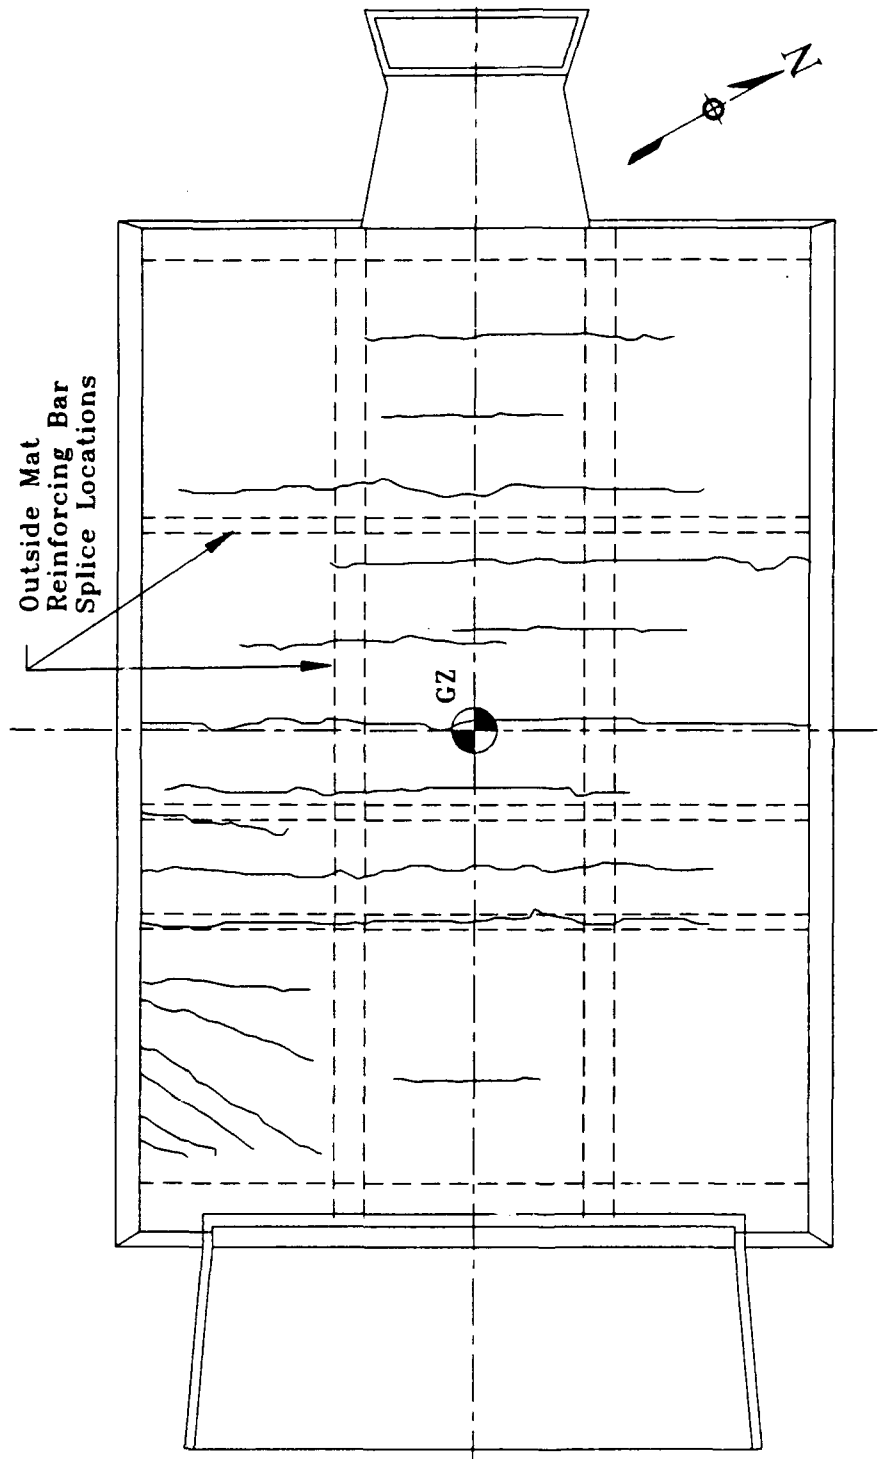
Figure 36. Crack pattern in arch, PAS-1.

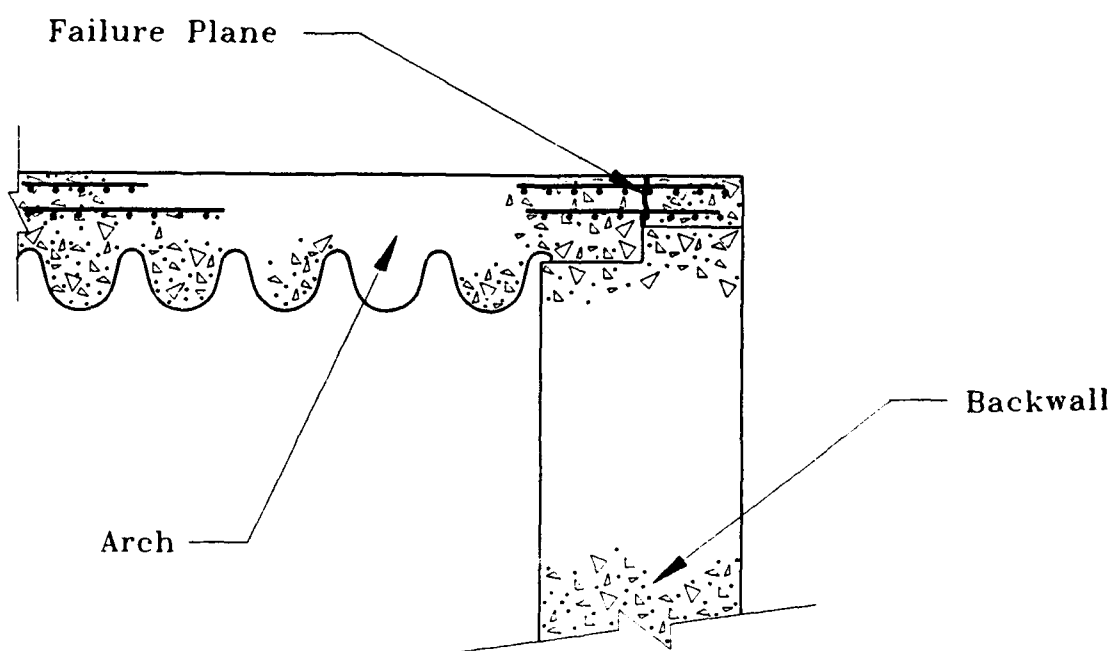
Figure 95. Section: Failure plane between the arch and backwall, PAS-3.

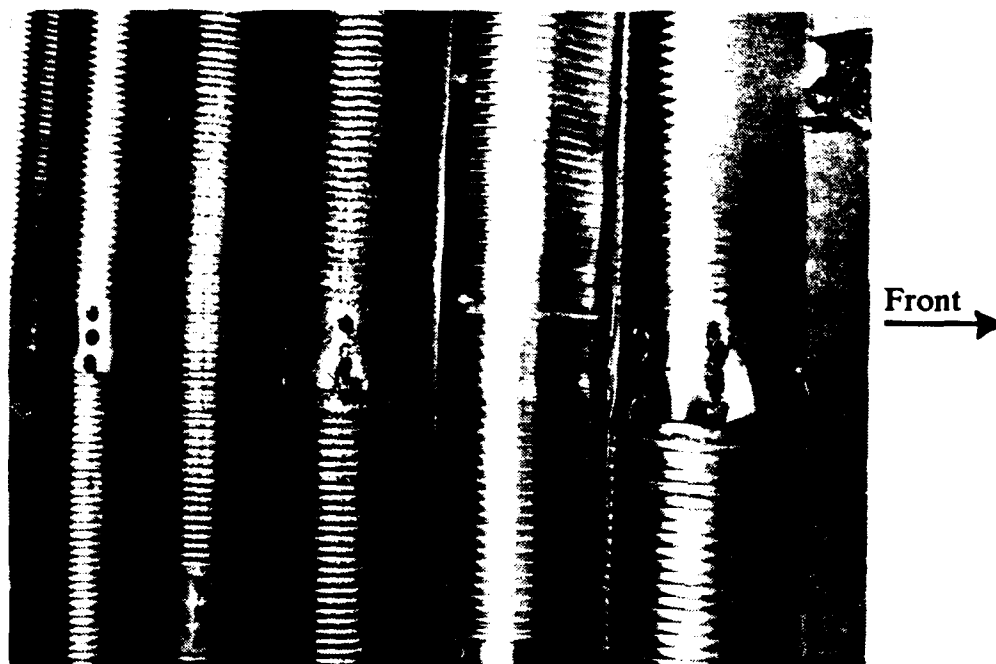
Figure 162. Condition of liner joints opposite longitudinal cracks, PAS-2.

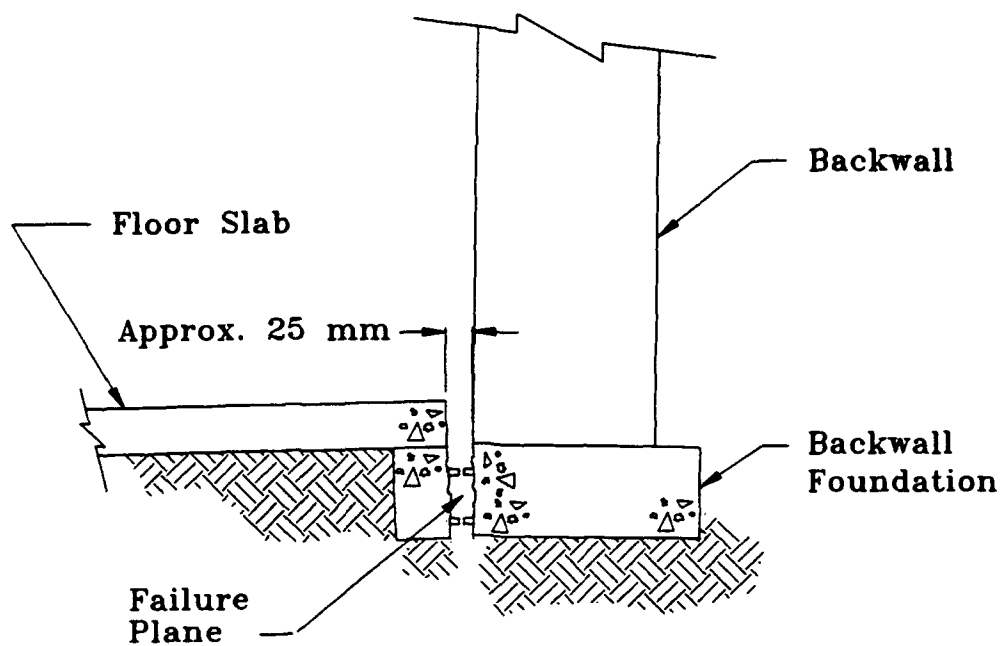
Figure 170. Section: Failure plane in backwall foundation, PAS-2.

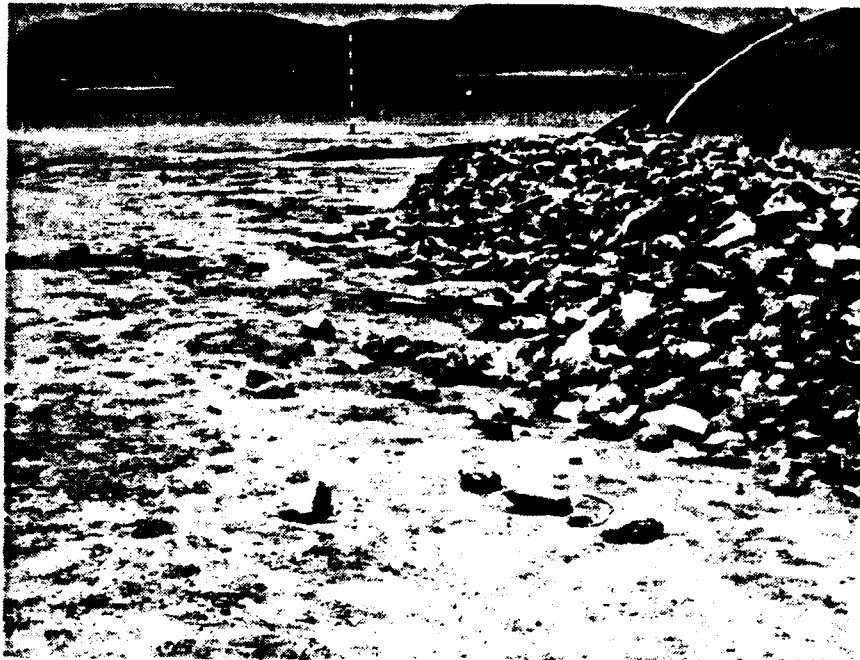
Figure 192. Rock rubble ejected from the berm, PAS-2.

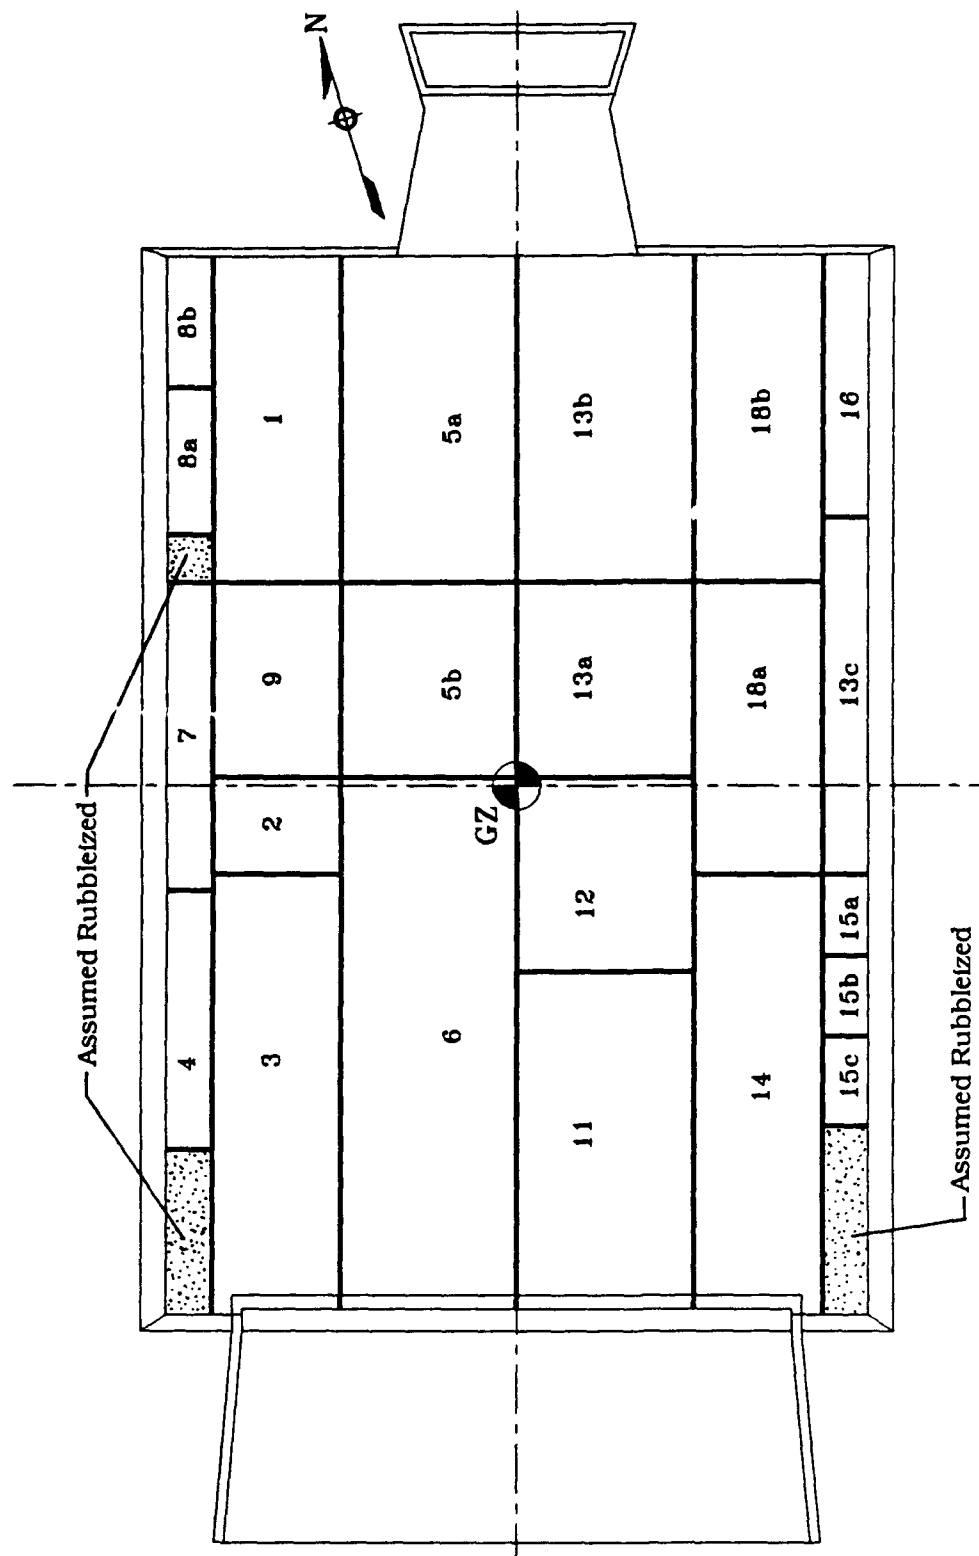
Figure 225. Crack pattern in arch, PAS-4.

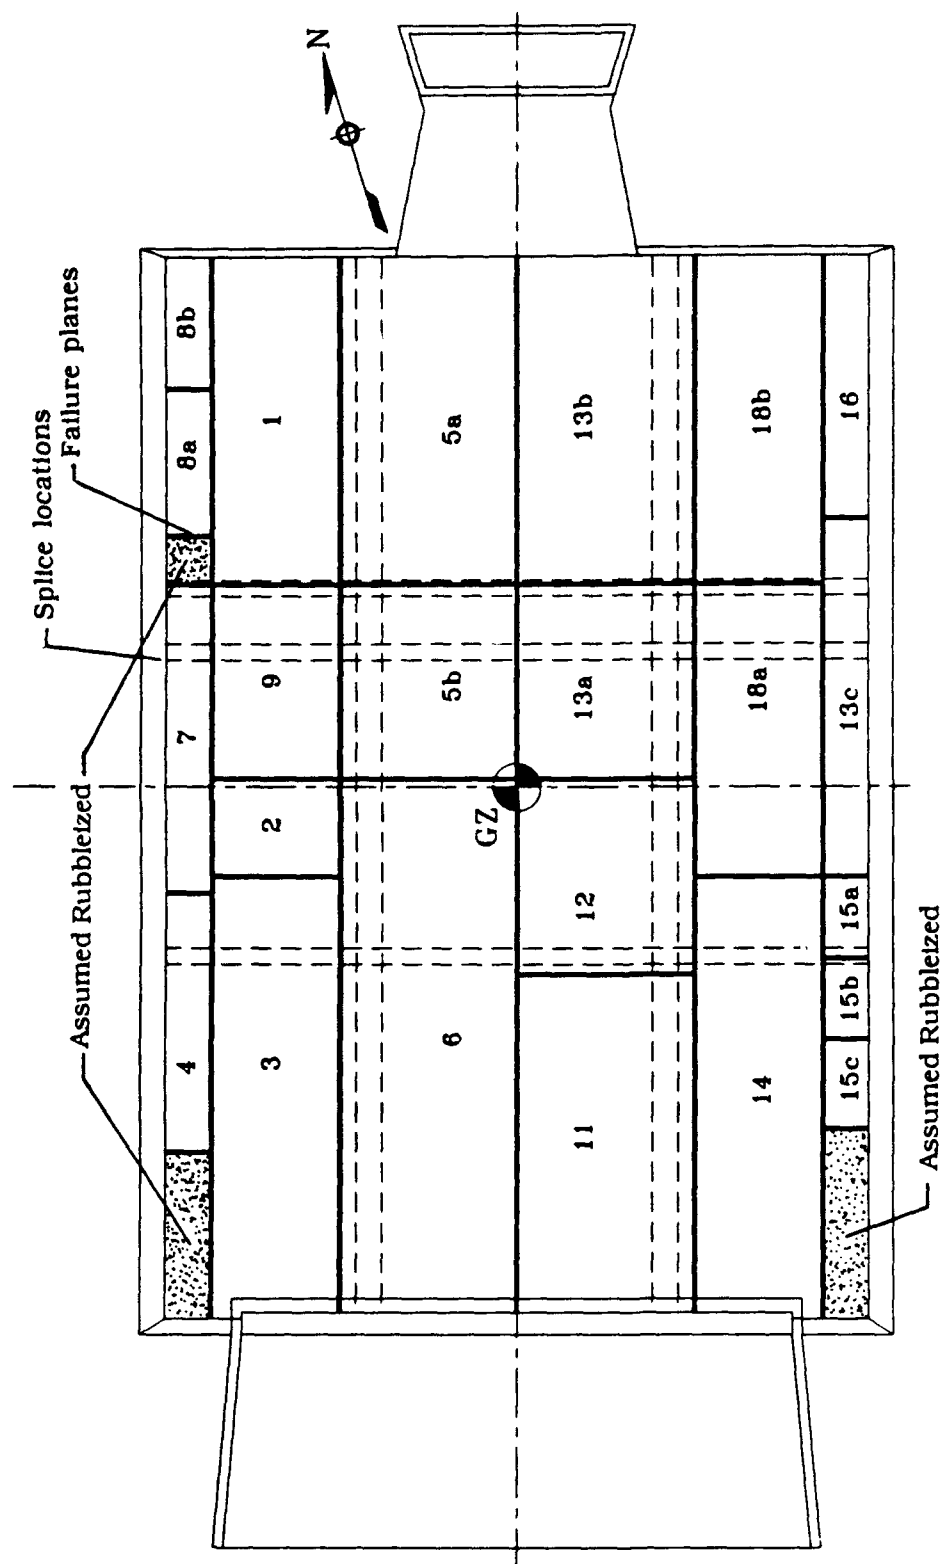
Figure 228. Failure planes and splice locations, PAS-4.

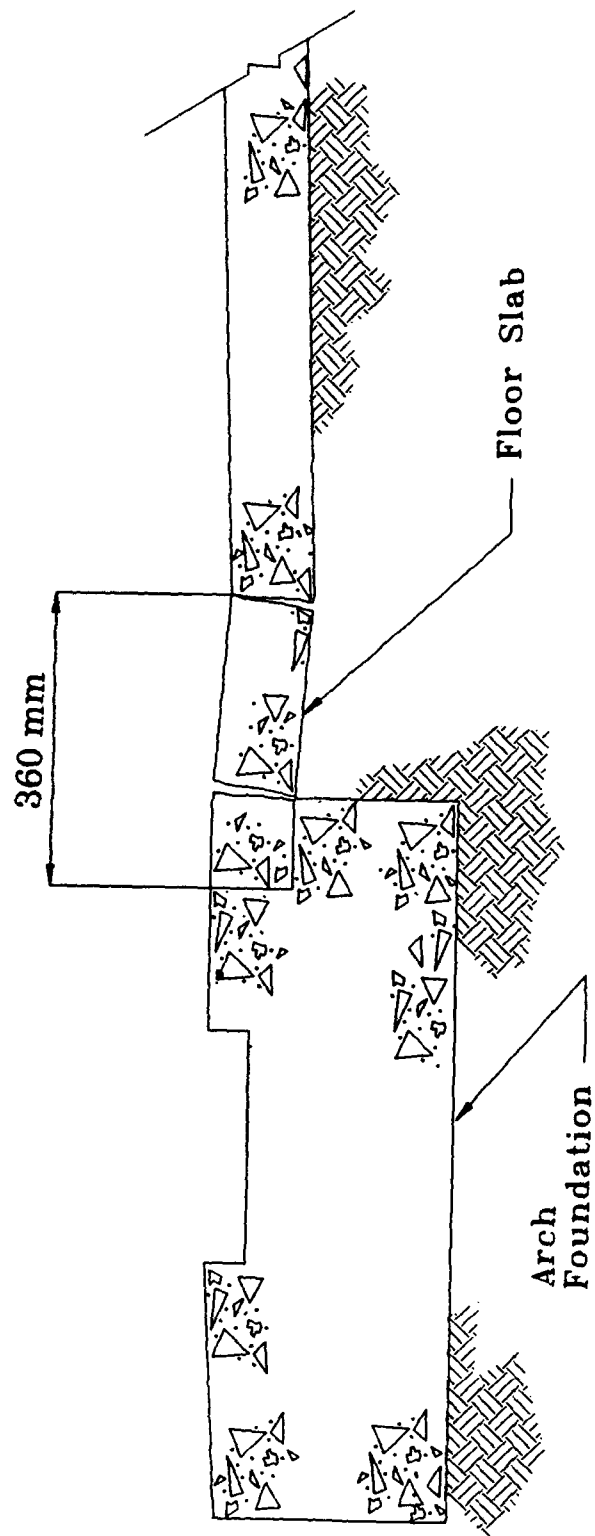
Figure 240. Section: Crack pattern in floor slab at arch foundation, PAS-4.

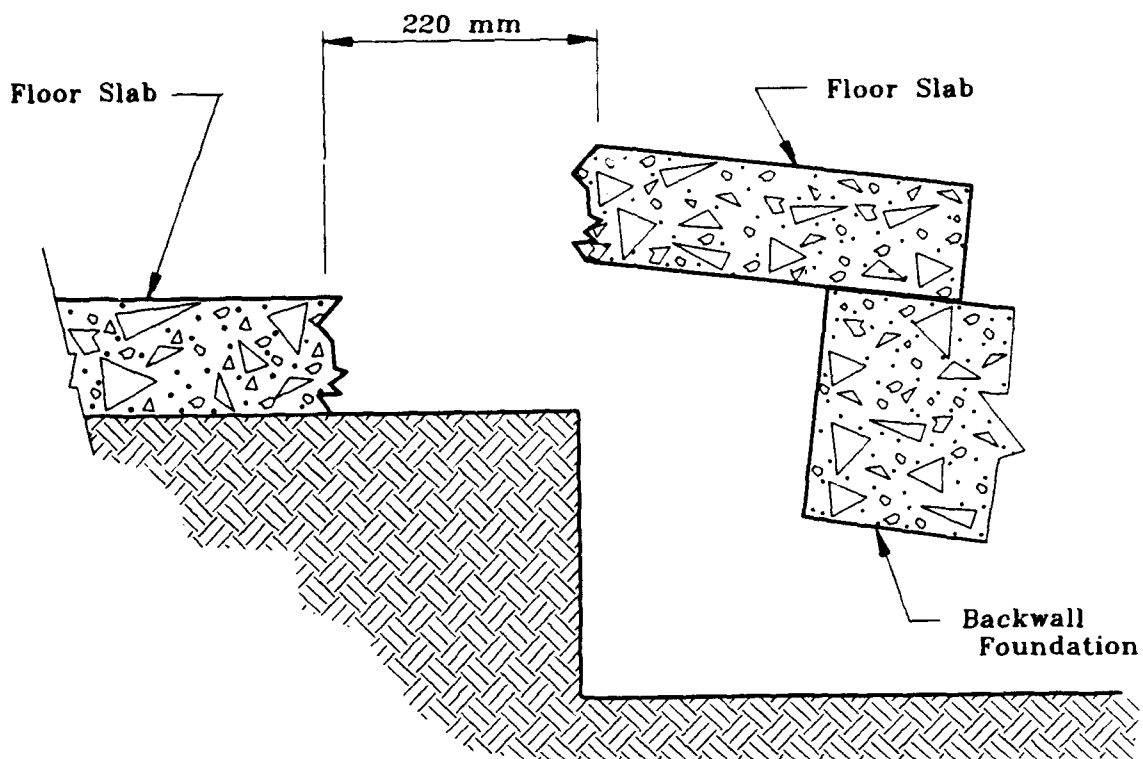
Figure 243. Crack pattern in floor slab at backwall foundation, PAS-4.

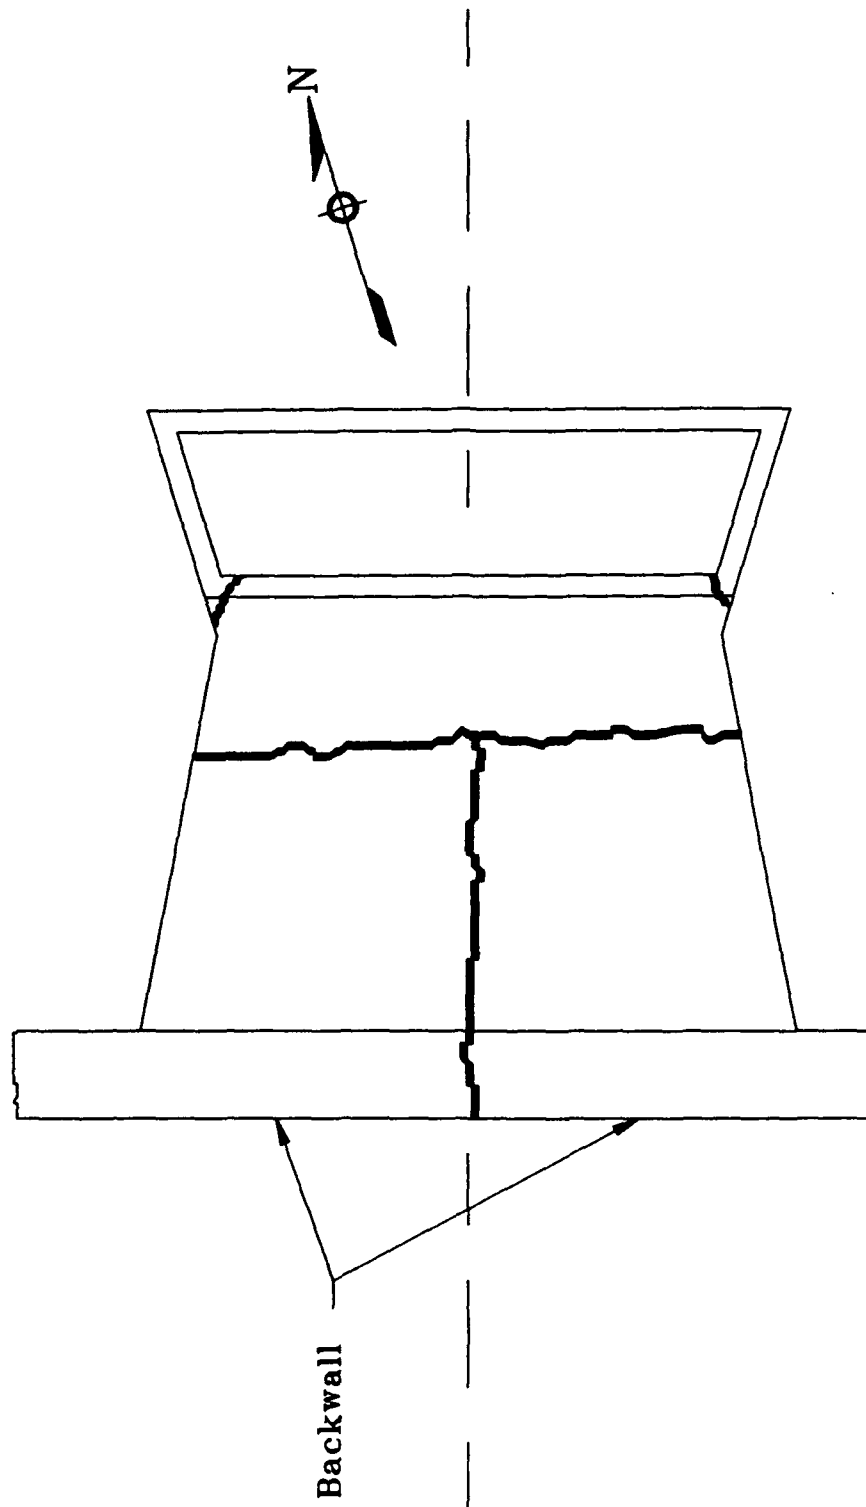
Figure 253. Plan: Breakup pattern of exhaust port roof, PAS-4.
