IRONDALE DBCP CONTROL SYSTEM

ROCKY MOUNTAIN ARSENAL

REVIEW OF 1987/1988 OPERATIONS

SEPTEMBER 1989

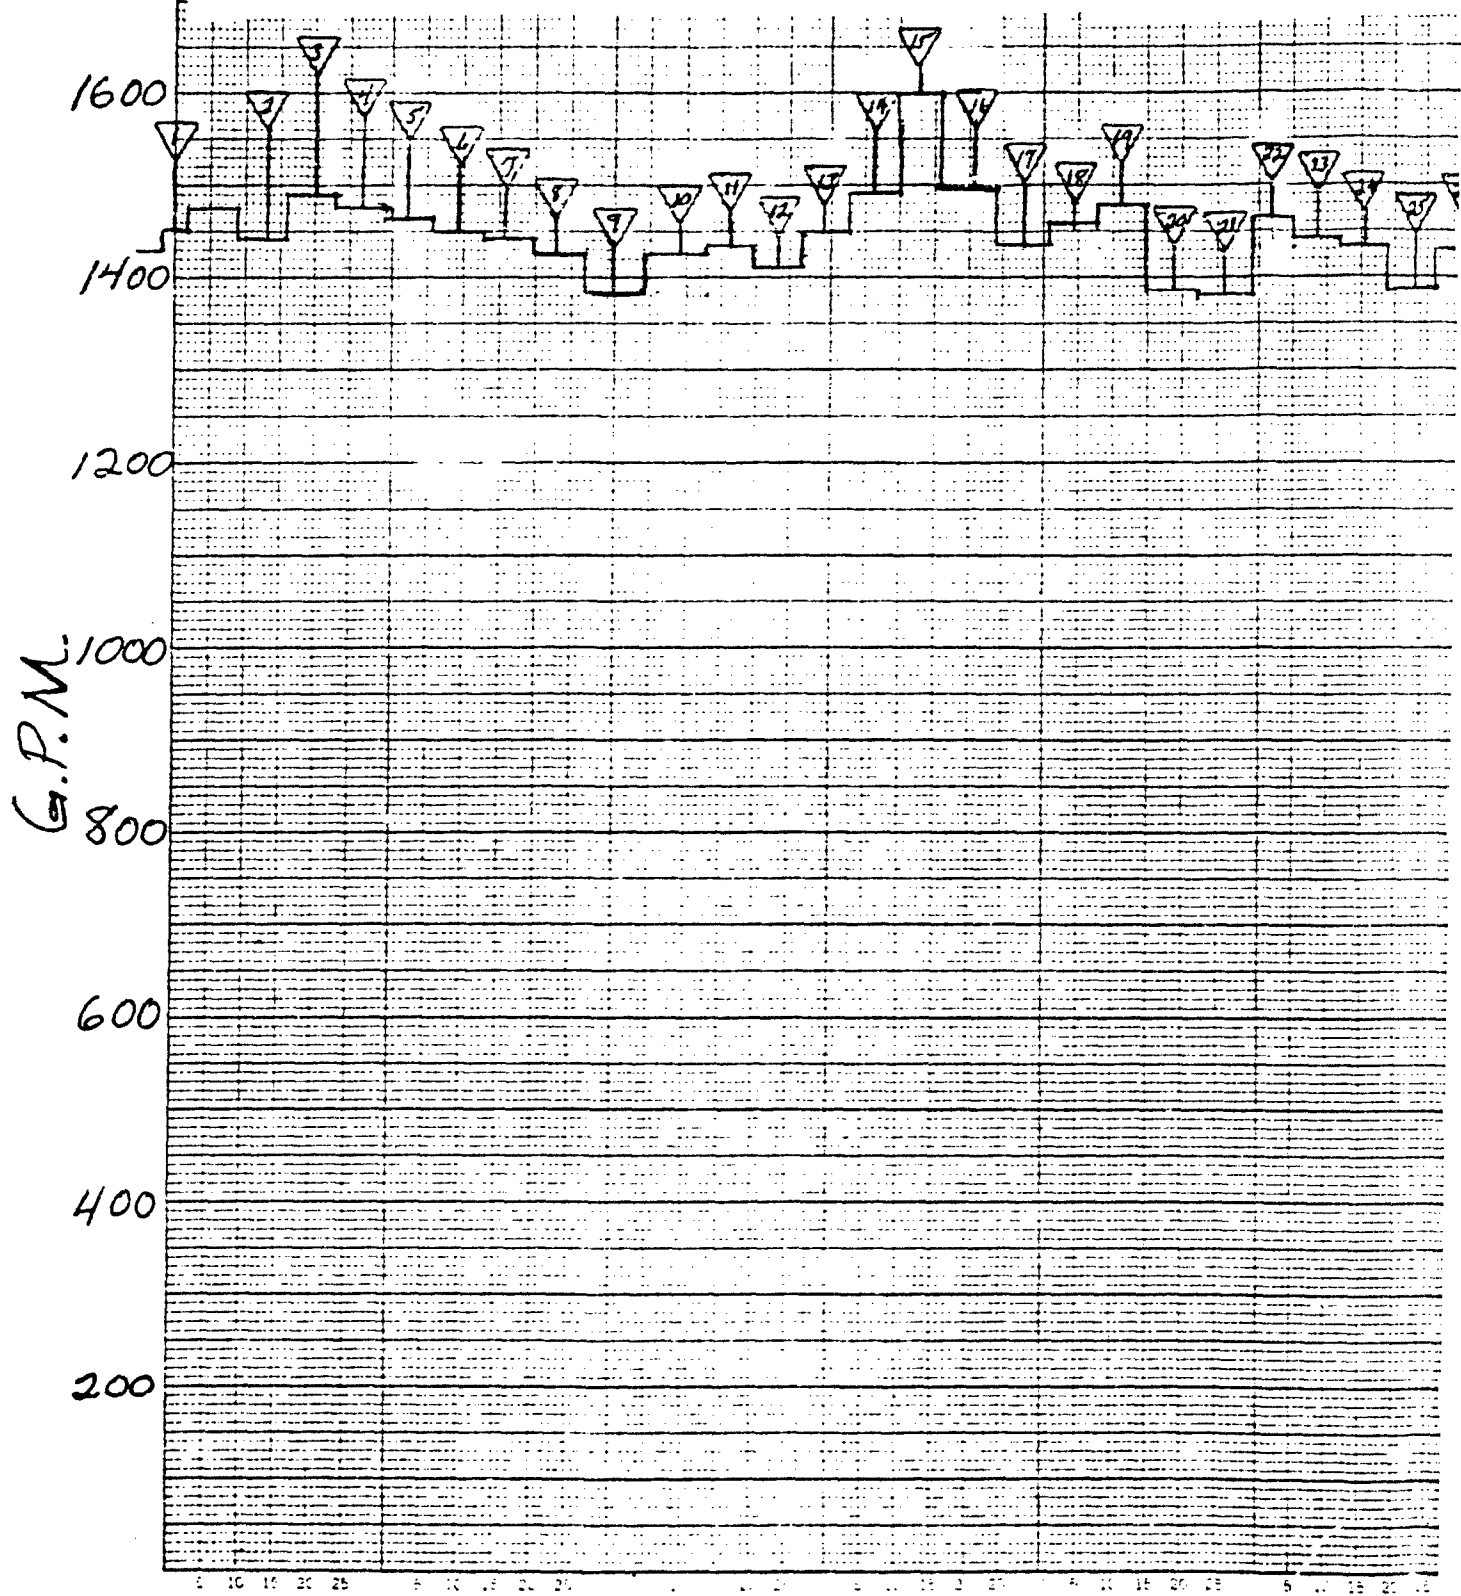
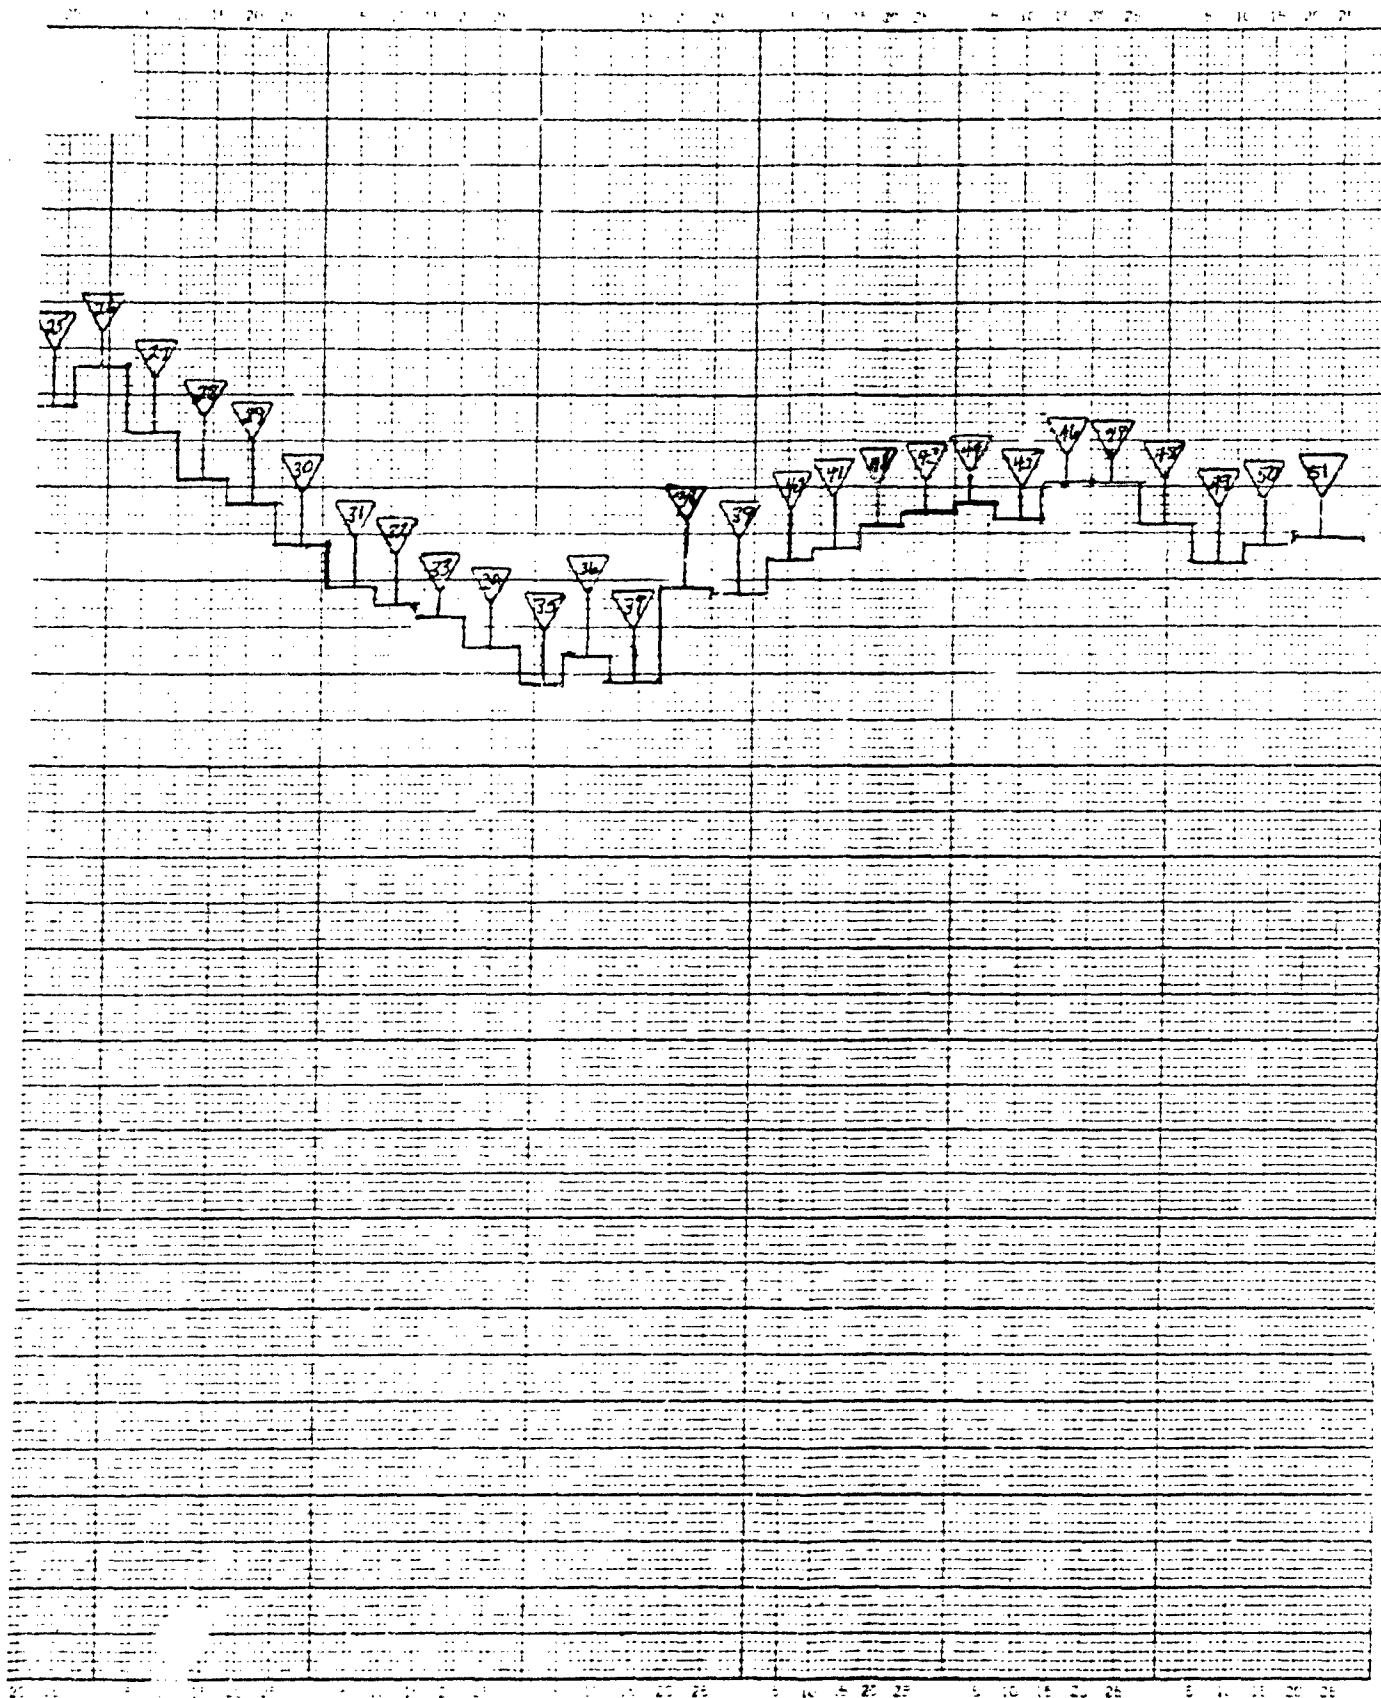
PLATE 5  
FLOW THROUGH ADSORBER - 1987

Weekly average total flow rates through the two GAC adsorbers, which were operated in parallel, are presented in Plates 5 and 6. Operational factors and incidents which effected the quantity of flow through the system are presented in Appendix A. Total flow through the system in 1987 ranged between 1,032 gpm to 1,601 gpm and averaged 1,339 gpm. In 1988, the flow through the

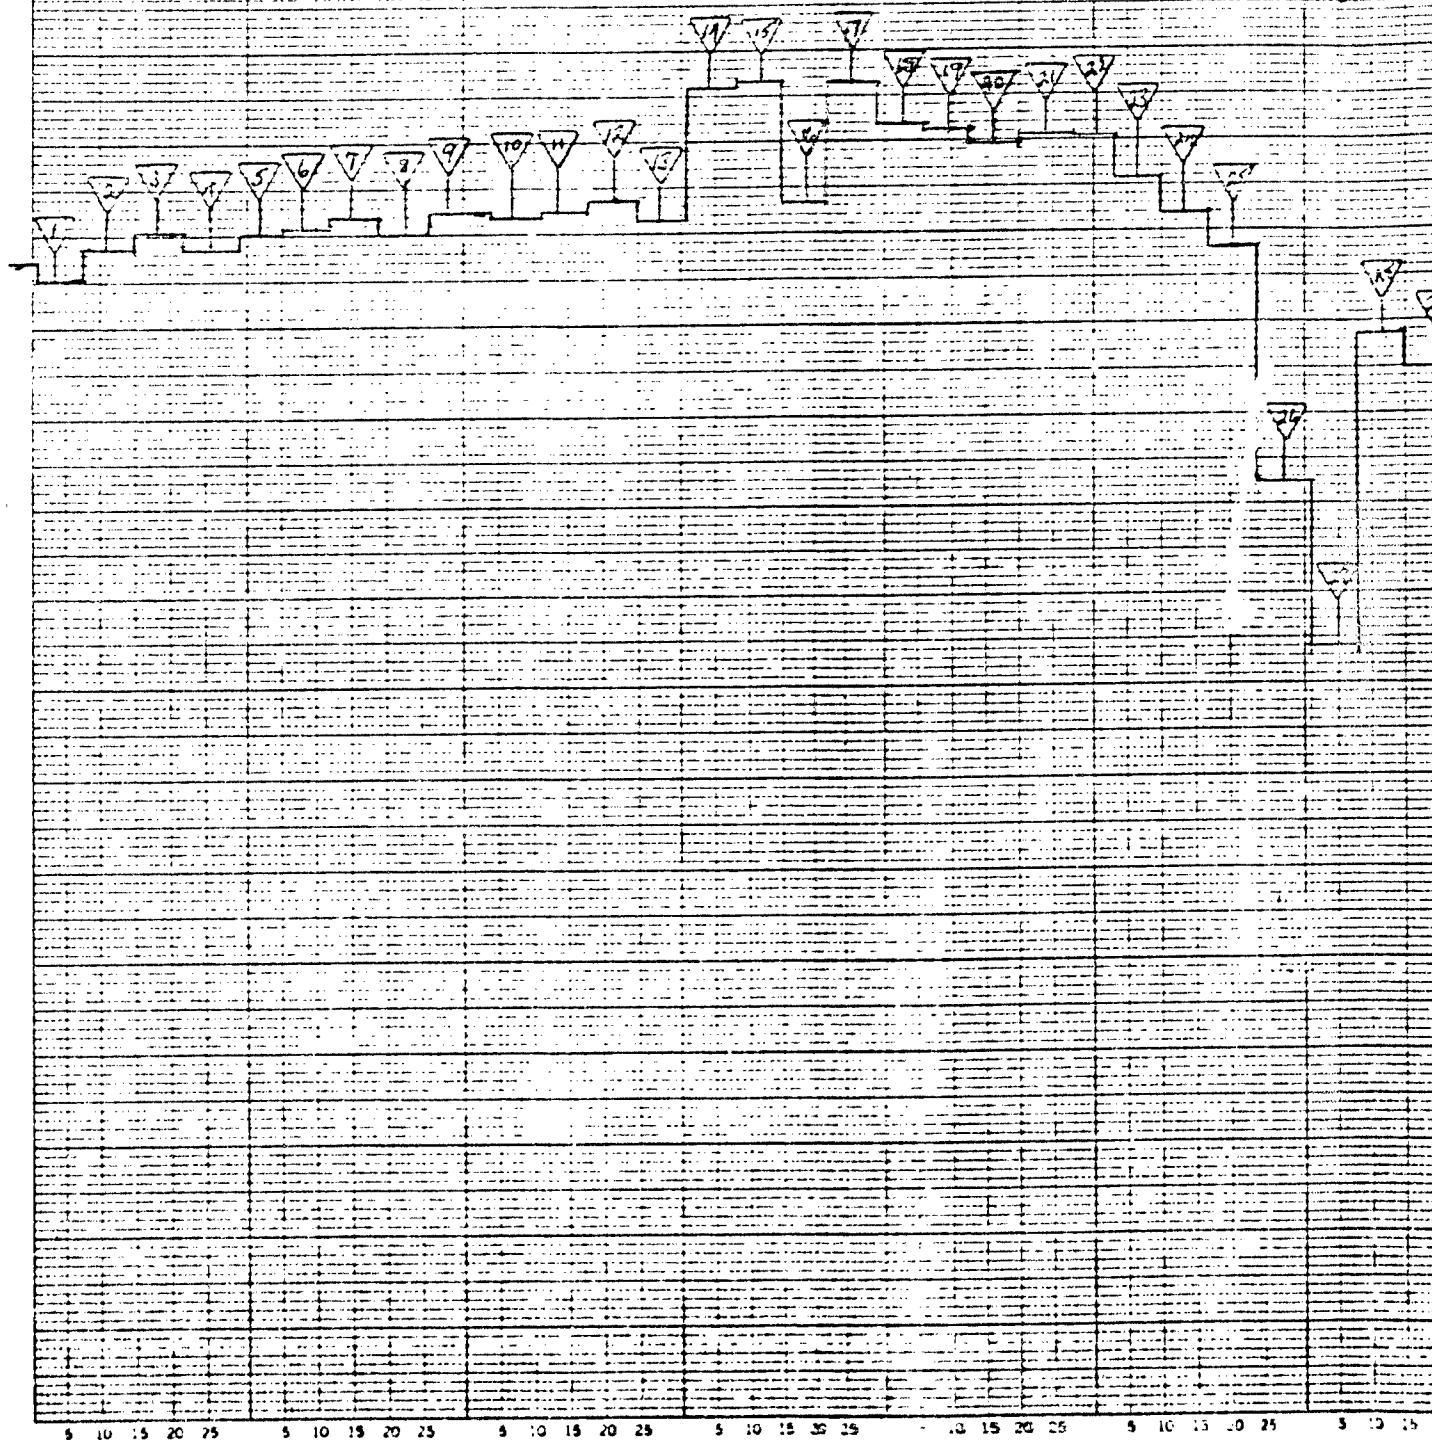
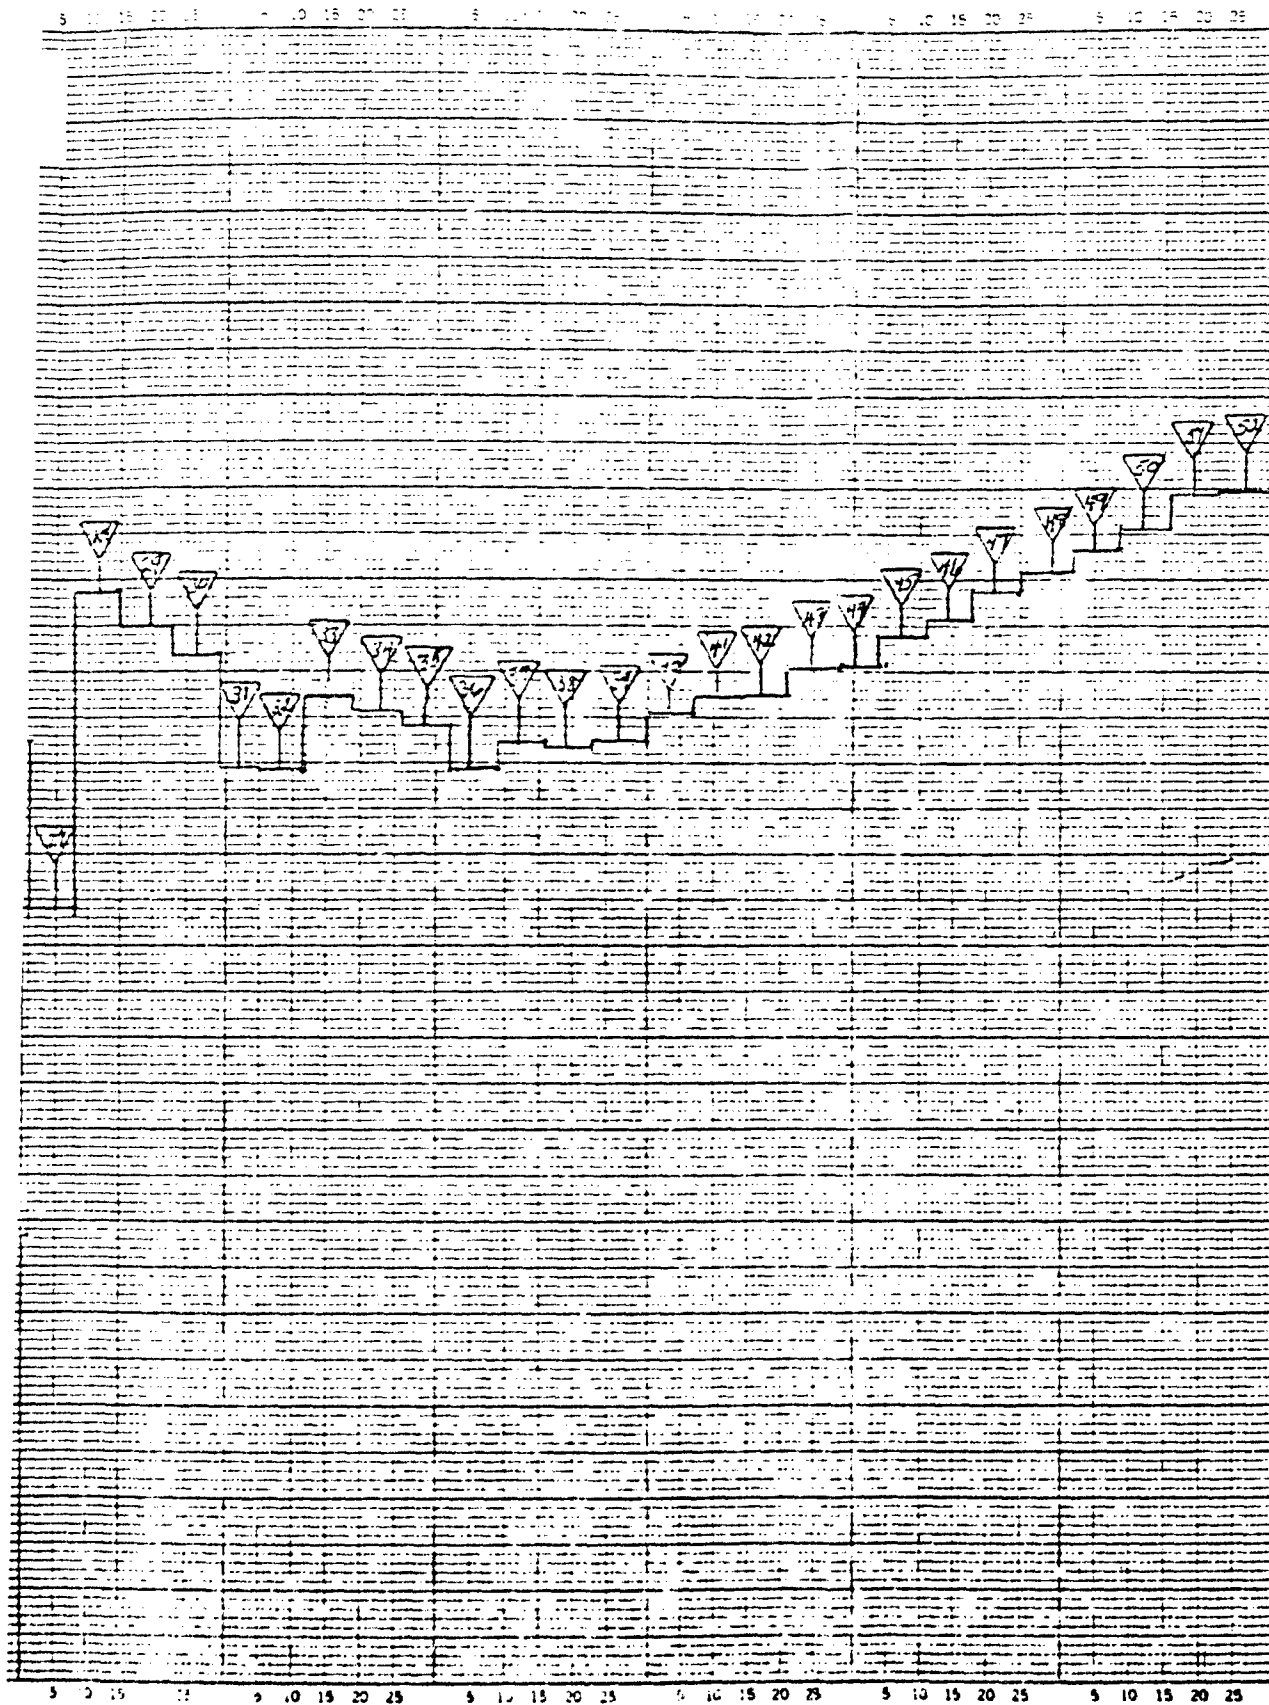
PLATE 6  
FLOW THROUGH ADSORBER - 1988

Both carbon treatment vessels operated at a 99+% stream factor in 1987, with 33 hours downtime for V-101 and 32 hours for V-102. In 1988, the system experienced more downtime because of corrosion problems with V-101 which necessitated repairs to the vessel and modifications to the system to install a third carbon treatment vessel, V-103. Total downtime for V-101/V103 was 126 hours for a 98.6% stream factor. V-102 downtime was 139 hours for a 98.4% stream factor.
