ARMY RESEARCH LABORATORY

## Investigation of the MK83 Bomb Ablative Coating Failures

ARL-TR-222

October 1993

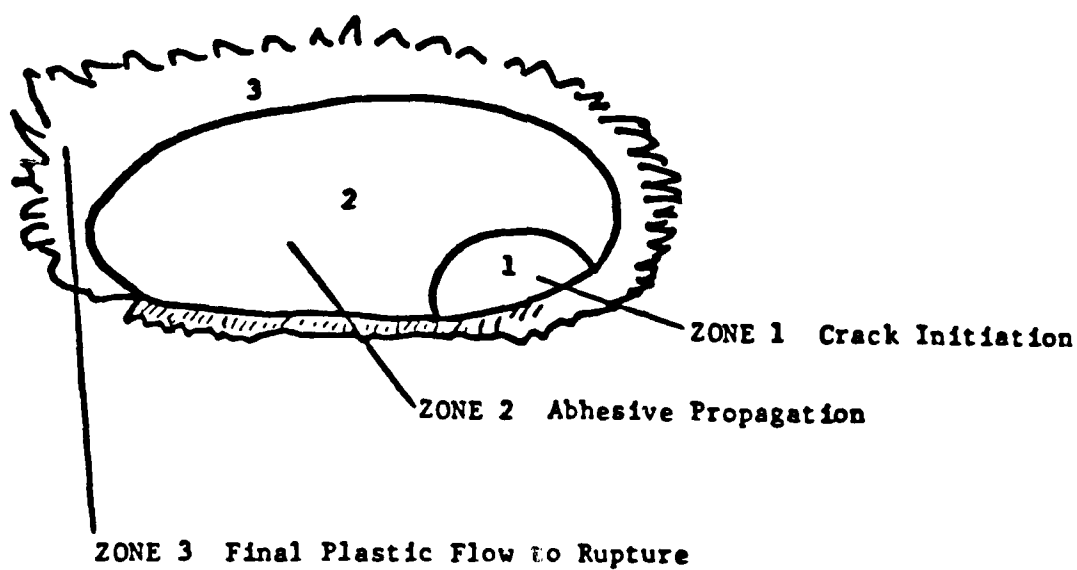
Figure 6. Schematic of the blister fracture face.

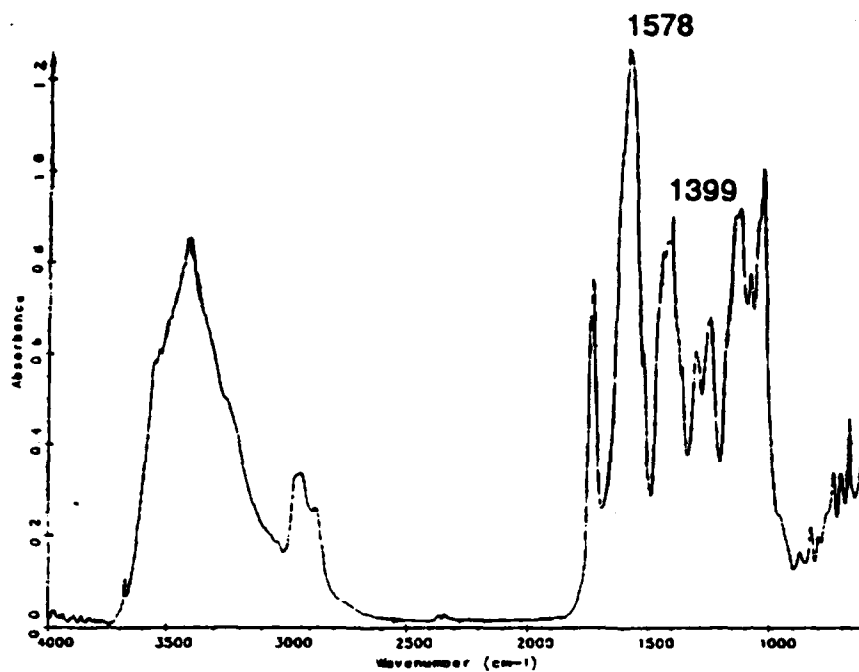
Attenuated total reflectance infrared spectroscopy was used to identify the crystalline spot on the interior primer surface of Specimen No. 2 and the fluid found on Specimen No. 4. Analysis of the crystalline spot on Specimen No. 2 (see Figure 7) revealed a spectrum that was similar to the spectrum obtained from the leached viscous fluid found on the bomb pallet saddle (see Figure 8). The peaks at 1580 cm<sup>-1</sup> and 1400 cm<sup>-1</sup> are typical of organic acid salts. These species may have formed when carboxylic acids generated by the oxidation or hydrolysis of a plasticizer (Dimethyl Phthalate) followed by reaction with aqueous salts. The aqueous salts would have originated from the contaminated zinc phosphate coatings and/or the dirty environments the bomb pallets were exposed to.

Figure 7. Infrared spectrum obtained from a crystalline spot on the interior primer surface of Specimen No. 2.

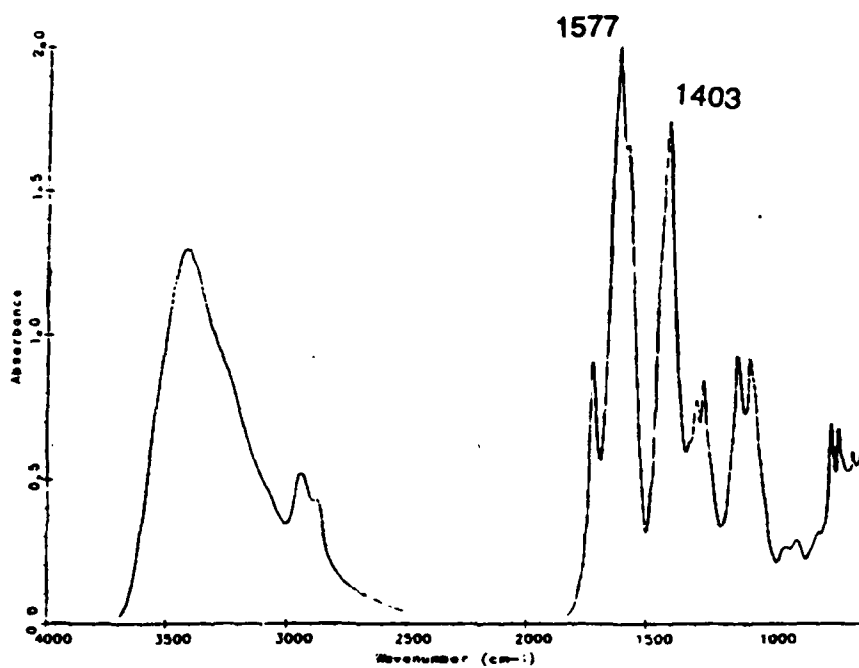
Further evidence supporting the presence of an organic acid salt was the decrease in the pH of distilled water from 6.1 to 5.6 when the leached viscous fluid from the bomb pallet saddle was dissolved in the water.

Figure 8. Infrared spectrum obtained from the leached viscous fluid found on Specimen No. 4, the bomb pallet saddle.

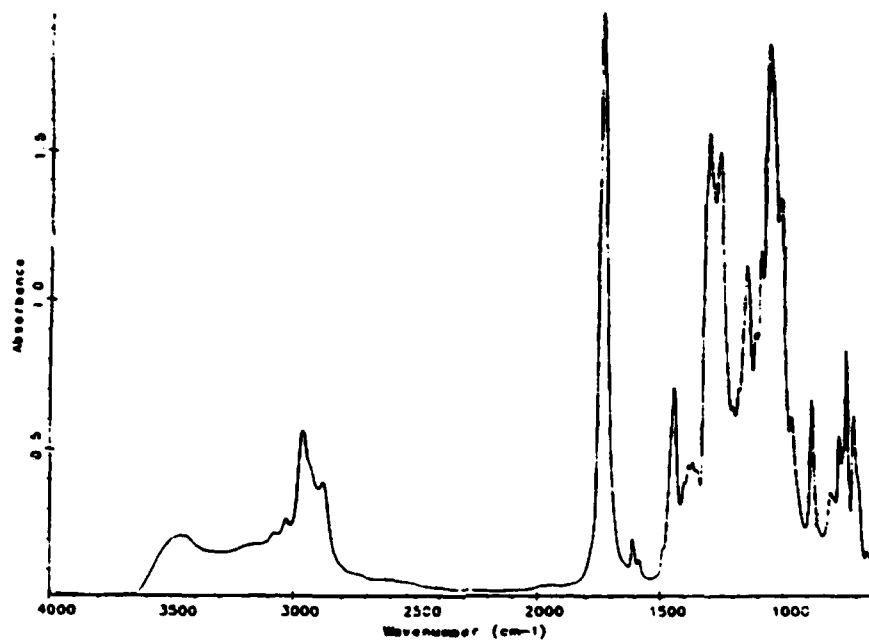
In a comparison of the spectra of an acetone extract of the ablative (see Figure 9), the leached viscous fluid and crystalline spot were similar as well; this suggests that the leached viscous fluid probably came from the polyester.

Figure 9. Infrared spectrum obtained from an acetone extract of the polyester ablative.
