**THESIS**

**A CASE STUDY OF THE USS *DWIGHT D. EISENHOWER*  
COLLISION AND ITS IMPLICATIONS**

**Patrick J. Dennison**

**September 1993**

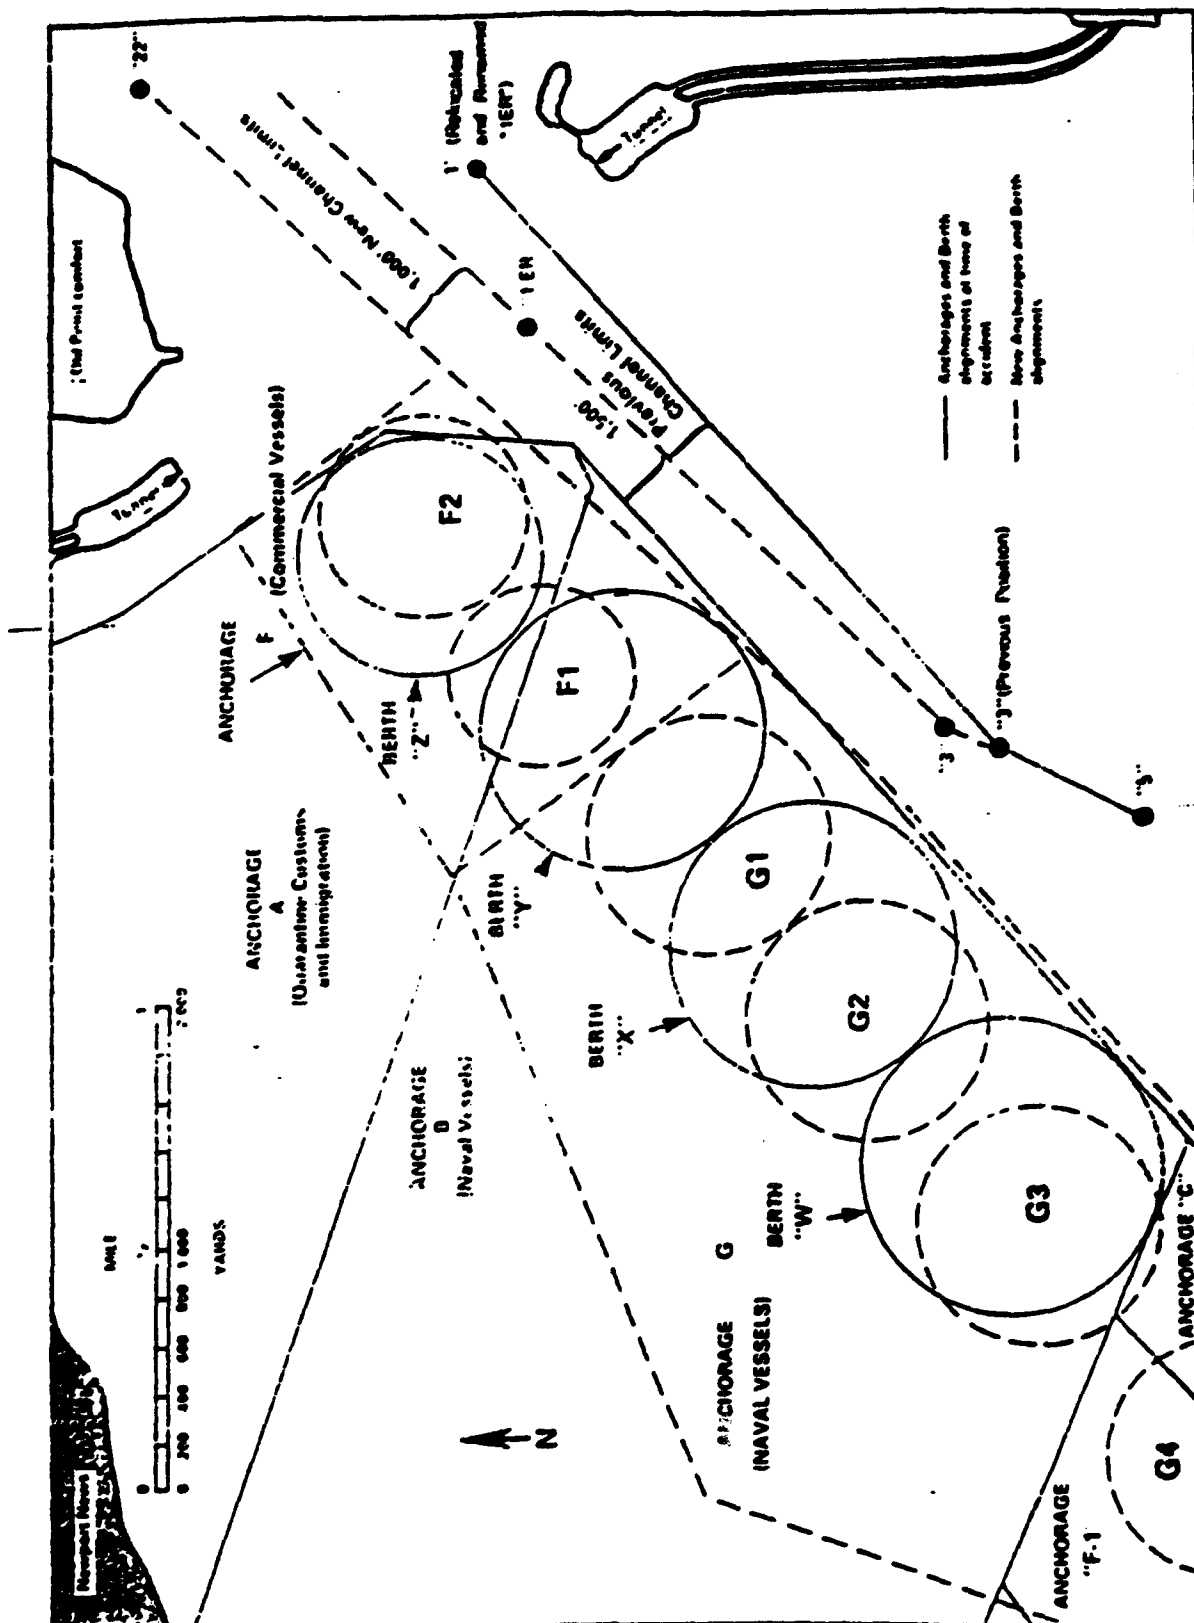
Figure II-2. Anchorages adjacent to Entrance Reach Channel

The *EISENHOWER's* track through Entrance Reach Channel was intentionally laid by the Navigator along the northwest edge of the charted reach to compensate for the new position of Elizabeth River Buoy 1. The *EISENHOWER's* new track passed within 200 yards of anchorage ZULU (where the *URDULIZ* was anchored) and was tangent to X-RAY and YANKEE anchorages 250 yards from the center of the channel (all anchorages are shown in Figure II-2).

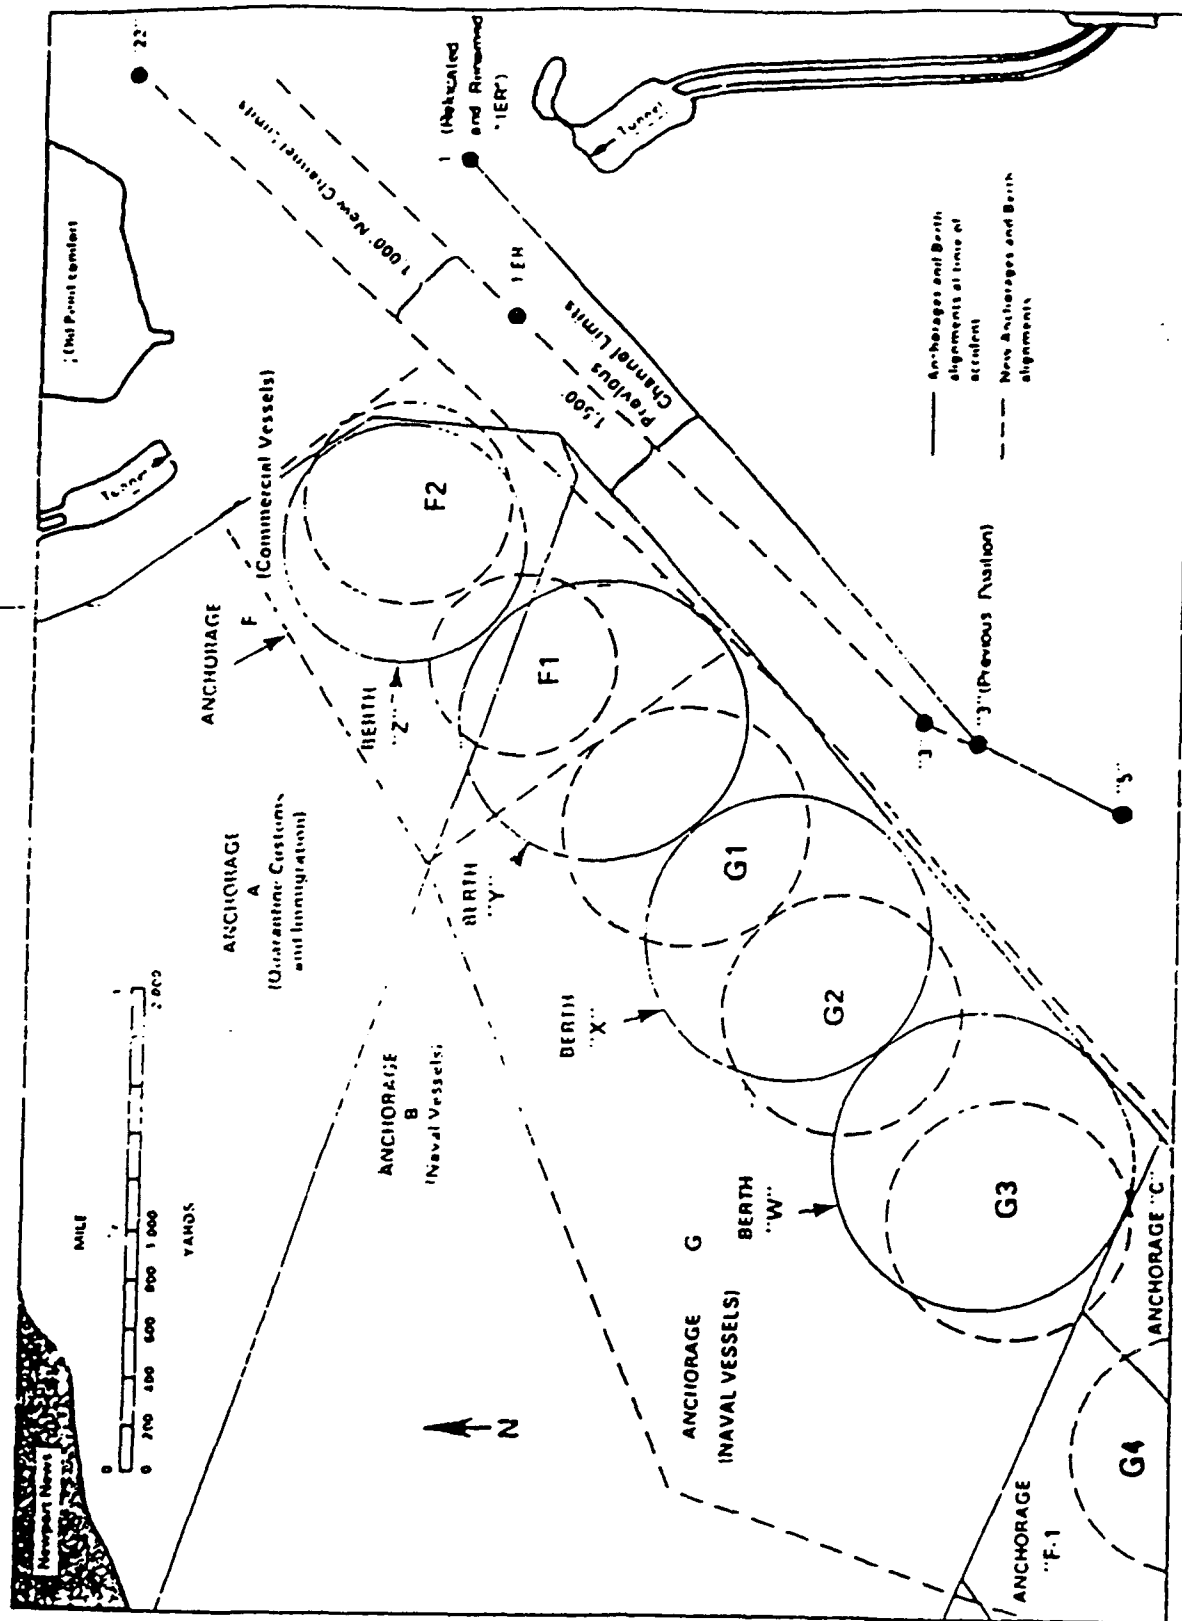
Figure III-1 Anchorages adjacent to Entrance Reach Channel

The pertinent anchorages in the Entrance Reach Channel at the time of the collision are labelled as shown in **Figure III-1**. Anchorage "A" was the Quarantine, Customs, and Immigration Anchorage for commercial vessels and was also used by deep drafts waiting to load or unload their cargo. The sizable anchorage included the 1,500 foot - radius berth "Z" in which URDULIZ was anchored. The southern edge of berth "Z" was located 600 feet north of the northern edge of Entrance Reach Channel **before** the channel was narrowed. After the channel was narrowed, the southern edge was only 300 feet from the channel edge. In fact, the southern boundary of Anchorage "A" was also the northern edge of the previous Entrance Reach Channel, yet was not marked by any navigational buoys. The explanation for the Coast Guard's decision not to place buoys near the anchorage was explained as follows: "...when you put buoys near an anchorage they get run over and serve only as a hazard to navigation" [Ref.2:p. 34].
