Technical Report SL-93-22  
November 1993

## Assessment of Accident at Radford Army Ammunition Plant

Final report

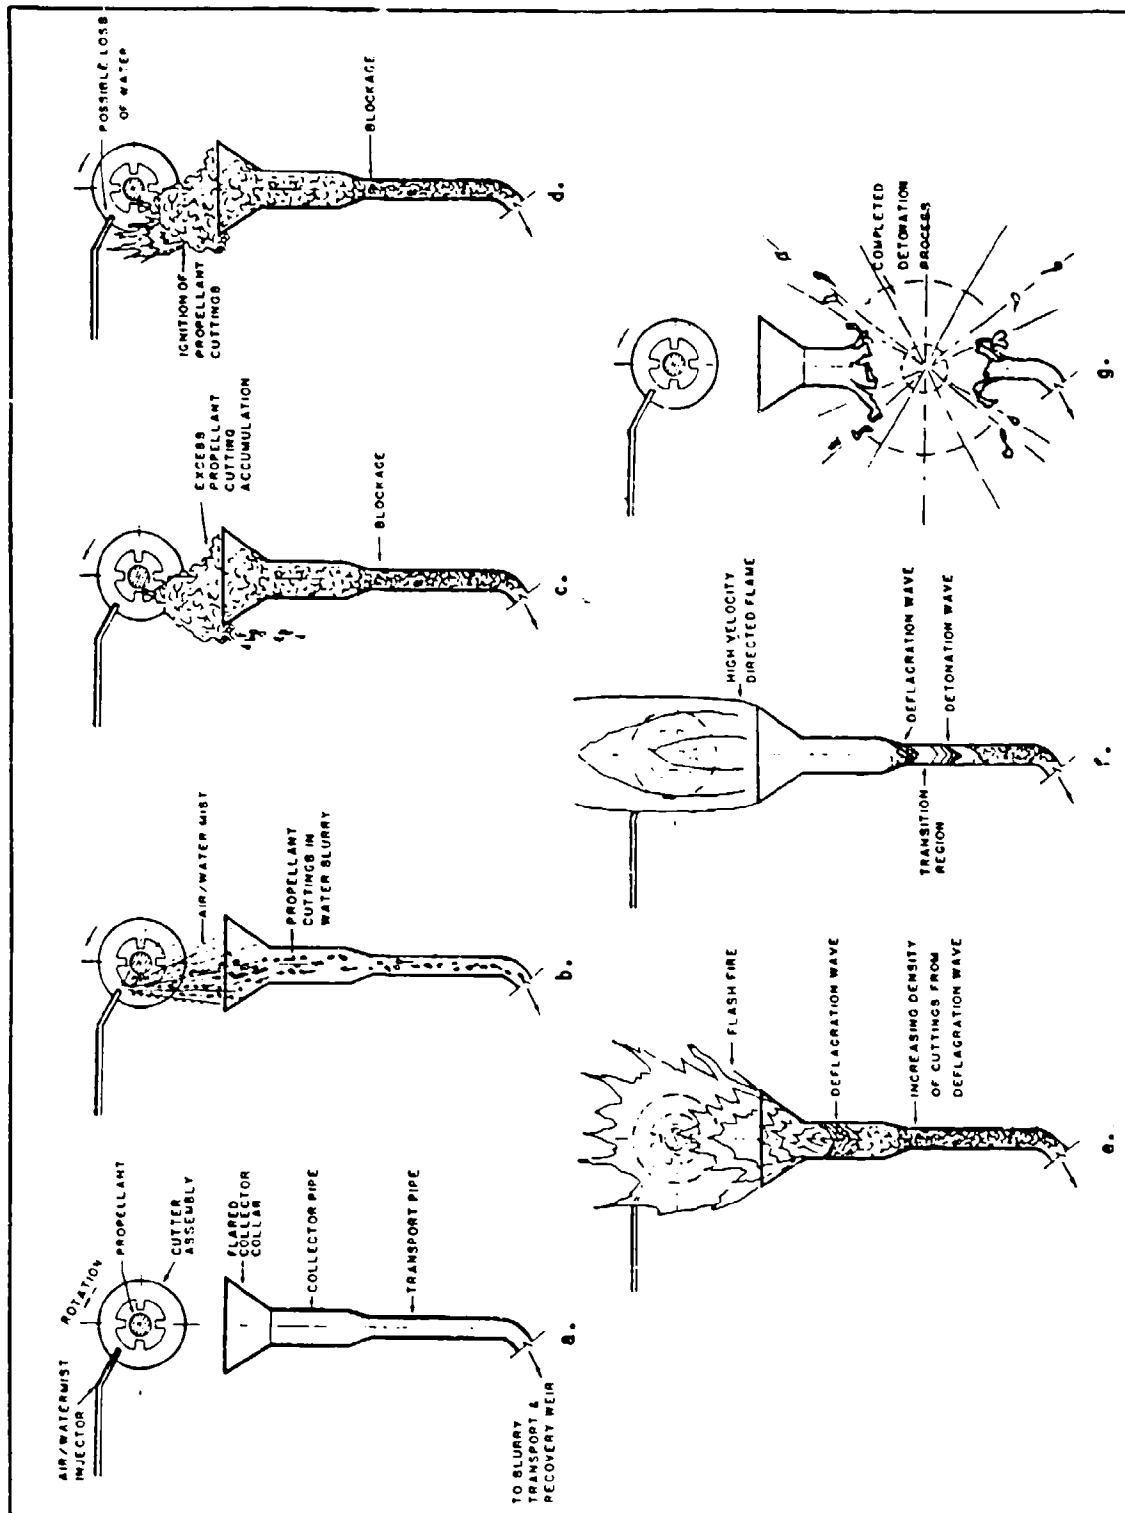
Figure 1. Postulated point of detonation and detonation sequence

- a. Cutting transport system failed (Figure 1c).
- b. Or did not remove the accumulated cuttings rapidly enough.
  - (1) The machinist may have been cutting the propellant at too rapid a rate.
  - (2) A portion of the propellant may have broken off and lodged in the removal pipe, causing a blockage.

- (3) The air/water mist system may have failed, leaving only dry, compressed air to remove the cuttings (Figure 1d).
  - (4) Any combination of b(1) through b(3) could have occurred.

- c. An excess of propellant cuttings accumulated up to the vicinity of the cutter head (Figure 1d).
- d. The excess, dry cuttings were ignited (Figure 1d).

- (1) From excess heat build-up.
  - (2) From a spark.
  - (3) From static build-up and discharge.
- f. The subsequent deflagration propagated into the discharge pipe (which likely was full of dry propellant cuttings), Figure 1e.

- g. The deflagration velocity jumped to detonation wave speed (Figure 1f)
  - (1) If sufficient confinement was present.
  - (2) If the pressure remained or increased such that the detonation wave was sustained (Figure 1f).

- h. An explosion would have then been probable (Figure 1g).
- i. Sympathetic detonation of the remaining propellant "dowels" could have occurred (if it was not already consumed by the initial fire).
