FINAL REPORT  
MAY 1993

REPORT NO. 93-20

TRANSPORTATION TEST OF  
M876A1 U.S. MARINE CORPS  
(USMC) TELEPHONE  
MAINTENANCE TRUCK (TMT)

VALIDATION ENGINEERING DIVISION  
SAVANNA, ILLINOIS 61074-9639

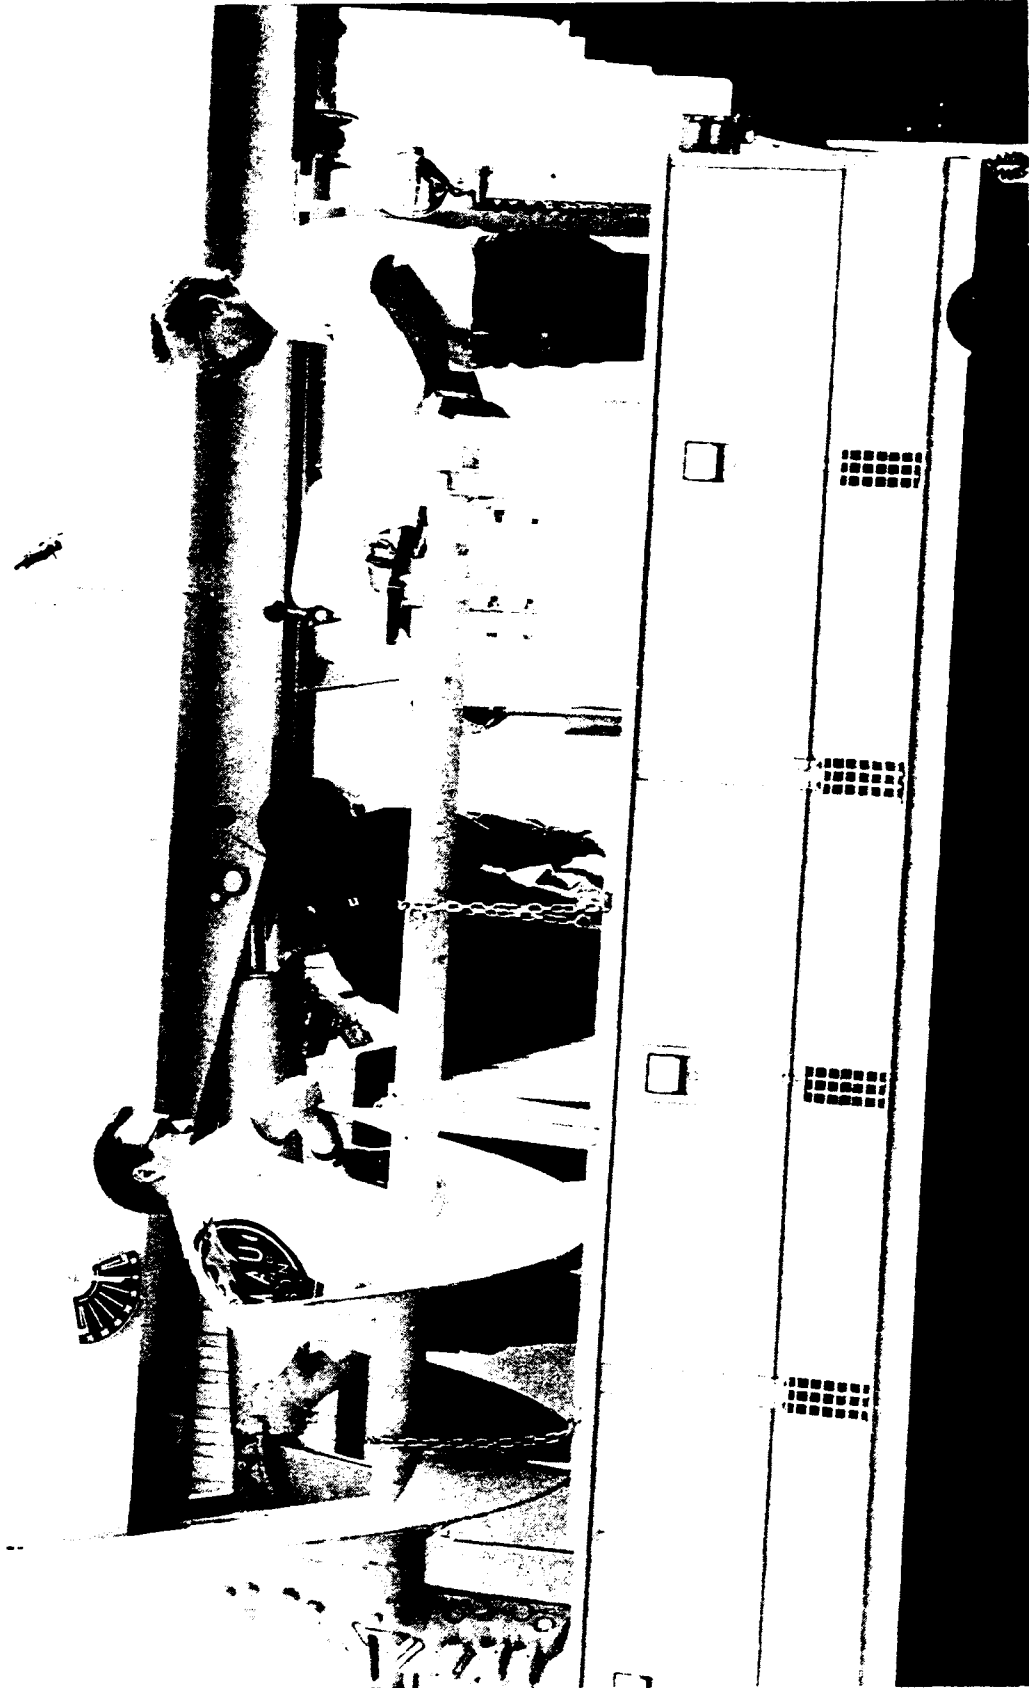
PHOTO NO. A0317 SCN93-152-1871. This photo shows a closeup view of the 30-inch auger mounting brackets which display the welding of the equipment cabinet tops. This mounting configuration was insufficient to secure the auger during rail transportation.

2. The 30-inch auger mounted on the equipment cabinets should either be removed or mounted in another location on the vehicle where it can be substantially secured.

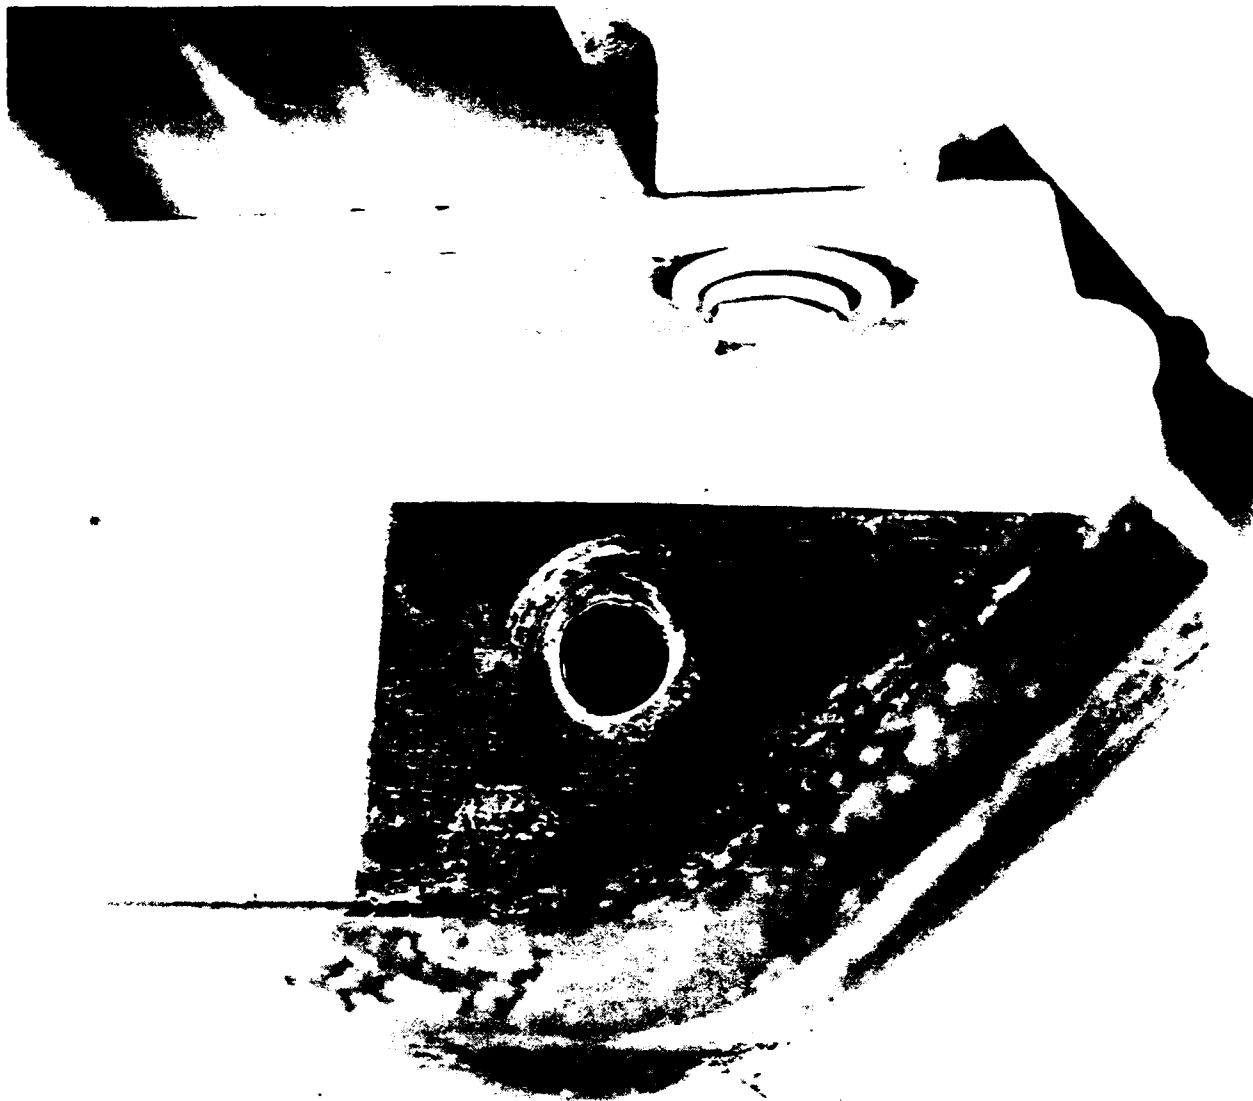
PHOTO NO. A0317-SCN93-152-2232. This photo shows the TMTB boom rest pedestal with the boom in the stowed position. A plate was welded to the pedestal and drilled through for a pin to lock the boom to the pedestal. The bolts used to secure the boom pedestal interface were resecured with Locktite adhesive to prevent them from vibrating out while going through the road hazard course.

b. Road Hazard Course Testing. Two modifications were made to the TMTB boom assembly. First, plates were welded to the boom rest pedestal and drilled so that the boom could be pinned to the pedestal. Secondly, a shim was welded into the auger clamp on the boom with the intent that the reduced tolerance on the clamp would reduce the rotation.

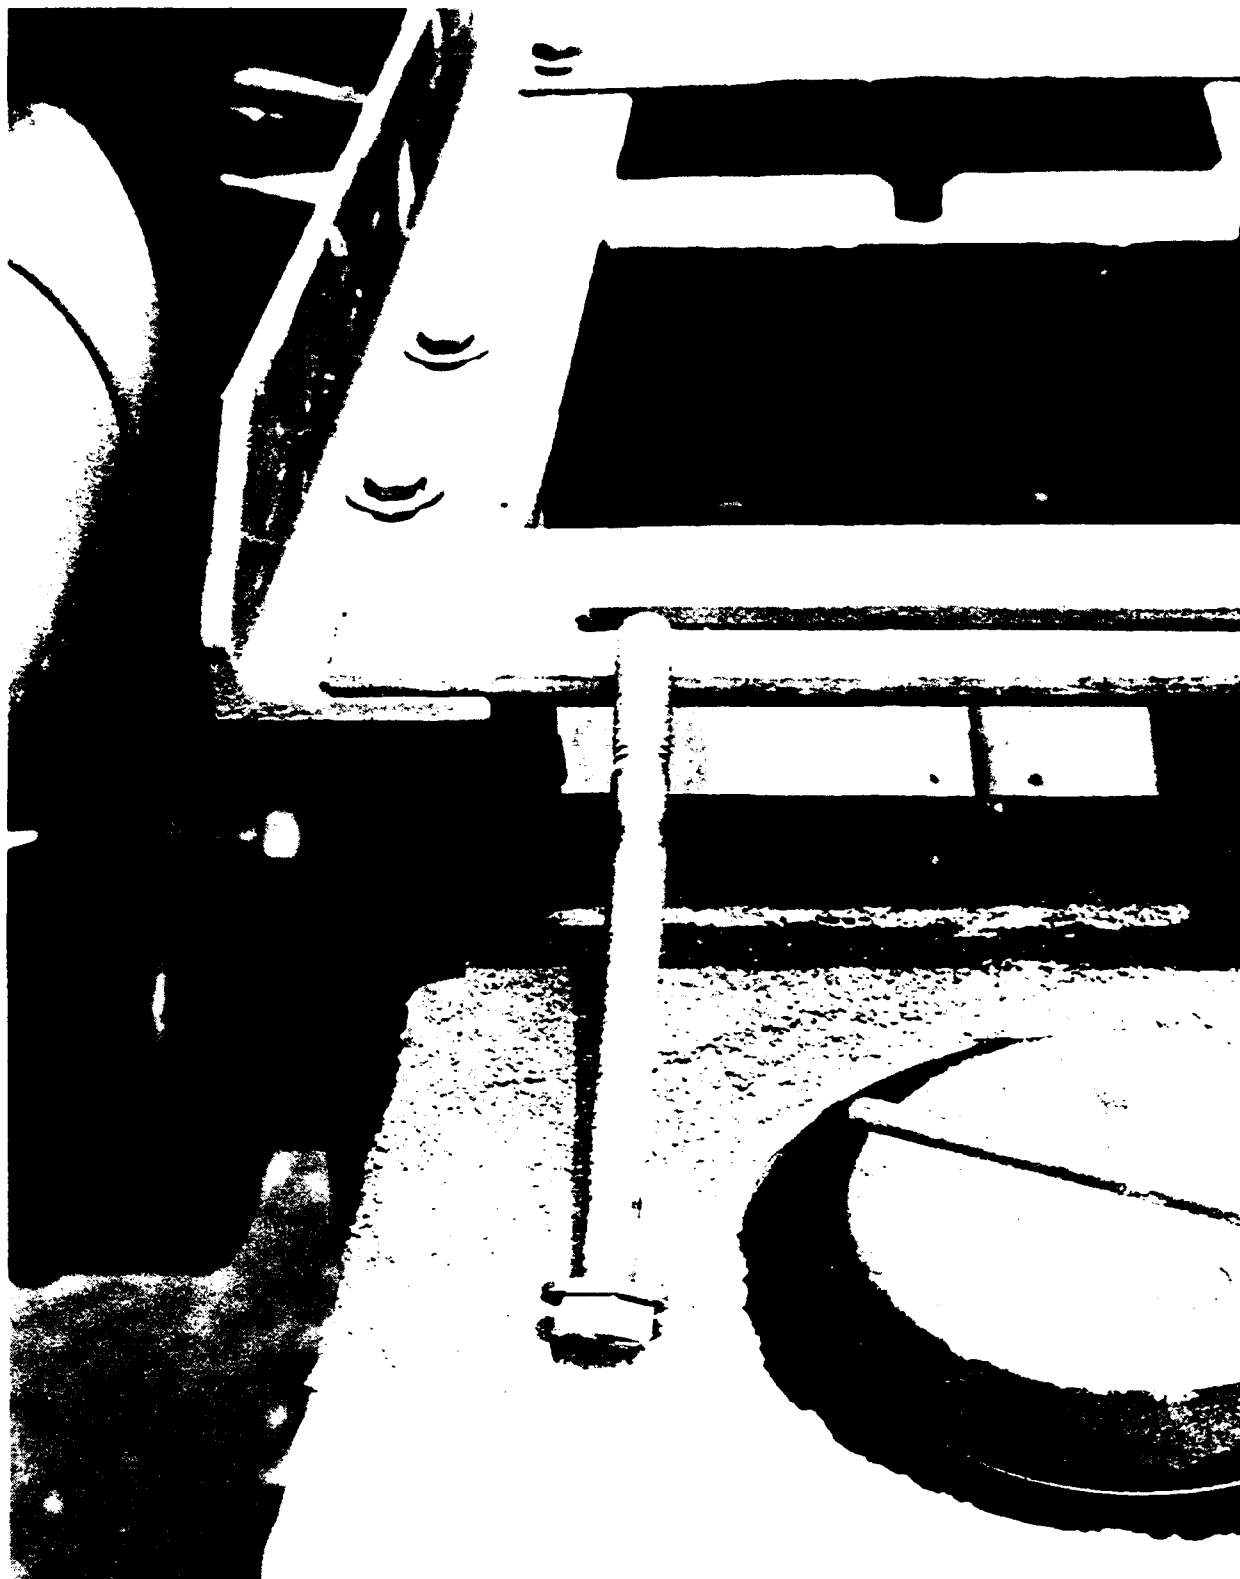
REMARKS: The pin used to secure the boom to the rest pedestal deformed after one pass over the course. It was replaced with a grade 8-equivalent steel bolt.

PHOTO NO. A0317-SCN93-152-2230. This bolt was originally used to secure the TMTB boom to the rest pedestal. Note the deformation. This bolt was replaced with a grade 8-equivalent bolt. No damage occurred to the grade 8 bolt during road hazard course testing.
