Technical Report RFMR-CS-42  
February 1994

## **Overlays on Horizontal Concrete Surfaces: Case Histories**

by *Roy L. Campbell, Sr.*  
*Structures Laboratory*

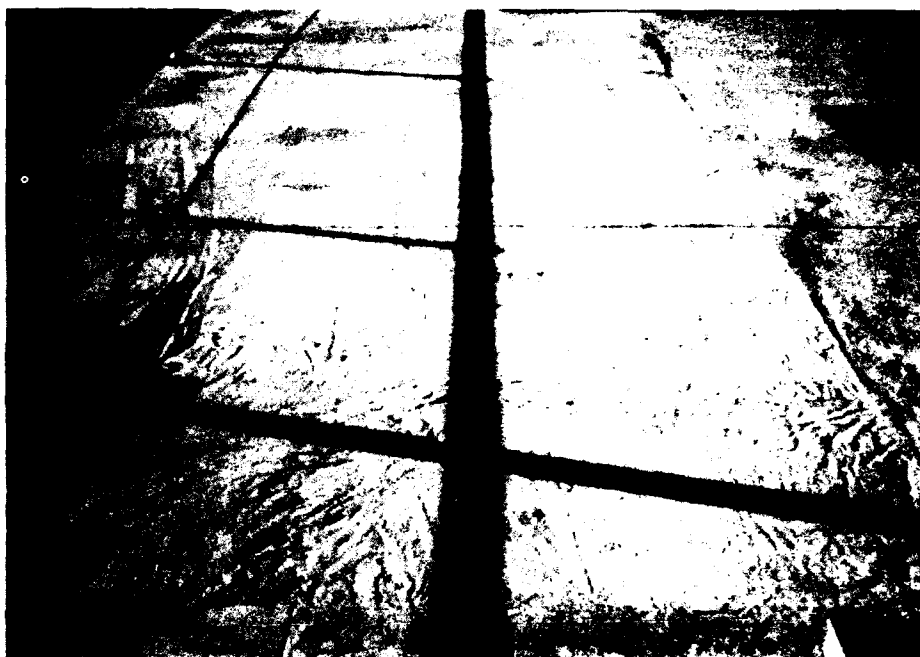
Minor cracking was observed in the overlay during a visit to Mississippi River Locks 22 in August 1991. Cracking was most frequent at corners of blockouts (Figure 30). These cracks were random in direction and typically intersected other cracks that were random in direction. In general, the cracks appeared to be: (a) smaller in width and length than similarly located cracks seen at Mississippi River Locks 17, 18, and 20 where 4-in. (102-mm) deep low-slump concretes had been placed; and (b) slightly larger longer than similarly located cracks seen at Mississippi River Lock 21 where 4-in. (102-mm) deep, polypropylene-fiber-reinforced concrete had been placed.

Figure 30. Cracking typically found at corners of blockouts, Mississippi River Lock 22, 1989

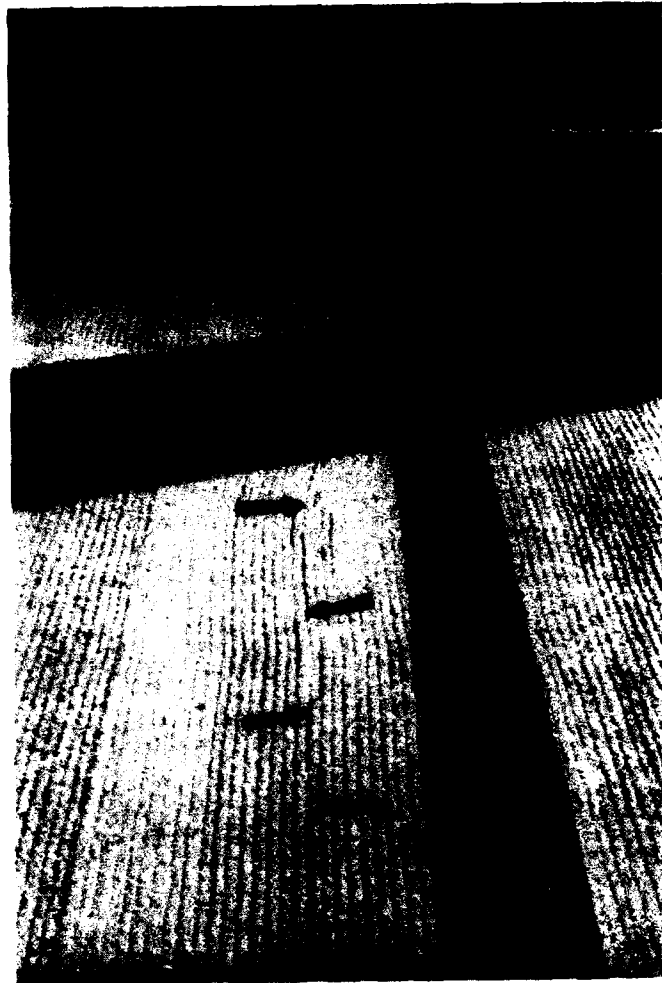
Figure 33. Transverse crack in overlay near joint,  
Reedv Point Bridge, 1990
