AEROSPACE REPORT NO.
TR-92(2935)-11

Surface Contamination on LDEF Exposed Materials

15 June 1992

C. S. HEMMINGER
Mechanics and Materials Technology Center
Technology Operations

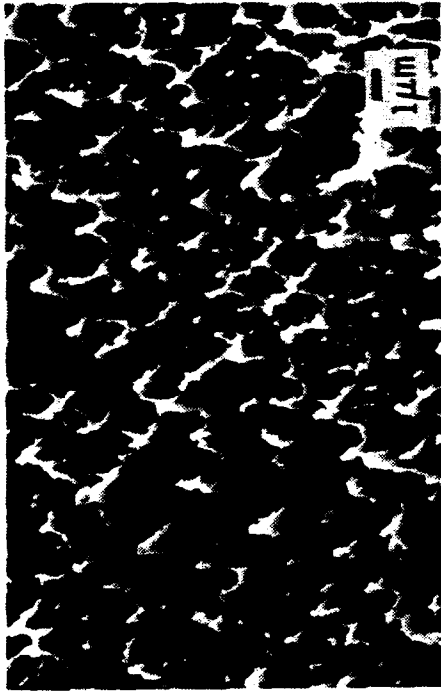
LDEF TRAY C11 EXPOSED TEFLON

The SEM and XPS results² for the exposed Ag/FEP surfaces are summarized in Table 7. The leading edge samples, from row 7 to 11, all had roughened surfaces typical of high velocity atomic oxygen erosion of FEP, as seen in Fig. 1 for FEP exposed on C11 compared to a featureless control surface. The highly textured surfaces gave rise to diffuse light scattering and the consequent cloudy appearance. The XPS data for the control surface showed carbon and fluorine only. The XPS analysis of the exposed surfaces showed that the surface composition of the FEP remaining after the erosion was indistinguishable in carbon and fluorine composition from the control, with trace amounts of some contaminants (Si, N, S, and Cl) and measurable oxygen present. This oxygen could be from the atomic oxygen interaction or from water adsorption from the atmosphere after retrieval. Water adsorption could be enhanced on the erosion-roughened surfaces which have much higher surface area than the control. The surface chemistry of these leading edge samples was identical to clean FEP Teflon, judged by a comparison of the F:C mole ratio and the C1s peak shape. The C1s spectrum from the D7 blanket surface is shown in Fig. 2a; curve-fitting revealed the major CF₂ peak at 292 eV and moderate CF and CF₃ peaks (approximately 10% each) at 289.5 eV and 294 eV, respectively. This matched the spectrum predicted for FEP with an approximate ethylene/propylene comonomer blend of 90%/10%. It appeared that deposited contaminants and damaged polymer were both removed during atomic oxygen erosion.

Fig. 1. SEM images and surface composition of FEP. A leading edge surface with atomic oxygen erosion is compared to a featureless control surface.

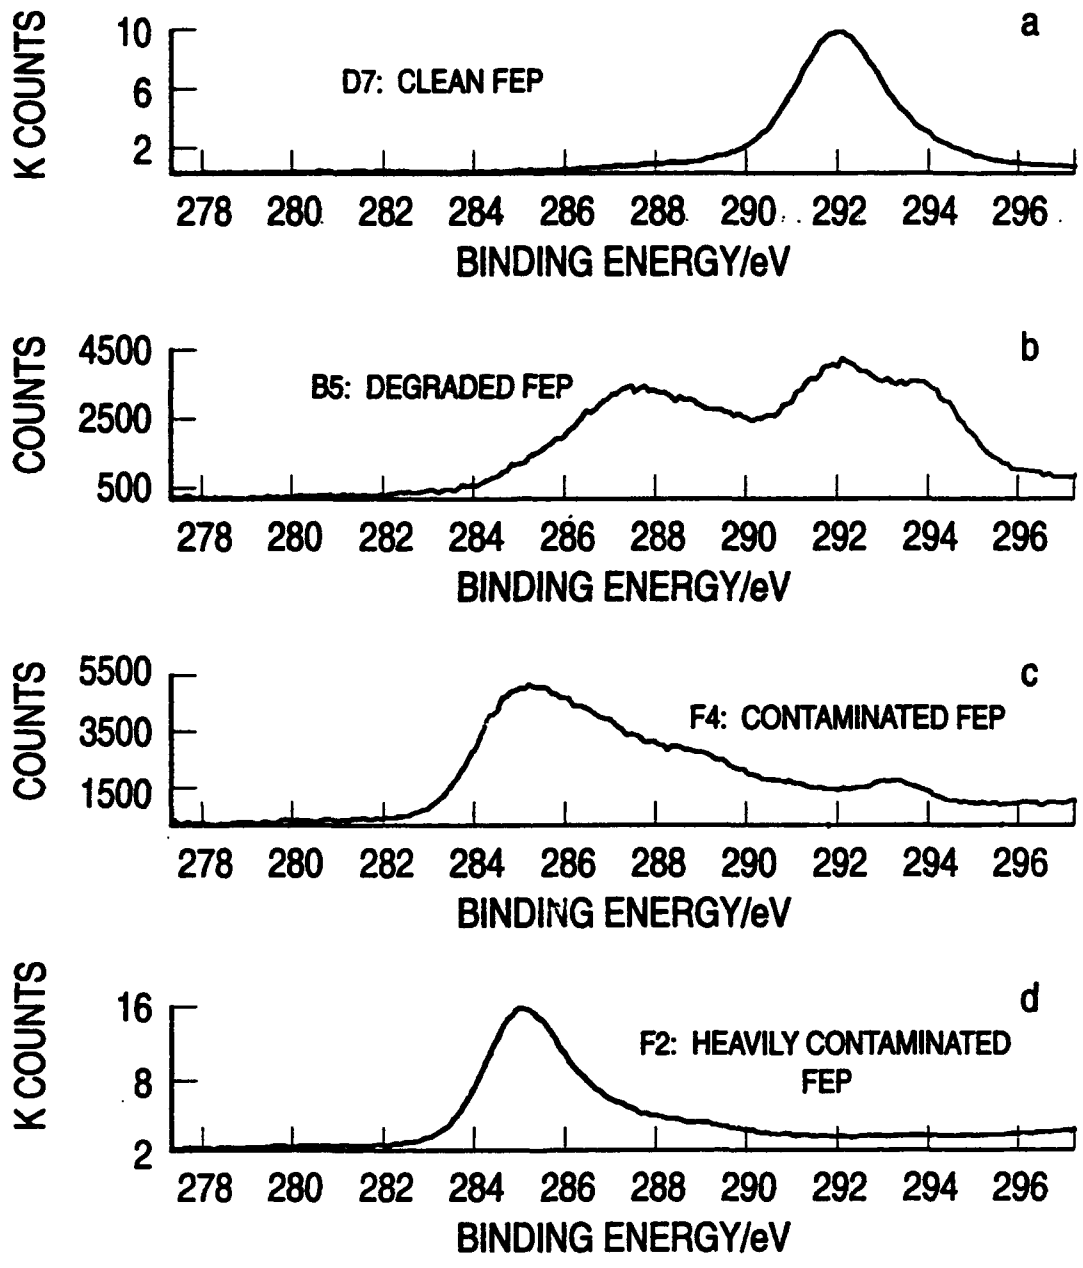
Fig. 2. XPS spectrum of the C1s peak; (a) of the D7 blanket surface representative of clean FEP; (b) of the B5 blanket surface-representative of degraded FEP.; (c) of the F4 blanket surface representative of contaminated FEP; (d) of the F2 blanket surface-representative of heavily contaminated FEP.

XPS data divided the trailing edge surfaces into two categories. The first was characterized by low contamination levels ($\text{Si} < 1\%$) and a C1s spectrum, as in Fig. 2b, that differs significantly from that of clean FEP, but does not have a major peak at 285 eV. The second category was characterized by moderate to high levels of surface contamination (Si , O , C , N , and S , and sometimes Cl) and a C1s spectrum dominated by a peak at 285 eV, as seen in Figs. 2c and d. Contaminant carbon was distinguishable from FEP and degraded FEP carbon by binding energy, and was measured at $\leq 20\%$ of the total surface composition. The C1s peak at 285 eV is predominantly due to C-C bonds, and is thought to build up on the trailing edge surfaces from decomposition products of outgassed silicones and hydrocarbons. The C1s spectrum in Fig. 2b arises from degradation of the FEP surface, for which the C1s spectrum is shown in Fig. 2a. Curve-fitting shows that the decrease in intensity of the CF_2 peak at 292 eV is accompanied by major increases in intensity at 294 eV, 289.5 eV, and 287 eV, assigned to CF_3 , CF , and $\text{C}-(\text{CF}_n)_4$, respectively. These changes are consistent with damage to the carbon backbone of the Teflon polymer resulting in molecular weight degradation, new chain terminations, branching, and crosslinking through free radical reactions. The solar ultraviolet (UV) radiation exposure of the LDEF surfaces is thought to have caused this FEP surface degradation. The FEP surfaces were also exposed to the stress of about 34,000 thermal cycles, but the maximum temperatures calculated for Ag/FEP blankets on LDEF are less than 0°C and not sufficient to break chemical bonds.³ Exposure of FEP to the XPS x-ray source for several hours induced similar shifts in the C1s spectrum; almost all of the FEP C1s spectra used for curve-fitting in this study were acquired during the first minute of sample exposure to the x-ray source to minimize surface degradation from the analysis itself. A recent study of the degradation of polytetra-fluoroethylene (PTFE) Teflon by 3 keV electrons showed very similar XPS C1s spectra changes to those seen in Fig. 2b as a function of electron irradiation and subsequent heating to drive off volatiles⁴. Degradation of the PTFE was attributed to the type of damage described above.

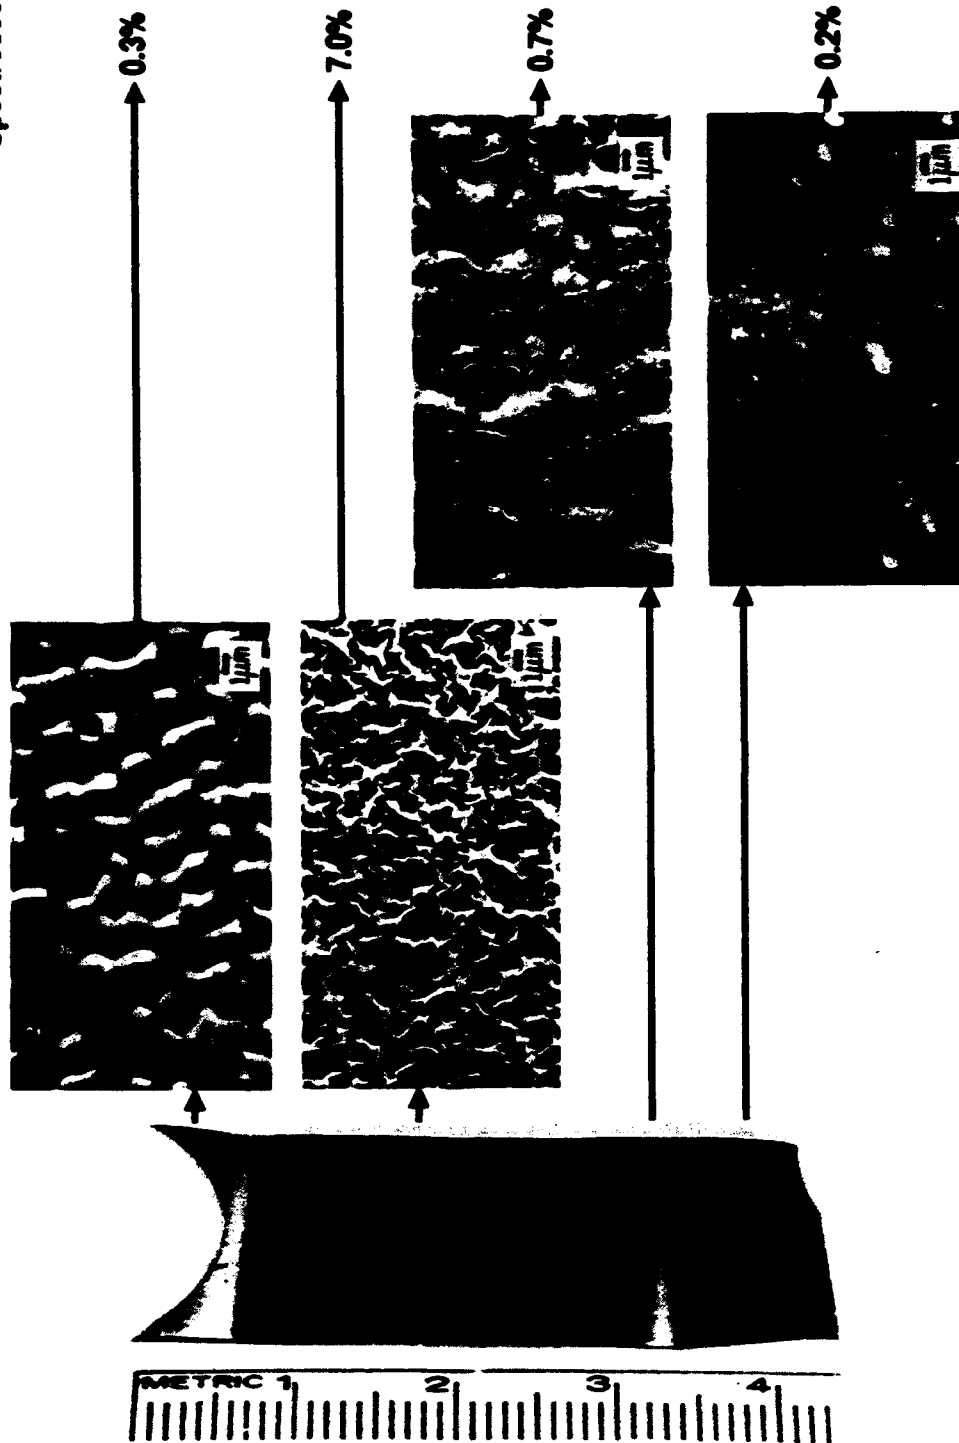
LDEF
Tray F4
Silver/Teflon

The predominant chemical state of Si identified on the trailing edge FEP surfaces was SiO_2 . Si concentrations were measured to be ≤ 20 mole %, indicating up to about 60% as the oxide. The contaminant film was definitely nonuniform over large areas, and was probably patchy on a submicron scale. Significant areas must be covered by $< 100 \text{ \AA}$ of deposited contamination, because fluorocarbon was detected on each FEP surface analyzed. The damaged FEP layer is probably thicker than the depth of analysis.

Fig. 3. SEM images of surface morphology changes observed on a section of the trailing edge F4 blanket surface. The FEP surface appeared visibly patterned, as seen in the photograph on the left. The surface contamination, represented by Si concentration, was very nonuniform.

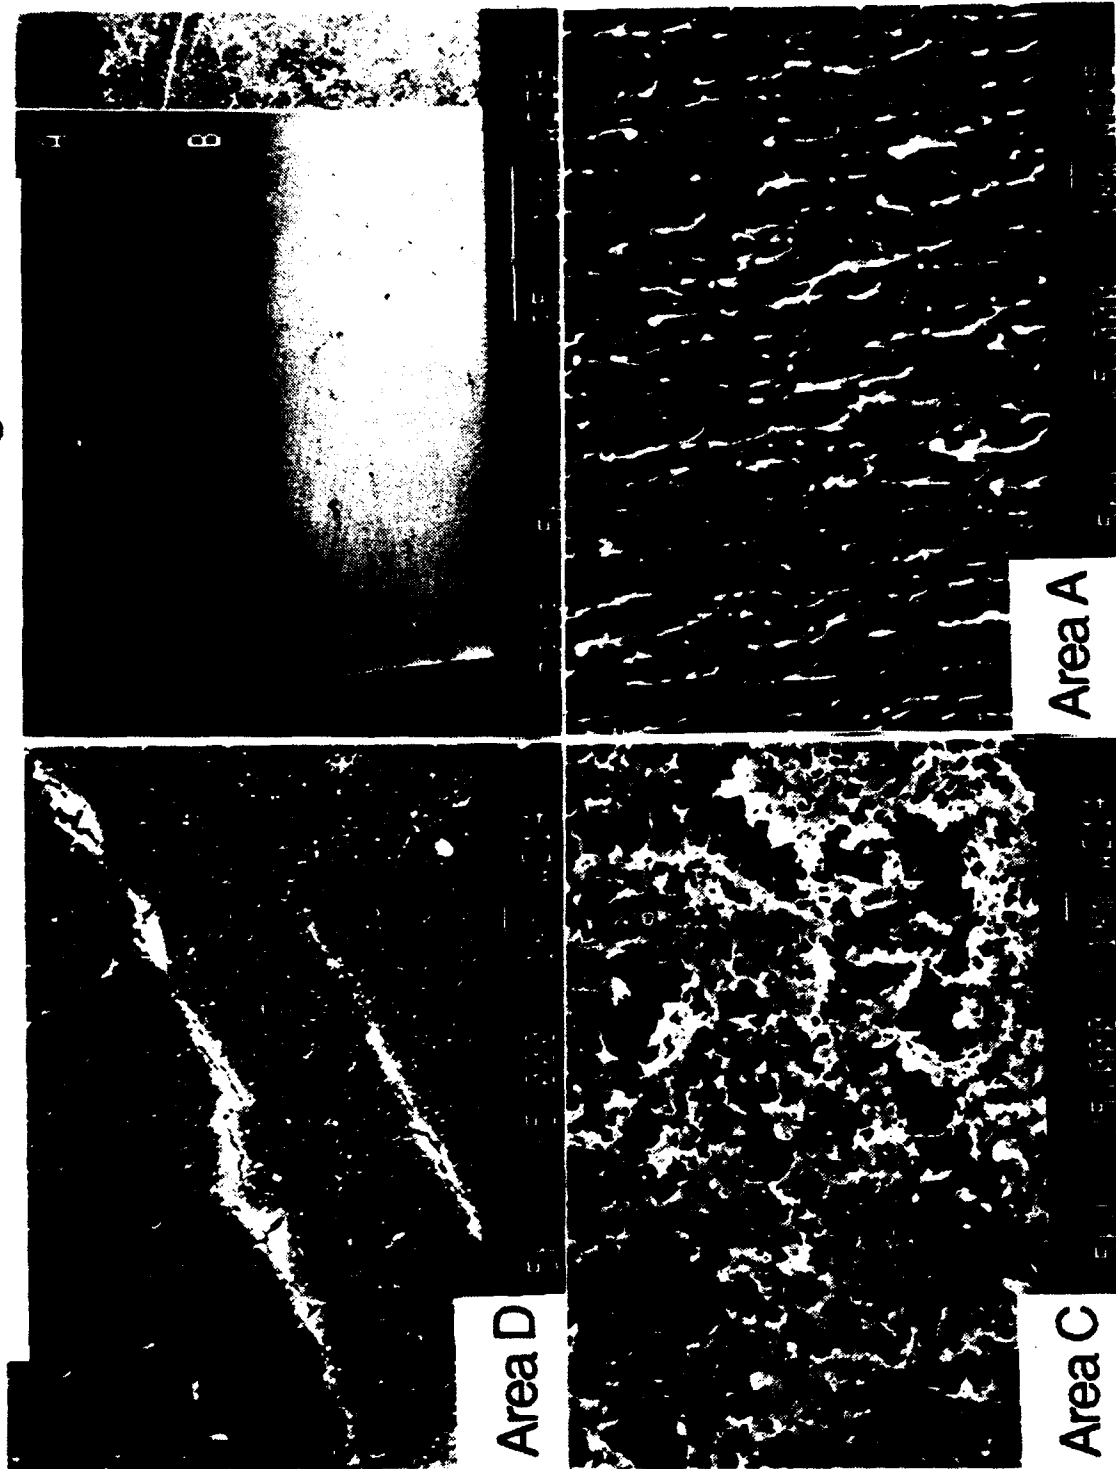
AO Erosion of A10 Thermal Blanket Edge Surface

The Ag/FEP thermal control blanket edges were contaminated, in many cases more than the exposed surfaces. Therefore, the masked edges did not provide good flight "control" samples. The transition zone from the exposed surface to the masked edge was particularly prone to contamination build-up. This was probably the result of the combination of high out-gas flux and radiation. The blankets were bent down around the edges of the tray so that the blanket edges were not rigorously shielded from radiation. SEM images from one transition zone, seen in Fig. 4, showed that during atomic oxygen erosion of the FEP surface, undercutting of the contamination and damaged polymer layer played a role in the development of a clean, highly textured surface. Area A, at the periphery of the exposed surface, had a characteristic atomic oxygen erosion pattern. Area D, closer to the blanket edge, was a surface with contamination coverage and UV degraded FEP. Area C, in the center of the transition zone, showed undercutting of the contamination and damaged polymer layer by atomic oxygen erosion. The development of submicron particles of SiO₂ was observed on some edge surfaces by SEM/EDS, as seen in Fig. 5. Such particle development was not detected on any of the other samples included in this study. Areas of orange/brown contamination were observed on some Ag/FEP edge surfaces near keyhole-shaped vent slots in the blanket edges. XPS analysis showed these stains to be high in carbon, sulfur, and nitrogen relative to other contaminated areas. The source of contamination was not identified, but it appears to have contained an amine/amide functionality.

Fig. 4. SEM images of a transition zone on the A10 blanket edge. Area A has the characteristic atomic oxygen erosion pattern. Area D is a surface with contamination coverage and UV degraded FEP. Area C shows undercutting of the contamination and damaged polymer layer.
