Community Environmental Response Facilitation Act (CERFA) Report

Bennett Army National Guard Facility Bennett, Colorado

April 1994

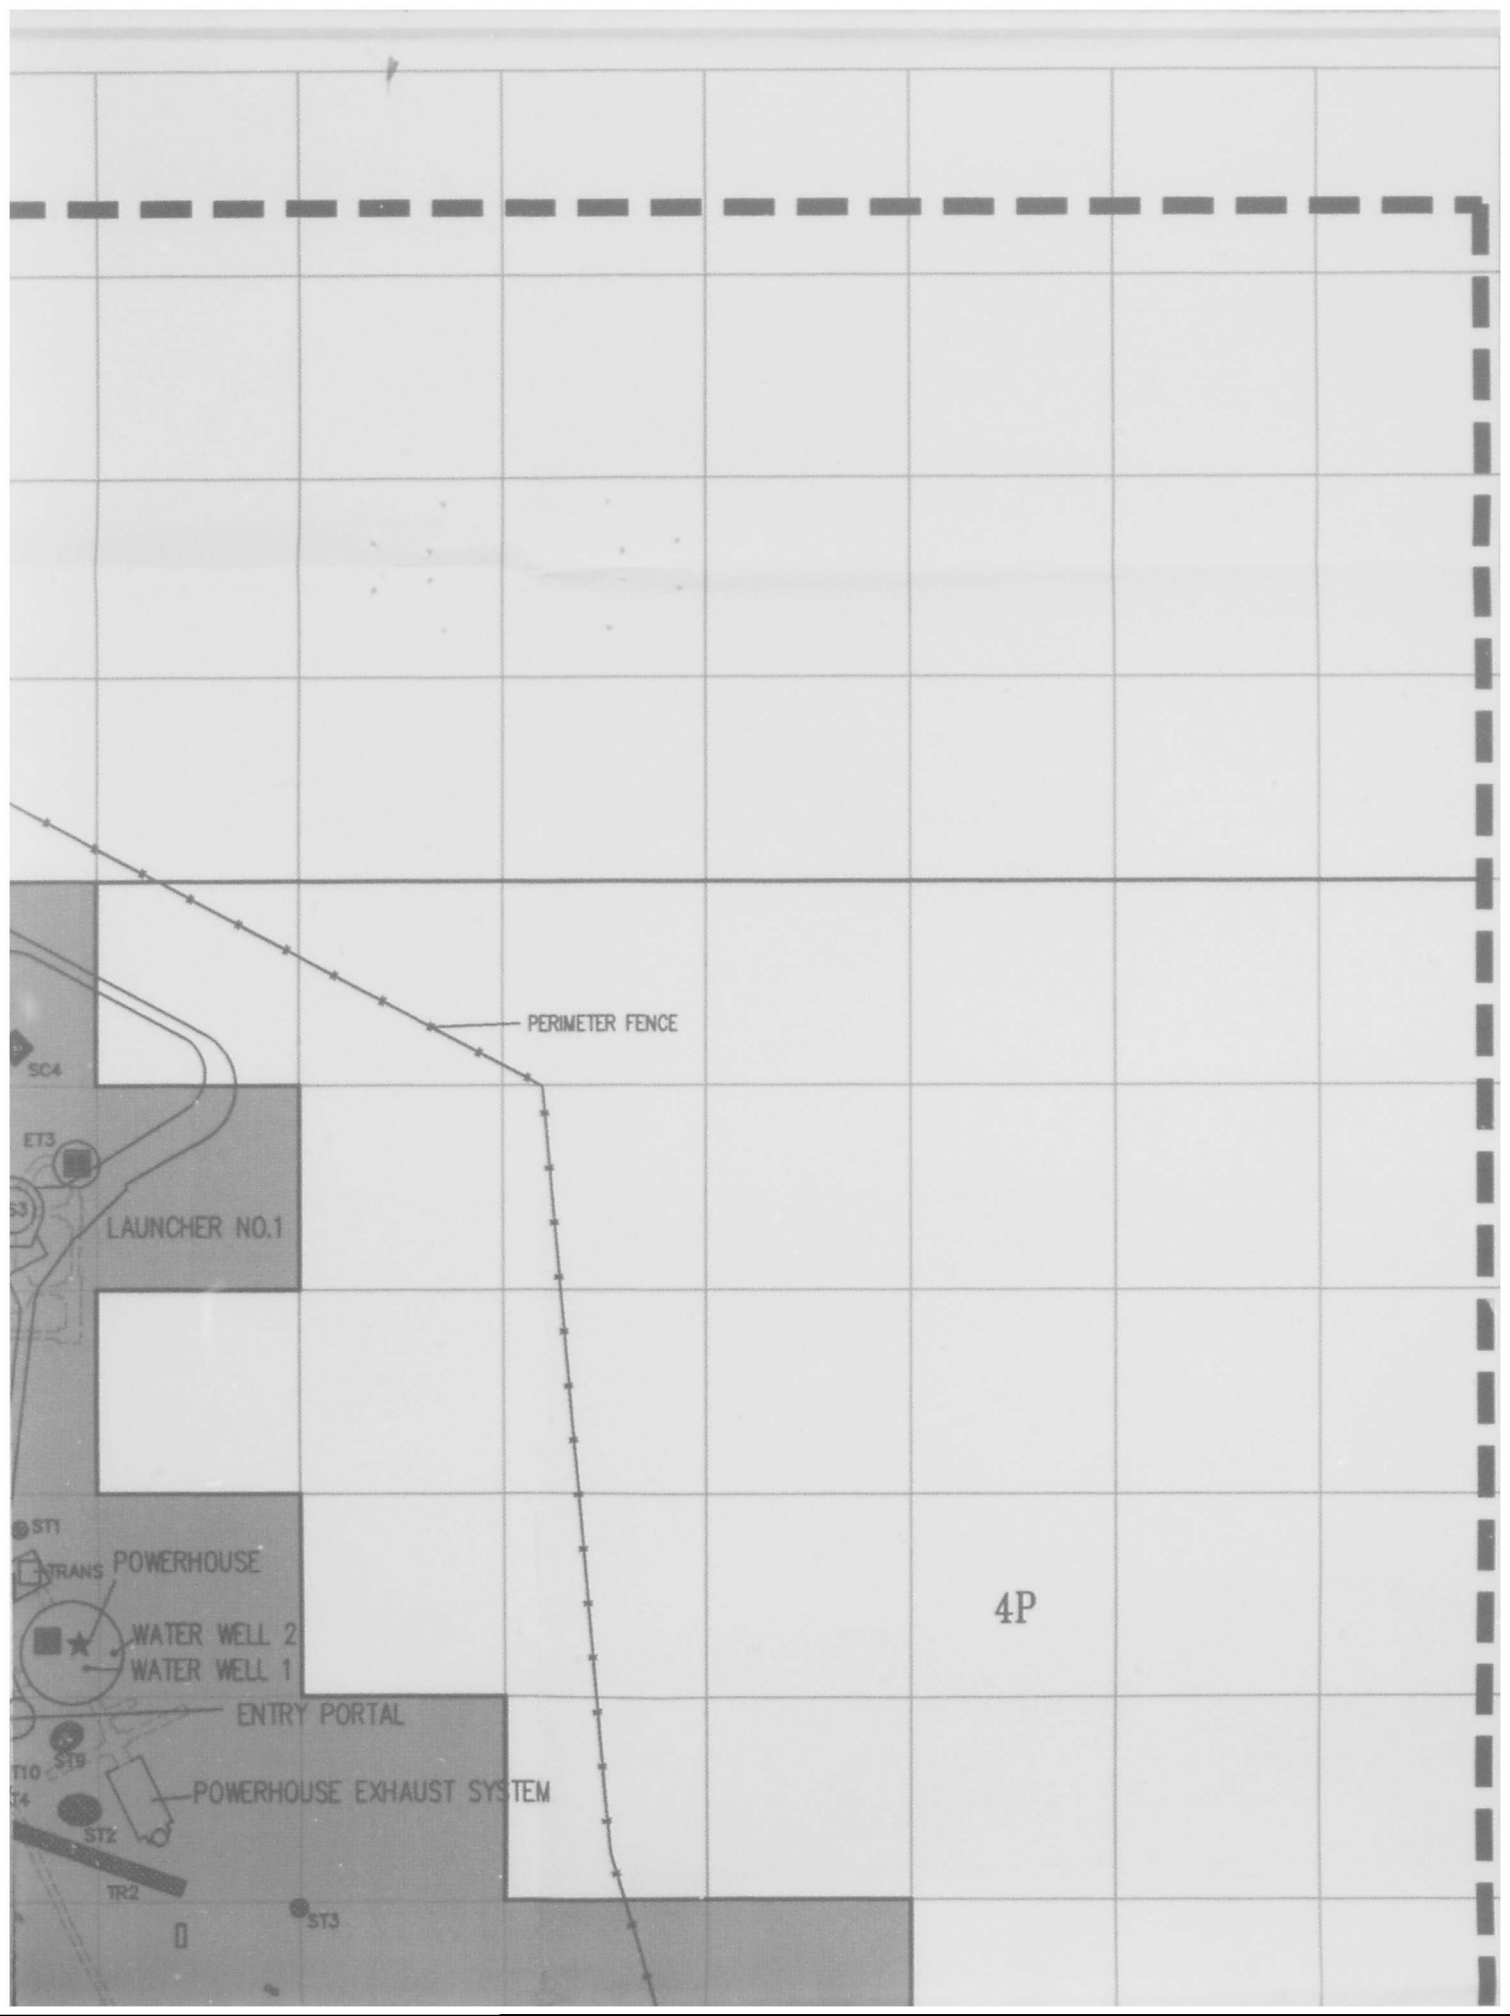
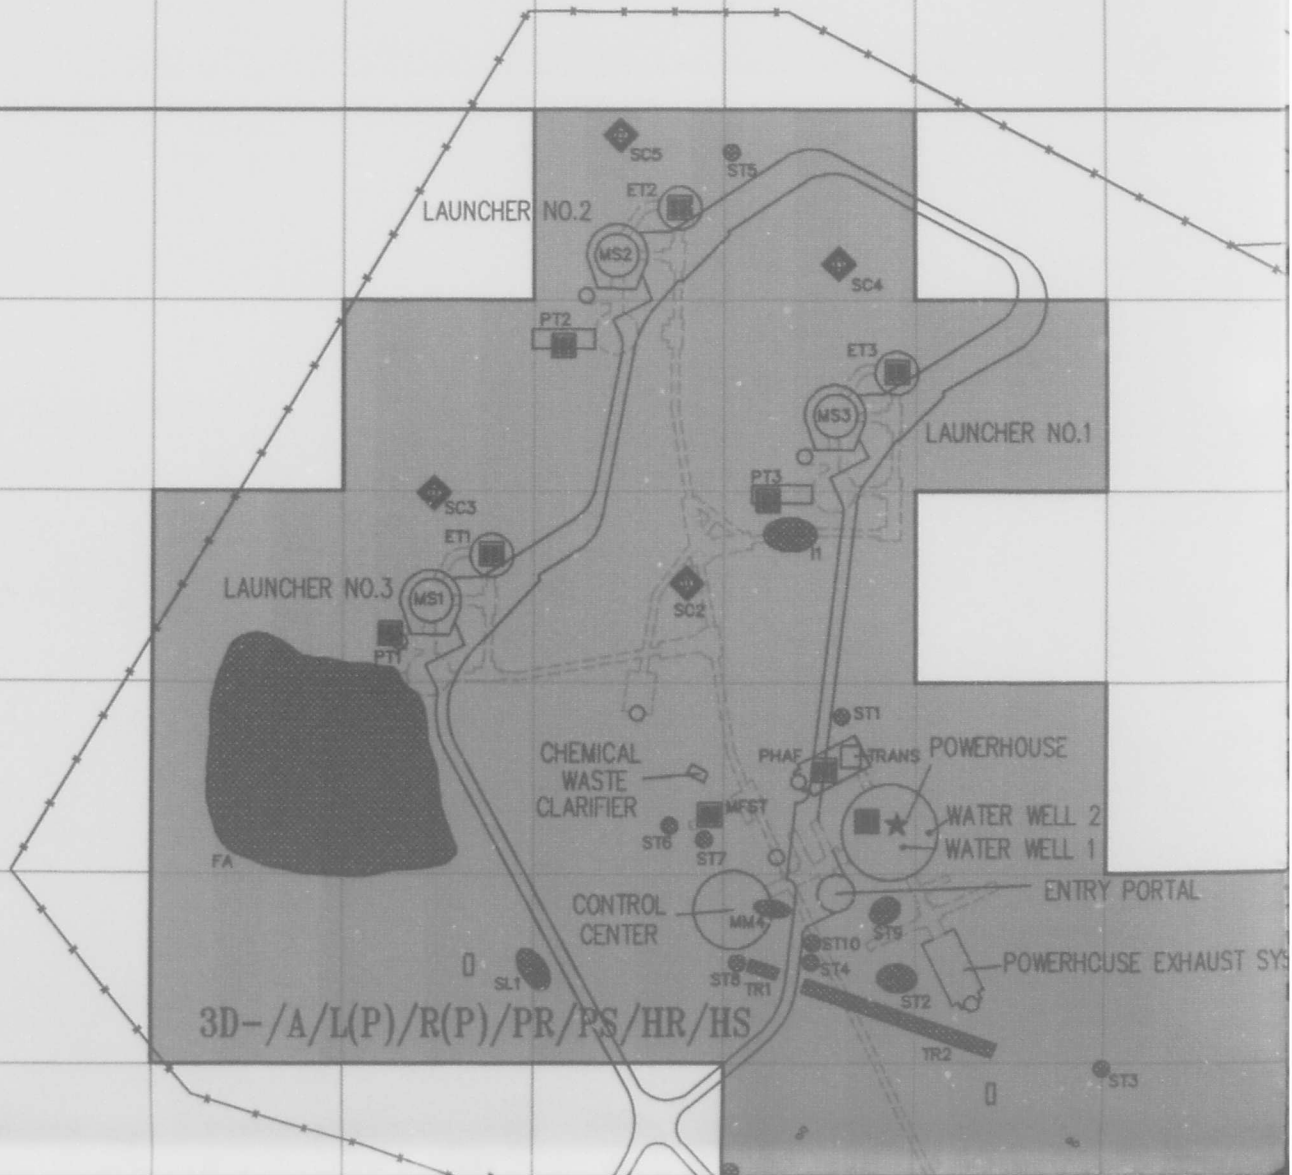
FIGURE 5-1
PARCEL DESIGNATION MAP
BENNETT ARMY NATIONAL GUARD FACILITY
BENNETT, COLORADO

3D-/A/L(P)/R(P)/PR/PS/HR/HS
