**DEPARTMENT OF DEFENCE**  
**DEFENCE SCIENCE AND TECHNOLOGY ORGANISATION**  
**AERONAUTICAL RESEARCH LABORATORY**  
**MELBOURNE, VICTORIA**

Research Report 13

**RESIDUAL STRENGTH OF COMPOSITES WITH MULTIPLE  
IMPACT DAMAGE**

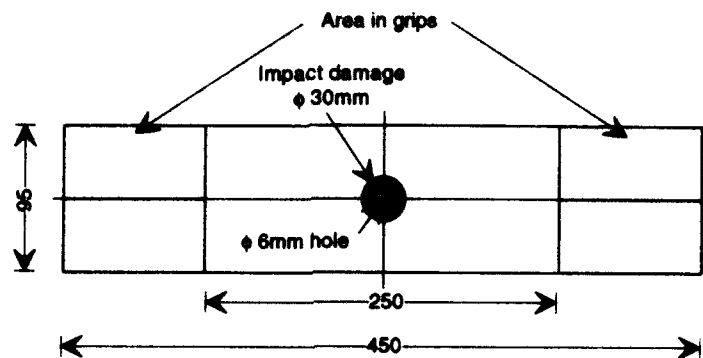
- 1) A single impact of 30 mm diameter and a 6 mm diameter hole in the centre of the specimen, see Figure 1a,
- 2) Two impacts of 30 mm diameter and one diameter apart, see Figure 1b and
- 3) Specimens impacted as per 1) and 2) above and subsequently repaired with a 16 ply external doubler.

Figure 1a: Single impact specimen configuration.

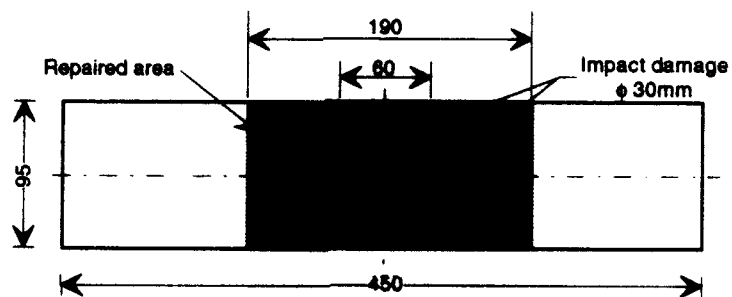
Figure 1b: Multiple impact specimen configuration.

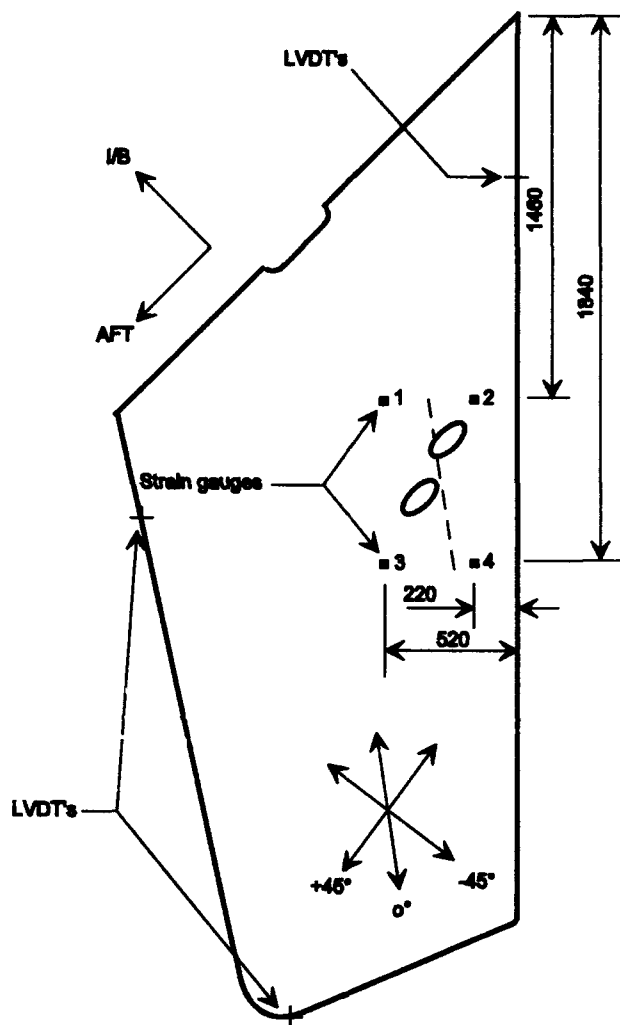
The F/A-18 horizontal stabilator comprises an aluminium honeycomb sandwich structure with graphite/epoxy skins, with fibres oriented in the  $0^\circ$  and  $\pm 45^\circ$  directions. The cross-section of the stabilator is fully symmetric. In the region of the damage the skin is 29 plies thick (3.68 mm), but tapers off to 7 plies (0.89 mm) at the leading edge and has incurred extensive local damage to the composite skin and underlying honeycomb, but neither fragment penetrated to the other side of the stabilator. As shown in Figure 3, the two damaged areas are approximately the same size; however there was a slight difference in the impact angle of the two fragment strikes. The location of the damaged zone and ply orientation can be seen in Figure 4.

Four strain gauge rosettes were located in a rectangular pattern around the damage zone and in the corresponding location on the undamaged skin, see Figure 4. The gauges in each rosette were aligned in the direction of the  $0^\circ$  and  $\pm 45^\circ$  fibres. Two displacement transducers, on the upper and lower surface, were placed halfway between the inboard rosettes (1 and 2), in the  $0^\circ$  fibre direction, as seen in Figure 3. The gauge length of the displacement transducers was 385 mm. The strain gauge rosettes and displacement transducers were positioned so as to evaluate the change in compliance of the structure due to the damage.

Figure 4: Location of impact damage, strain gauges and displacement transducers on the CREDP F/A-18 horizontal stabilator.

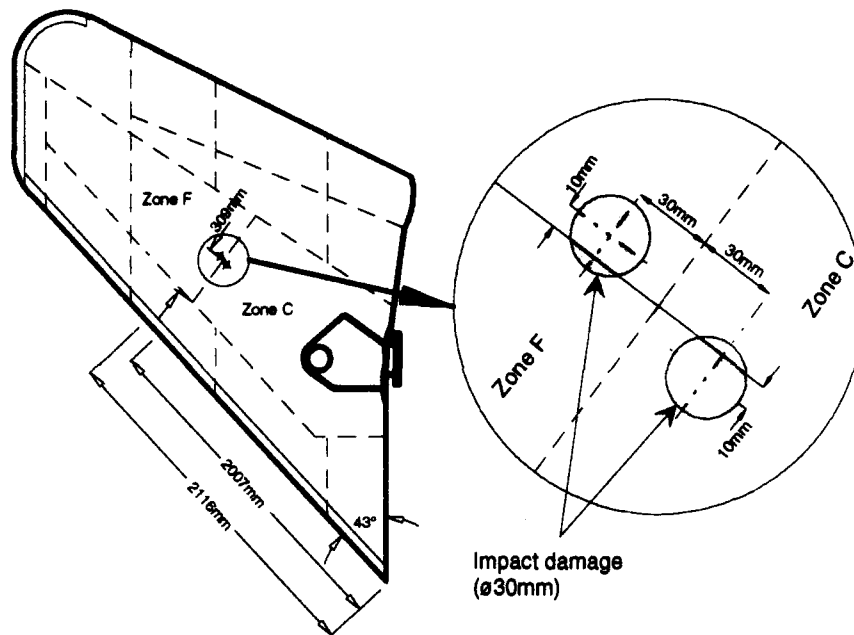
two sites on the top surface, thus inducing BVID in the composite skin. At each location the absorbed energy was approximately 12 Joules and the size of the damage was constrained to be approximately 30 mm in diameter. The distance between the two impact damage zones was approximately 30 mm (one diameter, as in the coupon test program). Of the two damage sites, see Figure 5, the one closest to the root was in a zone C which was classed as irreparable by the Structural Repair Manual (SRM). The second impact site was located in zone F. As such the SRM repair for the latter damage would have impinged into zone C thus, according to the SRM, this damage is also classed as irreparable. In zone C the ply configuration was [+45/-45/90/0/+45/0/-45/0/90/0/-45/0/45/0/90/-45/45], 17 plies, and in zone F the ply configuration was [+45/-45/90/0/+45/0/-45/0/45/0/90/-45/45], 15 plies, i.e. two 0° plies were dropped.

Figure 5: Location of impact damage on the IFOSTP F/A-18 horizontal stabilizer.

An externally bonded doubler (patch) of dimensions 260 mm by 160 mm and ten plies thick, with a ply configuration of [+45/-45/90/0]<sub>S</sub>, was used to repair this damage. The doubler was designed to reduce the net section stress by approximately 35% thus reducing the stress at the damage locations to under 3000  $\mu\epsilon$  at DLBM.
