**US Army Corps  
of Engineers**  
Waterways Experiment  
Station

August 1994

*Repair, Evaluation, Maintenance, and Rehabilitation Research Program*

## **Proceedings of REMR Workshop on Levee Rehabilitation**

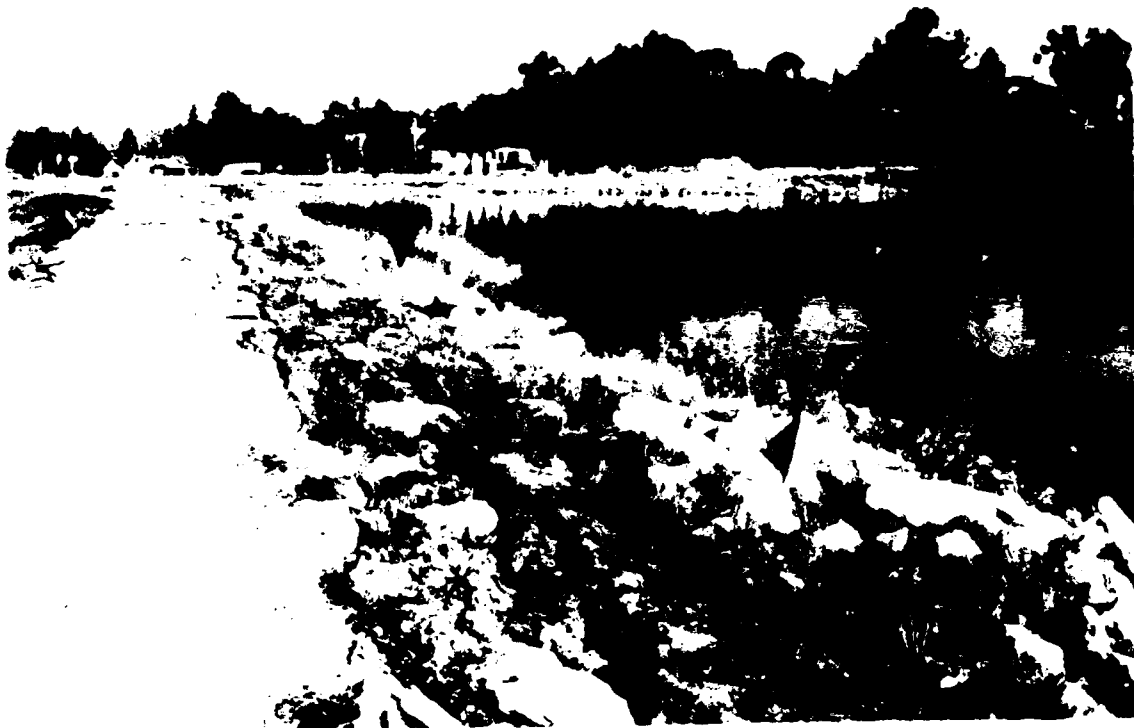
The earthquake caused severe cracking and deformation of the levee embankment. Approximately 3 to 4 ft of subsidence occurred in the levee crest. Large cracks up to 6 in. wide and several feet deep developed along the slope and crest of the levee within the lower reaches. Less damage occurred in the upper reaches. Pumping stations and drainage structures in the lower reaches were also damaged. Photos of the damage are shown in Exhibit A. A summary of the damage by reach is presented in Table 1.

a. Closeup of cracks along crest of levee

Photo 1. San Lorenzo River levee, Loma Prieta earthquake damage

The San Francisco District contracted to make emergency repairs to the damaged levees along the San Lorenzo River and the Pajaro River levee systems. Repairs consisted of excavating and recompacting up to 6 ft of embankment material in the severely damaged areas. Imported compacted fill was added to bring the repaired section back to grade. In areas where there were no apparent subsidence, the cracks were repaired by shallow excavating and recompacting the soil. Exhibit A shows typical repairs made to the damaged levees following the earthquake. Structural repairs were also made at pumping stations and gravity outlet works.

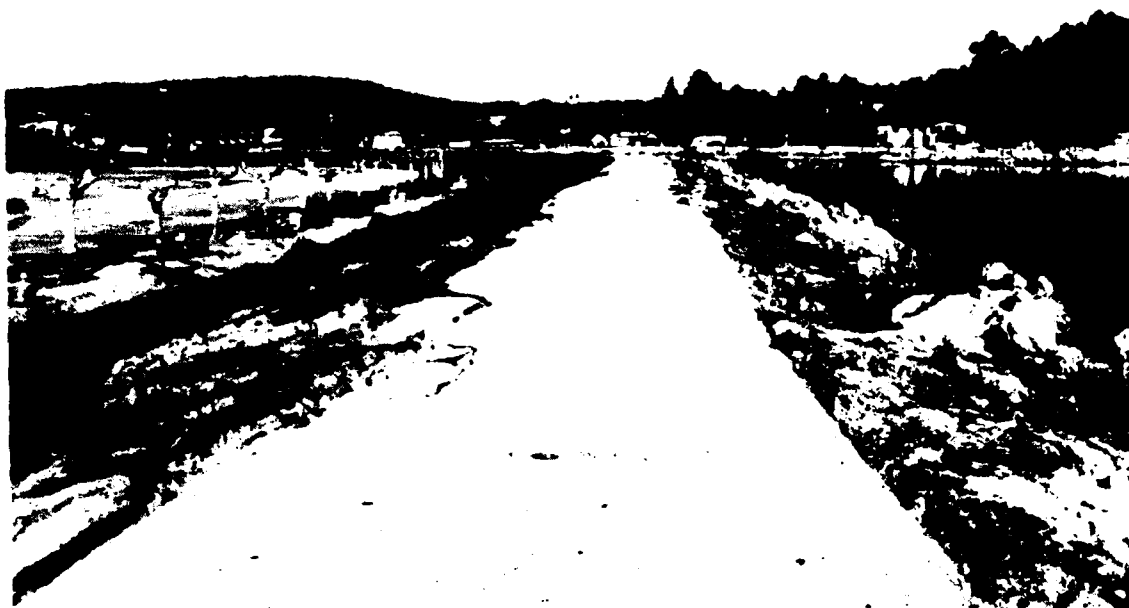
b. Damage along levee on right bank

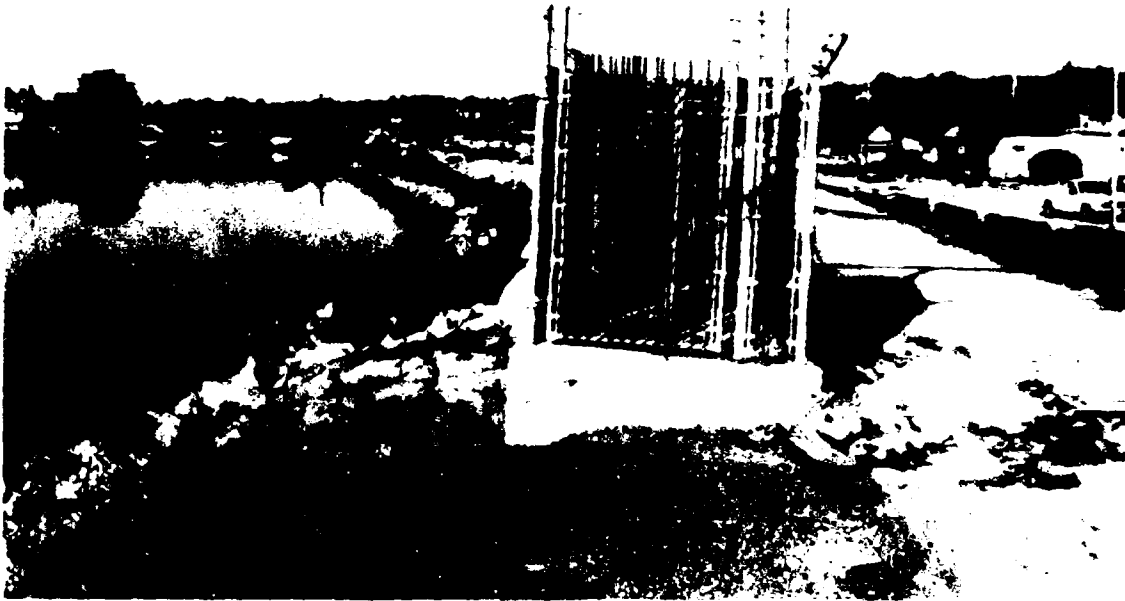
a. Damage at drainage structure, left bank levee (looking upstream)

Photo 2. San Lorenzo River, Loma Prieta earthquake damage

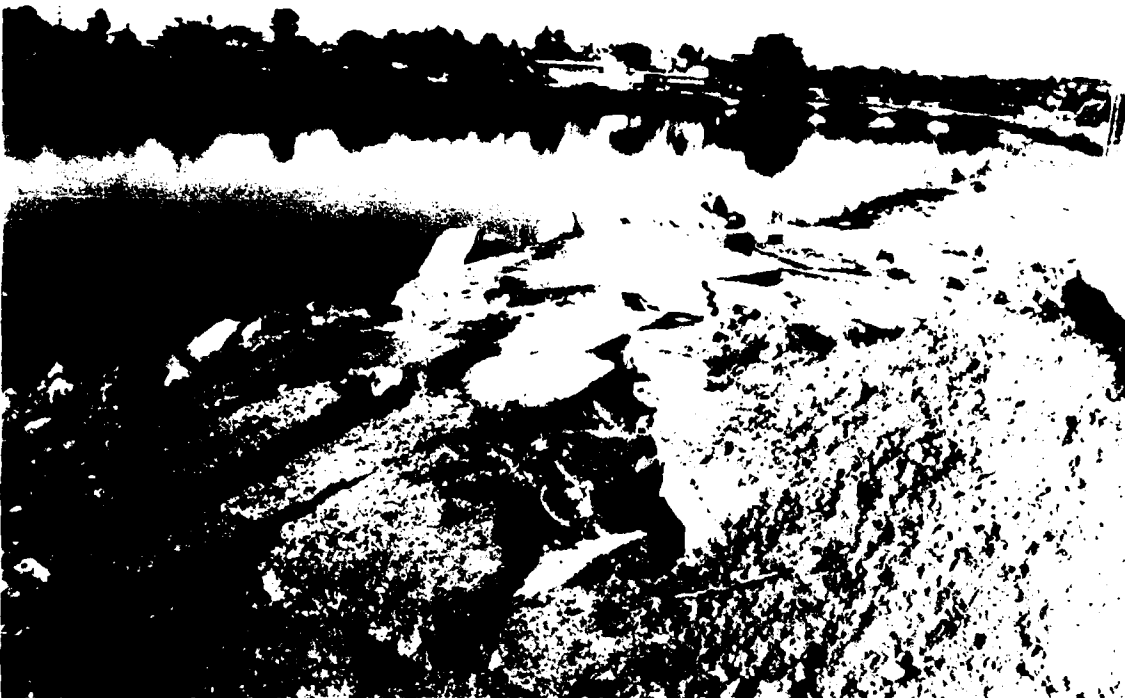
b. Damage to levee on left bank, San Lorenzo River, near mouth

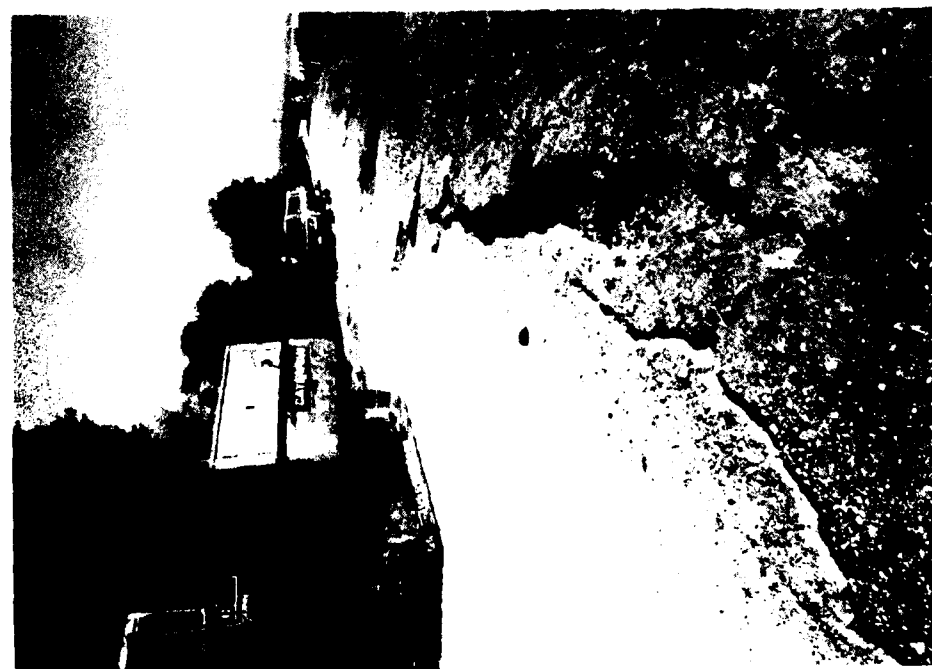
Large cracks developed in the crest, slopes, and along the toe of the levee. Most of these cracks were in the longitudinal direction. There were some locations where the cracks occurred in the transverse direction. The location and degree of damage caused by the earthquake are presented partially in Table 2.

a. Cracks along crest

Photo 3. Typical damage to levees along Pajaro River
