TECHNICAL REPORT ARCCB-TR-94030

**FAILURE ANALYSIS OF 120-MM  
MORTAR BUSHINGS AND FIRING PINS**

KATHRYN E. NOLL

AUGUST 1994

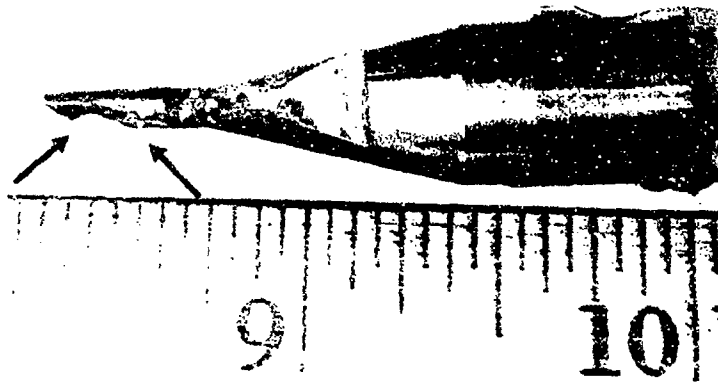
A visual examination was performed on the as-received firing pins and bushings in order to identify any significant features. Pins 1 and 2 displayed extensive damage toward the tip of the pin. Bushing 1 shown in the center of the bushing assembly in Figure 3 was also visibly damaged. The discoloration observed on the face of the bushing assembly is not considered unusual for components that have been subjected to firing tests. Pin 3 sustained minor damage (arrows, Figure 4), with the bushing assembly (Figure 5) displaying no visible damage to Bushing 2. The unfired pins (Pins 4, 5, and 6) were supplied for comparison with the fired pins. From the visual examination, there were no observable differences between the unfired U.S.-made and unfired Israeli-made firing pins.

Figure 1. Photograph of Pin 1, as-received, with arrows pointing to the damaged area.

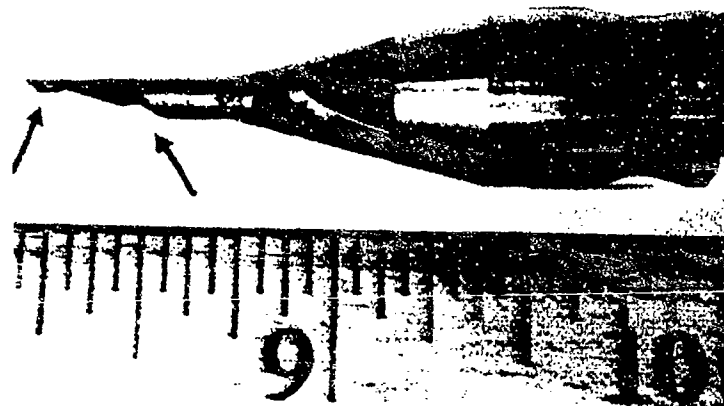
Figure 2. Photograph of Pin 2, as-received, with arrows pointing to the damaged area.

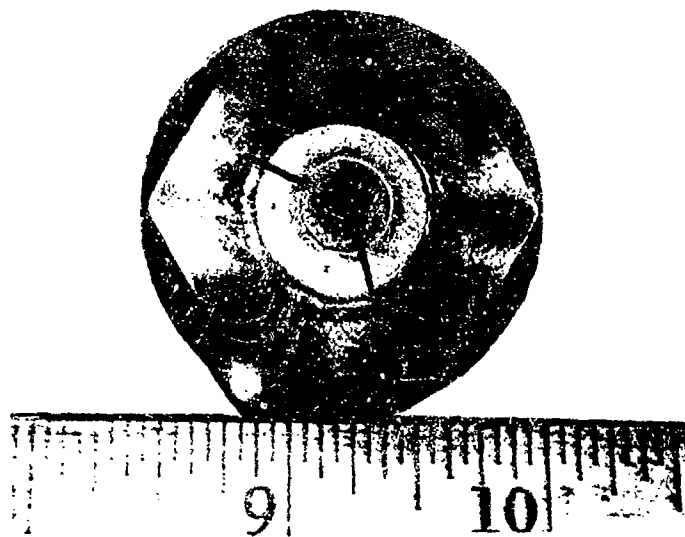
Figure 3. Photograph of bushing assembly, as-received, with arrows pointing to the damaged tungsten carbide of Bushing 1.

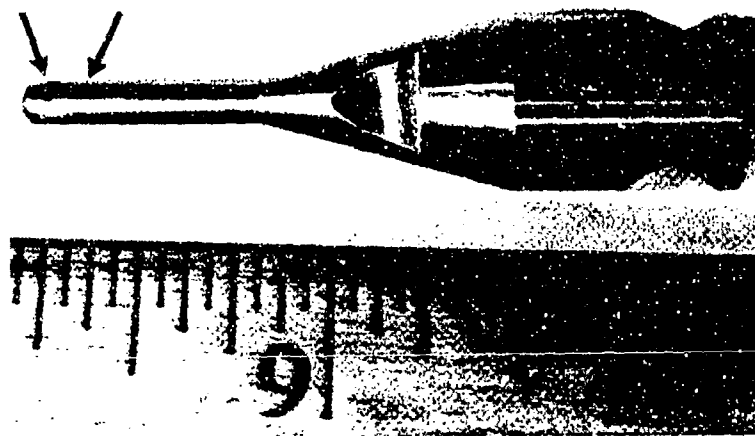
Figure 4. Photograph of Pin 3, as-received, with arrows pointing to the damaged area.

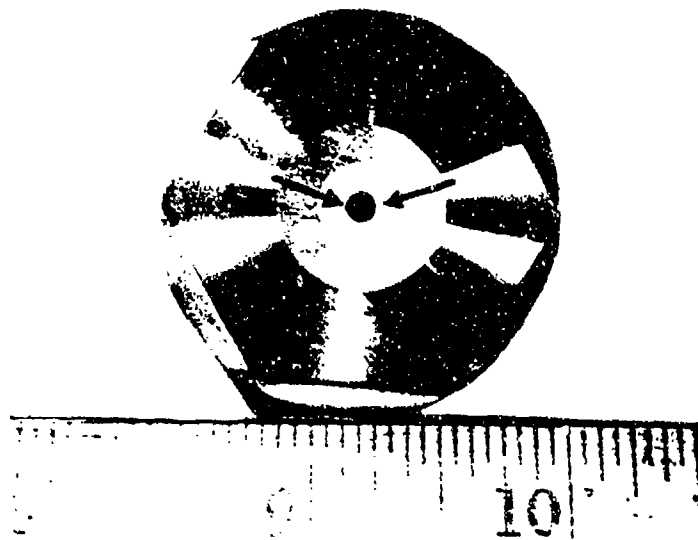
The hole in the U.S.-made bushings (arrows, Figure 9) was cut using wire electrical discharge machining (EDM). The Israeli bushing was cut with a conventional machining operation.

Figure 9. Photograph of bushing assembly, as-received, with Bushing 3 located at the center. Arrows point to the hole machined by wire EDM.

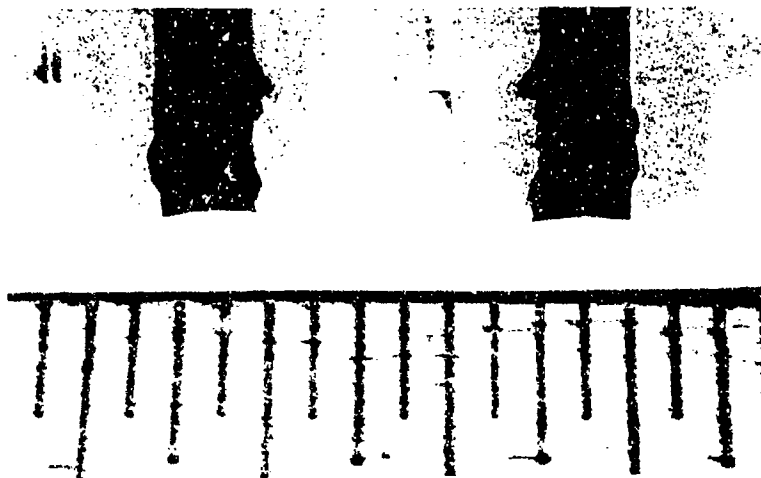
The bushing assemblies were then sectioned (Figure 10) and the bushings (arrows, Figure 10) were removed in order to further characterize the component. Overall photographs of the four bushings are shown in Figures 11 through 14. Bushing 1 sustained the more severe damage seen in Figure 11, with the inner diameter being affected down the entire length of the bushing. Bushing 2 experienced slight damage to the inner diameter of the bushing (Figure 12). Bushings 3 and 4 were supplied for comparison with the damaged bushings. From the visual examination, there were no observable differences between the proof-fired, U.S.-made and proof-fired, Israeli-made bushings (Figures 13 and 14, respectively).

Figure 11. Longitudinal view of sectioned Bushing 1 displaying the amount of damage sustained during firing.

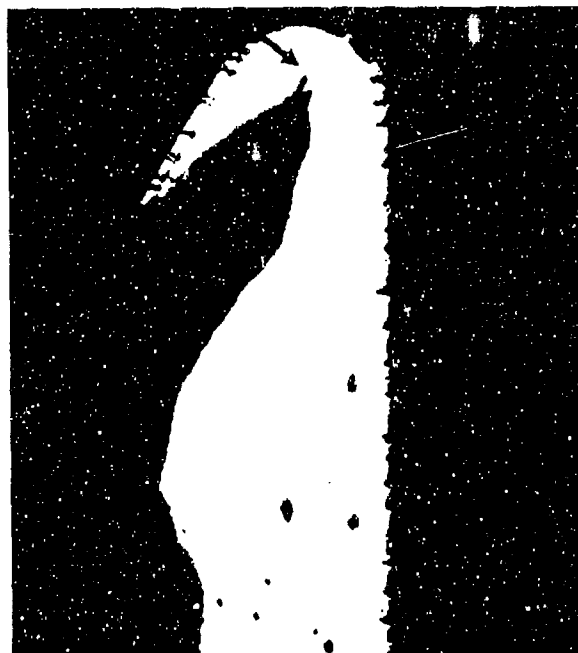
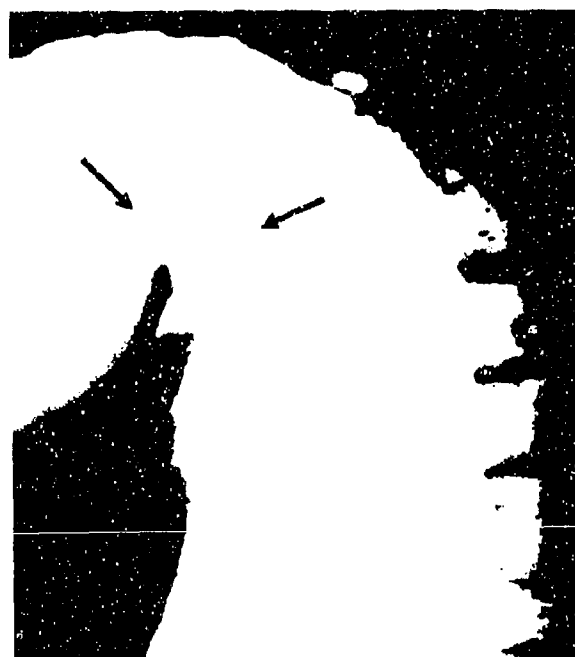
There were several areas, however, that did not exhibit this type of microstructure. The three fired pins displayed some microstructural variation near the damaged areas. Figures 17 and 18 show an as-polished and etched view, respectively, near the tip of Pin 1. The region displayed a much finer-grained microstructure than the rest of the material examined in Pin 1 (see Figure 16). Similar areas were also observed near the tip of Pin 2 and Pin 3 (Figures 19 through 22). The area shown in Figure 21b corresponds to the damaged region observed during the visual examination of Pin 3. This altered microstructure indicates that the three pins may have experienced some localized heating near the tip of the pins. Hardness measurements were taken in these areas and are described later in this report.

Figure 17. Photomicrographs showing as-polished view of Pin 1. Arrows point to location of microstructural variation.

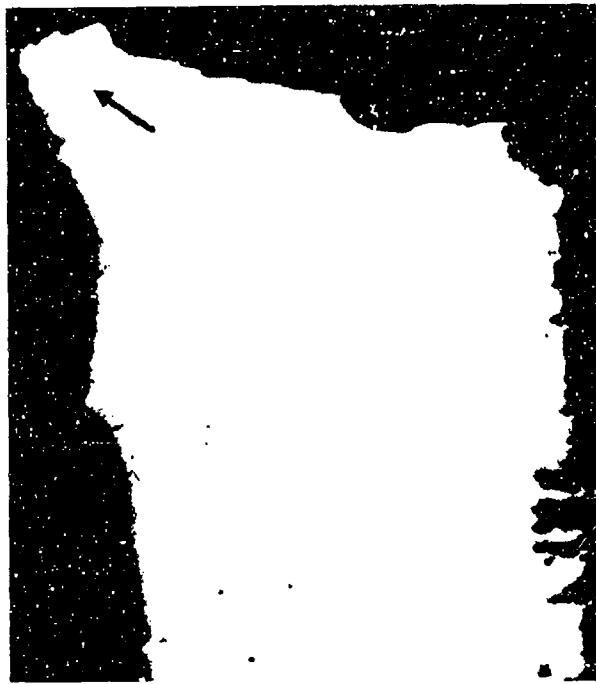
Figure 19. Photomicrograph showing as-polished view of Pin 2, at 400X.  
Arrow points to location of finer grained microstructure.

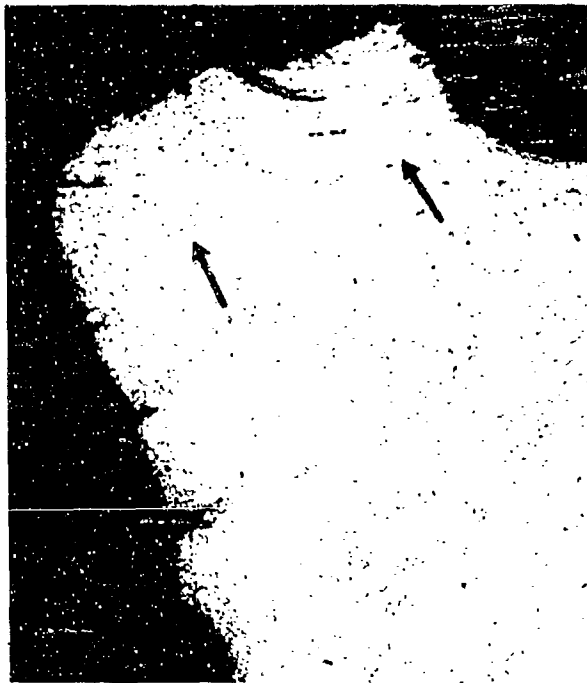
| Area | HRC |
|---|---|
| Figure 20 (Pin 2) | 33.0 |

These hardness values further suggest that the damaged pins experienced some localized overheating.

Figure 20. Photomicrograph showing etched view of Pin 2, at 1000X.  
Arrows point to location of finer grained microstructure.

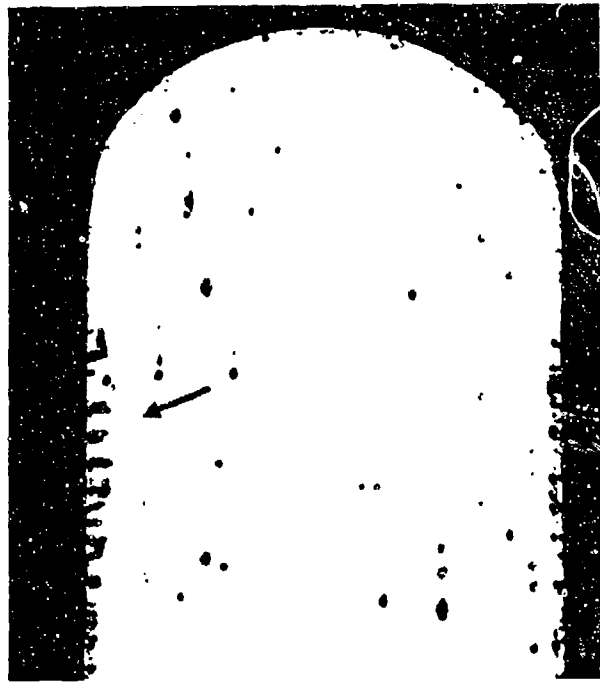
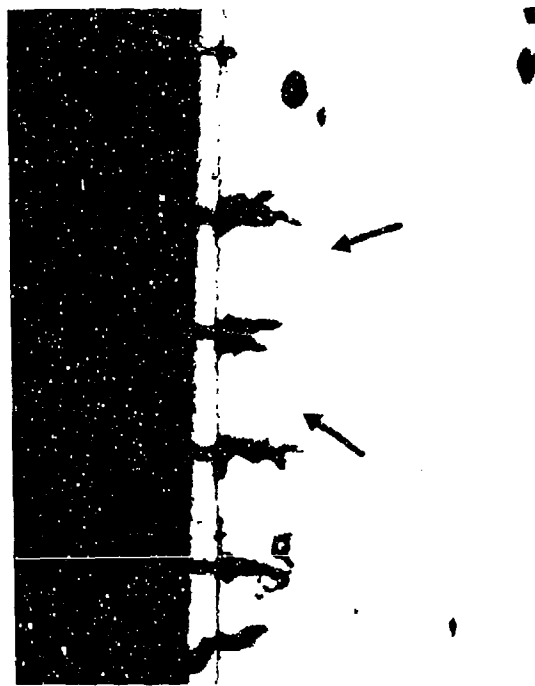
Figure 21. Photomicrographs showing as-polished view of Pin 3. Arrows point to location of microstructural variation.

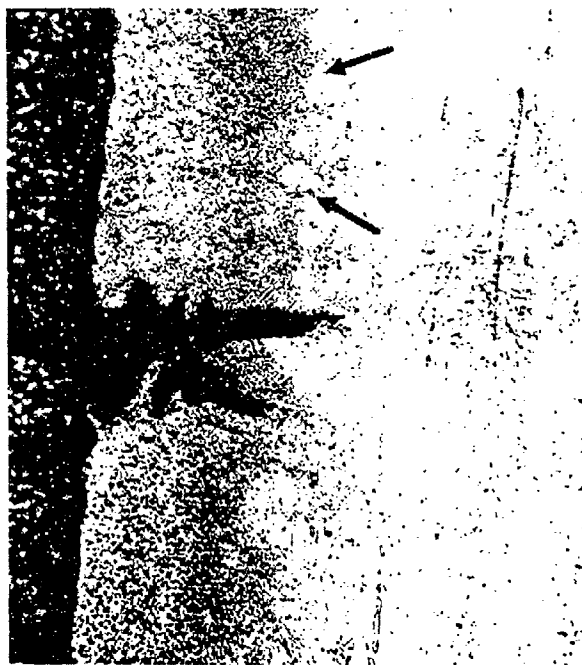
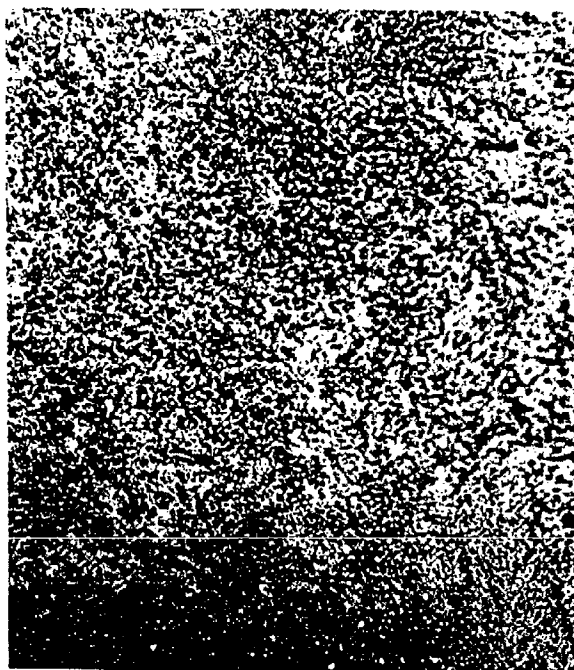
| Area | HRC |
|---|---|
| Figure 22 (Pin 3) | 32.0 |

Figure 22. Photomicrographs of finer grained region (arrows) found in Pin 3. Shown in the etched condition.

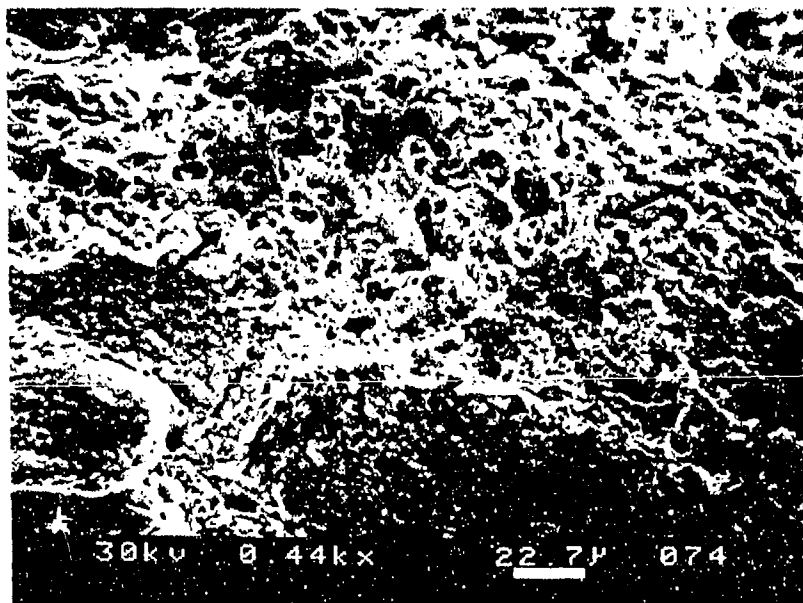
Figure 28b. Magnified view of Pin 1 showing area of melting, at 440X.  
Region was located at the tip of Pin 1.

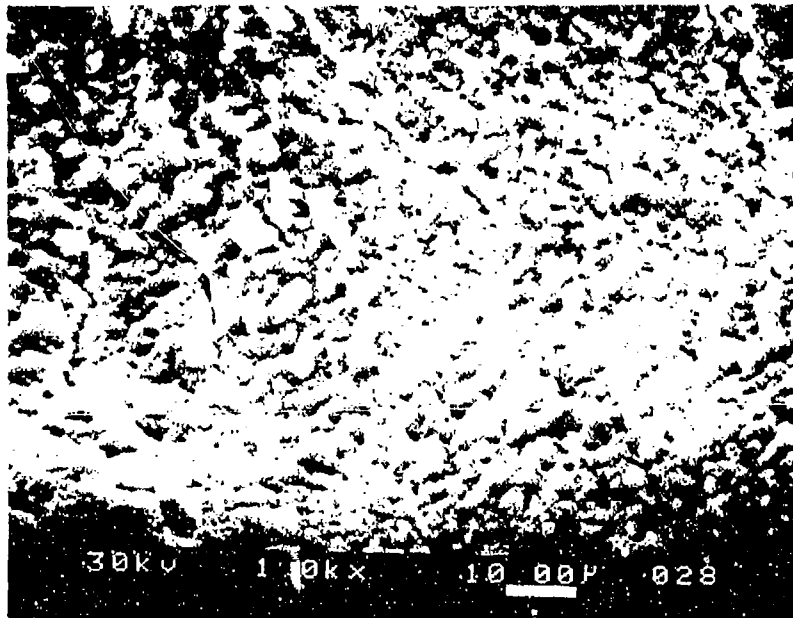
Figure 29b. Magnified view of Pin 2 showing area of melting, at 1000X. Region was located at the tip of Pin 2.

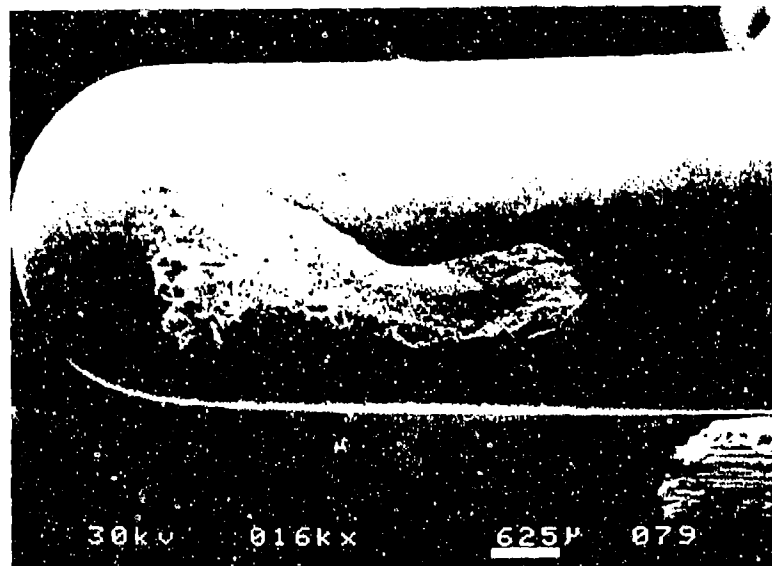
SEM was performed to further characterize the firing pins and tungsten carbide bushings. The three damaged pins are shown in Figures 28 through 30. A definitive fracture mode could not be determined for any of the firing pins. Pins 1 and 2 exhibited extensive damage with some regions displaying evidence of melting (Figures 28b and 29b). Pin 3 showed much less severe damage. Note the cracking network went beyond the damaged region (arrow, Figure 30b).

Figure 30a. SEM micrograph of Pin 3 showing the extent of damage, at 16X.

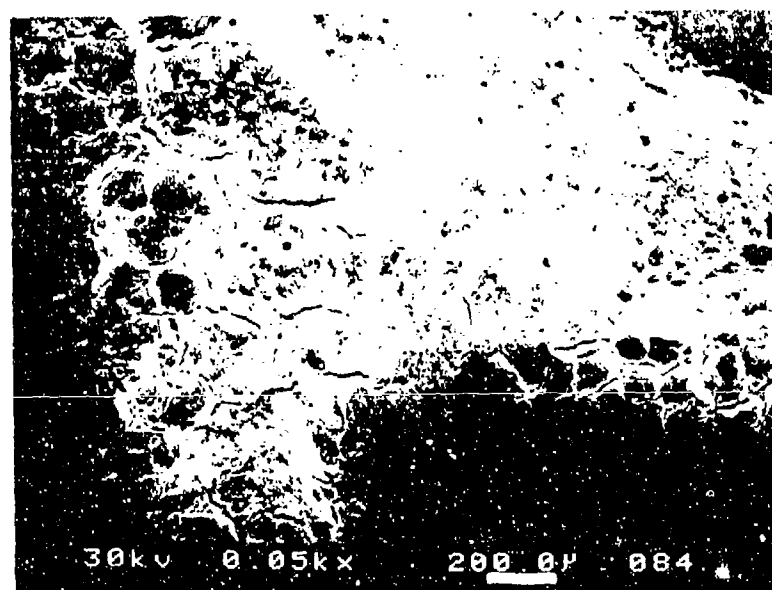
Figure 30b. Magnified view of damaged area in Pin 3, at 50X.  
Arrow points to the cracking network.

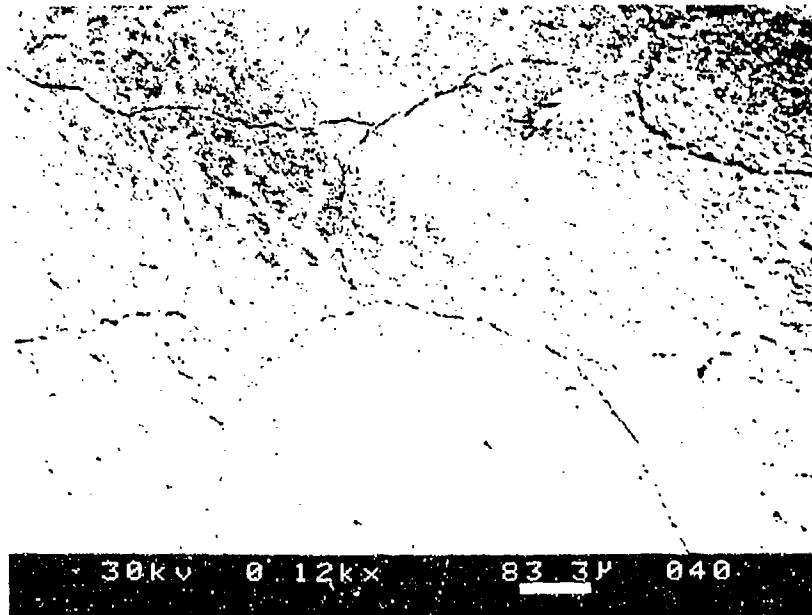
The four tungsten carbide bushings were examined and there were several noteworthy features observed. Bushing 1 (Figure 31) sustained considerable damage along the entire length of the inner diameter. Figure 32 shows the cracking network observed in the damaged regions. The cracking shown in Figure 33 was also seen in the other three bushings (Figures 34 through 36). Bushing 2 experienced slight damage to the inner diameter (arrows, Figure 34) and the cracking network was visible along the length of the bushing (see Figure 34b).

Figure 32. SEM micrograph displaying the cracking network observed in the damaged area of Bushing 1, at 120X.

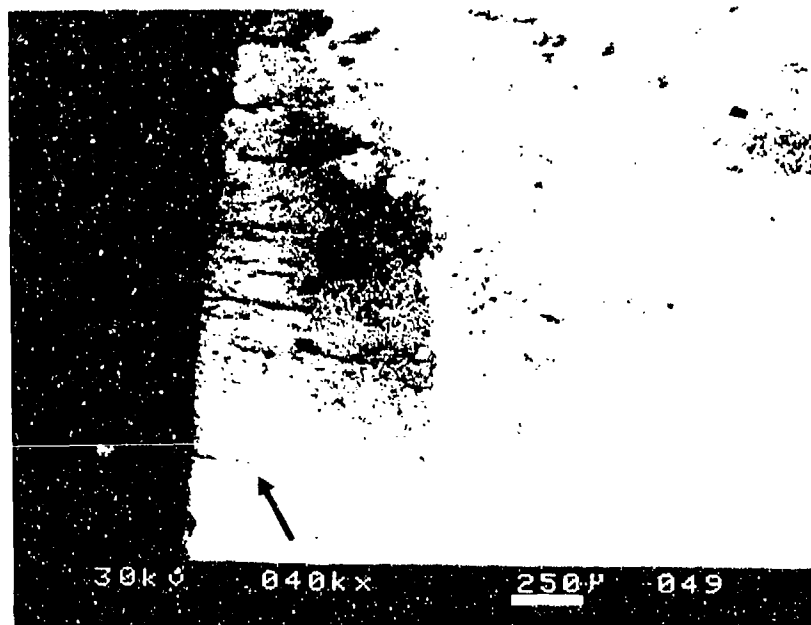
Figure 33. SEM micrograph displaying the cracking observed in the inner diameter of all four tungsten carbide bushings, at 40X.

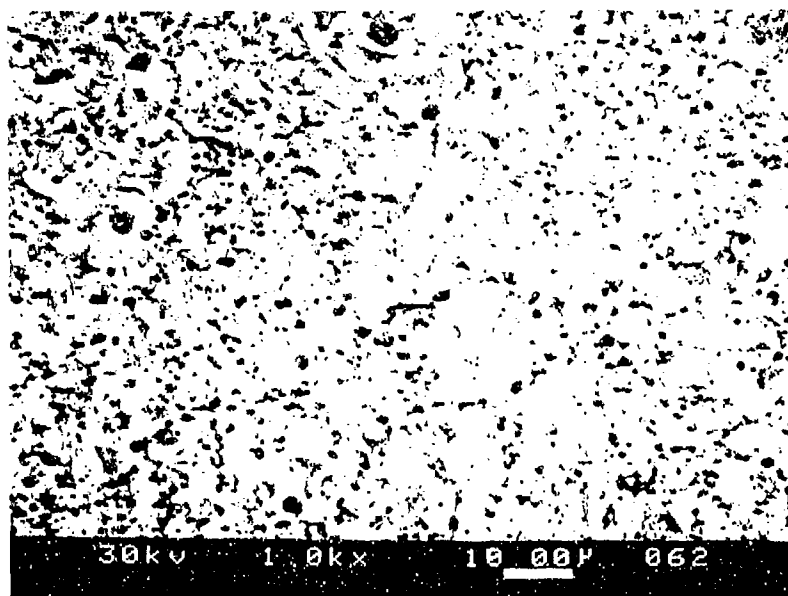
Bushings 3 and 4 were further examined to compare the U.S.- versus Israeli-made bushings. Figures 37 and 38 show a magnified view of the inner diameter surface. The two bushings displayed vastly different surfaces. Figure 37 shows a rougher surface topography than the Israeli-made bushing in Figure 38. The surface shown in Figure 37 was observed in all three, U.S.-made, wire EDM bushings. This type of surface was expected since the EDM process involves melting and/or vaporizing a thin layer of material during the machining. In the case of tungsten carbides, the electrical spark generated during the EDM process melts and rounds the normally sharp edges of the tungsten particles. This melting phenomenon is known as "remelt."

Figure 37. SEM micrograph showing magnified view of the wire EDM inner diameter surface of Bushing 3, at 1000X.

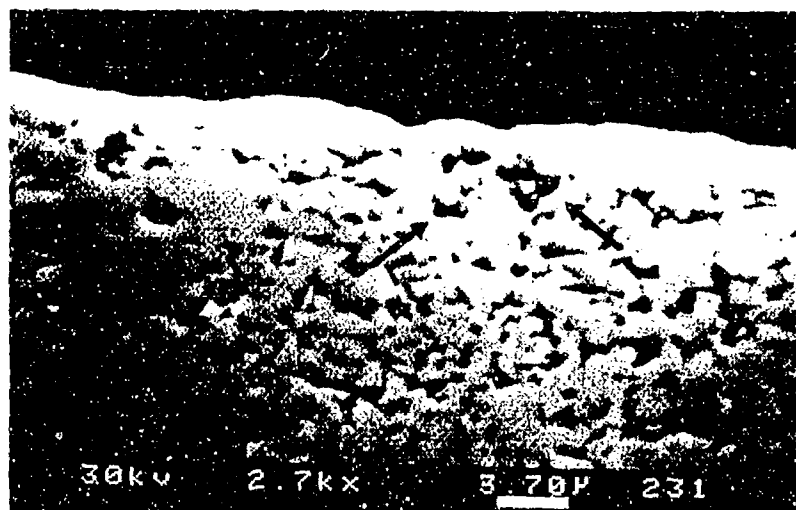
The EDM process also degrades the cobalt binder found in tungsten carbides. The cobalt binder holds the tungsten particles together in the material. The electrochemical reaction that degrades the binder causes a residue of loose tungsten particles to be left on the surface of the workpiece. Cross-sectional areas of the inner diameter of both Bushings 3 and 4 were examined are shown in Figures 39 and 40, respectively. There was a slight amount of degradation observed in the wire EDM surface of Bushing 3 (arrows, Figure 39).

Figure 39. SEM micrograph showing a cross-sectional area of the inner diameter of Bushing 3, at 2700X. Arrows point to slight degradation caused by the wire EDM process.
