MILD WIND SERIES  
MINUTE STEAK EVENT

PROJECT OFFICERS REPORT

TECHNICAL DIRECTORS SUMMARY REPORT

Issuance date: 20 November 1972

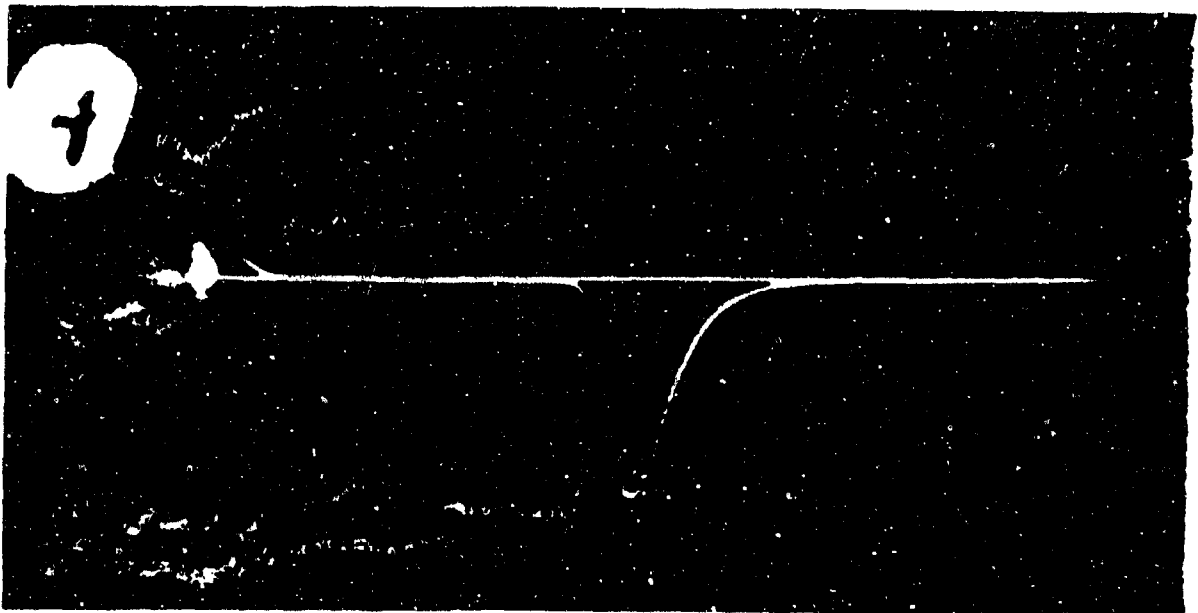
Figure 4.13 --Internal EMP detector output at  $T_0$ . Project 2.07
