LITIGATION TECHNICAL SUPPORT AND SERVICES  
ROCKY MOUNTAIN ARSENAL  
DRAFT FINAL VOLUME I  
INVENTORY REPORT  
POLYCHLORINATED BIPHENYL (PCB)  
INVENTORY

Contract No. DAAA05-89-C-0002  
September 1990

EBASCO SERVICES INCORPORATED

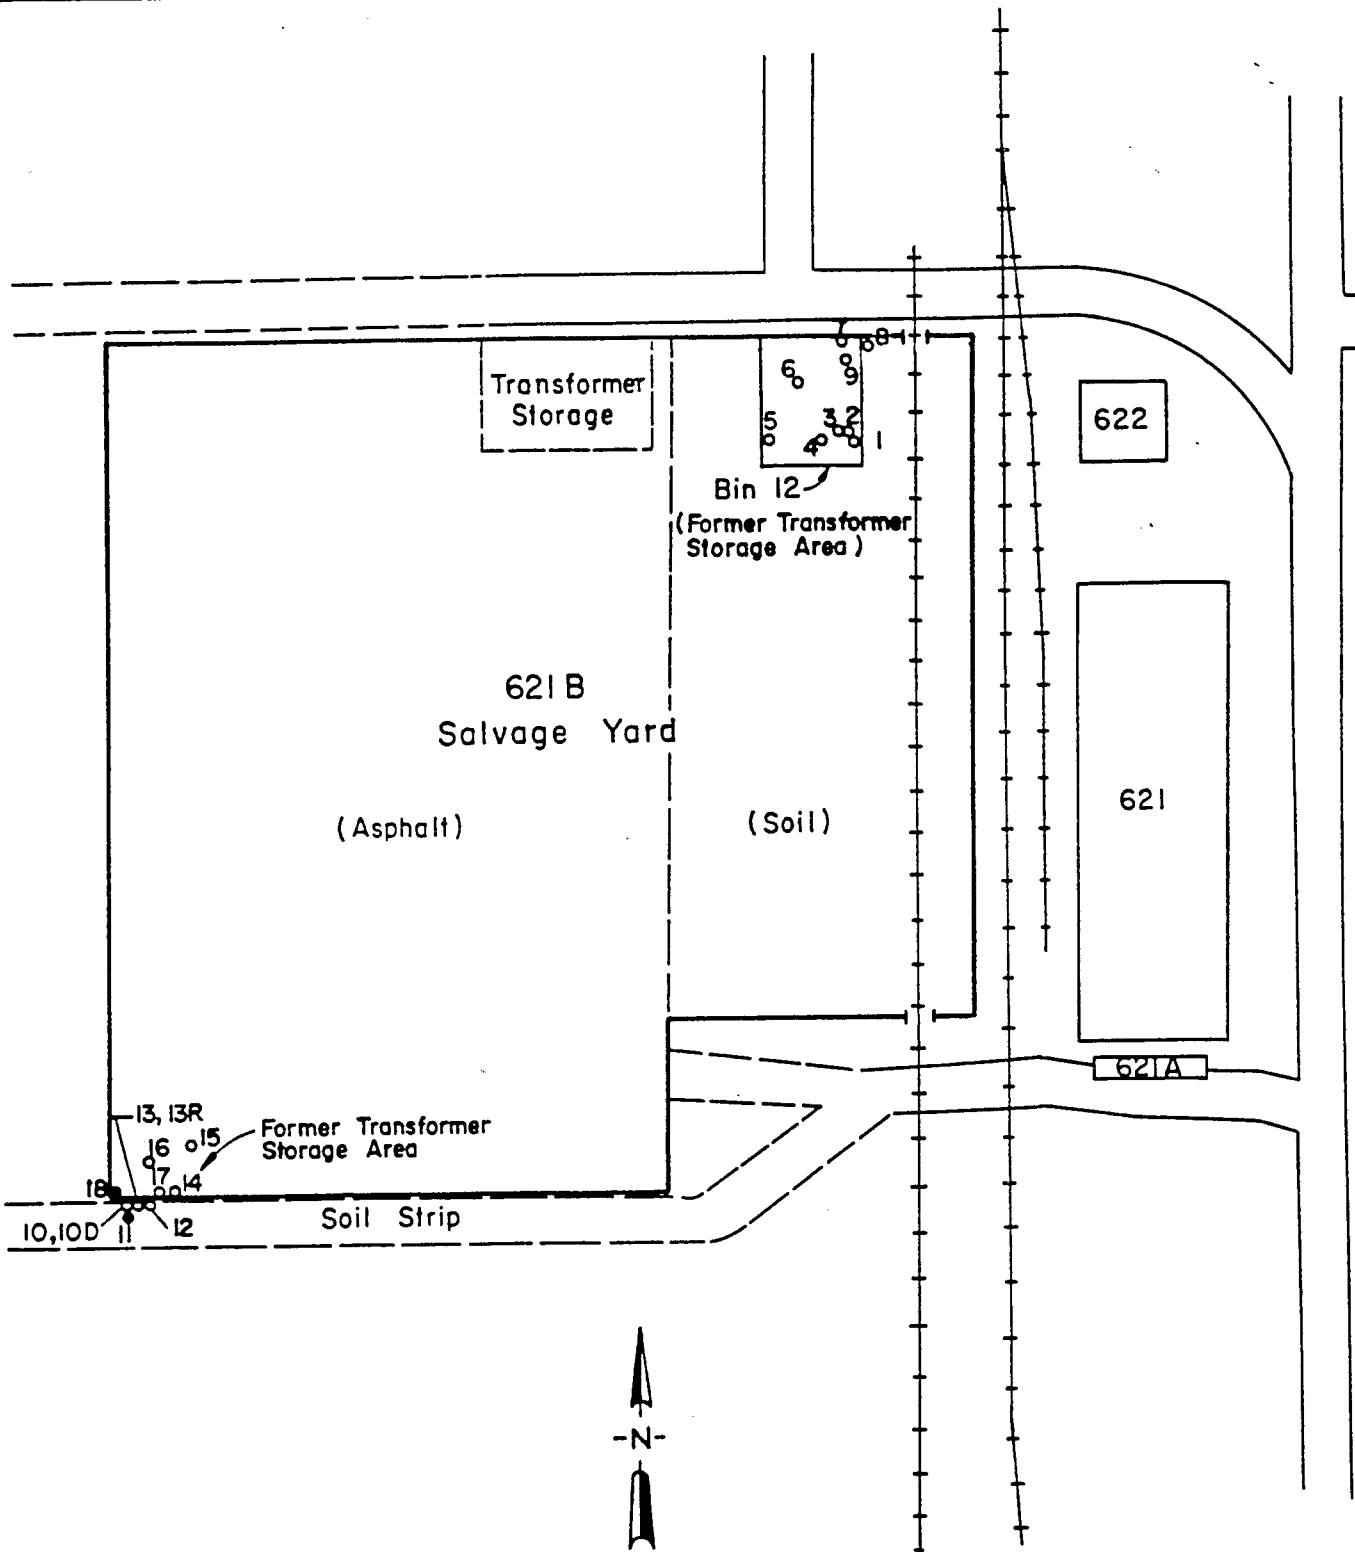
yard. The soil in the southeast corner of this bin is moderately stained. Eight 0 to 6 inch soil samples and one liquid sample of gear oil from a leaking container were taken from this area. A thin strip of stained soil lying immediately south of the southwest corner of the asphalt pad (edge of an old dirt road) was the second location sampled. Five soil samples at depths of 0 to 6 inches were obtained from this location, plus a rinse blank sample of the sampling equipment decon water (water used for decontamination of equipment). The third location sampled is the southwest corner of the asphalt pad where five distinct stained areas on the asphalt surface are visible.

PCBs were found above 50 ppm in the 0 to 6 inch interval of one soil sample from the soil strip south of the asphalt pad, and the 0 to 1 inch interval of one asphalt sample from the southwest corner. Both samples were obtained from the above mentioned former transformer storage locations within the 621B Salvage Yard.

As evidenced from the staining, a thin strip of soil (at one time, the northern edge of an old dirt road) lying immediately south of the southwest corner of the asphalt pad is believed to have served as a drainage receptor for any dielectric fluid or liquids leaking from the transformers previously stored on this portion of the asphalt pad. A concentration of 160 ppm in the 0 to 6 inch interval of Soil Sample (PCB)04621B2, and concentrations ranging from 6.8 to 26 ppm in adjacent soil samples (0 to 6 inch interval) from the immediate area further confirmed the release of PCB-bearing dielectric fluid into this portion of soil south of the asphalt pad.

The relatively low PCB concentrations (1.2 to 27 ppm) detected in soil samples from Bin 12 that accompany the minor staining observed in this soil also confirmed the release of PCB-bearing dielectric fluid from previously stored transformers into the soil of Bin 12; however, concentrations in this area were found to be below the 50 ppm storage and disposal standard. There will be no labelling or marking of equipment in accordance with 40 CFR 761 because equipment containing PCBs in concentrations of 50 ppm to 500 ppm was not found in the Group I buildings.

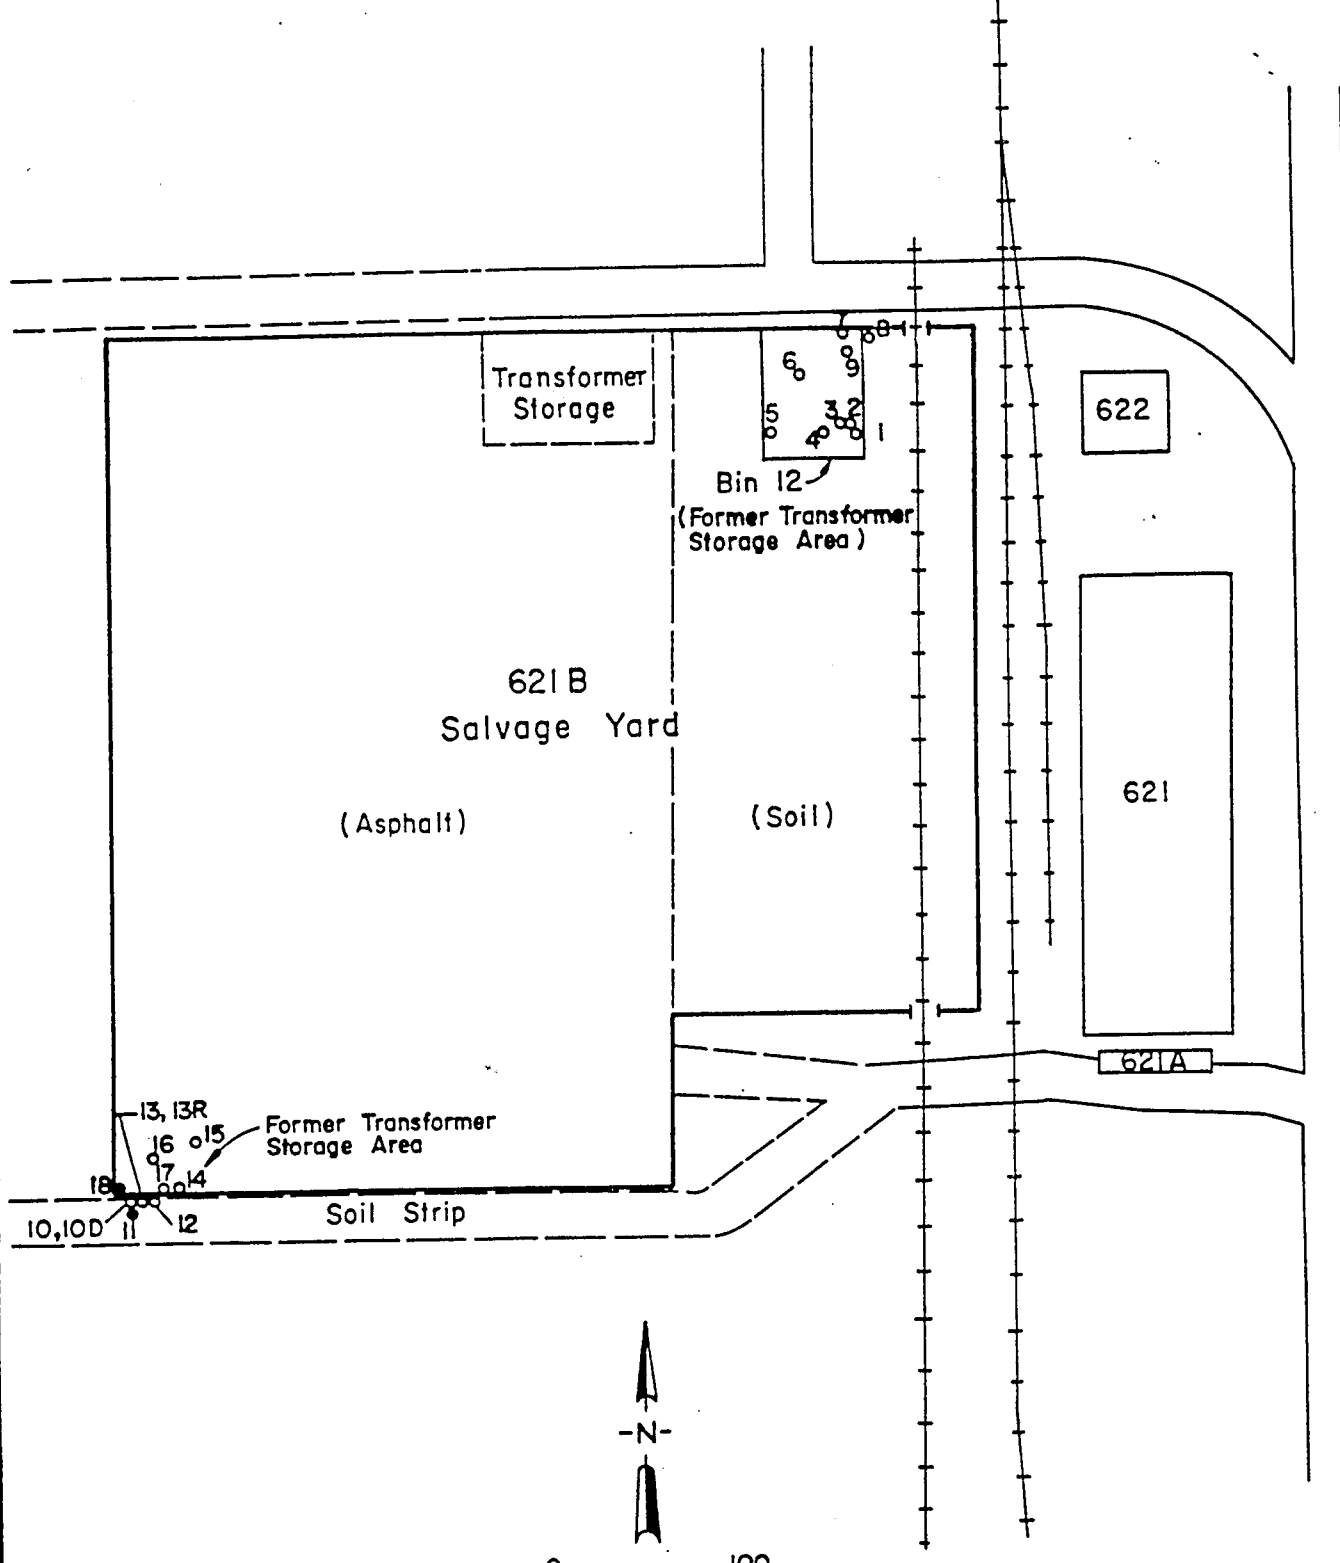
yard. The soil in the southeast corner of this bin is moderately stained. Eight 0 to 6 inch soil samples and one liquid sample of gear oil from a leaking container were taken from this area. A thin strip of stained soil lying immediately south of the southwest corner of the asphalt pad (edge of an old dirt road) was the second location sampled. Five soil samples at depths of 0 to 6 inches were obtained from this location, plus a rinse blank sample of the sampling equipment decon water (water used for decontamination of equipment). The third location sampled is the southwest corner of the asphalt pad where five distinct stained areas on the asphalt surface are visible.

PCBs were found above 50 ppm in the 0 to 6 inch interval of one soil sample from the soil strip south of the asphalt pad, and the 0 to 1 inch interval of one asphalt sample from the southwest corner. Both samples were obtained from the above mentioned former transformer storage locations within the 621B Salvage Yard.

As evidenced from the staining, a thin strip of soil (at one time, the northern edge of an old dirt road) lying immediately south of the southwest corner of the asphalt pad is believed to have served as a drainage receptor for any dielectric fluid or liquids leaking from the transformers previously stored on this portion of the asphalt pad. A concentration of 160 ppm in the 0 to 6 inch interval of Soil Sample (PCB)04621B2, and concentrations ranging from 6.8 to 26 ppm in adjacent soil samples (0 to 6 inch interval) from the immediate area further confirmed the release of PCB-bearing dielectric fluid into this portion of soil south of the asphalt pad.

The relatively low PCB concentrations (1.2 to 27 ppm) detected in soil samples from Bin 12 that accompany the minor staining observed in this soil also confirmed the release of PCB-bearing dielectric fluid from previously stored transformers into the soil of Bin 12; however, concentrations in this area were found to be below the 50 ppm storage and disposal standard. There will be no labelling or marking of equipment in accordance with 40 CFR 761 because equipment containing PCBs in concentrations of 50 ppm to 500 ppm was not found in the Group I buildings.
