Technical Report REMR-CS-46  
March 1995

## **Repair and Maintenance of Masonry Structures: Case Histories**

*by Edward F. O'Neil*

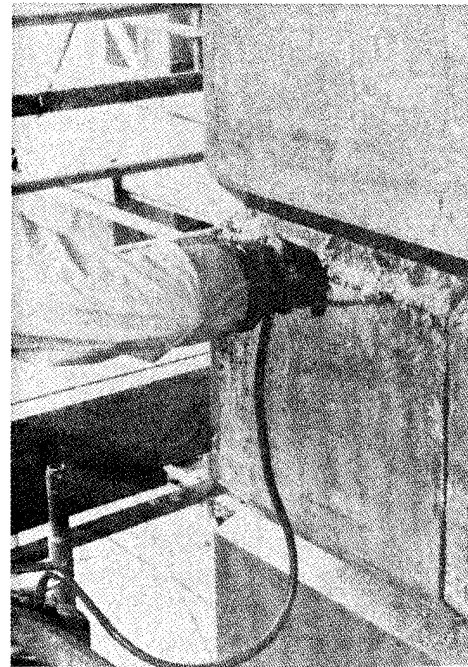
Figure 5. Application of stone strengthener to sandstone

Before the coating was begun, the stone was cleaned to ensure that no loose material was left on the surface. The coating material could be applied by brush, roller, or airless spray but was applied by the latter method because of all the detail in the carvings of the stone. Since it was to be sprayed on, it was diluted with up to 15 percent fresh water to thin it for even application through the spray nozzle.

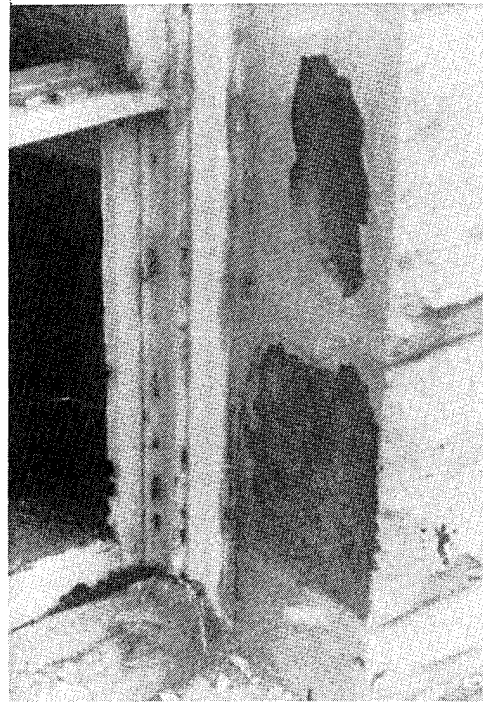
Figure 8. View of wall showing spalling damage to sandstone

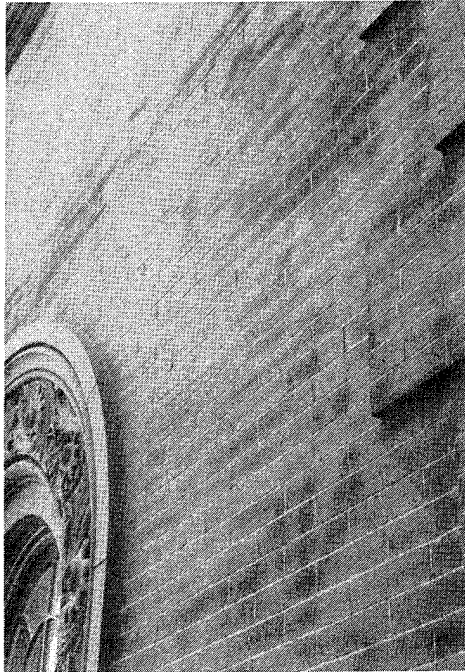
Figure 9. View of brick showing nozzle damage

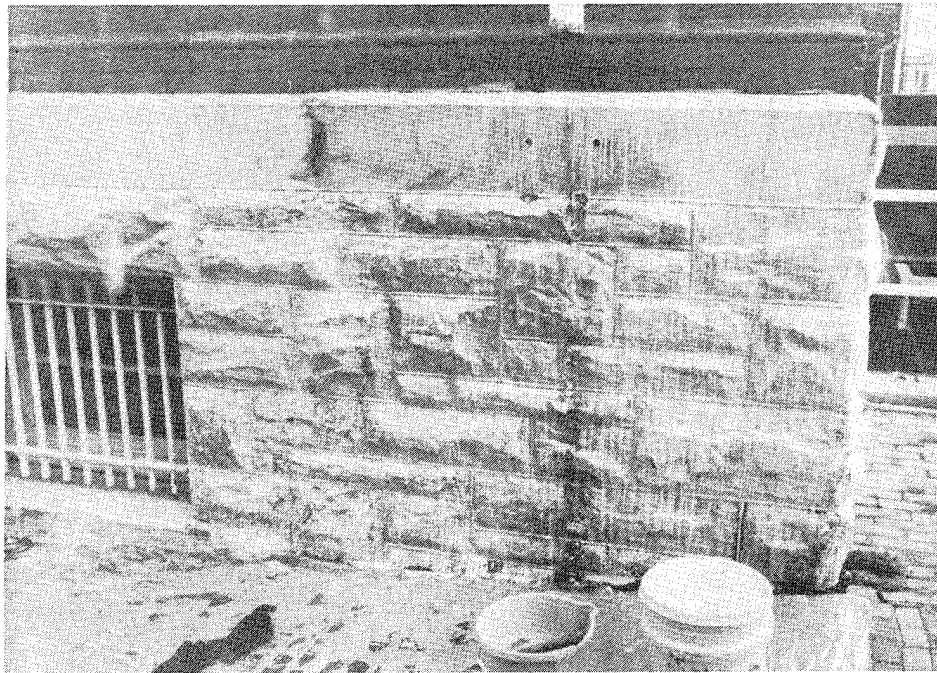
Figure 12. Limestone being cleaned with chemical spray

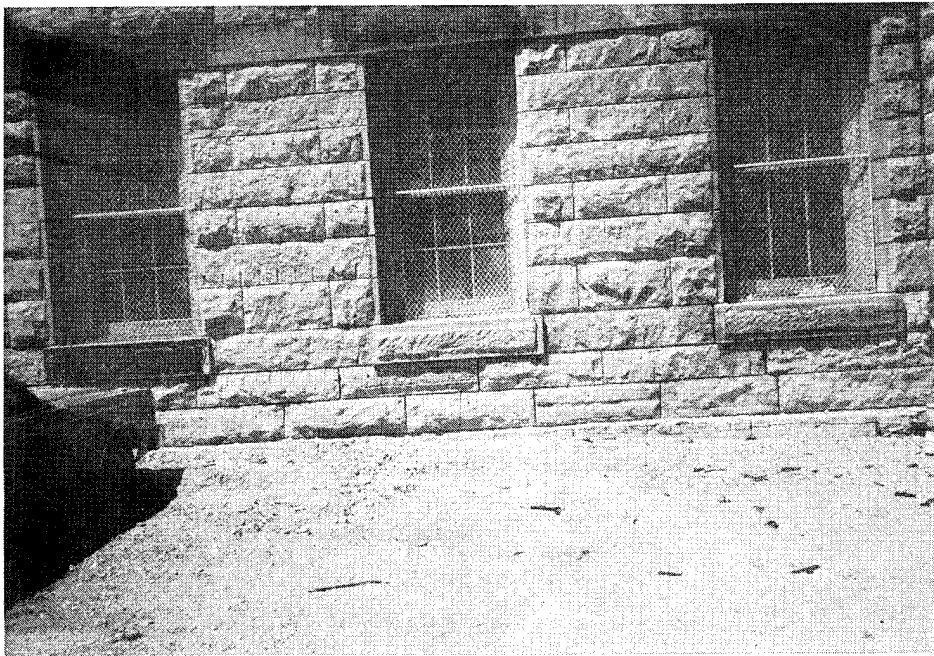
Figure 18. Sandstone sills during cleaning

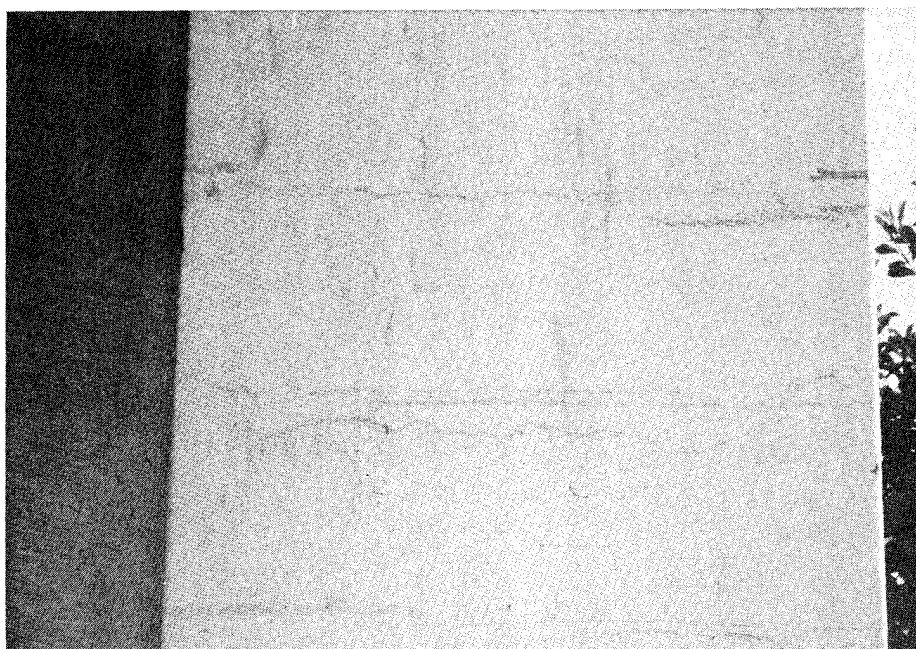
Figure 31. Cracked column panel showing smooth panel coating

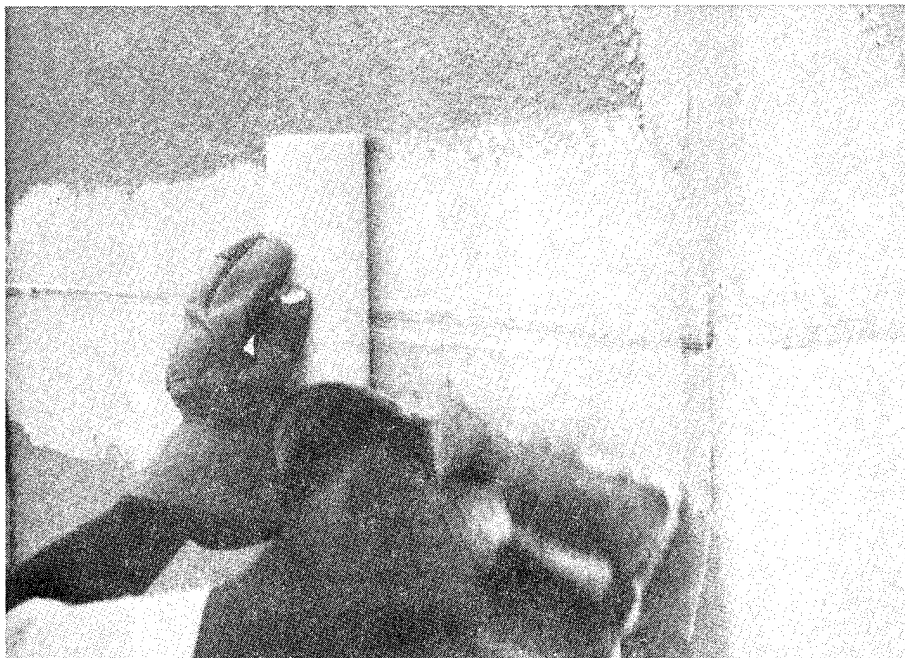
Figure 34. Trowelling of the mesh into place

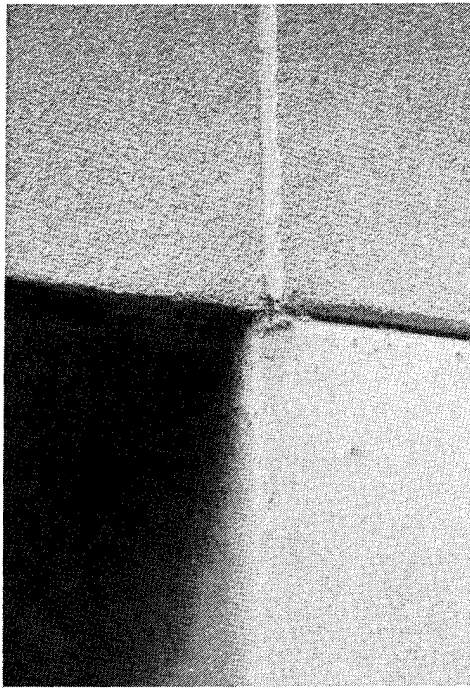
Figure 35. Contrast between base coat and finish coat

The final coating is the stucco-like coat. This coating is the same as the high-flexibility acrylic polymer coating with the addition of sand particles to the mixture. When trowelled onto the surface, this material simulates the cement stucco finish of the original building. It is also trowelled on in a 1/32-in.-thick coating. Figure 35 shows a corner detail in which the finished top coat is at the top of the figure and the base coat with the mesh is shown at the bottom.

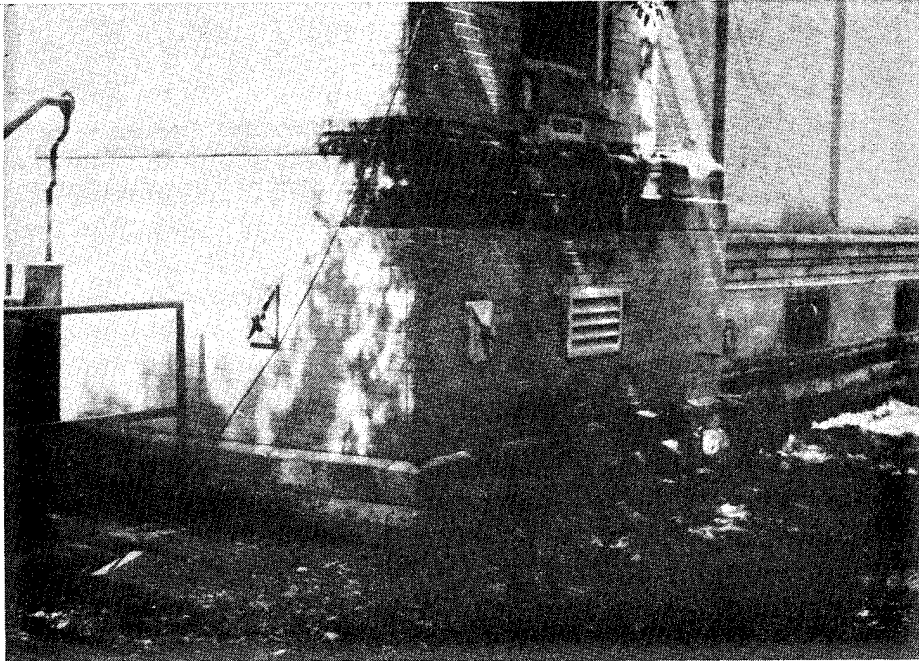
east-west direction (Figure 40). These had been in place from previous repairs. The tie rods that were to be installed during this renovation were to run north and south to address the separation of the building in this direction.

Figure 40. Existing tie-rod anchor in east facade at northeast corner

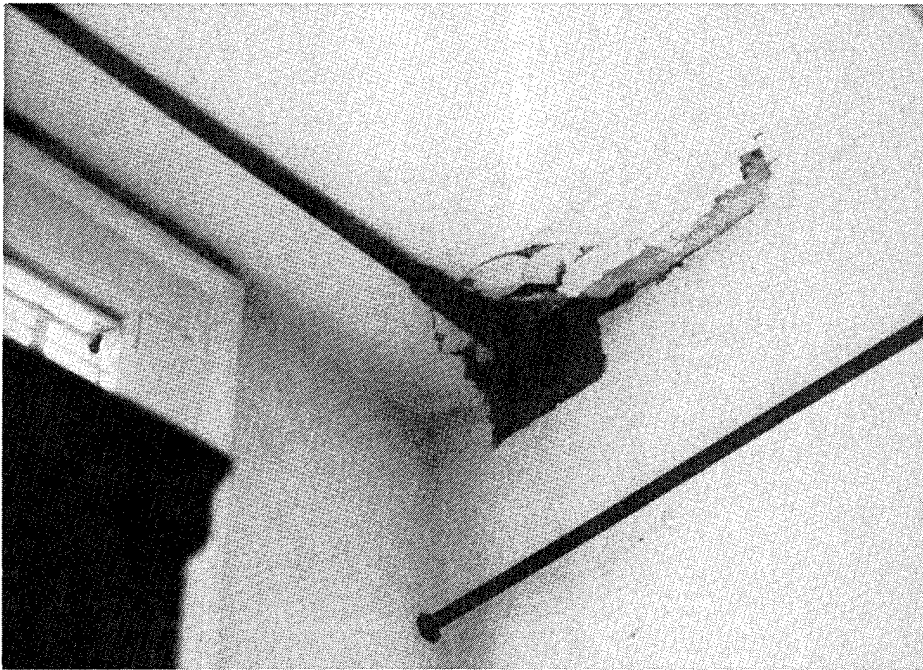
Figure 42. Two tie rods in the northeast corner of the chapel

In choosing the location of the rods, the engineering team gave much consideration to visibility, safety, and proper location. Consideration was given to routing the rods within the walls and inside the woodwork that runs around the balcony of the central chapel. However, the effort to accomplish such a feat was not economically feasible, and the rods were run adjacent to walls. Their final location was chosen so that their visibility would be limited. They were run near the floor, behind pews, and in corners between

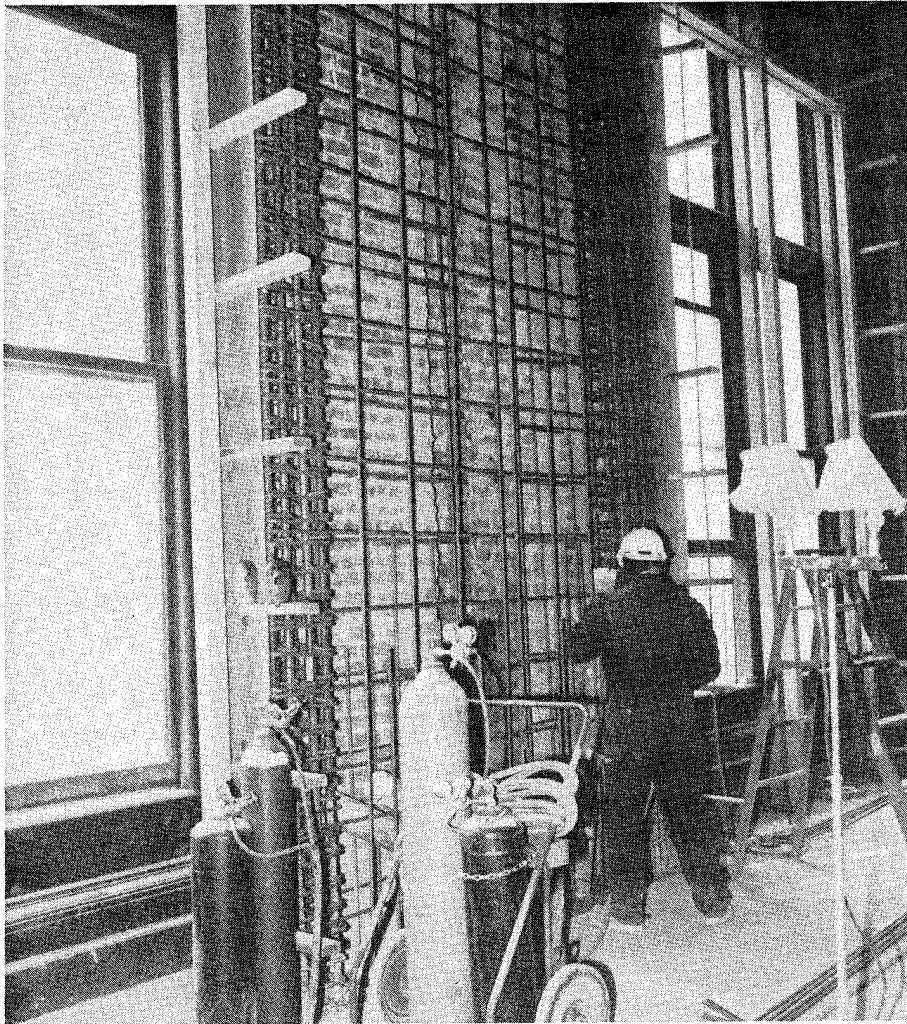
Figure 52. Strengthening of walls behind historical facades
