## **Evaluation of a Retrofit OH-58 Pilot's Seat to Prevent Back Injury**

**December 1994**

**United States Army Aeromedical Research Laboratory  
Fort Rucker, Alabama 36362-0577**

| REPORT DOCUMENTATION PAGE | | | | Form Approved<br>OMB No. 0704-0188 | | |
|---|---|---|---|---|---|---|
| 4. PERFORMING ORGANIZATION REPORT NUMBER(S)<br>USAARL Report No. 95-9 | | | 5. MONITORING ORGANIZATION REPORT NUMBER(S) | | | |

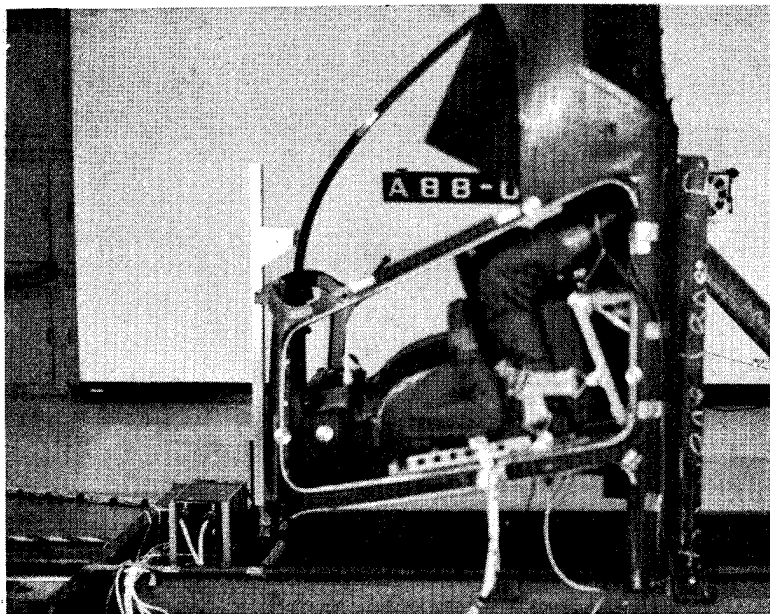
Pre- and posttest profile photographs are at Figures 13 and 14. All transducer traces for the test are at Figures A-1 through A-3. The right seat 50th percentile dummy stroked 4.75 in at the BRP, a point on the surface of the seat cushion located 5.75 inches forward of the seat reference point (SRP) with the cushion deflected under a 1 G load (see Figure 5). As shown in Table 3, the stroke of the seat was determined by BHT, based on the deformation of the wire bender which was replaced after each test; the seat BRP displacement also was measured directly by a CAMI rotary potentiometer with a quoted "5 G extraction limit." In this one case, the two methods agreed within experimental accuracy (4.75 and 4.8 inches), but the potentiometers showed excessive deflection in the other five readings shown in Table 3. The potentiometer output traces are shown in Figures A2, A5, and A9, and the probable potentiometer "overrun" points are shown on these traces. Since the seat pans were accelerated downward at 1000 G/sec up to a sustained 20 G level, it is clear that the "5 G extension" limit was exceeded, but the error appears to be related to rotational inertia of the device which permitted it to reel out excessive cable; the beginning of seat pan stroke agrees with film analysis and with dummy transducers.

Figure 14. Posttest view of test 88057. (Note the stroked position of the bottom armor plate.)

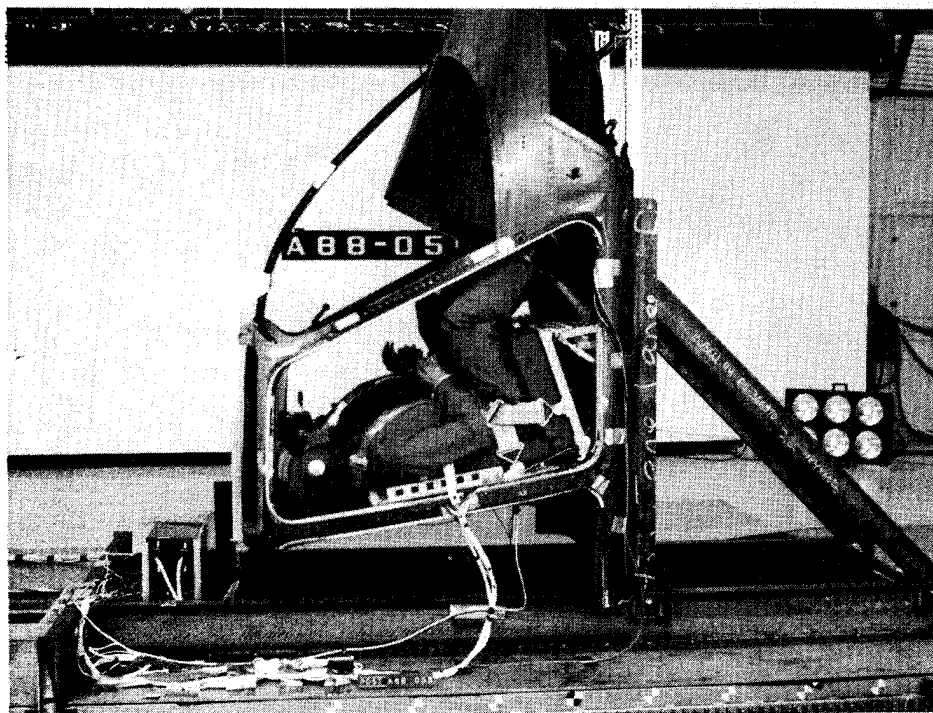
**Figure 19.** Posttest view of test 88058 (note the stroked position of the bottom armor plate).

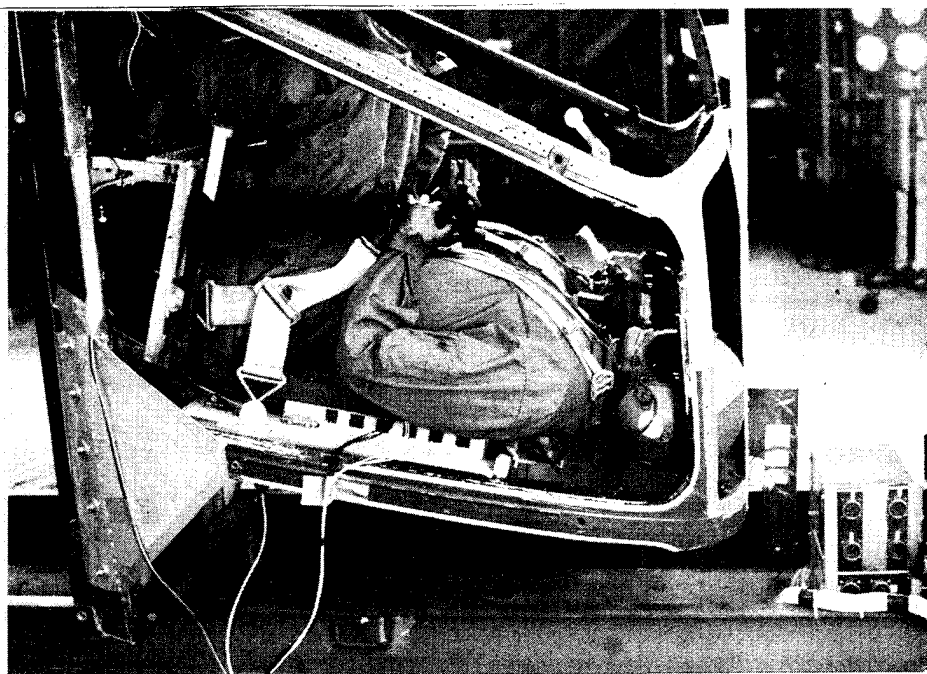
Figure 20. Posttest view of test 88058, showing 95th percentile VIP dummy (note the .05-inch thick aluminum sheet used to stabilize the floor-to-bulkhead joint, and the slack in the wire bender at point "W").

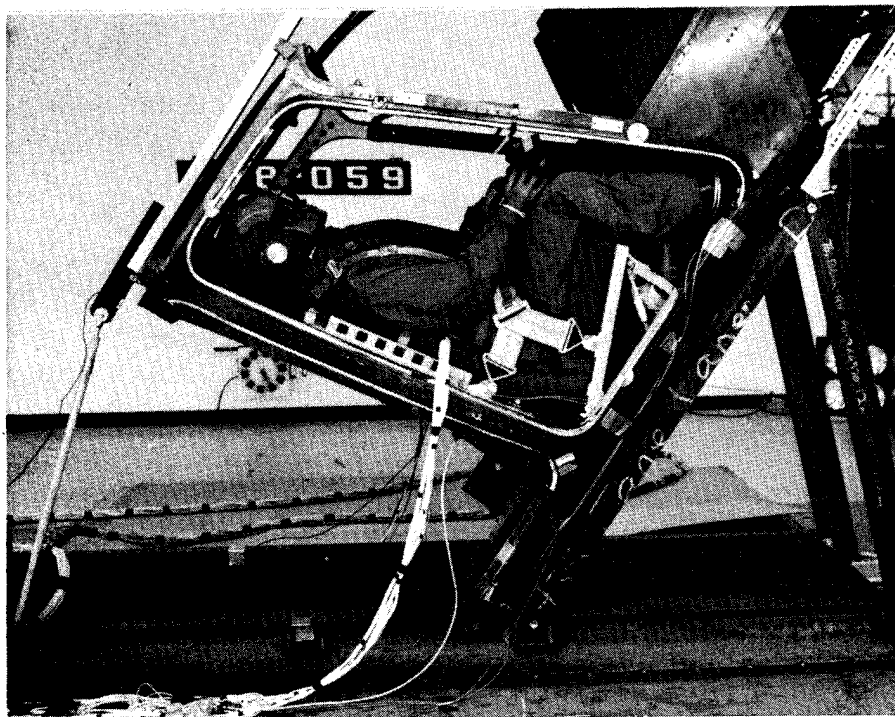
Figure 22. Posttest view of test 88059 (note slack wire bender device).

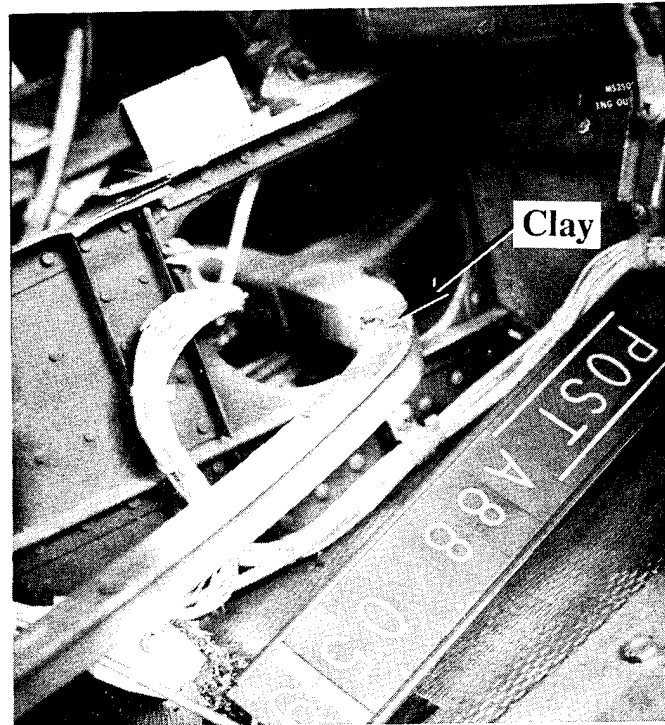
Figure 23. Modeler's clay on underfloor yoke revealing the impact point of the left armor plate (note failure of BL 5.21 brace tube anchorage).

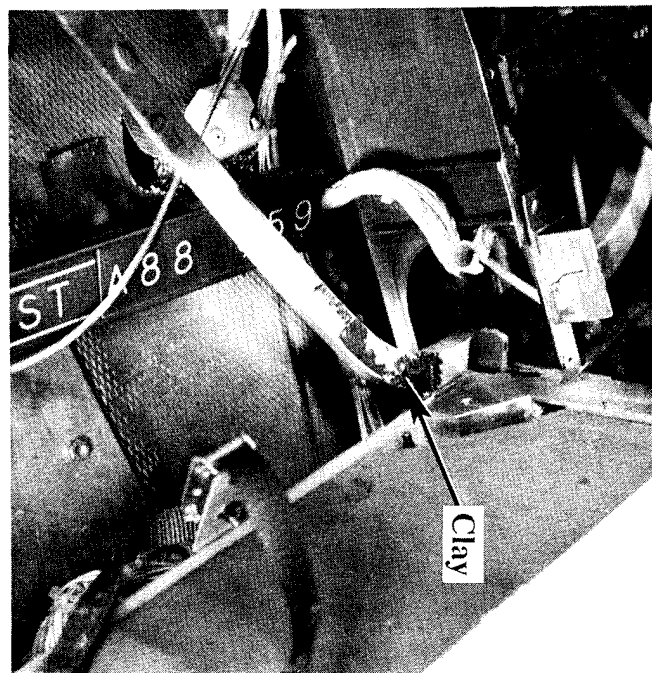
Figure 24. Underfloor yoke impact at bottom armor plate rear edge.

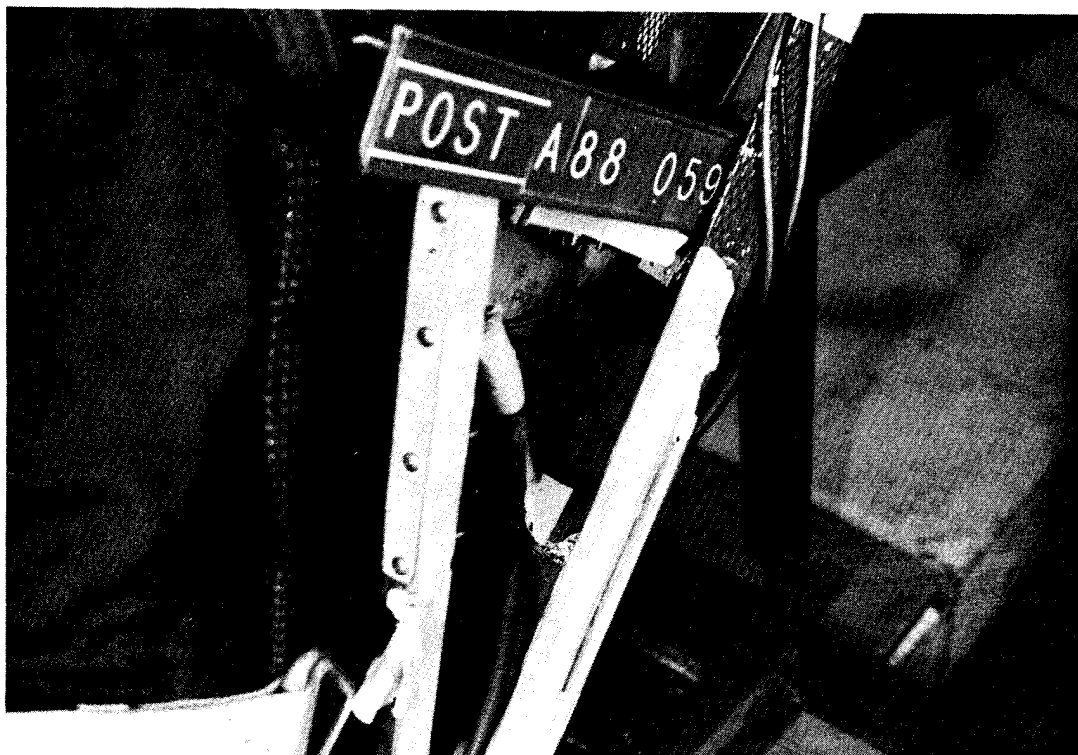
The recorded transducer traces may be reviewed at Figures A-8 through A-11. The seat leading edge bulkhead braces at BL 17.5L, 5.2L, 7.2R, and 20.3R were torn free from their anchorages to the cockpit floor. The failures of these anchorages in the honeycomb floor were photographed and are shown in Figures 23 through 29. The stresses and corresponding loads in the three tubular braces are presented in Figure 17. The brace loads in this test are compared to those from the two pure vertical tests. Note an initial compressive load, due to the downward impact, did not occur in this test, and some tensile load appeared at 34 ms about the same time that the armor plate accelerometers showed deceleration (Figure A-8). The chest X deceleration of the right dummy (Figure A-8) peaked at 24 G, reflecting dynamic overshoot from the 34 G peak sled value acting at 34 degrees from the z-axis. The chest z-value, on the other hand, peaked at only 6 G, a value apparently incompatible with the known 12 G input to the buttocks as indicated by the 1300-lb load shown in Figure A-9. The same chest z-value was correspondingly too low in Figures A-1 and A-4 for tests 88057 and 88058, respectively. The chest z accelerometer appeared to have been inadvertently plugged into the y-axis chest accelerometer. This conclusion is based on the fact that the transducer also read very low negative and positive G in later PDU tests (runs 88060, 88061, and 88062), but when the cockpit was yawed 15 degrees for tests 063 and 064, the z-axis transducer came alive and displayed values of 10 to 15 G as would be expected for the y component. Thus, the chest z values shown are assumed to be chest y values.

The failure of all four brace anchorages at a horizontal velocity change of only 18 fps and approximately 20 G impact is a point worthy of redesign effort for a production seat. The right inboard (BL 7.2R) anchorage failed at only 1373 lb, little more than half the failure load of the other two tubes at 2203 lb  $((2222+2184)/2)$ . If failure had not occurred in the right inboard brace, and 2203 lb were sustained in each brace, the horizontal x-axis load would be as follows:

Figure 25. Failure of BL 20.3 right outboard brace tube anchorage to floor.

Since the anchorages did fail after sustaining this force for about 10 ms (Figure 17), we believe only a small strength increase would sustain the test loads. It is suggested the horizontal shear be carried through the honeycomb "bathtub" at the outboard edges of each seat and at the center console web. The cost and weight of a web structure should be lower than the separate bracing tubes.

| <u>Item</u> | <u>Weight difference<br/>(pounds)</u> |
|---|---|
| #6. Delete floor-to-bulkhead braces at BL 17.5L, 5.2L, 7.2R, and 20.3R and replace with horizontal beam between knee bulkhead and FS 73.06 canted bulkhead. | -2.0 (approximately) |

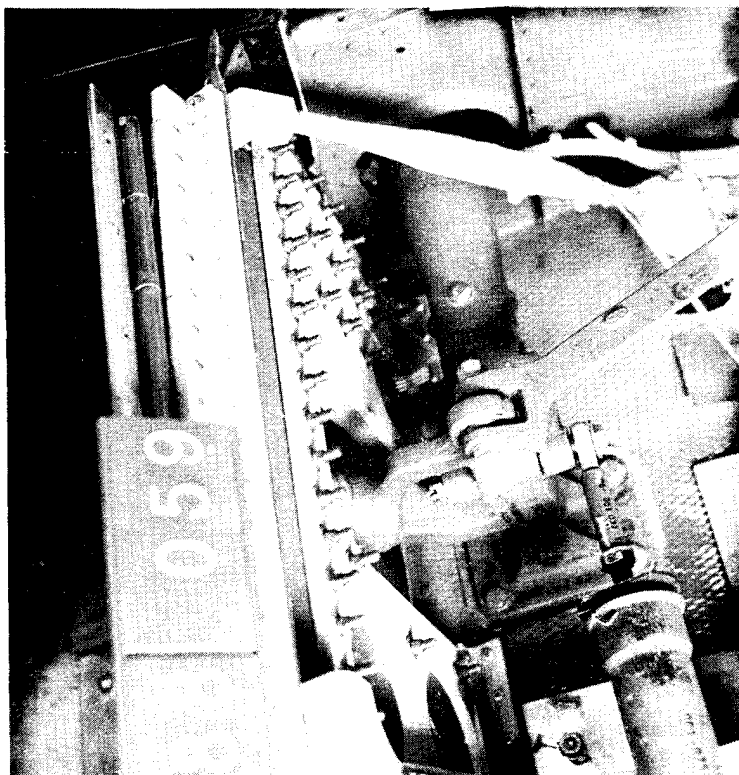
Figure 26. **Postmortem view of BL 17.5 left brace and BL 5.2 left brace tube (note slight separation of M535830 hinge at inboard edge).**

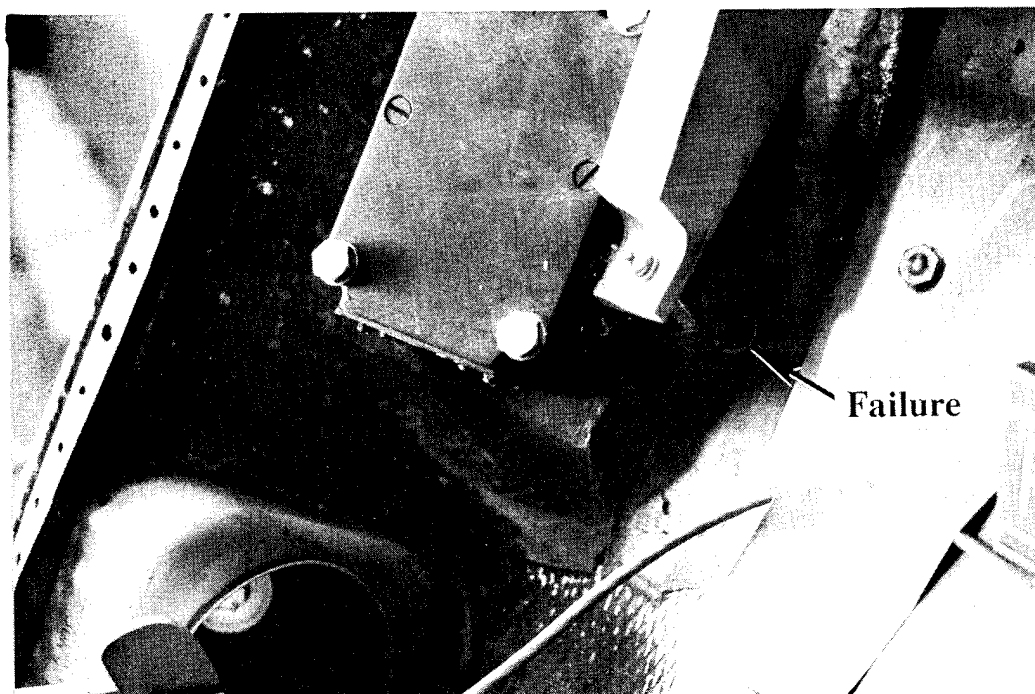
Figure 27. **Failure of BL 17.5 left brace anchorage to floor.**

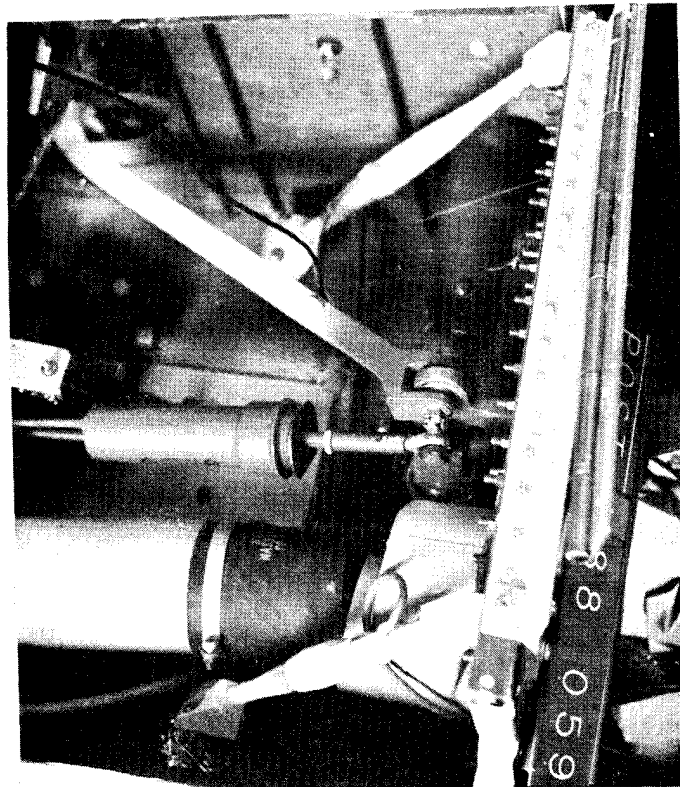
Figure 28. View of right seat area after removal of armor plate at hinge (note separation of M535830 at bottom of photograph).

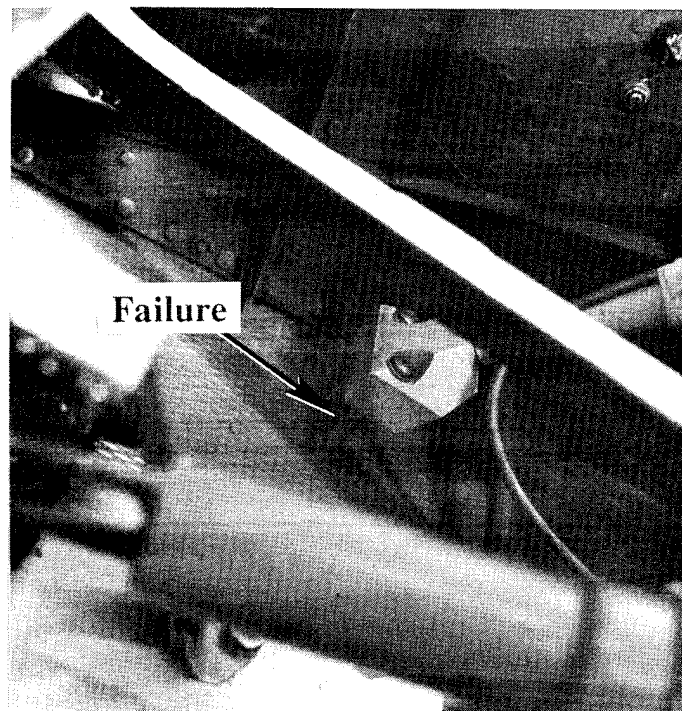
Figure 29. Closeup view of BL 7.2 right anchorage failure at 1373 lb.

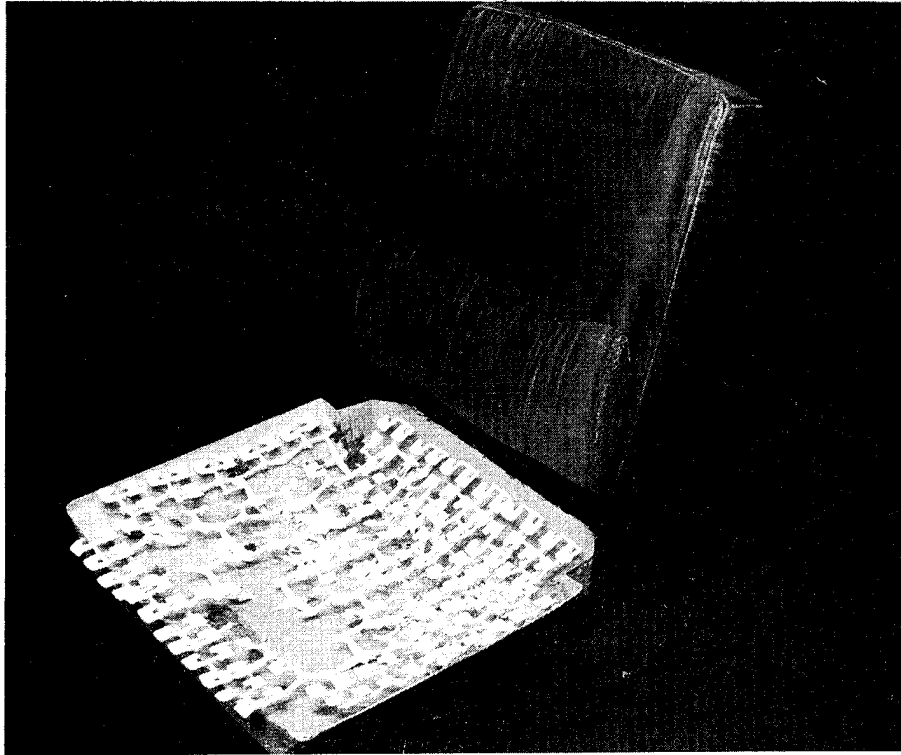
The degraded PREQUAL™ was replaced with foam cushions (cut to size) from wrecked UH-60 seats, and the frayed, worn SPACEFABRIC™ was replaced with black sheepskin covers, also from UH-60 wrecked seats. A recent inspection reveals the seat cushions are still serviceable, but the sheepskin is faded somewhat after 4 years exposure in the JOH-58A. Unless SPACEFABRIC™'s resistance to sunlight is improved, the sheepskin material appears to be a viable candidate to replace it.

Figure 36a. Copilot seat bottom and back cushions after removal of PREQUAL™ cover after 20 months and 100 flight hours in JOH-58A (Ser 71-20778).

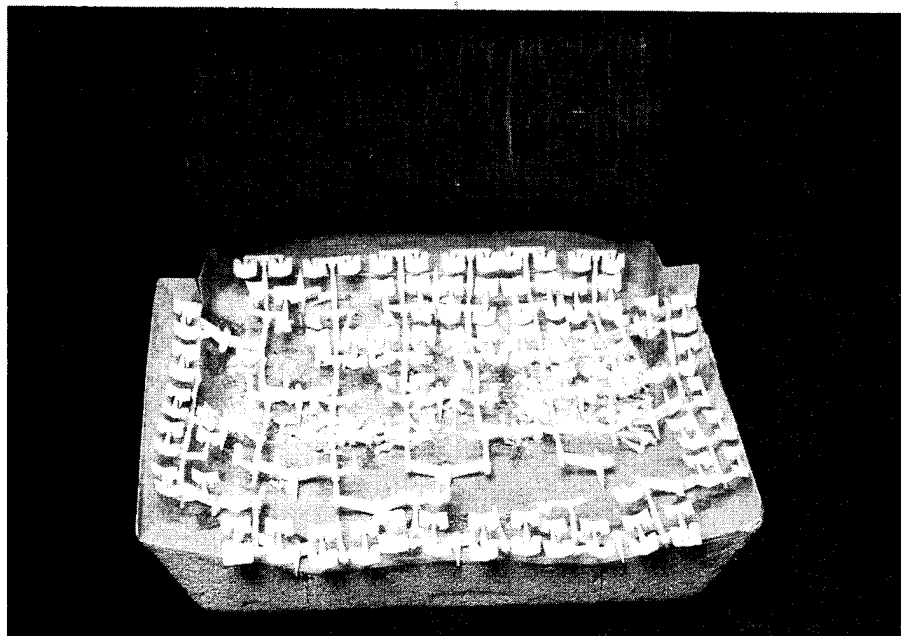
Figure 36b. Copilot (left) seat bottom and back cushions (note disintegrated plastic lever supports).
