# Review of Long-Term Maintenance Plans for the South Jetty, Grays Harbor, Washington

June 1995

Final report

Prepared for U.S. Army Engineer District, Seattle  
Seattle, WA 98124-2255

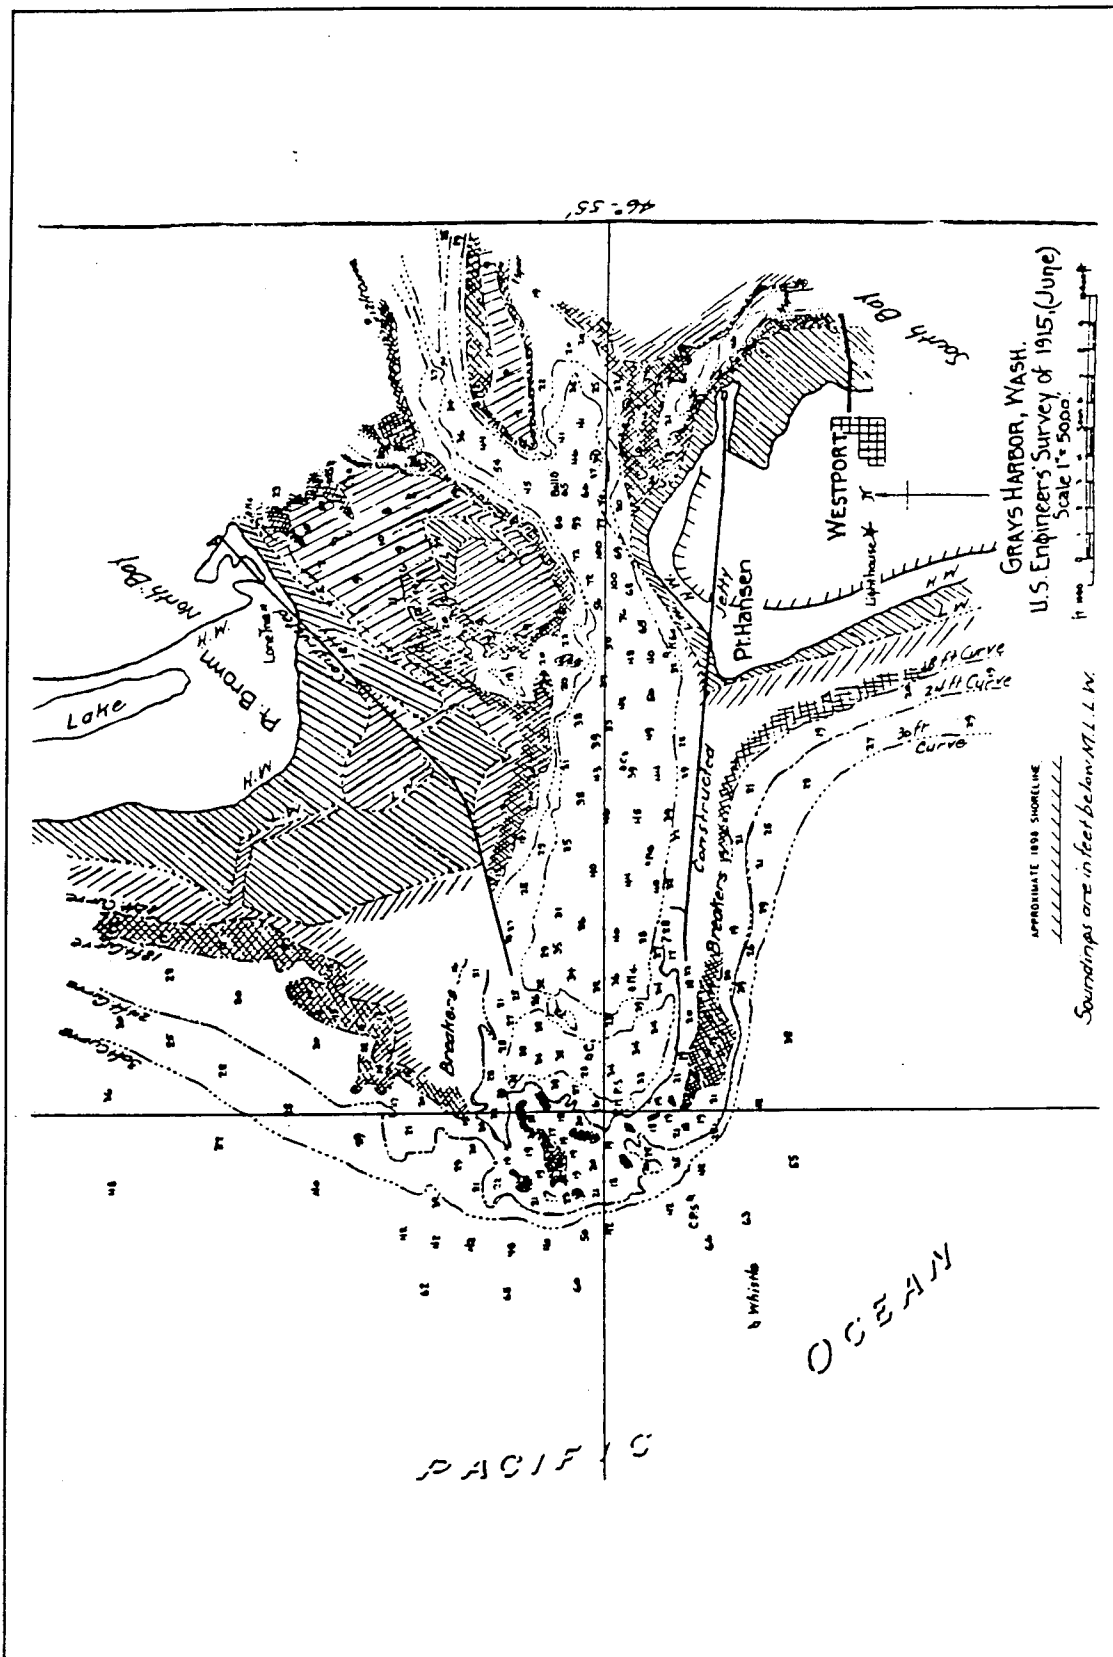
Figure 3. Entrance configuration on completion of jetties

15. Figure 3 shows the configuration of the entrance in 1915, the time when the jetties were nearly completed. The entrance channel is broader than the channel was prior to construction, shown in Figure 2, and has about the same depth. It emerges near the center of the outer ends of the jetties. Material had been scoured from the entrance and deposited on the outer bar. Sand was deposited along the south side of the south jetty (then 13 years old).

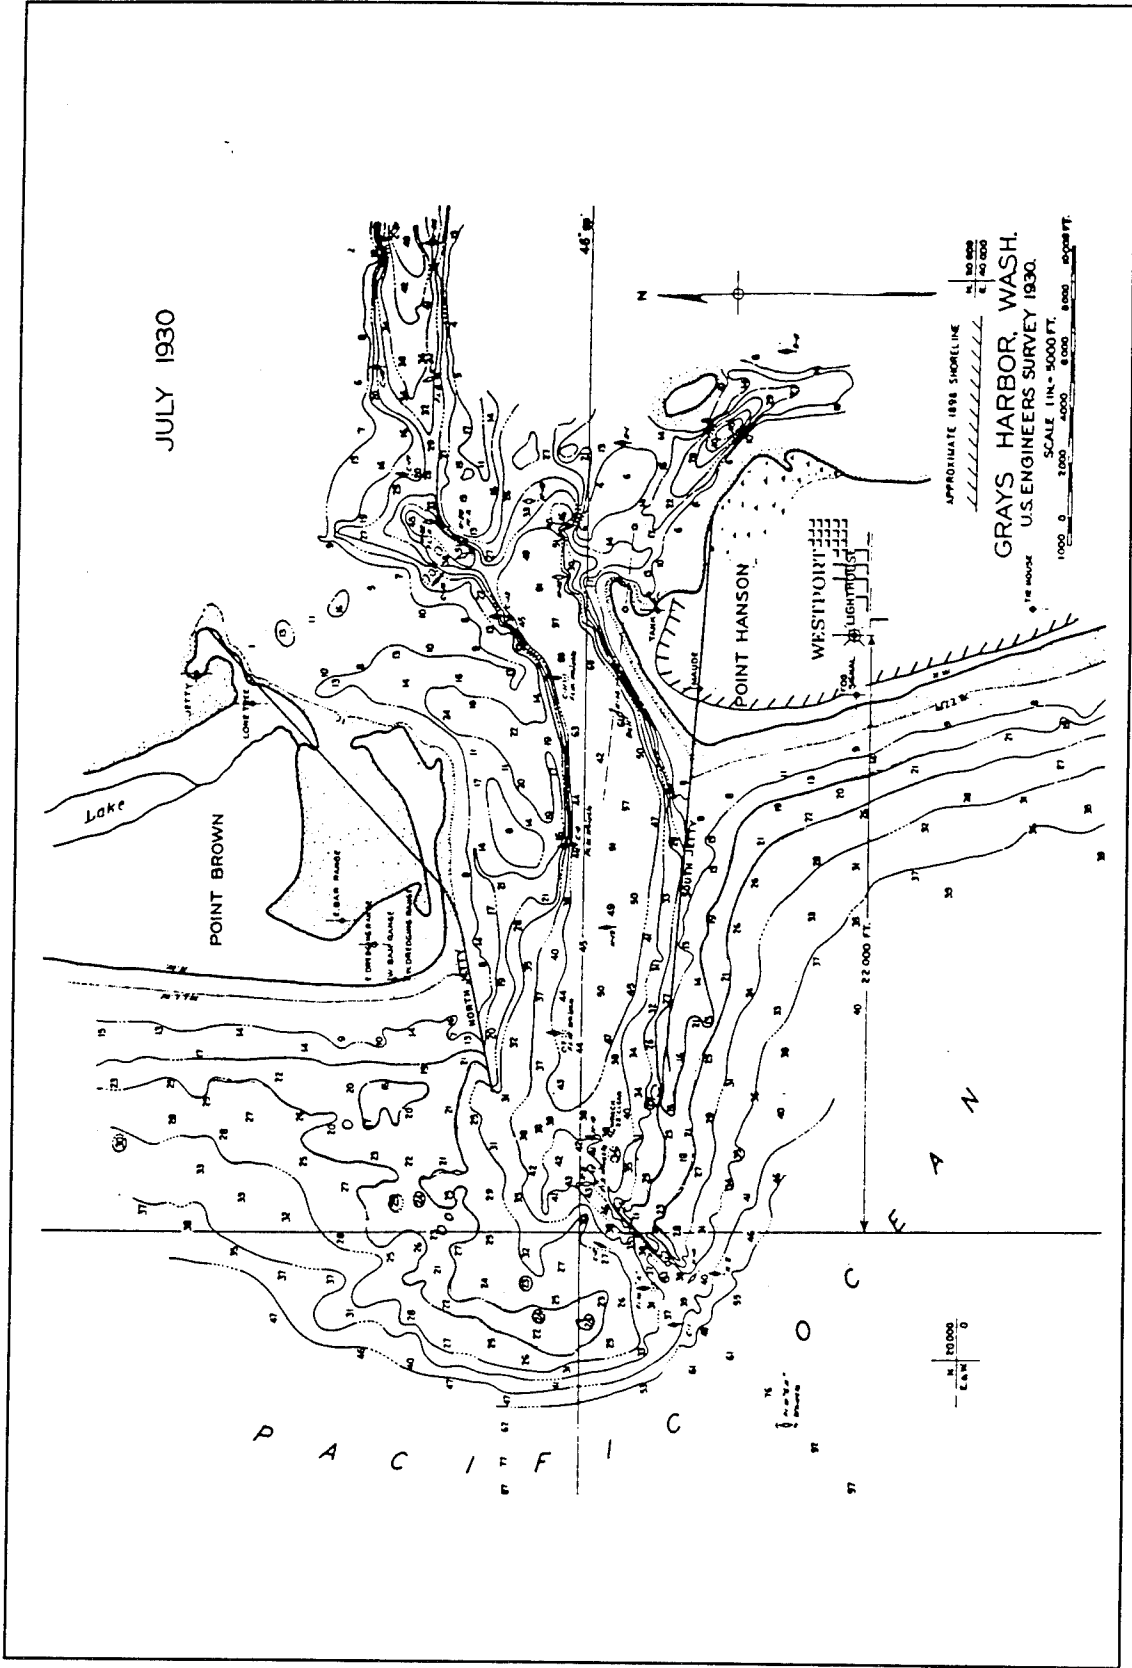
Figure 4. Entrance configuration in 1930

16. Figure 4 shows the configuration of the entrance in 1930. Comparison with Figure 3 shows that the entrance channel is deeper but narrower, and the north side of the entrance channel has moved south. Depths of water over the outer bar were greater, and Point Brown extended further south and west. The west shore of Point Hanson (South Beach) was eroded.

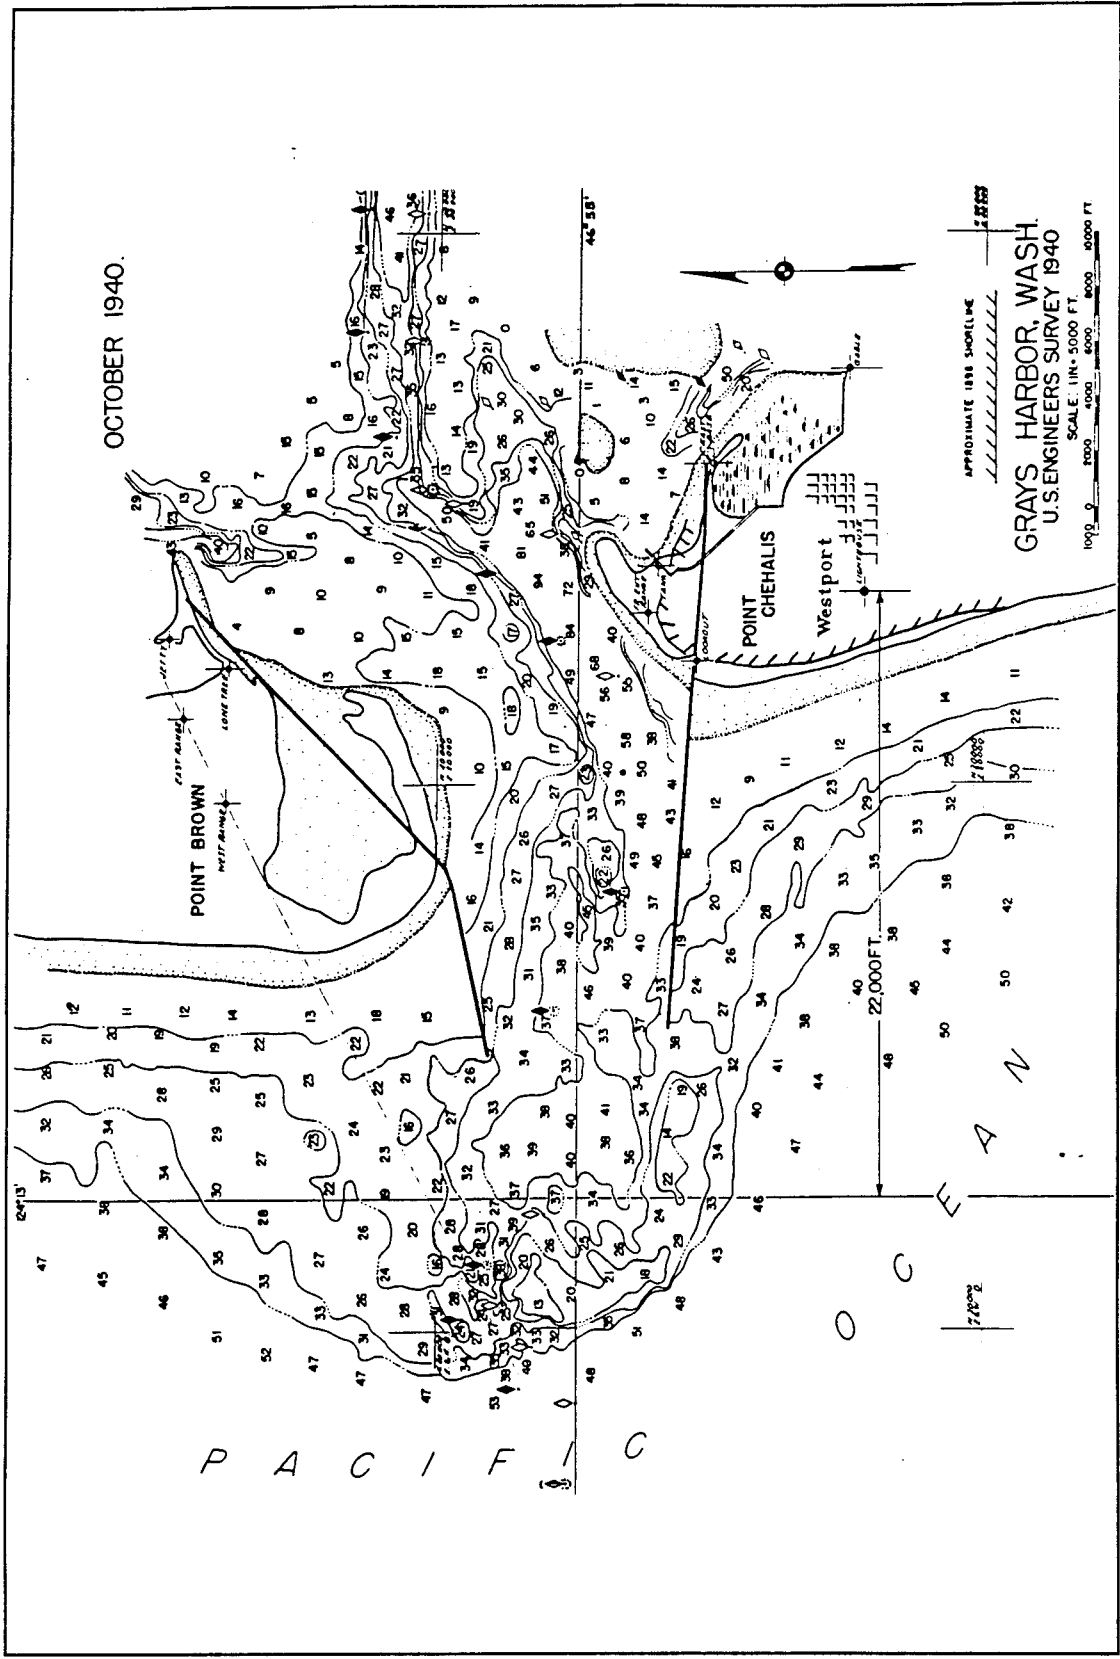
Figure 5. Entrance configuration in 1940

17. Figure 5, showing the configuration of the entrance in 1940, indicates a continuation of the trends described above. The entrance channel was hard against the south jetty and still narrower than it was in 1930. The inner bar deposit south of the north jetty, across the jetty from Point Brown, has accumulated more sediment, as had the deposit at the north tip of Point Hanson -- now Point Chehalis. South Beach was eroded further.

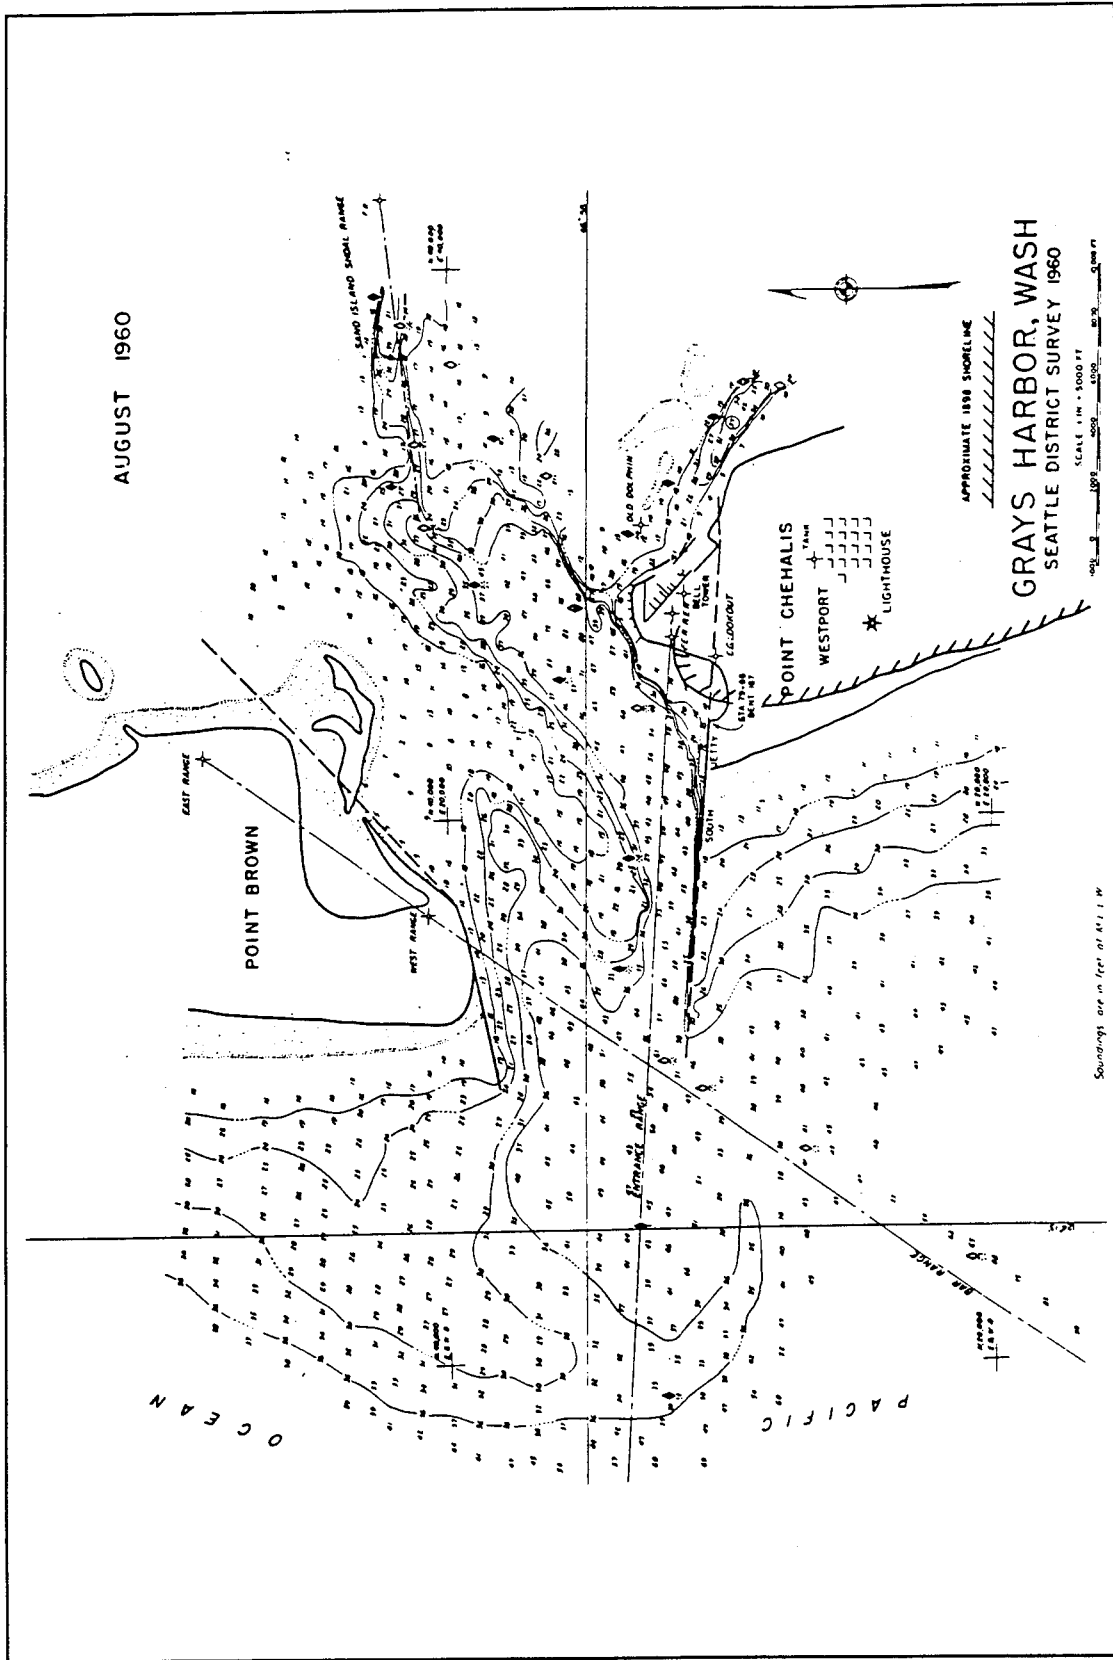
Figure 7. Entrance configuration in 1960

19. Figure 7, dated 1960, when compared with Figure 6, shows erosion of the outer bar and widening of the entrance channel. There was slight erosion of North Beach and some deposition on South Beach. Erosion at the east end of the south jetty had progressed, forming Half Moon Bay. Further erosion of the Point Chehalis shoreline had occurred.

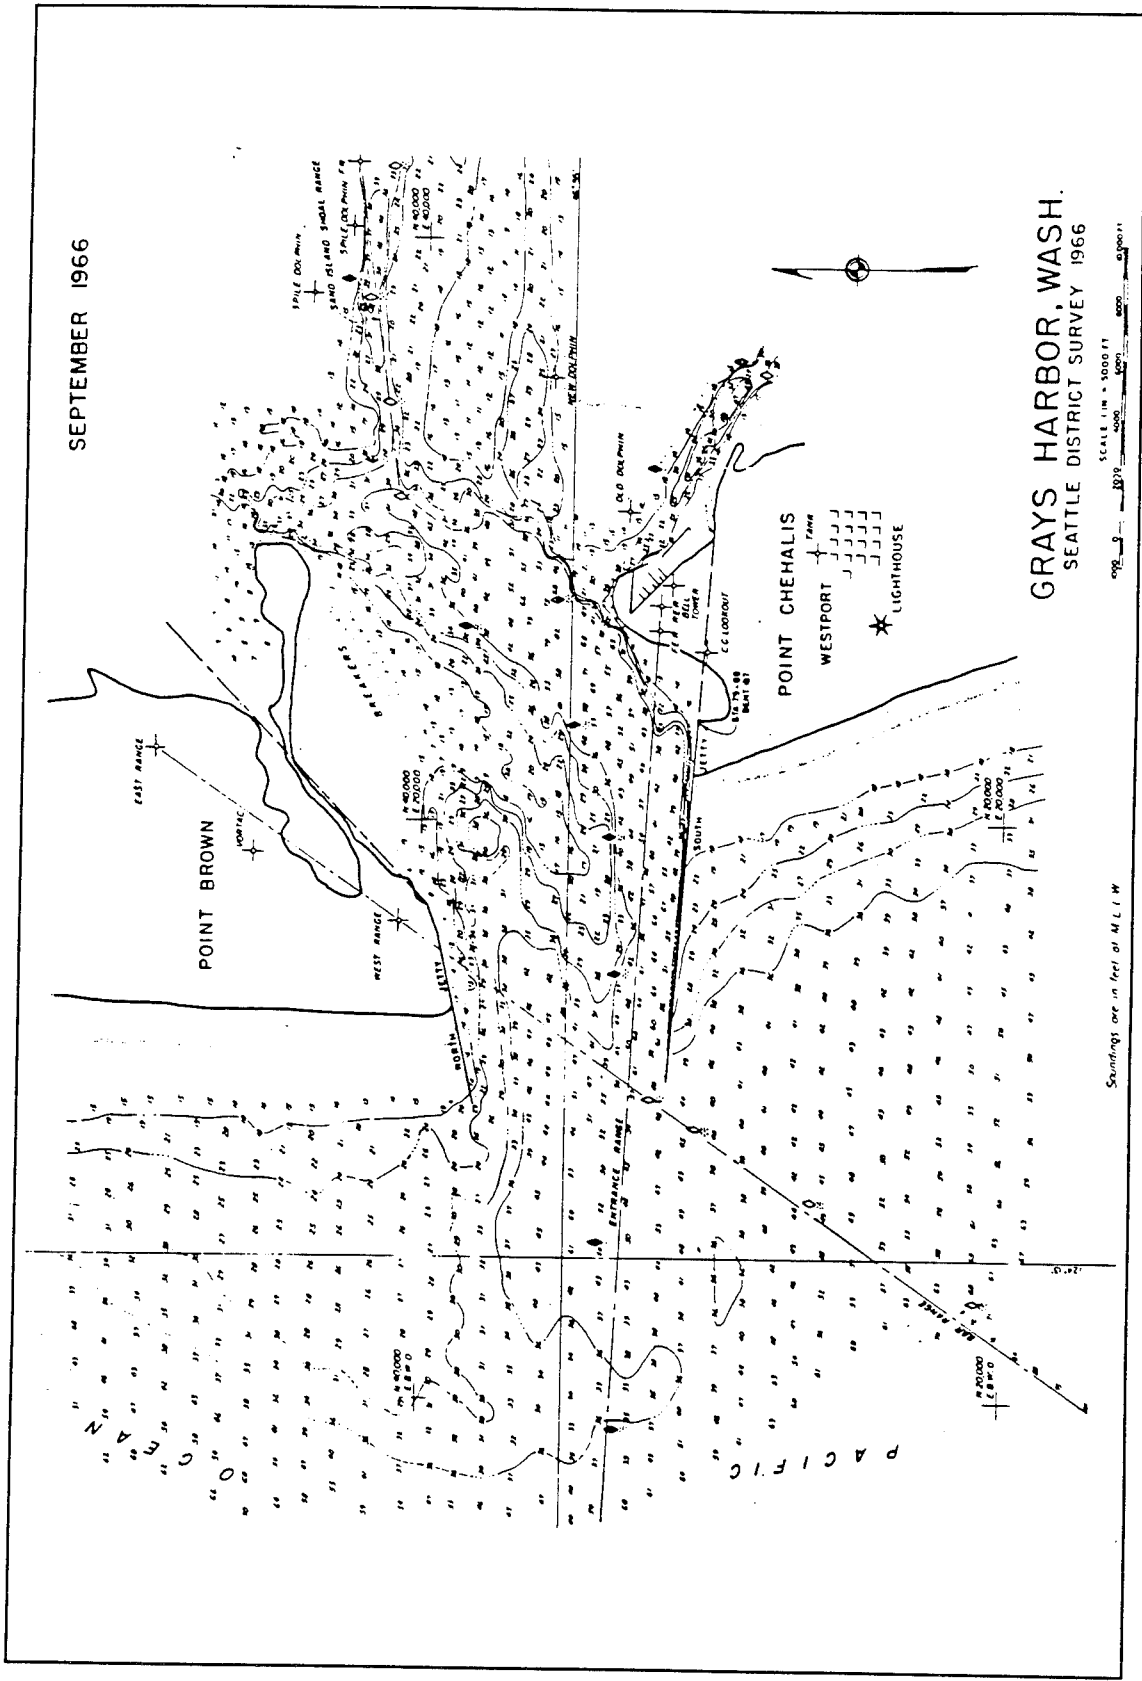
Figure 8. Entrance configuration in 1966

20. Figure 8, dated 1966, when compared with Figure 7, shows additional deposition on the inner bar deposit south of the north jetty and some erosion of the east shore of Half Moon Bay. There was further erosion of the outer bar.

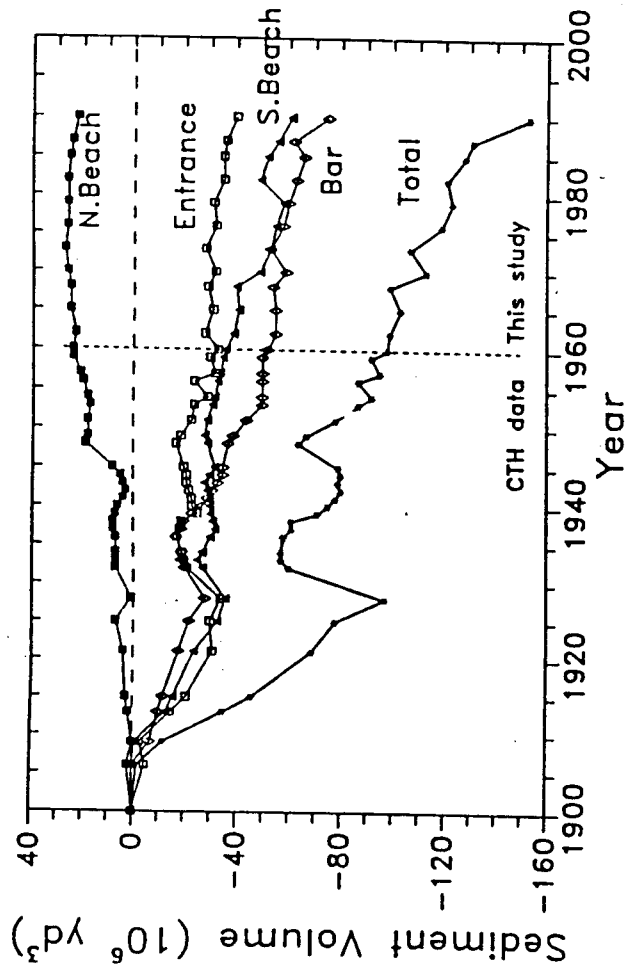
38. The plot of total volumes in Figure 13 shows continuing loss of sand from the region over a period of ninety years. This period is too long to attribute the loss to cyclic causes, such as variability of winter weather. It is most likely a result of the impacts of the jetties on the areas included in the computation. The jetties first caused erosion of sand from the entrance and its deposition on the bar, where it was subsequently eroded by waves and coastal currents. Sand that entered the entrance from North Beach crowded the entrance channel until velocities were sufficient to carry additional sand seaward or landward beyond the areas included in the calculation. Waves in the entrance must also have contributed to movement of sand. And finally, South Beach was deprived of a sand supply and subjected to erosion as described in paragraph 31.

Figure 13. Historic volume changes for selected areas (from Battelle/Marine Sciences Laboratory 1992)

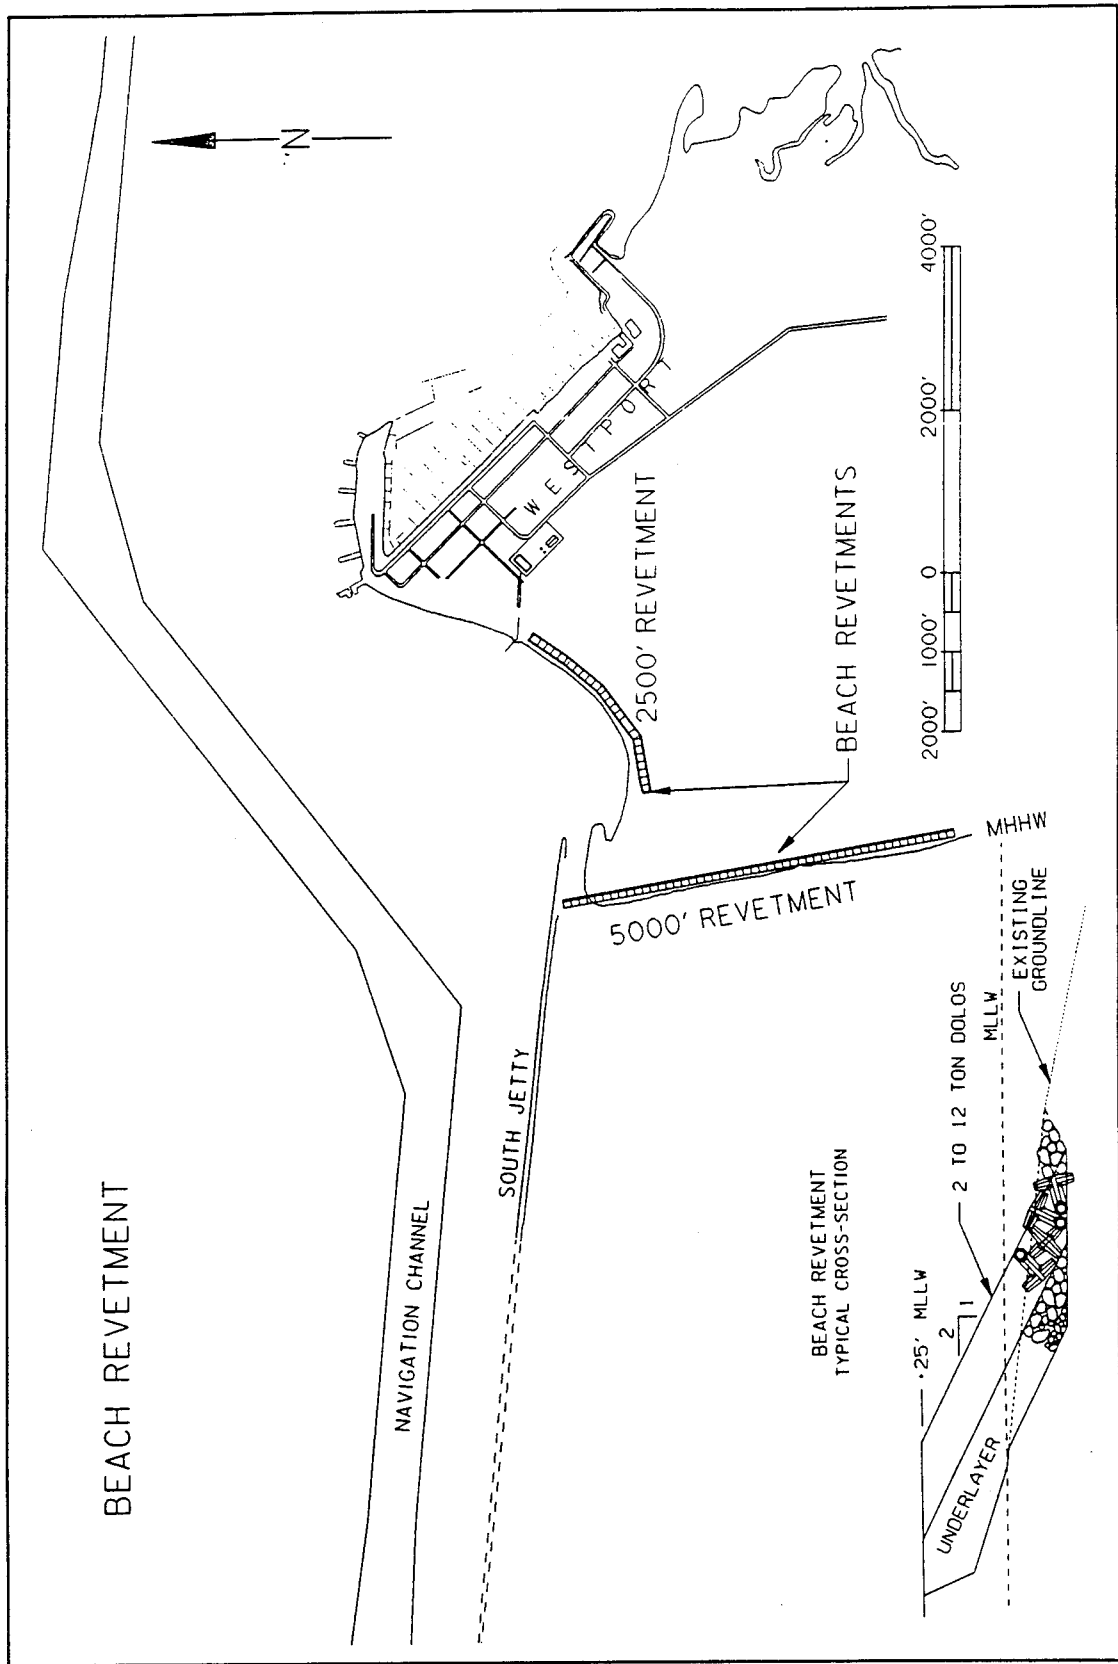
46. This alternative is shown in Figure 15. It includes revetment along South Beach and extension of the revetment in Half Moon Bay. In addition to a very high initial cost, erosion of sand at the base of the revetment down South Beach would cause continuing requirements for expensive maintenance.

Figure 15. Beach revetment alternative

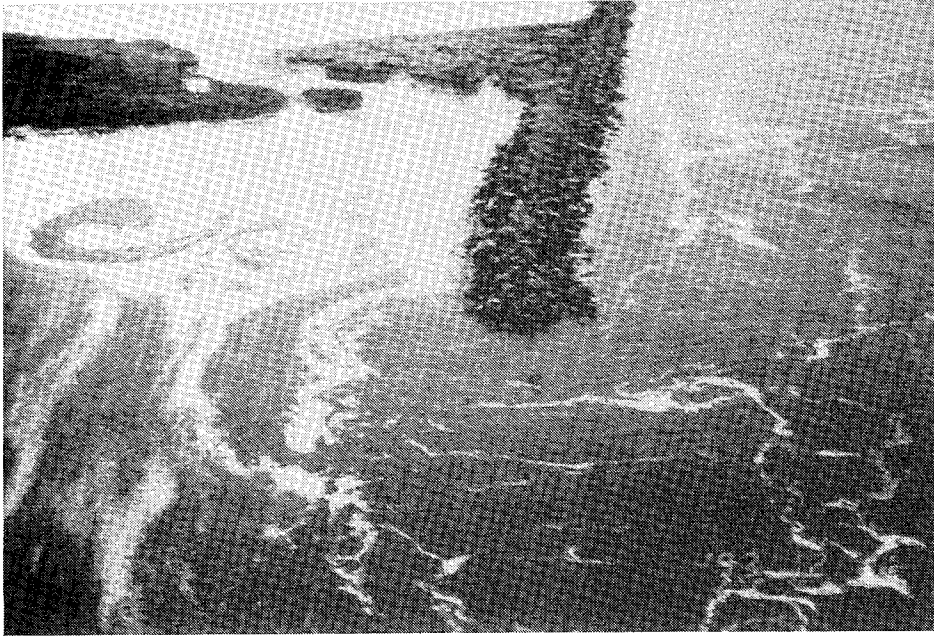
Photo 1. Initial breach formation, looking seaward, 10 December 1993

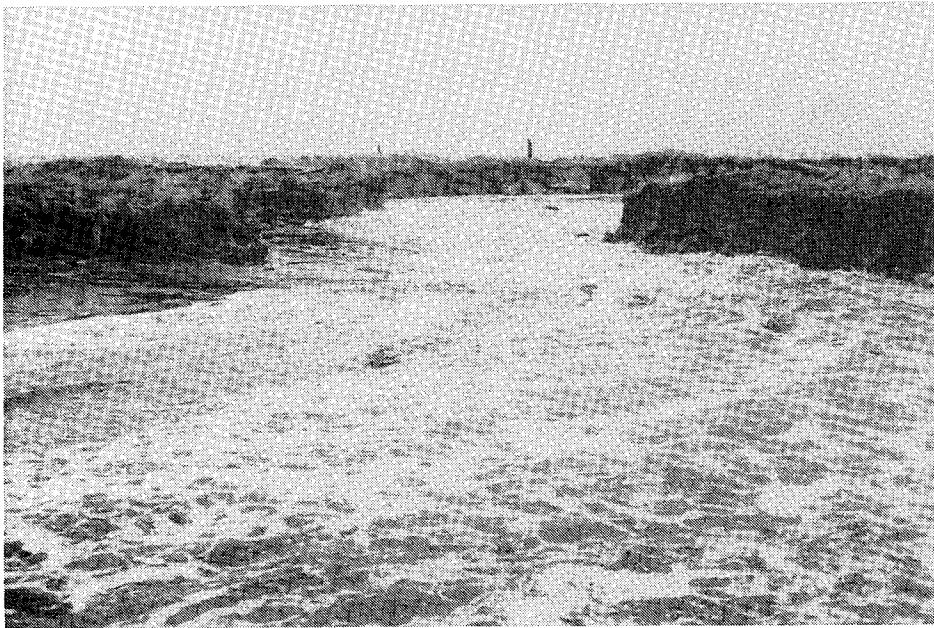
Photo 2. Initial breach formation, looking landward, 10 December 1993
