# EXAMINATION OF CORRODED TUBES FROM THE BOILERS OF THE USS EDWARDS (DD-950)

August 1959

U. S. NAVAL RESEARCH LABORATORY  
Washington, D.C.

NRL MEMORANDUM REPORT 964

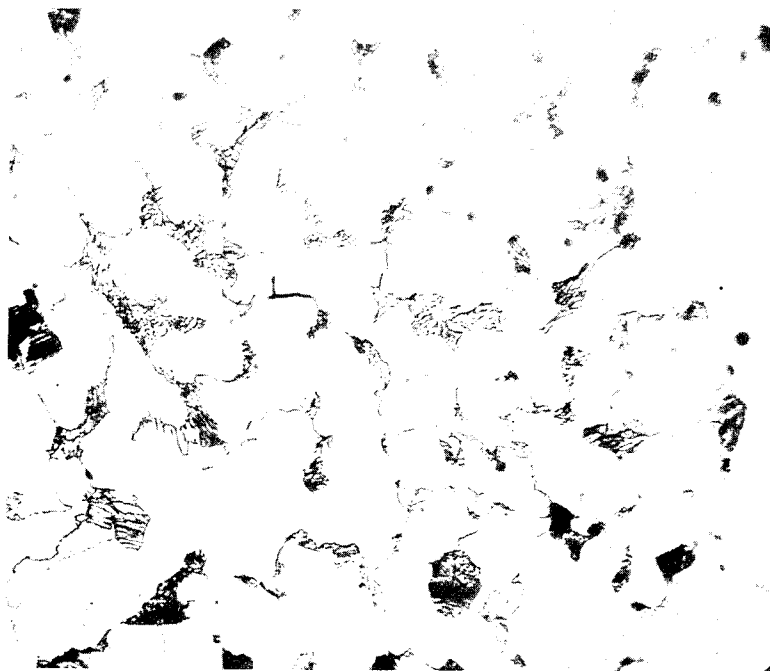
- Fig. 3 - 1B Boiler - RW No. 18 (Section through bulge that had not cracked). Note lamellar (new) pearlite which indicates that service temperature exceeded 1335°F. Etchant: 1% Nital plus 2% Picral. 1000X.

Fig. 3 - 1B Boiler - RW No.18 (Section through bulge that had not cracked). Note lamellar (new) pearlite which indicates that service temperature exceeded 1335<sup>0</sup>F. Etchant: 1% Nital plus 2% Picral. 1000X.
