1. AGENCY USE ONLY (LEAVE BLANK)	2. REPORT DATE 5 September 1995	3. REPORT TYPE AND DATES COVERED Professional Paper	
4. TITLE AND SUBTITLE  Developing Flight Test Techniques to Ensure Proper Rigging of Highly Augmented Aircraft		5. FUNDING NUMBERS  <b>19951107 055</b>

6. AUTHOR(S)  CAPT Ricardo Traven, CAF Susan E. Whitley		8. PERFORMING ORGANIZATION REPORT NUMBER	
7. PERFORMING ORGANIZATION NAME(S) AND ADDRESS(ES)  Visual and Technical Information Branch 7.2.4.3.A, Mail Stop 2, Bldg. 405 Naval Air Warfare Center Aircraft Division Patuxent River, Maryland 20670-5304

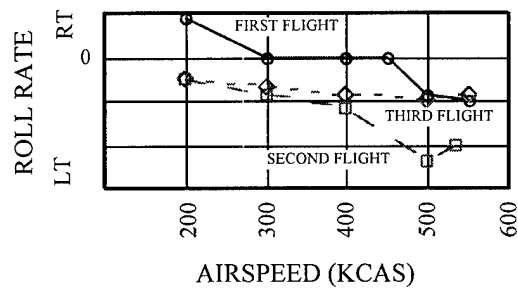
Figure 5  
CASE STUDY #2  
CR FLIGHT DATA

The airplane was flown prior to the first rigging to assess the handling qualities of the airplane and to quantify the complaints of the squadron pilots. The airplane exhibited a strong tendency to roll and yaw to the right above 25 deg AOA. By

35 deg AOA, the right roll and yaw rates were uncontrollable, as characterized by the NAWC-AD test pilot. Figure 5 presents the roll rate data and figure 6 presents the maneuvering flight data. The maneuvering flight data (figure 6) confirmed the squadron's most significant complaint, which was the inability to perform straight loops or any left rolling scissors maneuvers above 25 deg AOA and below 150 KCAS.

A second flight was flown on the airplane after a complete re-rig of the flight control surfaces. The results from this flight are presented in figure 5. While the CR roll rate trace shows a significant amount of roll

rate, the overall aircraft handling qualities were an improvement over those reported by the squadron's pilots. There was no maneuvering flight data collected on this flight; however, the NAWC-AD test pilot reported that although the yaw rate problem at high AOA was not ideal, it was tolerable. A comparison of the simulator data to the data from the second flight revealed that the probable cause was a TEF mis-rig in the mid-speed range and a LEF mis-rig in the high speed range. The NAWC-AD test pilot also noted that in flight the outboard LEF's were noticeably out of alignment with respect to the inboard LEF's, due to the effects of air loads on the LEF freeplay. The TEF's and the outboard LEF's were adjusted to correct the adverse handling qualities.

The data from the final flight are presented in figures 5 and 6. The roll rate in configurations PA and PA1/2 was reduced to insignificant levels ( $< 2$  deg/sec) and the highest roll rate observed in configuration CR was 5 deg/sec. This was considered acceptable by the NAWC-AD team. The yaw rate at high AOA during maneuvering flight was greatly reduced. The NAWC-AD test pilot was able to perform slow speed "over the top" maneuvers with no difficulty. Left rolling scissors, once impossible, were now easily flown at speeds below 150 KCAS and above 25 deg AOA.
