DOT/FAA/AR-95/51

Nondestructive Inspection of Piper PA-25 Forward Spar Fuselage Attachment Fitting

Final Report

| 7. Author(s) David G. Moore | | | | 8. Performing Organization Report No. | |

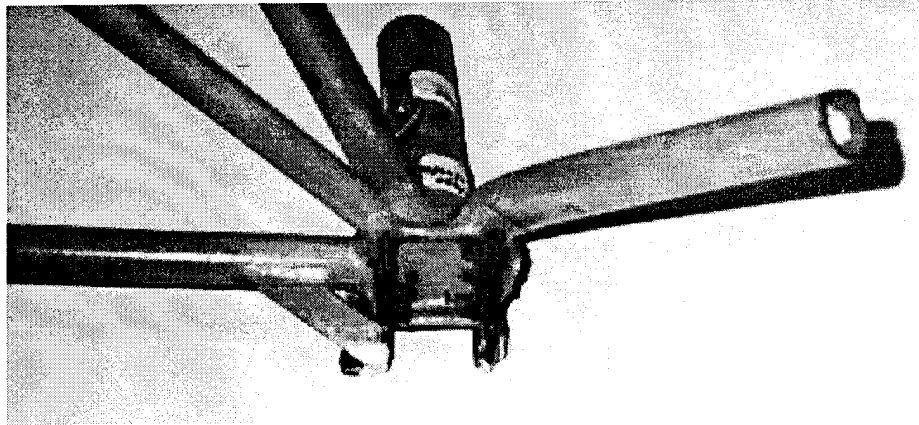
On May 21, 1993, an in-flight separation of the wing from a Piper PA-25 airplane occurred. The investigation of the affected airplane revealed corrosion and cracks in the forward spar fuselage attachment fittings. The forward spar fuselage attachment fitting consists of a clevis ear welded to a 4130 steel tube forward spar as illustrated in figures 1 and 2. This welded metal interface fractured at the base of the clevis ear. Extensive corrosion was found at the fracture site. Further review revealed that a strong oxidation layer between the two welded sections of the fitting assembly (washer and ear flange) had occurred over a long period of time. Figures 3 and 4 are photographs showing the corroded spar fuselage attachment. This airplane was used for agricultural crop dusting and had accumulated over 5,000 hours time in service (TIS) at the time of the accident. A similar accident had occurred previously on September 21, 1991, to an airplane with 10,000 hours TIS. These two different accidents alerted the FAA that an unsafe condition may exist on the Piper Model PA-25. The FAA also believes that airplanes utilized in agricultural environments are extremely susceptible to the above corrosion conditions.

FIGURE 3. PICTURE OF THE FORWARD SPAR FUSELAGE ATTACHMENT CLUSTER CUT FROM AN ACCIDENT AIRPLANE IN ALABAMA.

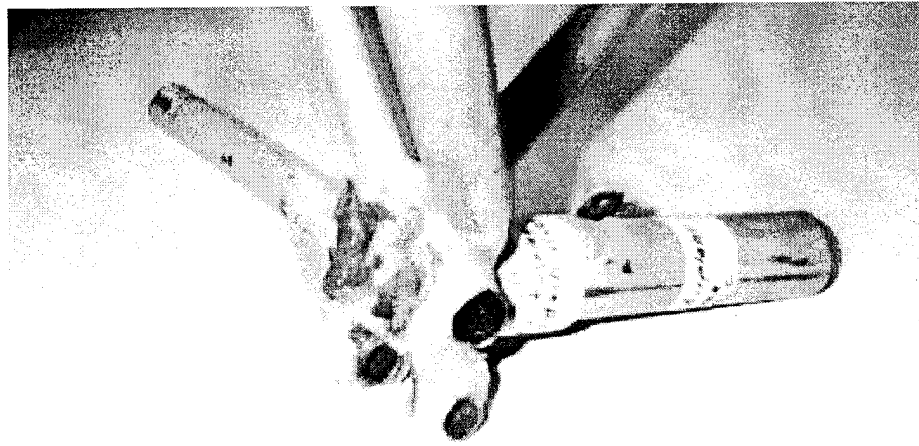
FIGURE 4. SIDE VIEW OF FIGURE 3 THAT DISPLAYS THE EXTENSIVE CORROSION OF THE FITTING EARS.

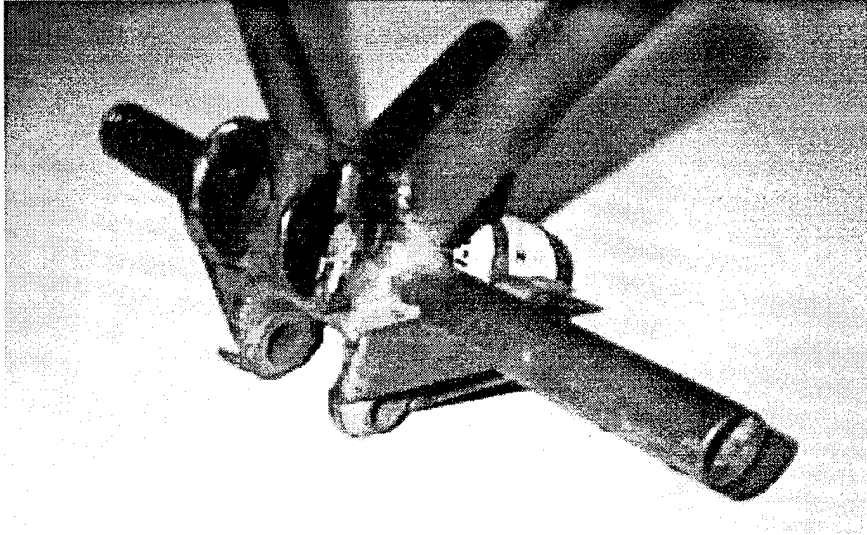
corrosion on both ear fittings. Half of one ear was removed by a bandsaw to reveal the inner layer corrosion shown in figure 6. Sample 3 was a forward spar fuselage attachment cluster used as a blind sample to develop the inspection techniques. It was not known if corrosion existed between the inner layers. Sample 3 is shown in figure 7. The AANC staff performed both radiography and ultrasonic inspections on the spar cluster assembly. Test setup, calibration, and inspection techniques are described, and findings from each technique are stated.

The gap between the washer and ear flange was measured to be between 0.015 to 0.025 inch for the corroded sample 2. The standard design tolerance for this gap, however, was unknown so an assessment of the corrosion thinning could not be made. Cracks in the inside tube diameter of sample 2 could not be detected. Alignment between the x-ray source and the spar cluster would be critical if this technique was used to find cracks in the tubing. For this application, radiography would not be reliable in finding cracks in the tubing without conducting several exposures at different orientations.

FIGURE 6. SAMPLE 2 - FORWARD SPAR FUSELAGE TUBULAR ATTACHMENT CLUSTER FROM A PA-25 AIRPLANE. NOTE: HALF OF ONE EAR WAS REMOVED BY A BAND SAW. THE DARKER AREA IS CORROSION.

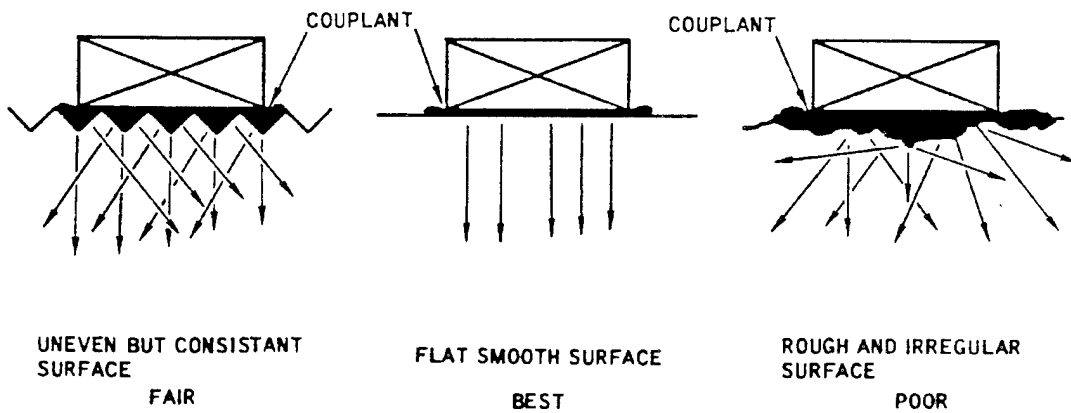
The test setup was then applied on the surface corroded sample 2. The thickness of sample 2 could not be determined. The instrument sensitivity (gain) was increased and the backwall echo still could not be detected. The problems with sample 2 were due to the rough outer surface of the test sample. Figure 11 illustrates the undesirable effect of surface roughness on the distortion of ultrasonic wave propagation. This probe and technique were abandoned.

FIGURE 11. ILLUSTRATION OF THE UNDESIRABLE EFFECT OF DISTORTION OF WAVE DIRECTIVITY DUE TO THE SURFACE OF THE TEST SPECIMEN AND HOW IT CAN GREATLY AFFECT ULTRASONIC WAVE PROPAGATION.
