# NASA Contractor Report 3715

## DC-10 Composite Vertical Stabilizer Ground Test Program

J. M. Palmer, Jr., C. O. Stephens,  
and J. O. Sutton

CONTRACT NAS1-14869  
AUGUST 1983

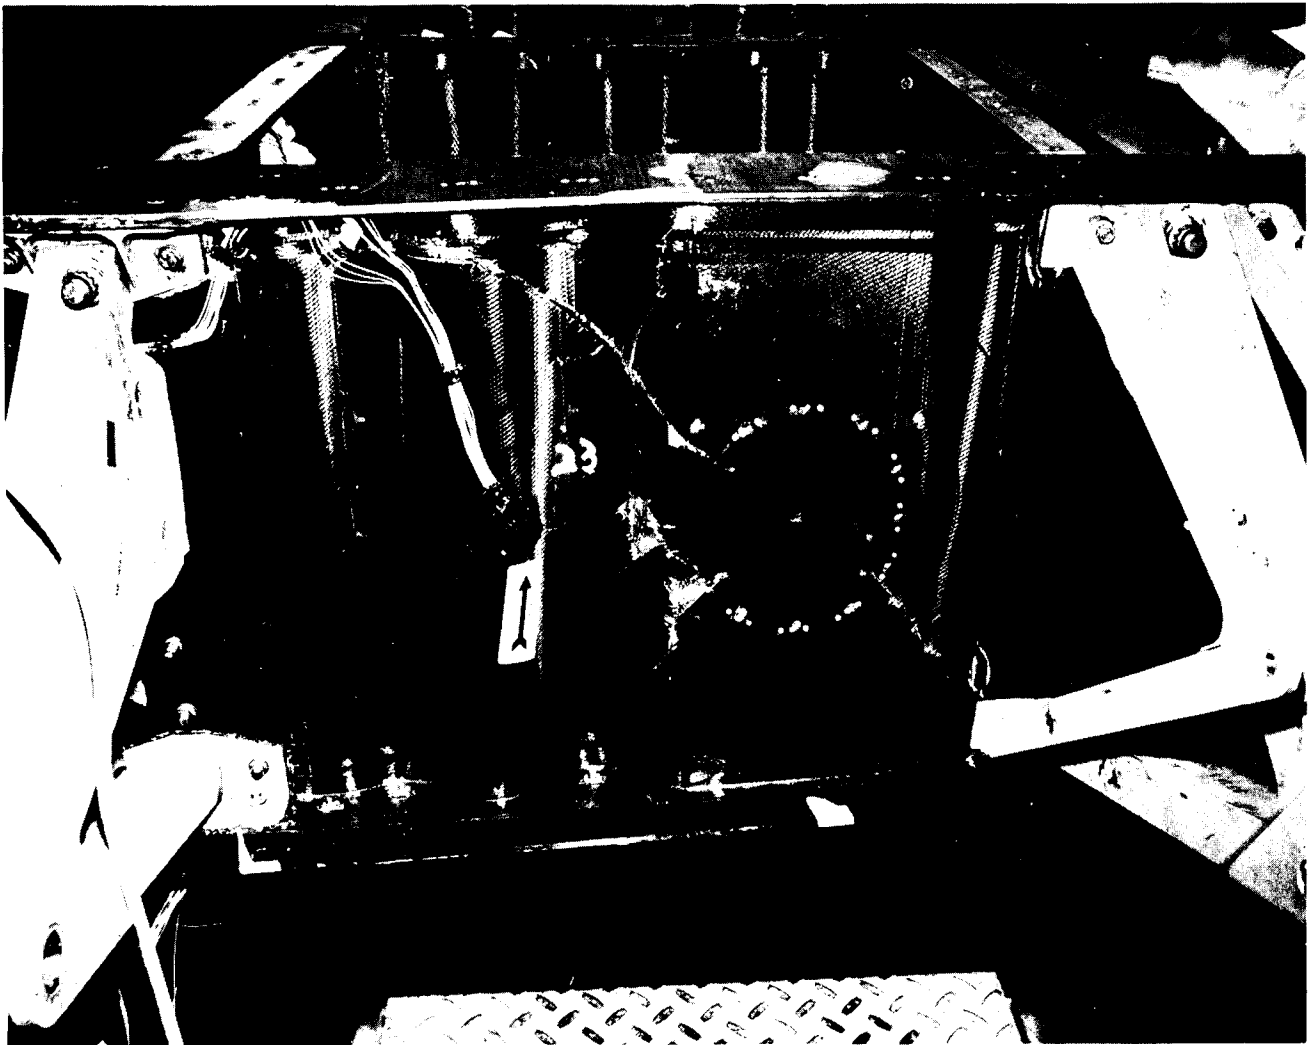
**FIGURE 19. FAILURE OF REAR SPAR WEB IN GROUND TEST UNIT**

Posttest visual examination of the specimen revealed structural failures in the rear spar web in the bay above the lower actuator cutout (Figure 19) and failures in the left-hand (compression side) skin panel. Following this preliminary survey of the damage, the specimen was removed from the test jig and returned to the manufacturing assembly area for more detailed damage assessment.

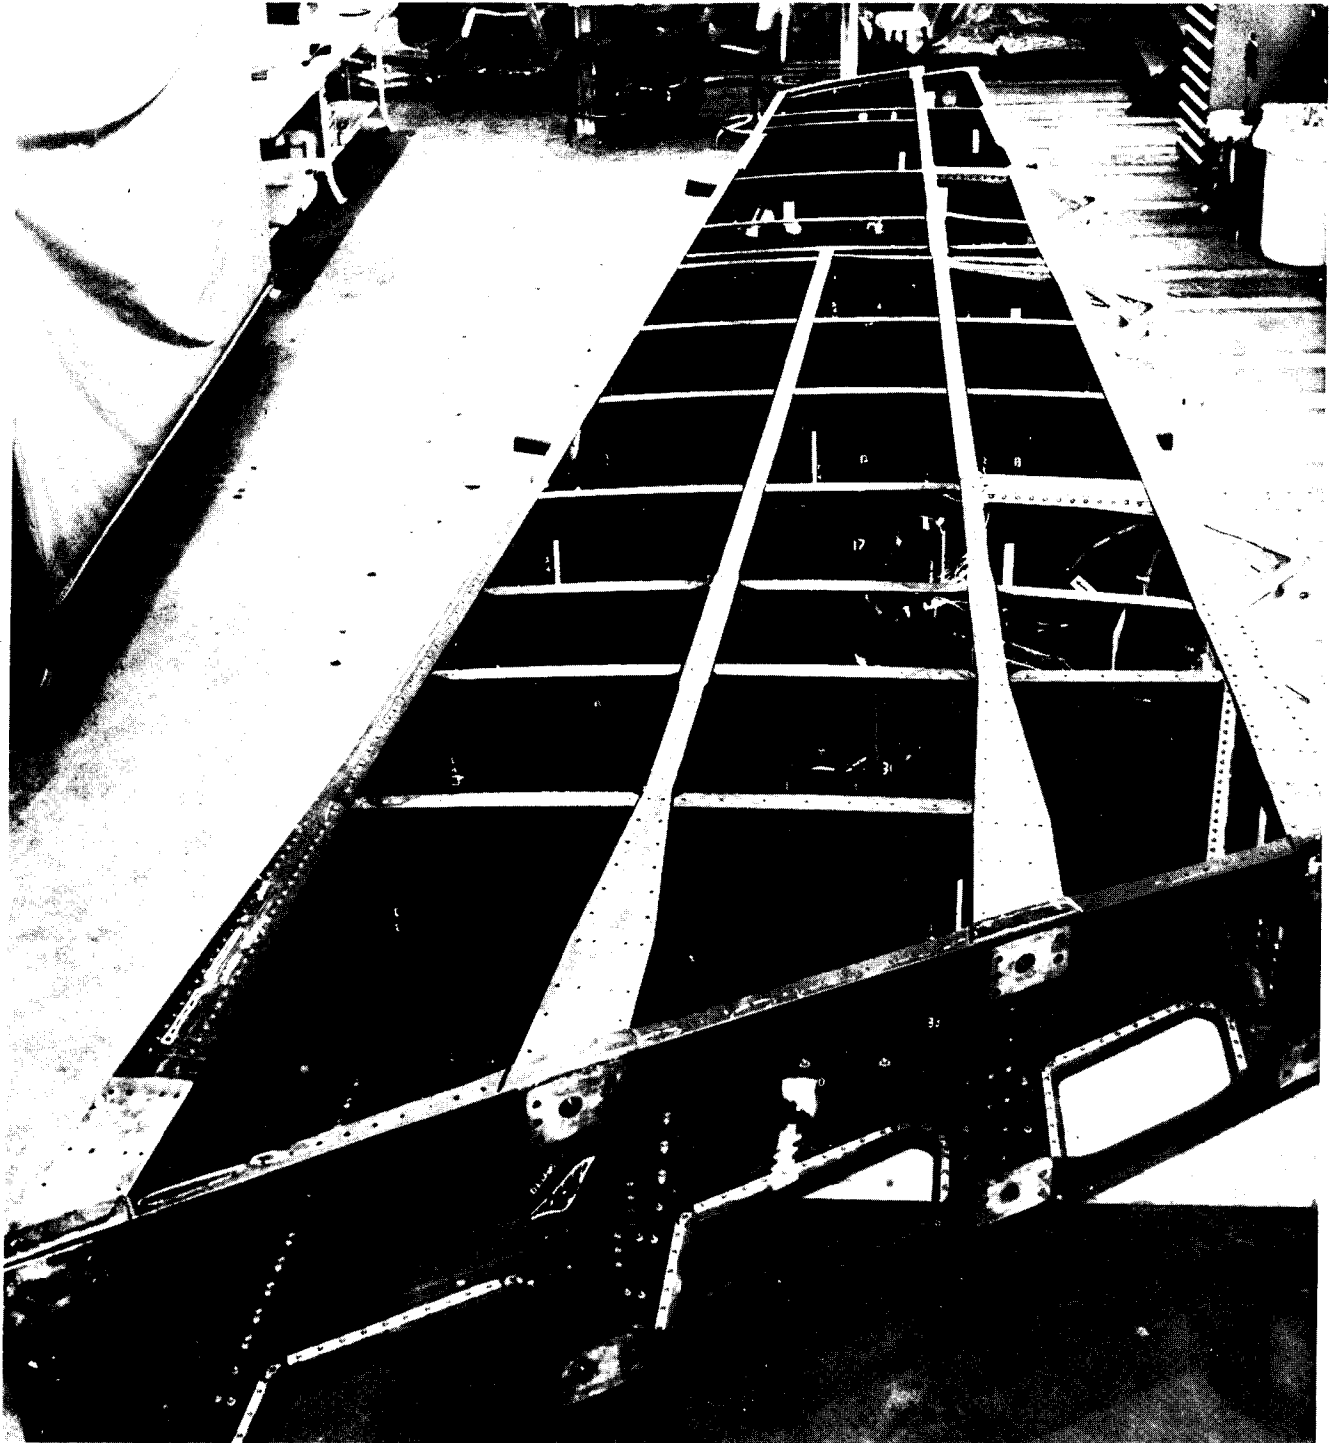
FIGURE 20. GROUND TEST UNIT AFTER TEST FAILURE WITH LEFT HAND SKIN REMOVED

The left-hand (compression side) skin panel was first inspected ultrasonically to detect any invisible damage. No significant damage other than that apparent by visual examination was found. This skin panel was then removed to allow a more detailed inspection of the damage to the substructure. Figure 20 is a view of the substructure after removal of the skin panel.

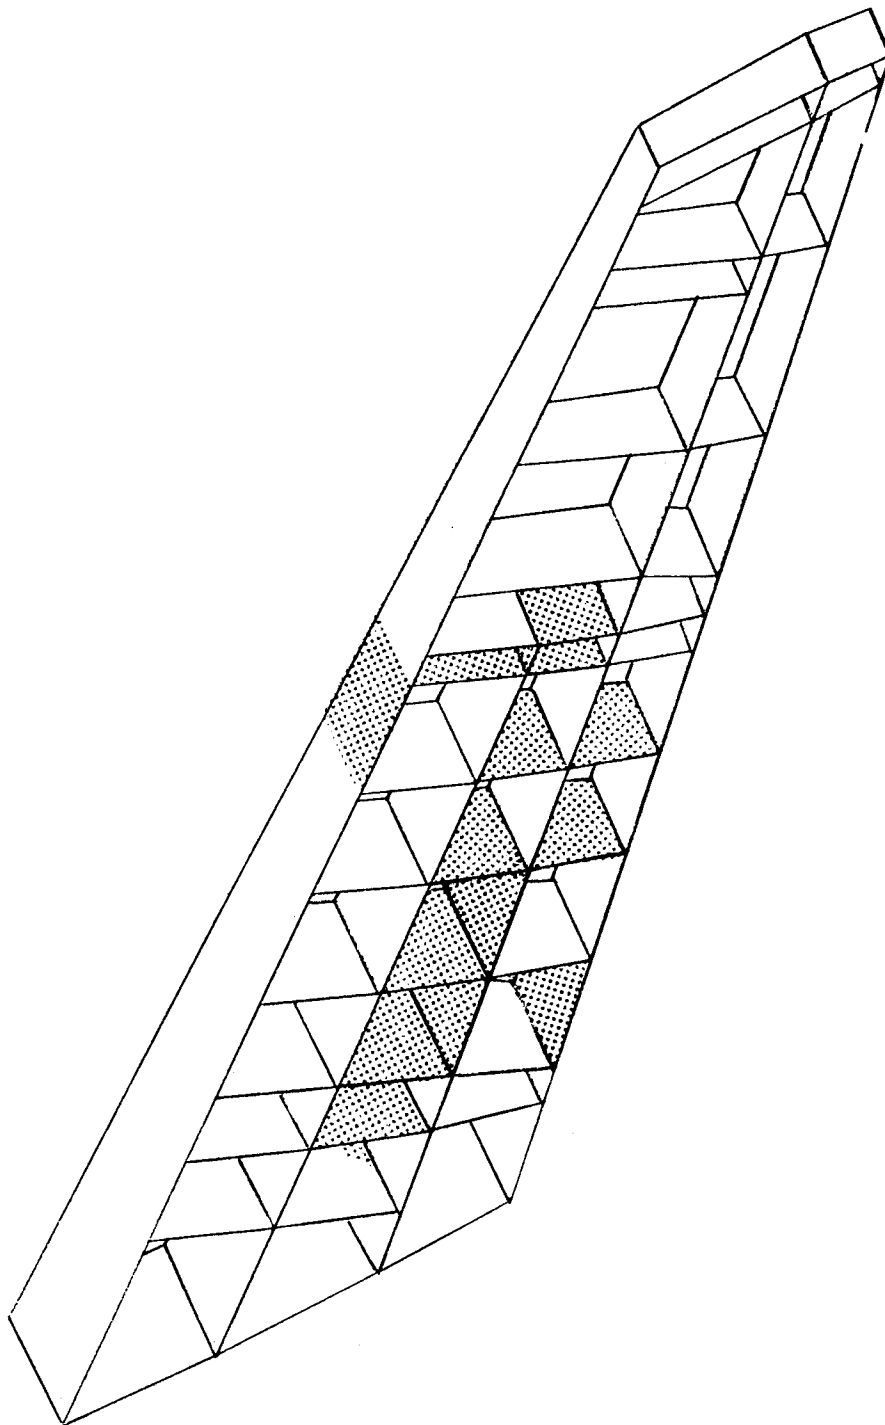
**FIGURE 21. LOCATION OF TEST FAILURES IN GTU SUBSTRUCTURE**

Failures were noted in the rear spar web and caps above the lower actuator cutout, the aft center spar web and caps, the forward center spar and front spar webs, and in a number of rib webs. Figure 21 is a sketch showing the location of the failed members in the substructure.

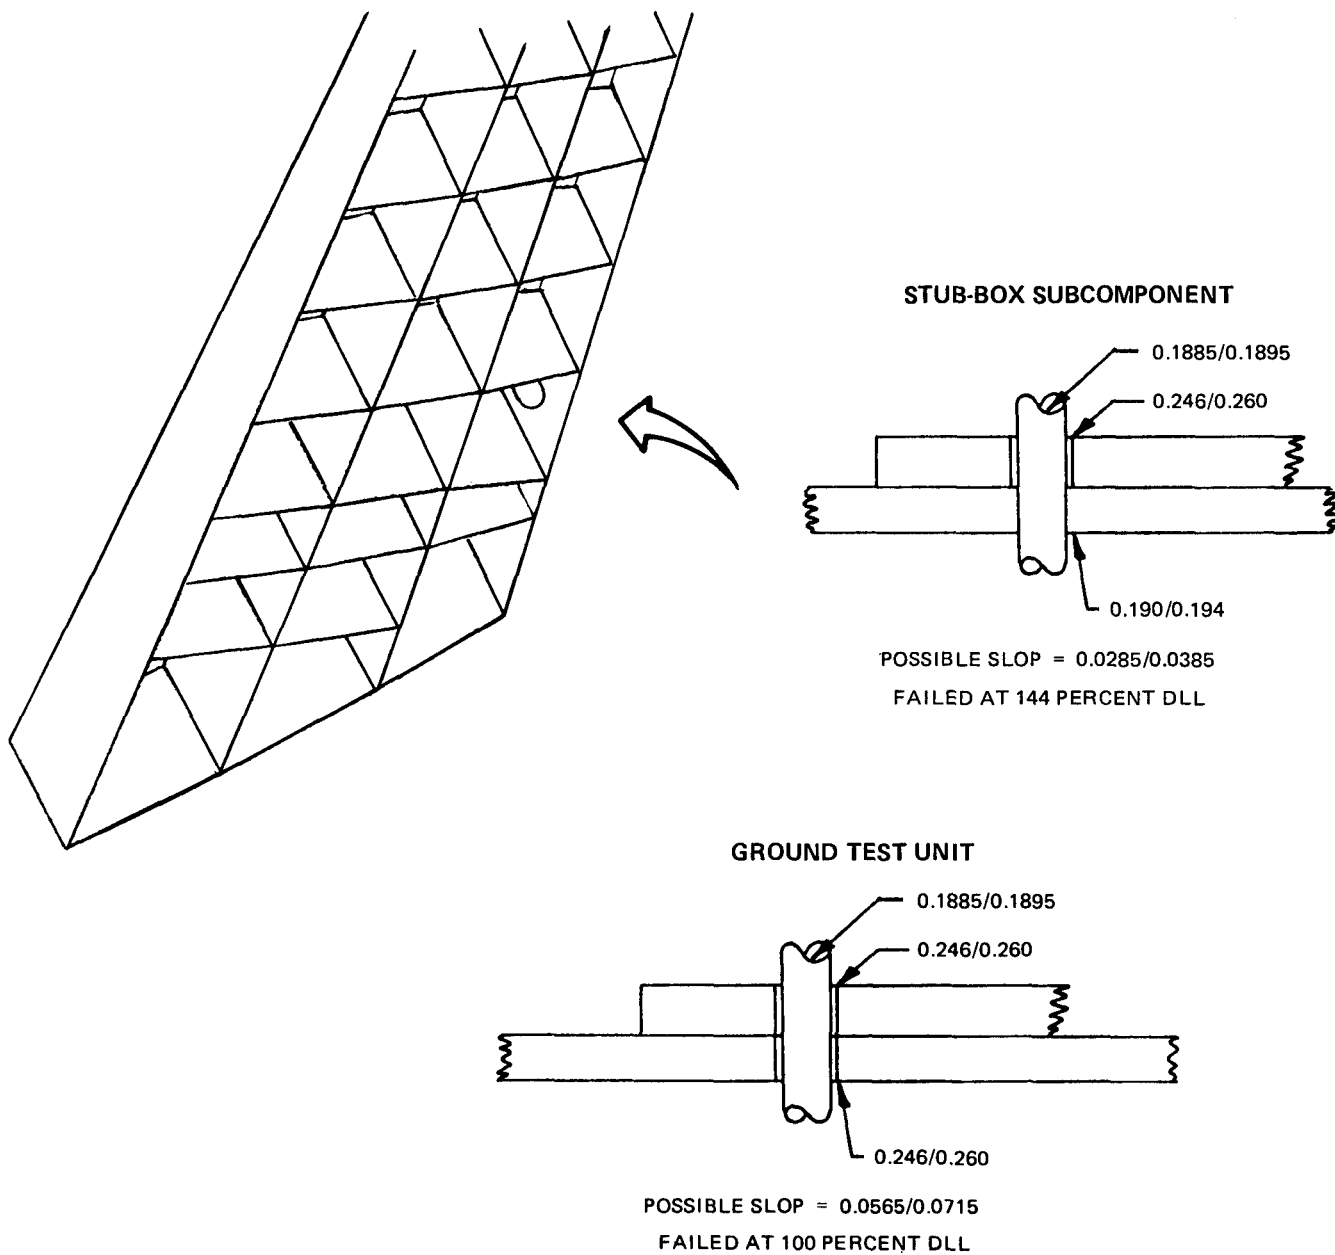
**FIGURE 22. FASTENER FIT IN CRITICAL REAR SPAR WEB DOORS**

2. The center bay of the Z<sub>FR</sub> Station 314 rib has a hole and cover plate similar to the one in the rear spar. In the stub box, the fastener holes in both the rib web and the cover plate were of the appropriate size for the fastener. In the GTU, the fastener holes in the cover plate were 0.060- to 0.066-inch oversize.

3. The lower rear spar is spliced to the upper rear spar at approximately Z<sub>FR</sub> Station 326. At that point the splice diverts the spar cap load outward through the skin panel and inward through an aluminum splice fitting. In the stub box, this splice was built to nominal clearances. In the GTU, a gap of about 0.060 inches developed between the left hand skin panel and the upper rear spar cap. This gap was improperly shimmed resulting in an indeterminate preload in the assembly.

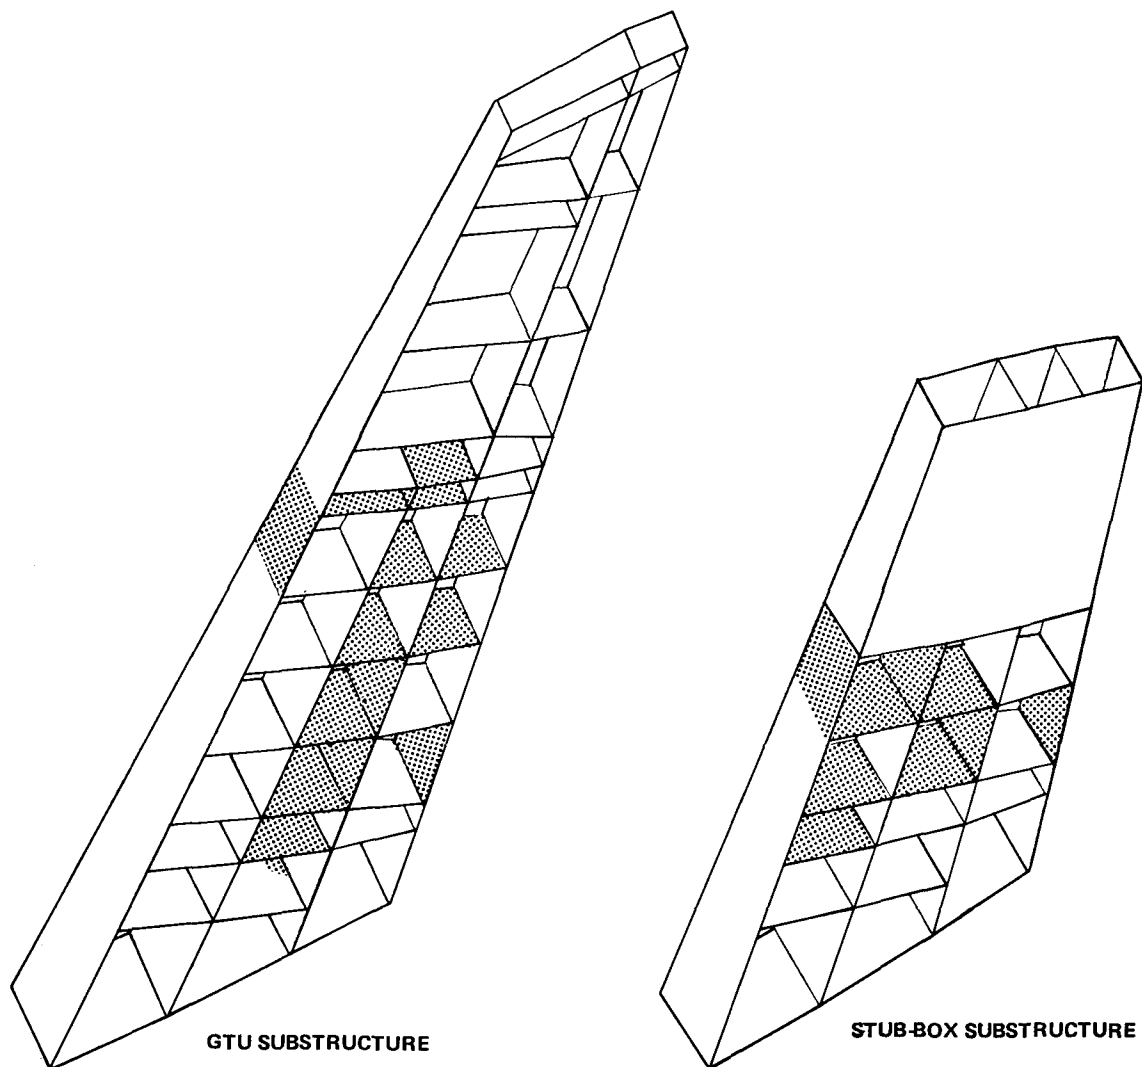
**FIGURE 23. COMPARISON OF TEST FAILURE LOCATIONS IN STUB-BOX AND GTU SUBSTRUCTURES**

Figure 23 is a comparison of the failure locations in the GTU substructure to those in the stub box subcomponent. The failed areas are in similar locations and differ only because of the influence of the boiler-plate dummy extension structure in the stub box.

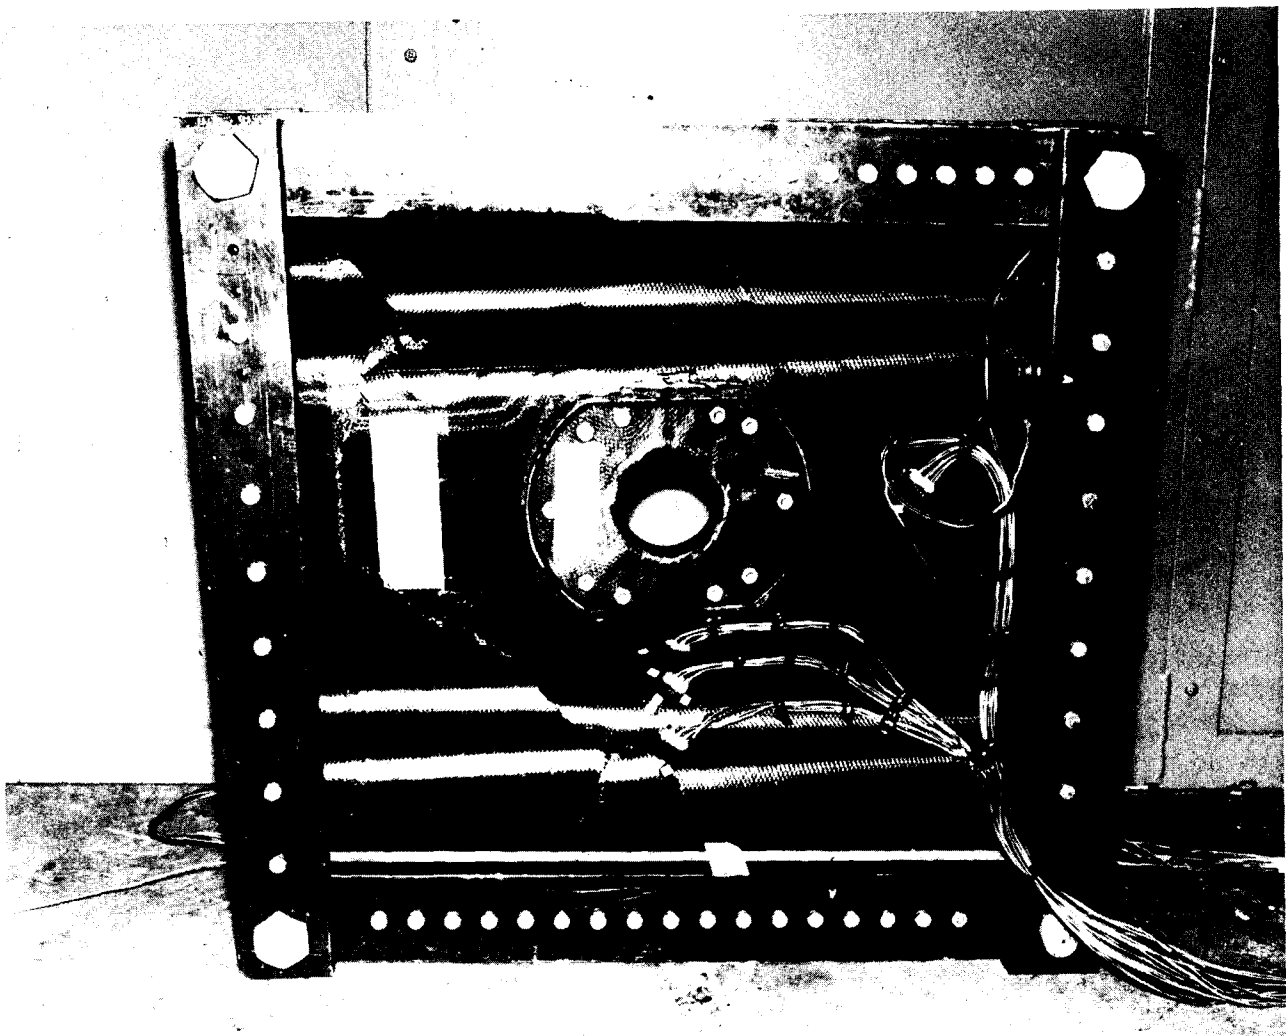
**FIGURE 32. AMC7855-5 RIB COMPONENT AFTER TEST SHOWING WEB FAILURE**

To test the validity of the concept, a flanged plate was made and installed on the AMC7855-5 rib test specimen (Figure 31). The panel was tested to failure, with failure occurring in the basic sine-wave web, well away from the opening (Figure 32). The strains measured at the perimeter of the hole with the bonded cover in place are shown in Figure 33.
