737 GRAPHITE COMPOSITE FLIGHT SPOILER FLIGHT SERVICE EVALUATION

THIRD ANNUAL REPORT
APRIL 1976 THROUGH APRIL 1977

Prepared under contract NAS1-11668 by
BOEING COMMERCIAL AIRPLANE COMPANY
P.O. Box 3707
Seattle, Washington 98124

for
Langley Research Center
NATIONAL AERONAUTICS AND SPACE ADMINISTRATION

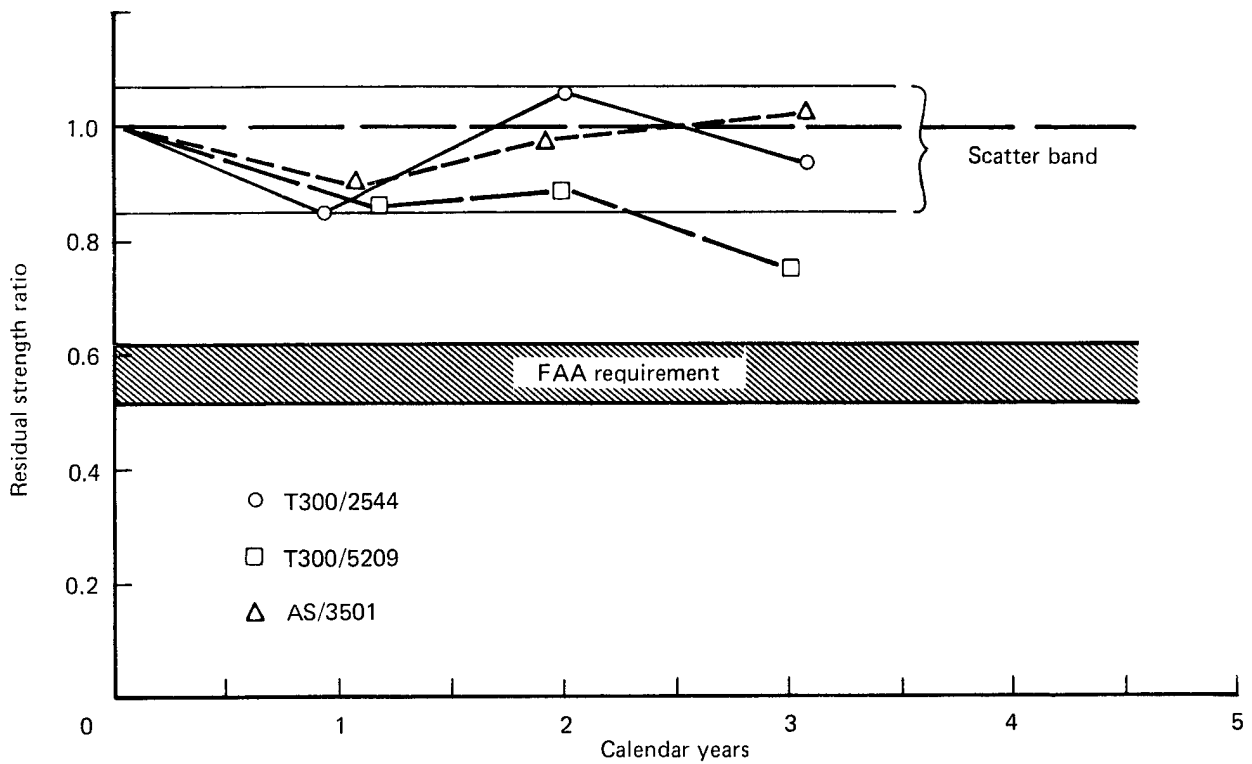
The scatter band represented by these values is displayed graphically on figure 2. Consideration of this scatter contributes to the previous observation that the 350° F curing systems are maintaining relatively stable residual strength.

Figure 2. — Residual Strength After Exposure

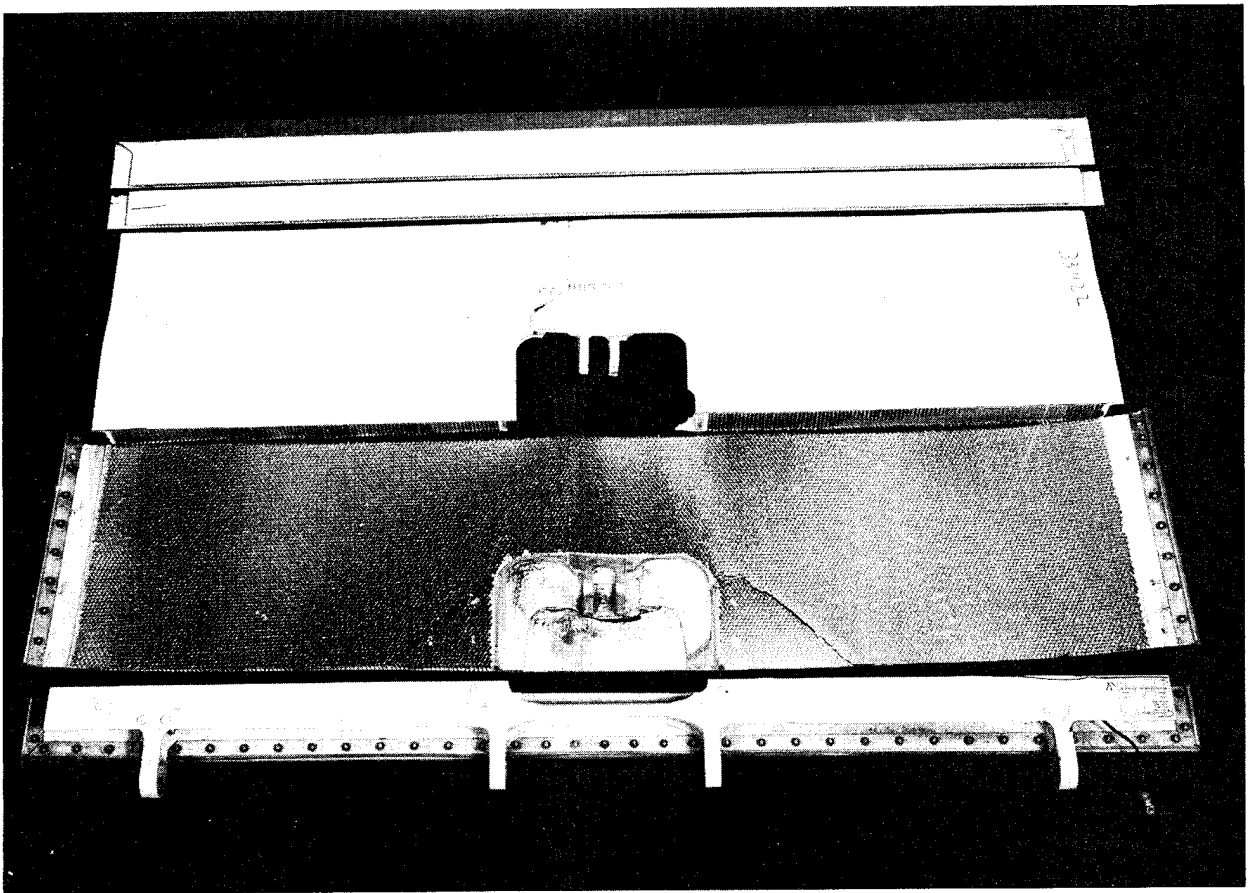
The examination technique for honeycomb core corrosion has been expanded to encompass all units that are tested in the static test laboratory. Each spoiler assembly is completely sectioned to enable visual observation of both bond lines in virtually all portions of the panel. Figure 4 shows a typical example of the degree of dissection achieved. A total of five static test spoilers (S/N 0057 and 0109 from the second year testing and S/N 0026, 0054, and 0116 from the third year testing) have been sectioned in this manner. Not only has there been a complete absence of corrosion in the honeycomb, but the physical appearance of both the honeycomb and the cured EA9628 adhesive compares favorably with newly manufactured assemblies.

Figure 4. — Dissection of S/N 0054 for Corrosion Inspection

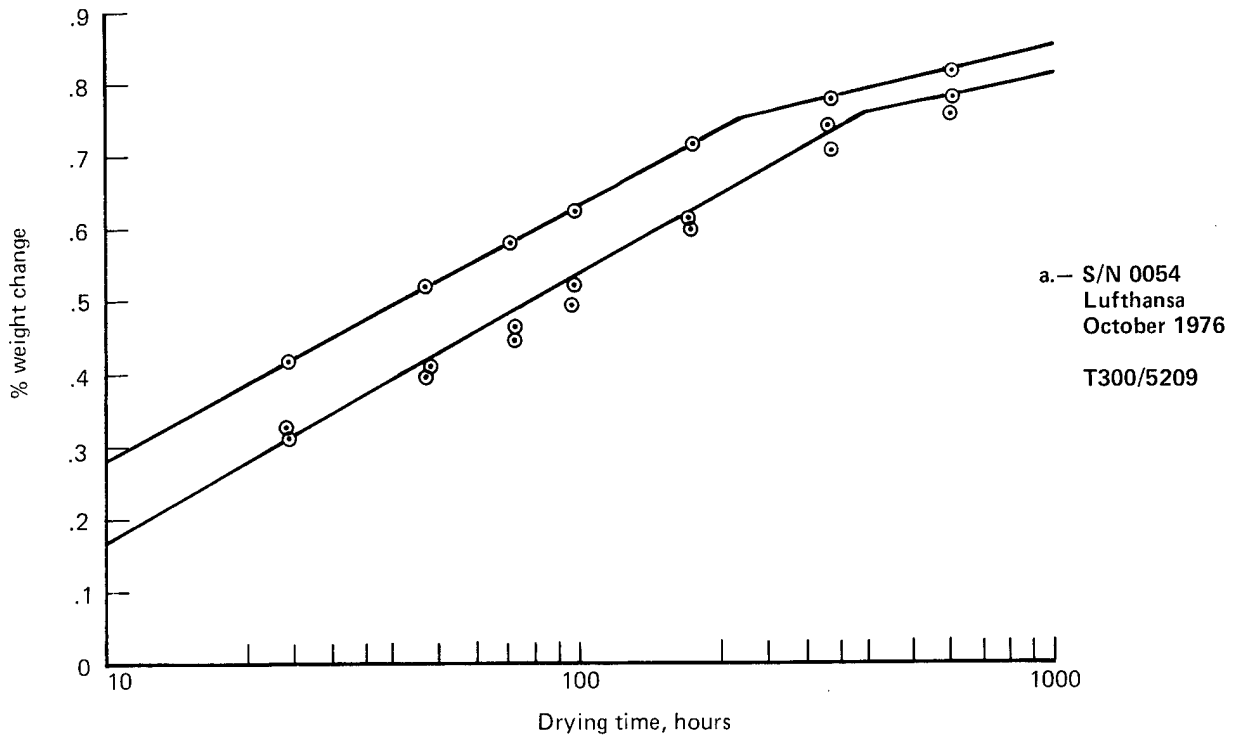
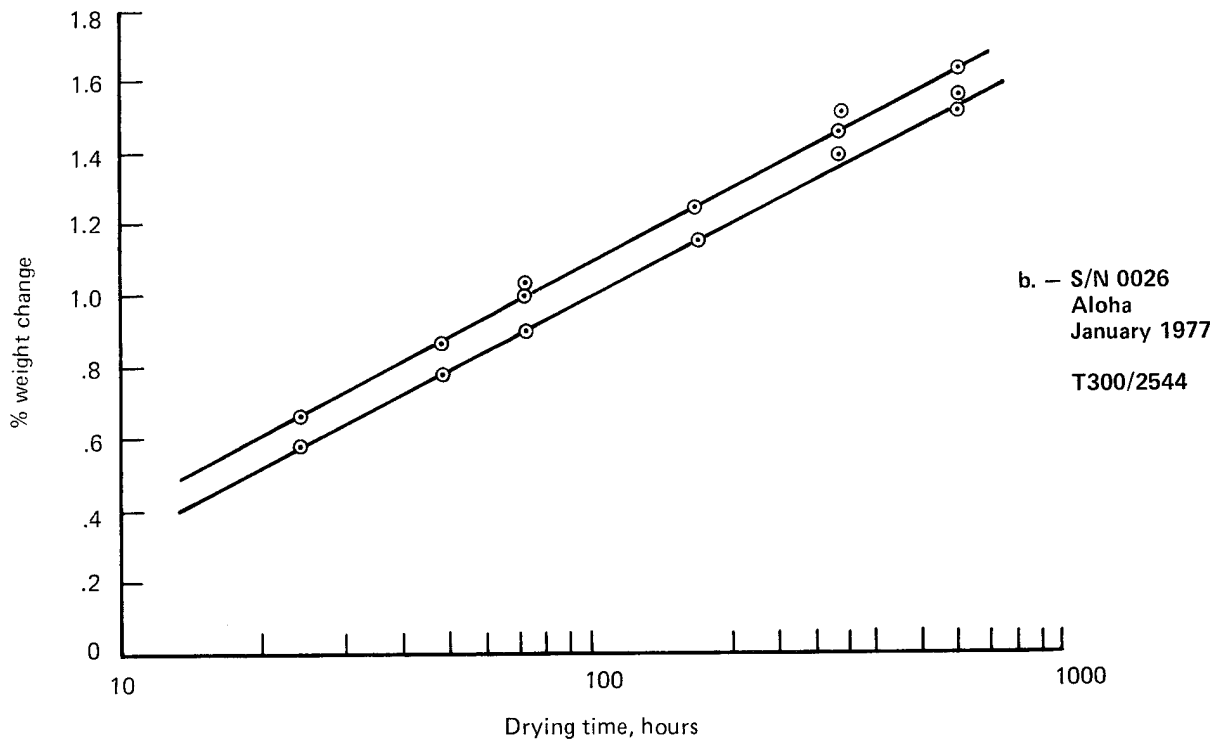
Two spoiler panels (S/N 0026 and S/N 0054) have been core-sampled prior to static test. The results of drying these samples are given in figure 6. Correlation of the effect of moisture absorption on the residual strength of the spoiler panels remains to be accomplished.

Figure 6. — Moisture Weight Change

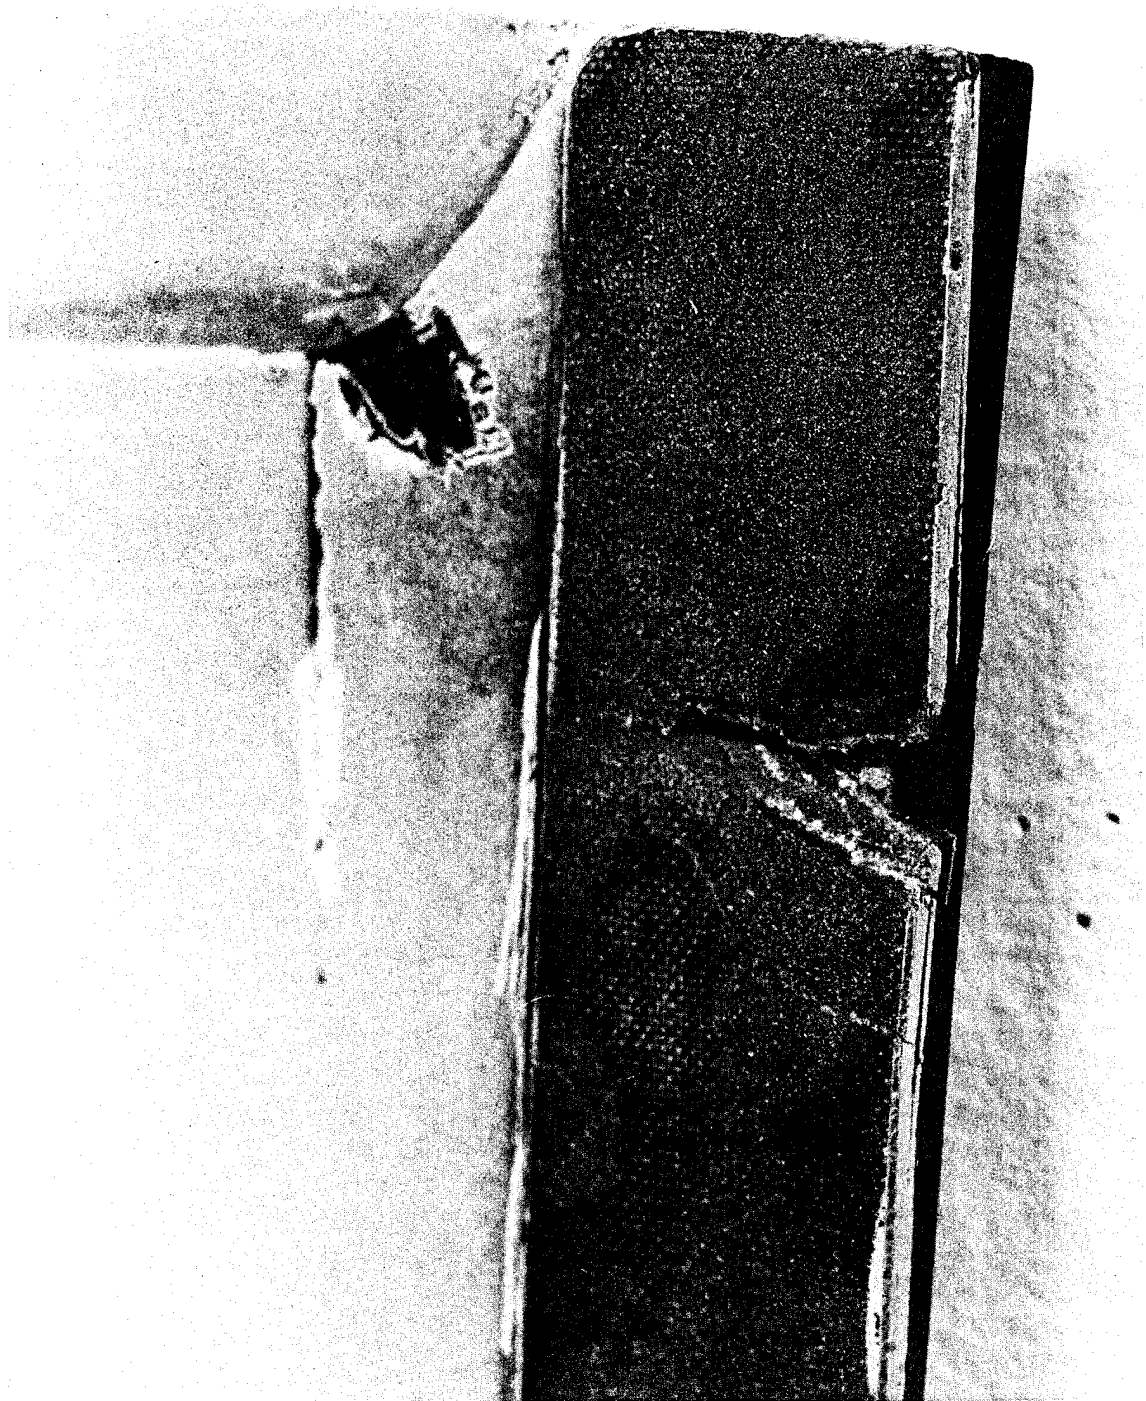
The three cases of maintenance damage are illustrative of the ever-present risks associated with maintenance operations. Each instance of maintenance damage occurred inside the maintenance hanger area and was a result of activity involving aircraft components in the vicinity of the spoilers themselves. Two incidents resulted in damage to the trailing edge (figs. 7 and 8) and one panel received handling damage to the leading edge spar (fig. 9). The rate of maintenance damage approximates that of the previous year of operation.

Figure 7. — Trailing Edge Damage — S/N 0089

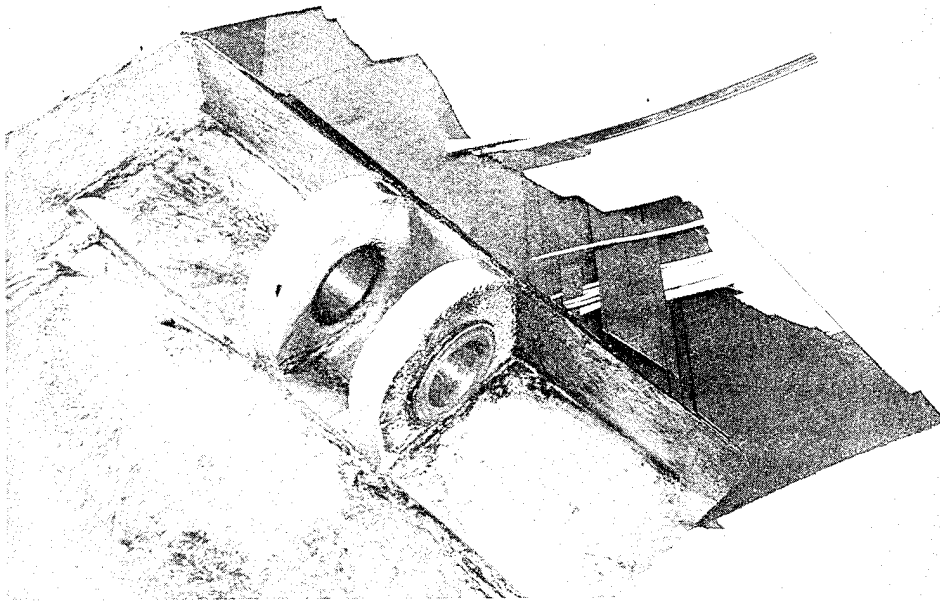
Figure 10. — Lower Surface Delamination—Aloha Spoiler S/N 0306
