Report No. NAWCADWAR-95045-4.3

METALLURGICAL EXAMINATION OF A DAMAGED V-22 HYDRAULIC LINE

1 SEPTEMBER 1995

FINAL REPORT

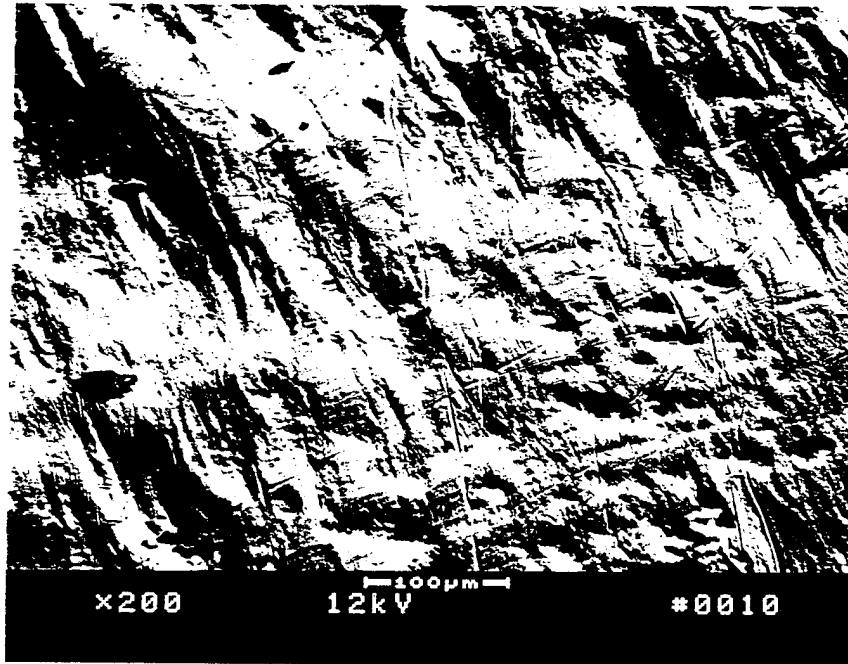
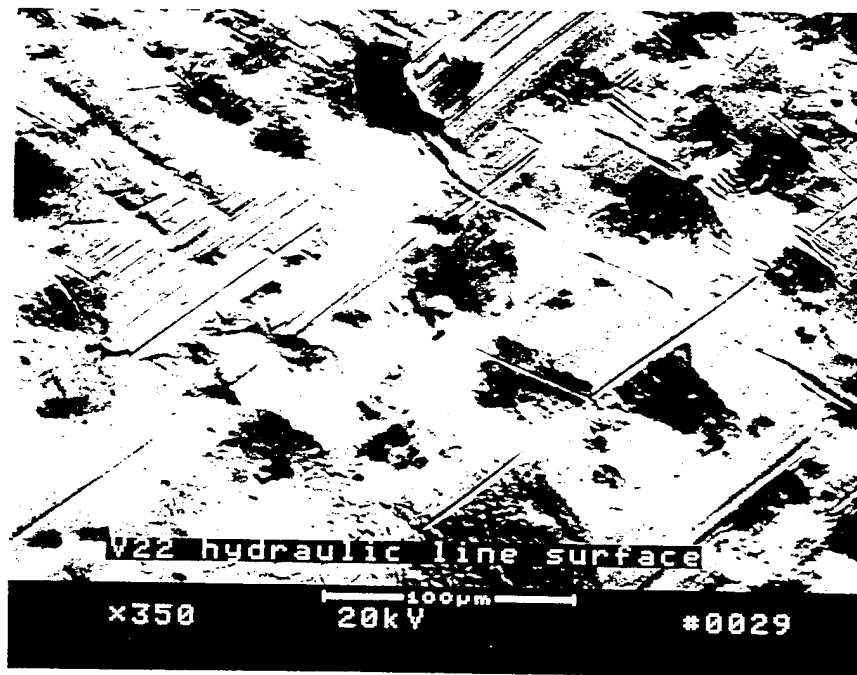
The surface of the damaged tube was observed to be pitted with an indication of abrasion, **Figure 2**. There was a bimodal distribution of pit sizes. The larger pits were rounded with scratches running through them. The smaller pits were more clearly defined with sharp edges. Generally, the surface of the tube was free of oxides and other corrosion products (e.g. titanium hydrates). Upon close examination of the pitted areas, a second phase of particles was found. EDS results of these second phase products are displayed in **Figures 5 and 6**, indicating a presence of Al and O. However, only constituent elements of Ti-3Al-2.5V were detected in the cross-sectional area of the damaged tube, as shown in the spectrum of **Figure 7**.

The directionality of the pits seen on the surface of the damaged tube, as shown in **Figure 2**, tends to imply some type of abrasion due to mechanical means. In addition, after metallographical preparation of the transverse section of the damaged area, no alteration in microstructure was detected; despite the existence of minor surface damage - depressions, as seen in **Figure 4**. Therefore, no microstructural indication of corrosion was present; but there was evidence of good texture control of the tubing (**Figure 3**). In general, the surface topography of

the damaged hydraulic line tended to resemble those that are caused by classic cases of fretting, more particular to its early onset.

Figure 2: SEM micrographs of the damaged surface of the V-22 Hydraulic Line (as-received).

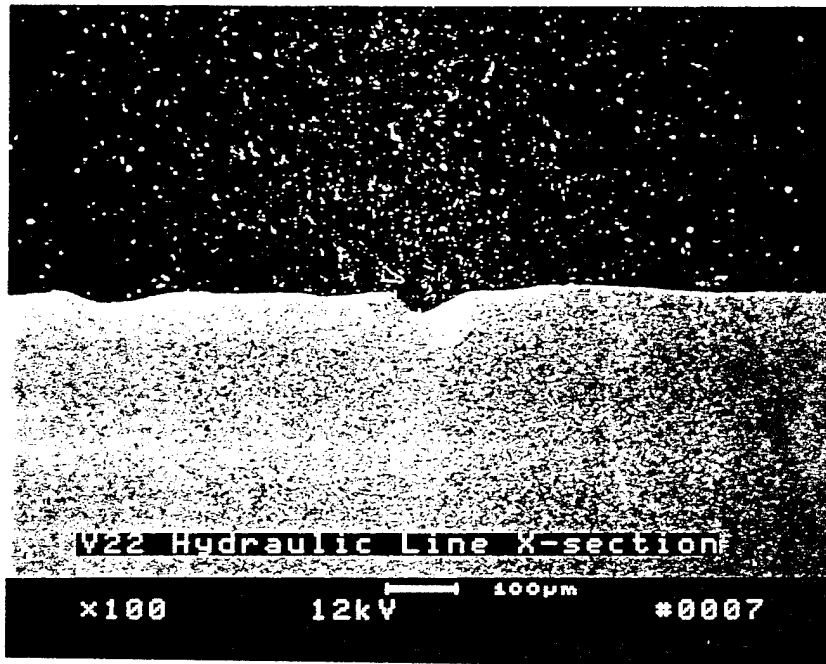
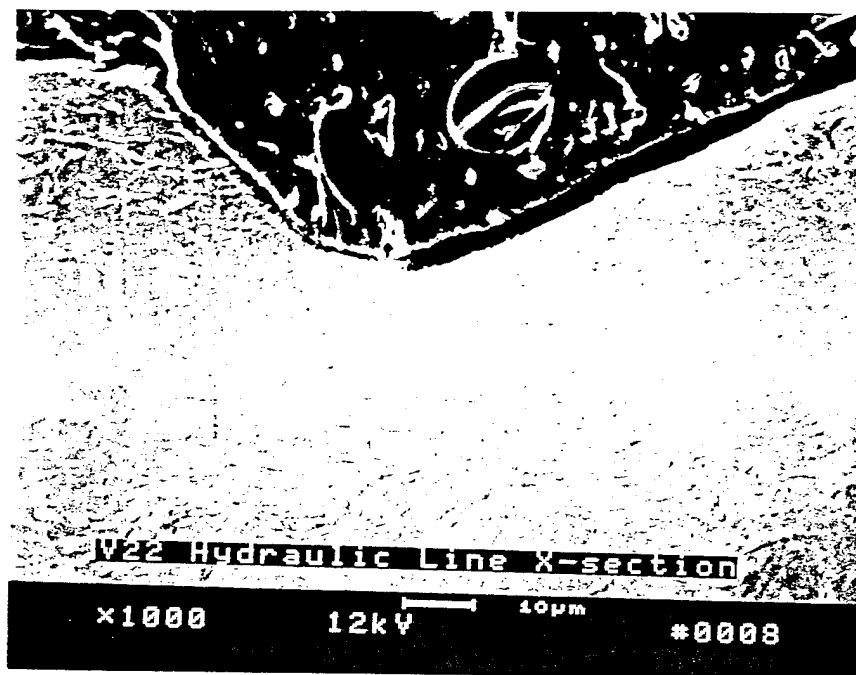
Figures 2 and 3 are SEM micrographs of the damaged surface and the corresponding cross-section of the pump suction tube (as-received). Pits and gouges were detected on the surface; no evidence of cracking and intergranular attack was found. However, there was some directionality observed with the orientation of some pits. These particular pits were aligned as if created by some mechanical means. The micrographs also reveal a fine grained, oriented alpha-beta microstructure, in which the alpha is observed as the lighter phase dispersed in the darker beta matrix.

Figure 3: SEM micrographs of the damaged cross-section of the V-22 Hydraulic Line. Samples were polished and etched in Kroel's reagent (3:1).

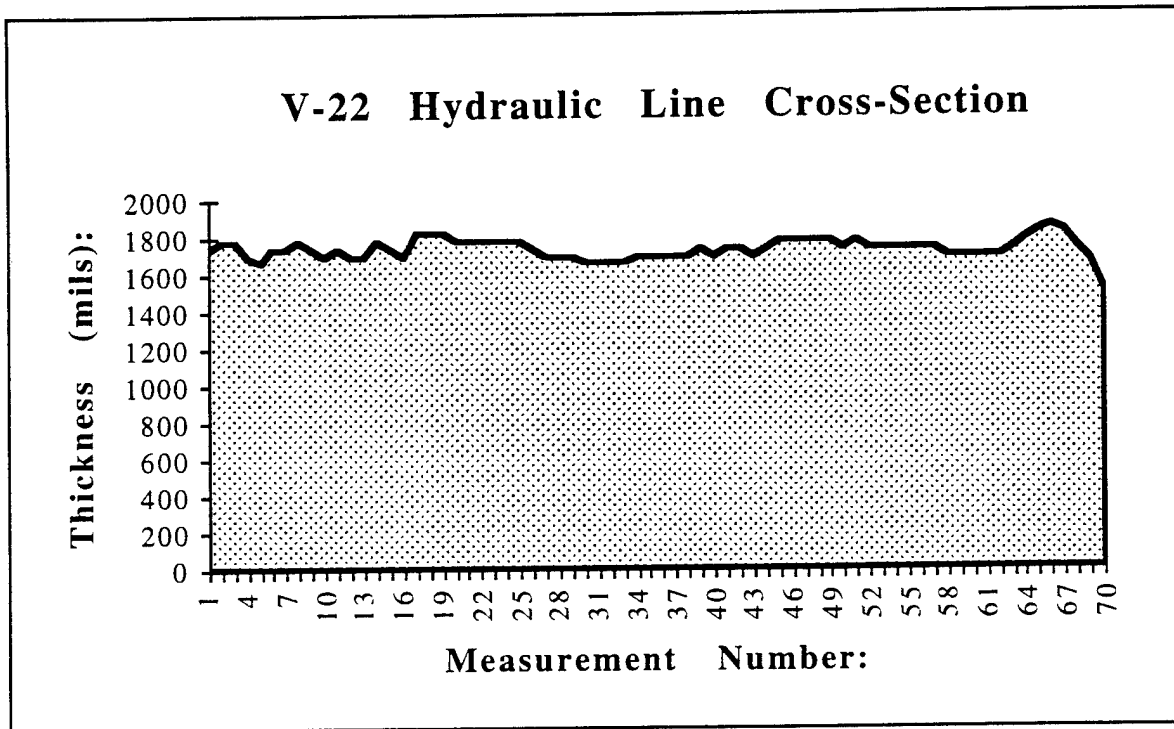
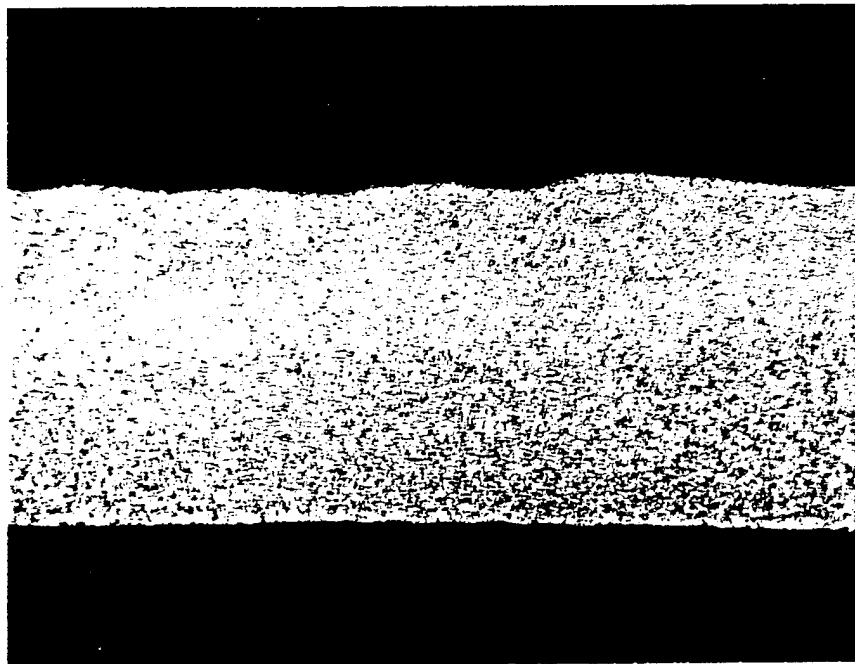
A profile of a representative cross-section of the damaged tube is portrayed in **Figure 4**. This was constructed from a compilation of linear measurements of the damaged tube's cross-section taken from optical micrographs (of which an example is also included in **Figure 4**). A maximum pit depth was measured to be approximately 30 mils (0.07 cm). The average thickness of the V-22 hydraulic line was determined to be 1750 mils (4.45 cm) with a standard deviation of 50 mils (0.13 cm).

Figure 4: A compiled cross-section of the damaged V-22 Hydraulic Line obtained with linear measurements taken from optical micrographs of the entire cross-section.
 (An example of a photographed cross-sectional area is shown below.)

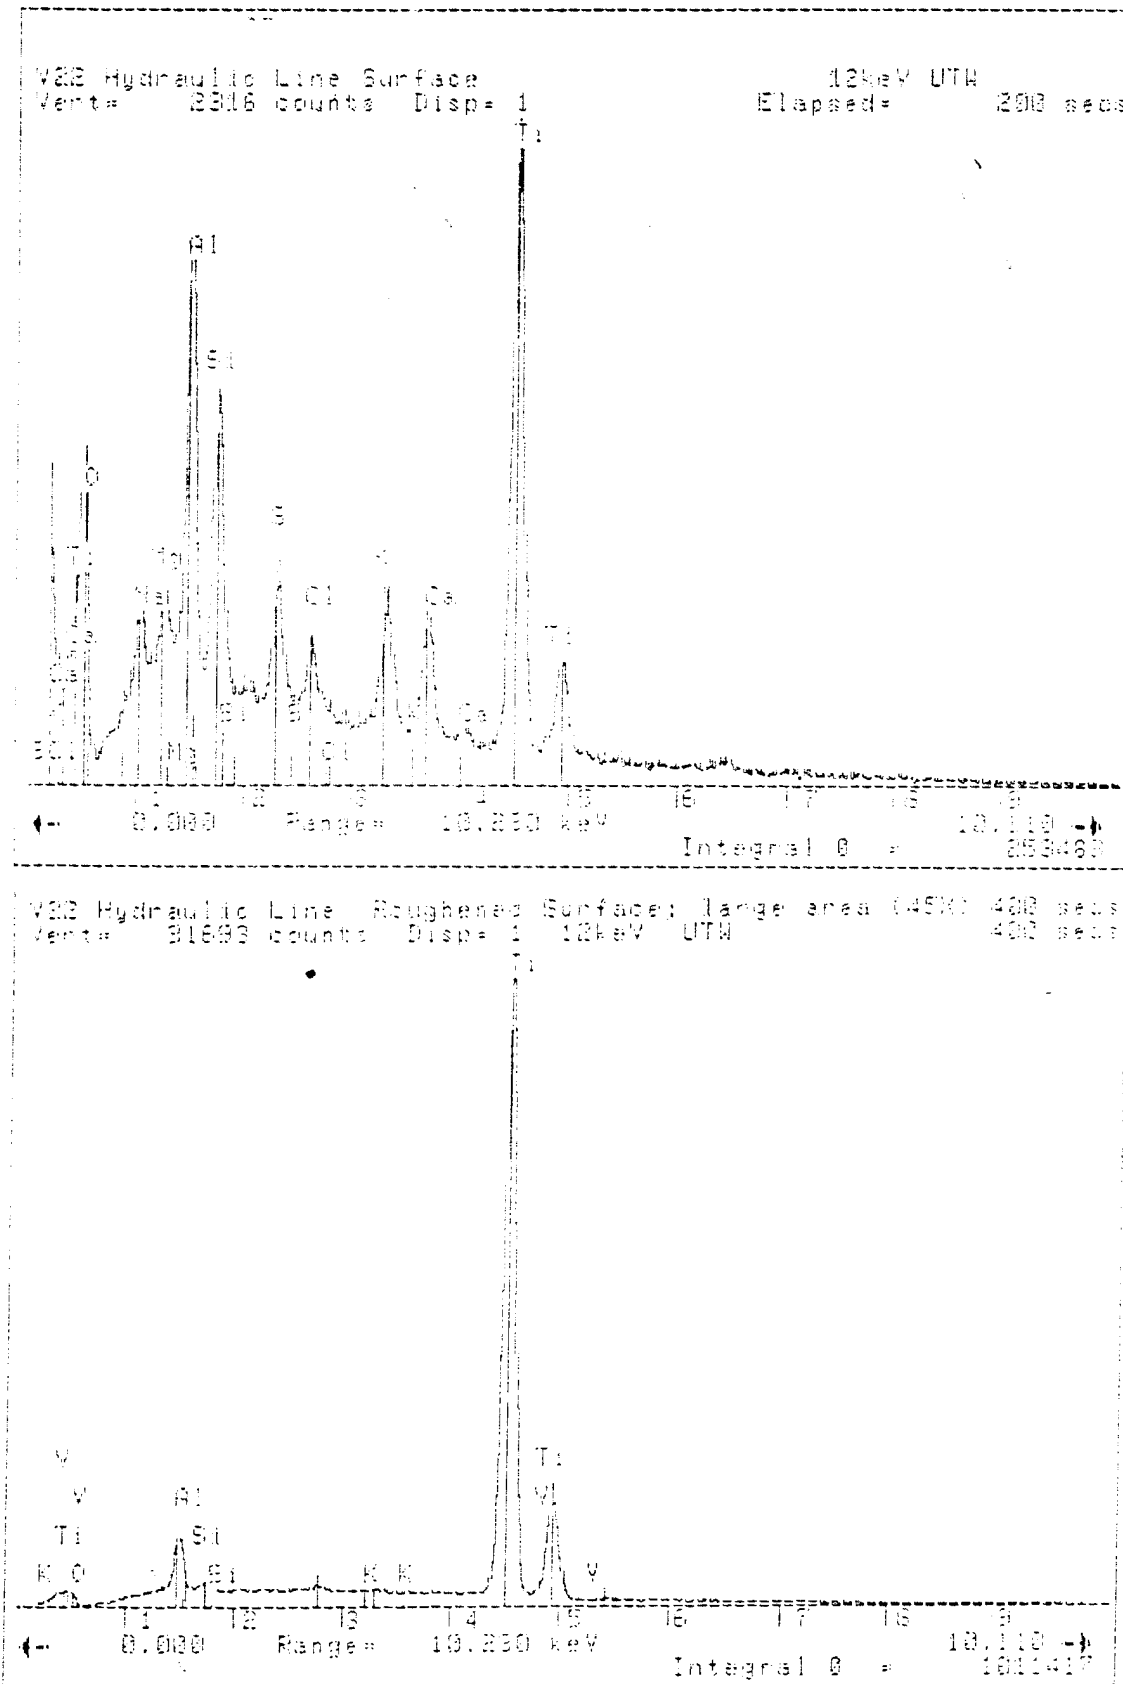
Figure 5: Elemental analyses (EDS) of the damaged surface of the V-22 Hydraulic Line.

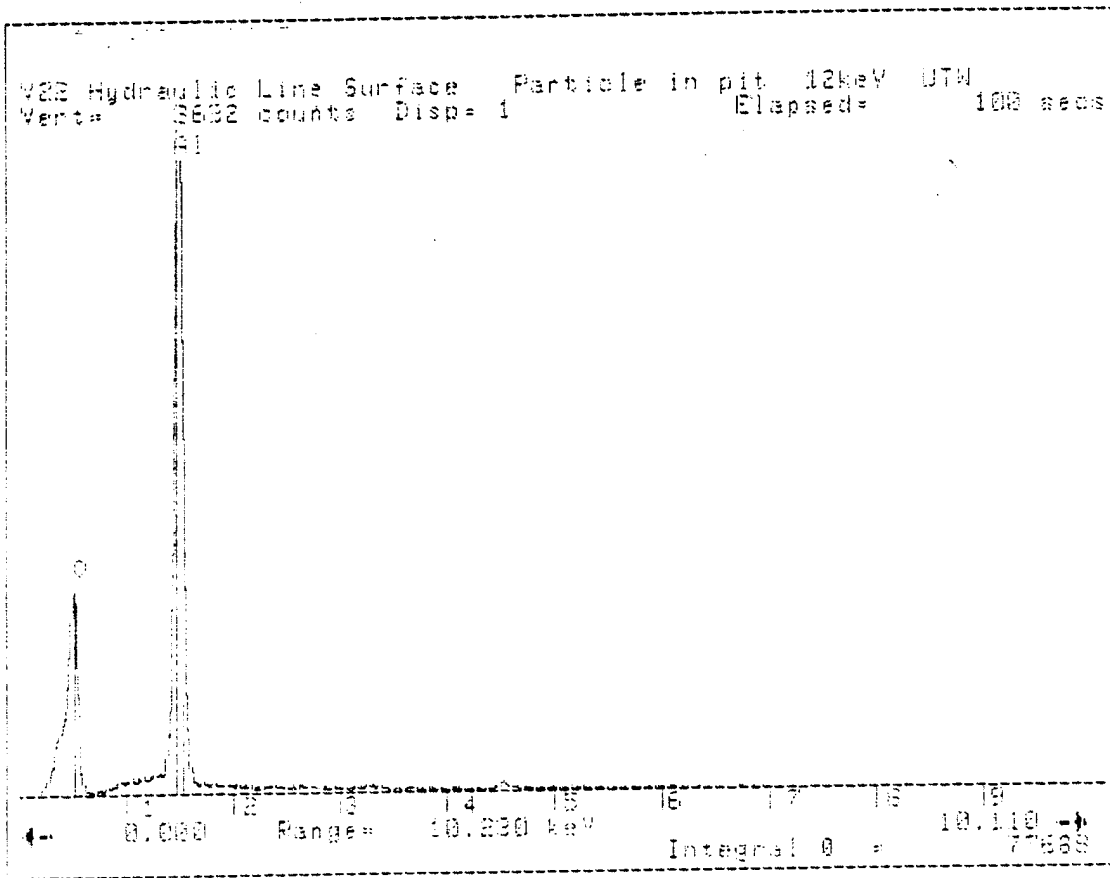
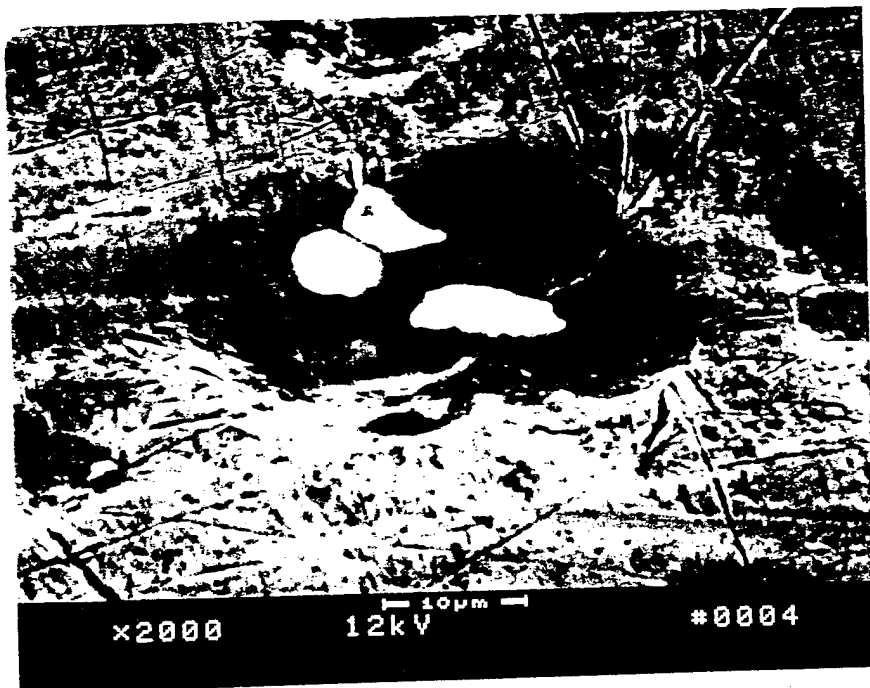
Elemental analyses (EDS) had shown a large quantity of foreign elements present in both the damaged area (surface) of the tube and its connecting rubber clamp, but not in its corresponding cross-section, **Figures 6-10**. Yet, there was no evidence of any corrosion by-products. However, identifying the foreign particulates as largely sand (SiO_2) and alumina (Al_2O_3), as seen from the resulting spectra of **Figures 6 and 8** respectively, had suggested that it was most likely the hostile environment that this piece of suction tube was subjected to that led to the contamination of the contact areas of its surface and of the rubber clamp; thereby created the damage observed. This was also verified from the two similar spectra obtained of the darkened areas on the pitted surface and on the rubber clamp, **Figures 9 and 10**.

Figure 6: Elemental analysis (EDS) of the foreign particulates discovered of the surface of the damaged V-22 Hydraulic Line.

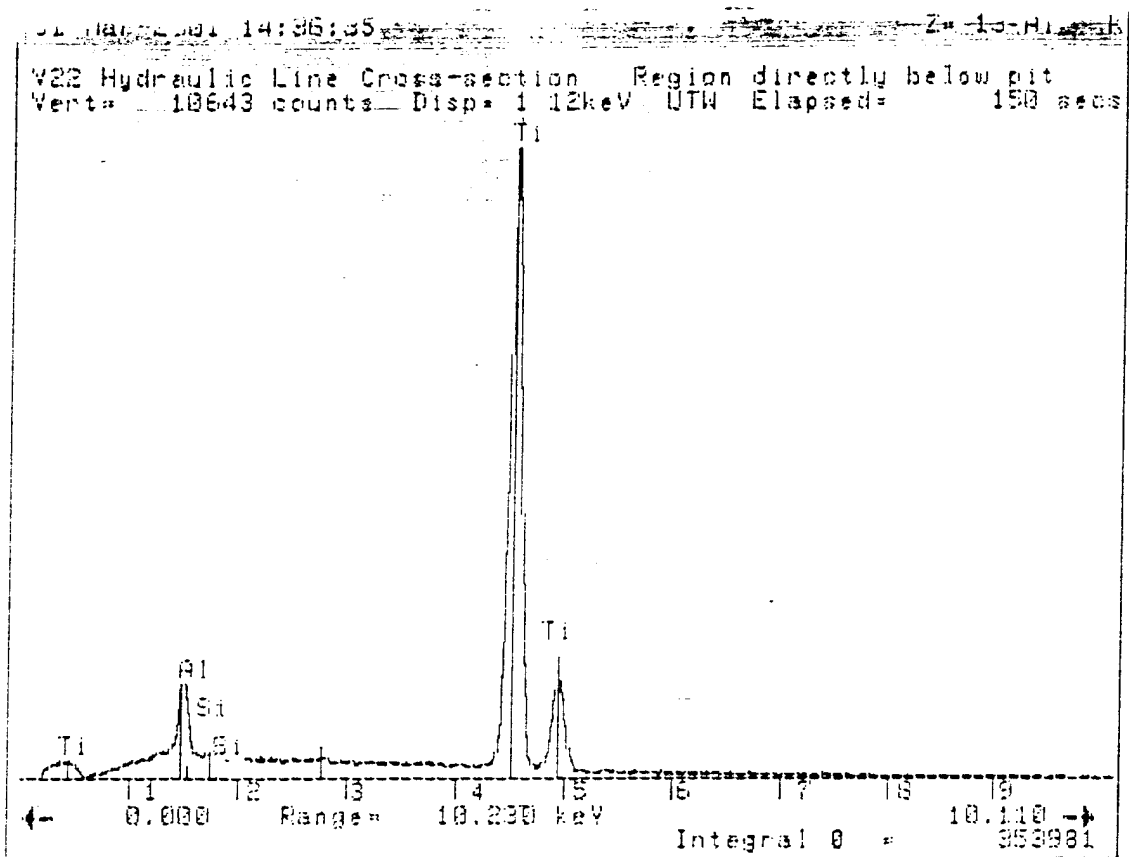
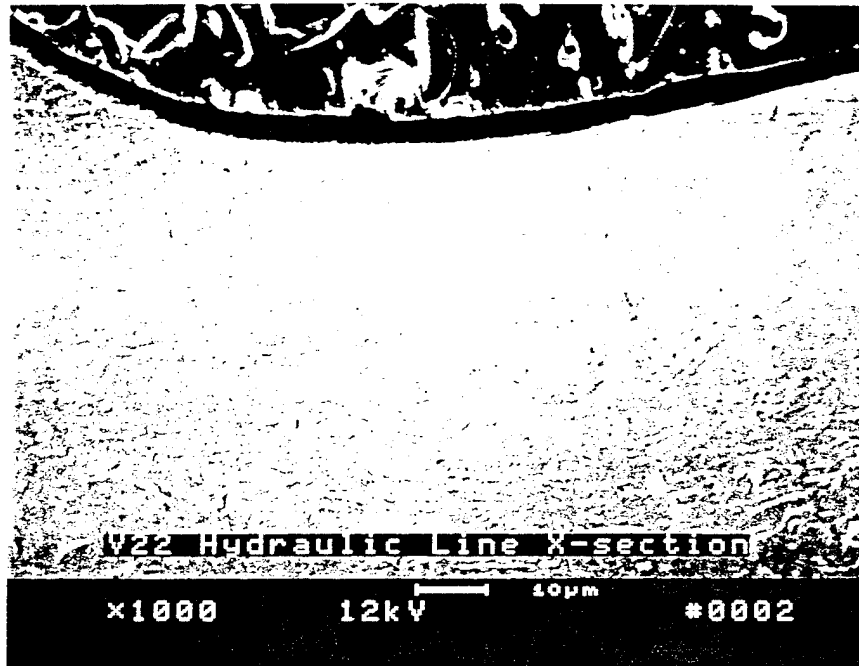
Figure 7: Elemental analysis (EDS), along with its corresponding SEM micrograph, of the damaged V-22 Hydraulic Line's cross-section. Sample had been polished and etched in Kroll's reagent (3:1).

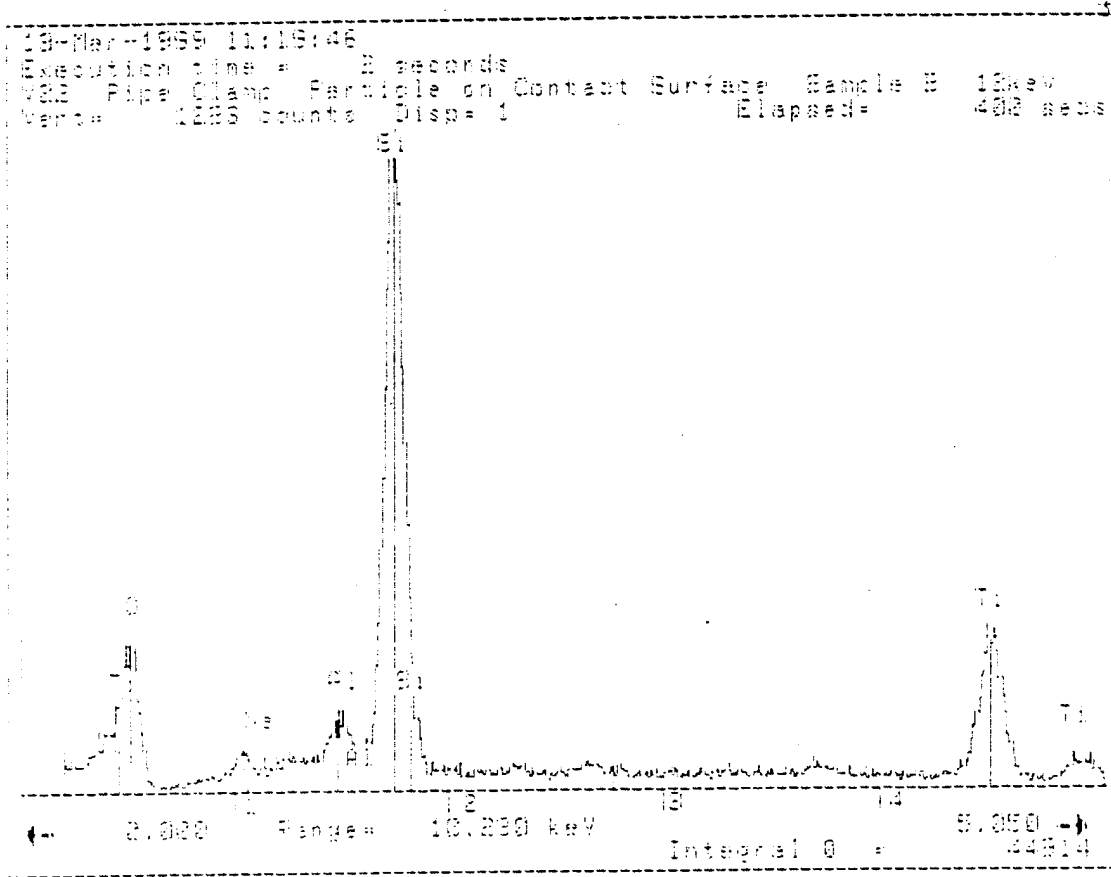
With regard to the corresponding contact area of the rubber clamp, large peaks of Si and O were identified by EDS (**Figure 8**). Furthermore, the black gritty area of the clamp, when compared to the nascent rubber, was discovered to contain large peaks of C, Na, O, and S with an additional presence of Ca and K (**Figure 9**). This result is similar to the EDS spectrum of the darkened pit areas of the tube (**Figure 10**).

Figure 8: Elemental analysis (EDS) of the rubber clamp's surface that was in contact with the damaged V-22 Hydraulic Line.

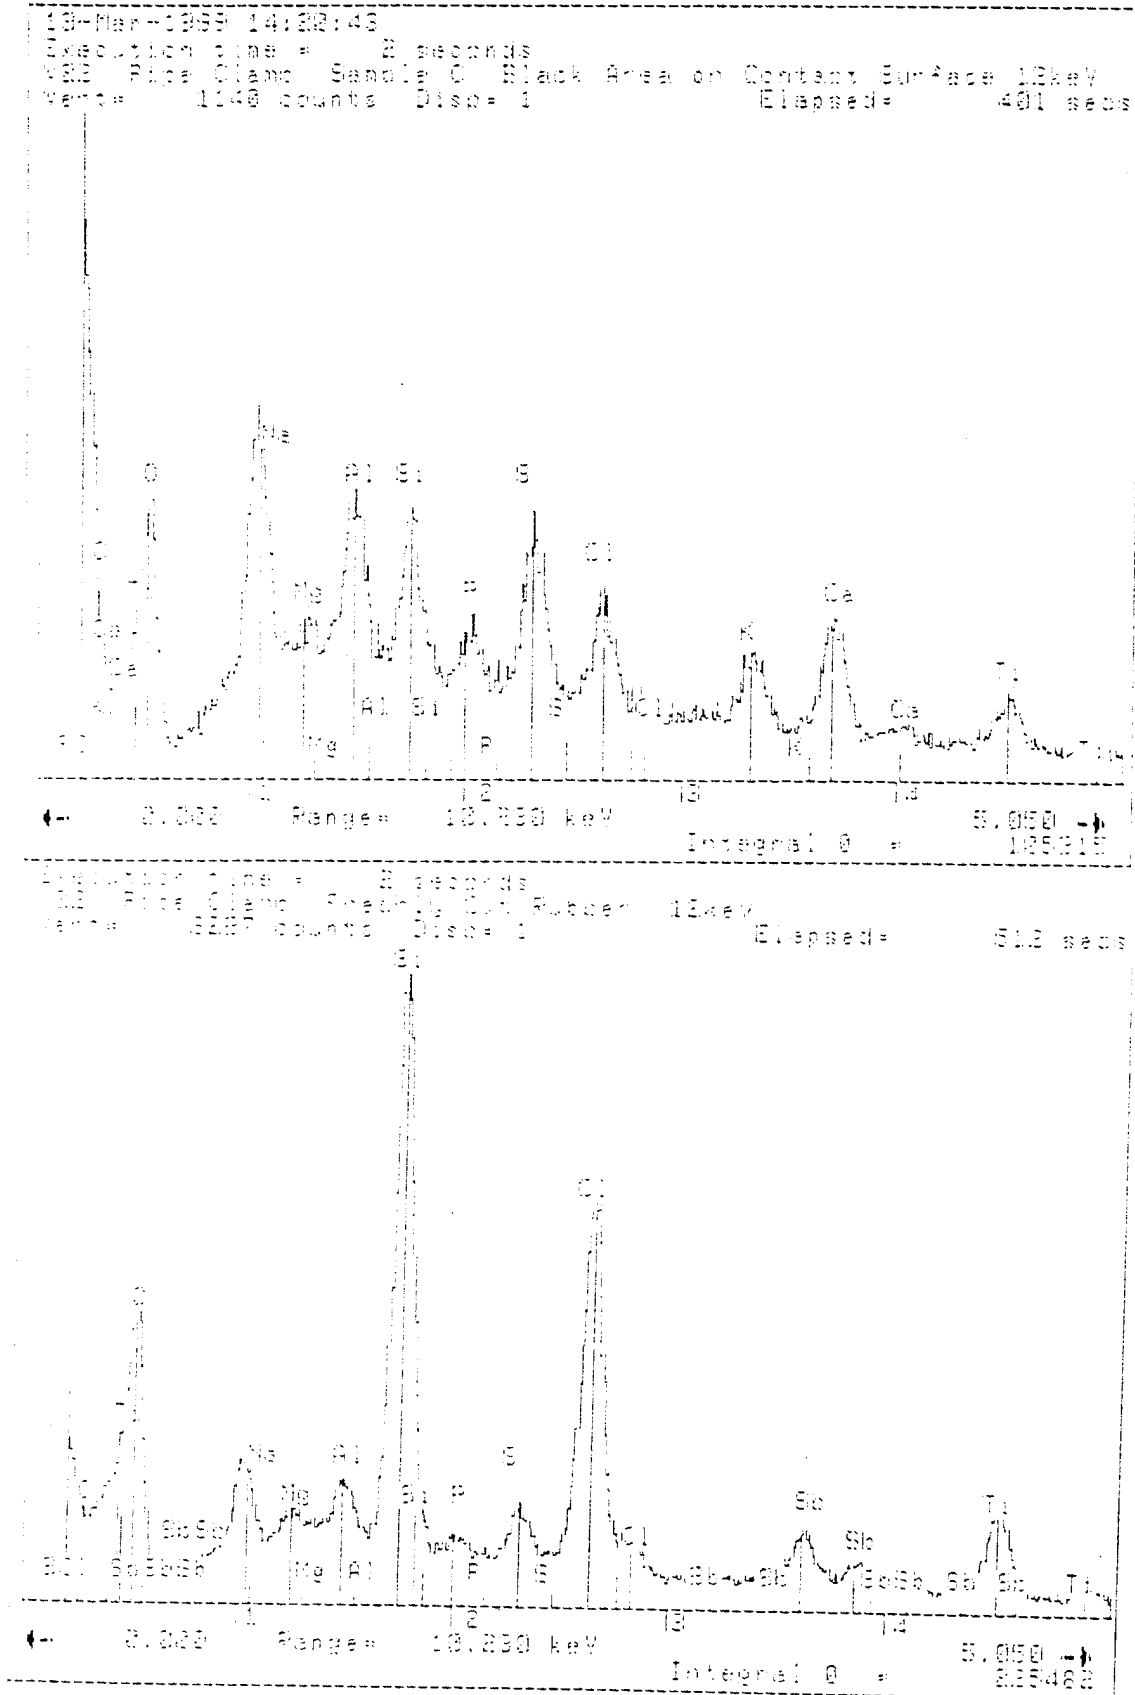
Figure 9: Elemental analyses (EDS) of the damaged V-22 Hydraulic Line's contacting rubber clamp and of a nascent rubber clamp (of same mil-spec.).

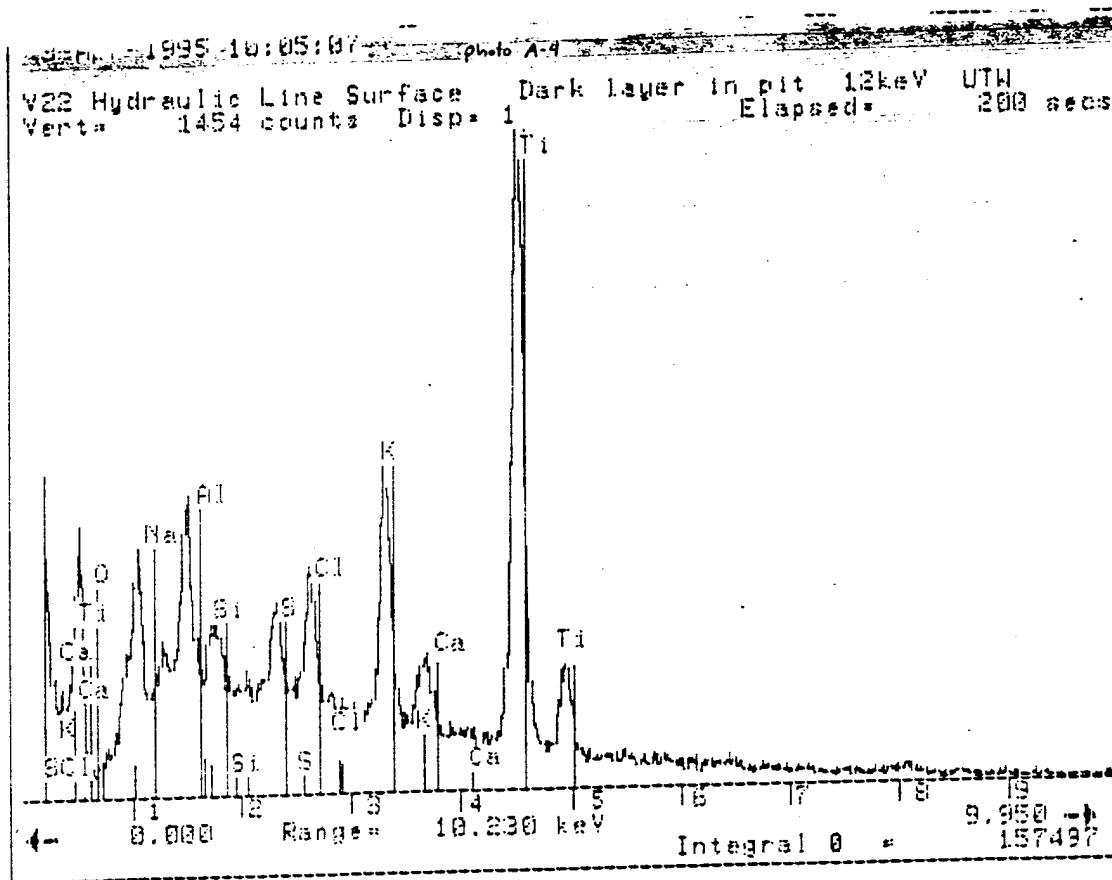
Figure 10: Elemental analysis (EDS), along with its corresponding SEM micrograph, of the darkened areas on the surface of the damaged V-22 Hydraulic Line.
