**Beaver Dam - White River, Arkansas**

# **Beaver Dam Secant Pile Wall Completion Report**

**OCTOBER 1995**

**Volume 1**

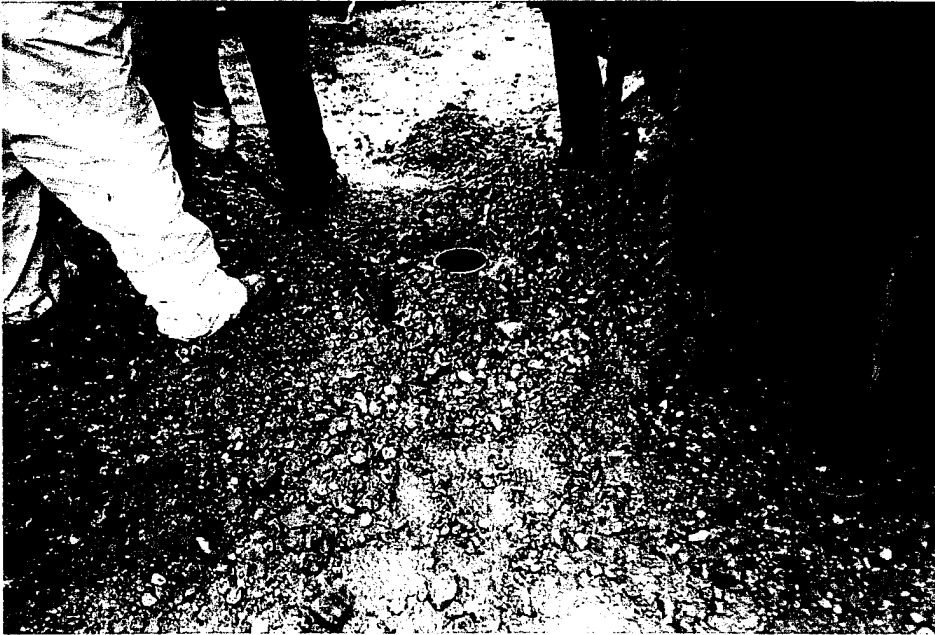
**PHOTO No. 6**

Large gravel found in the Random Fill Portion of the Beaver Dam  
Main Embankment.

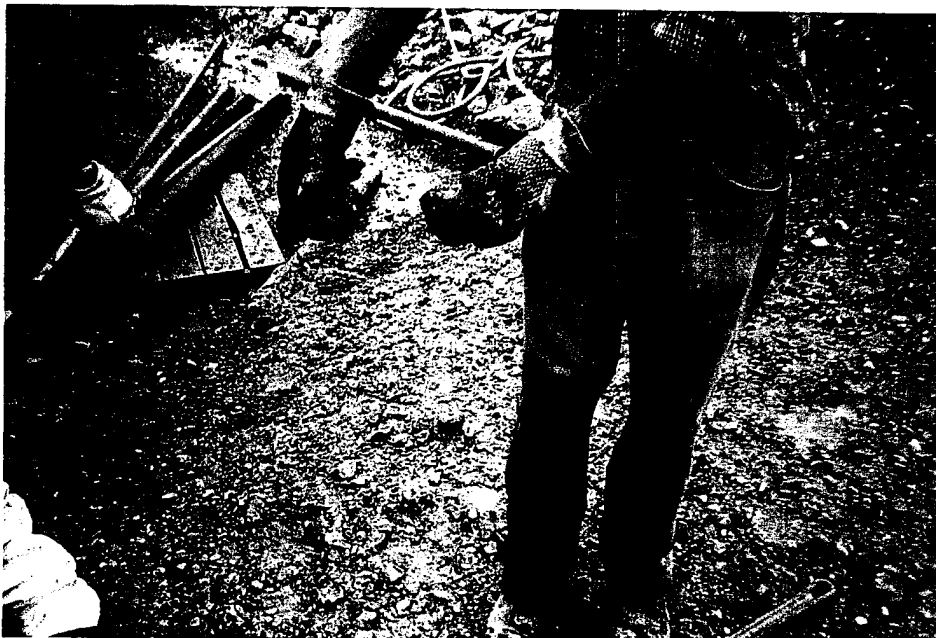
**PHOTO No. 7**

Close up of some of the larger gravel found in Random Fill.

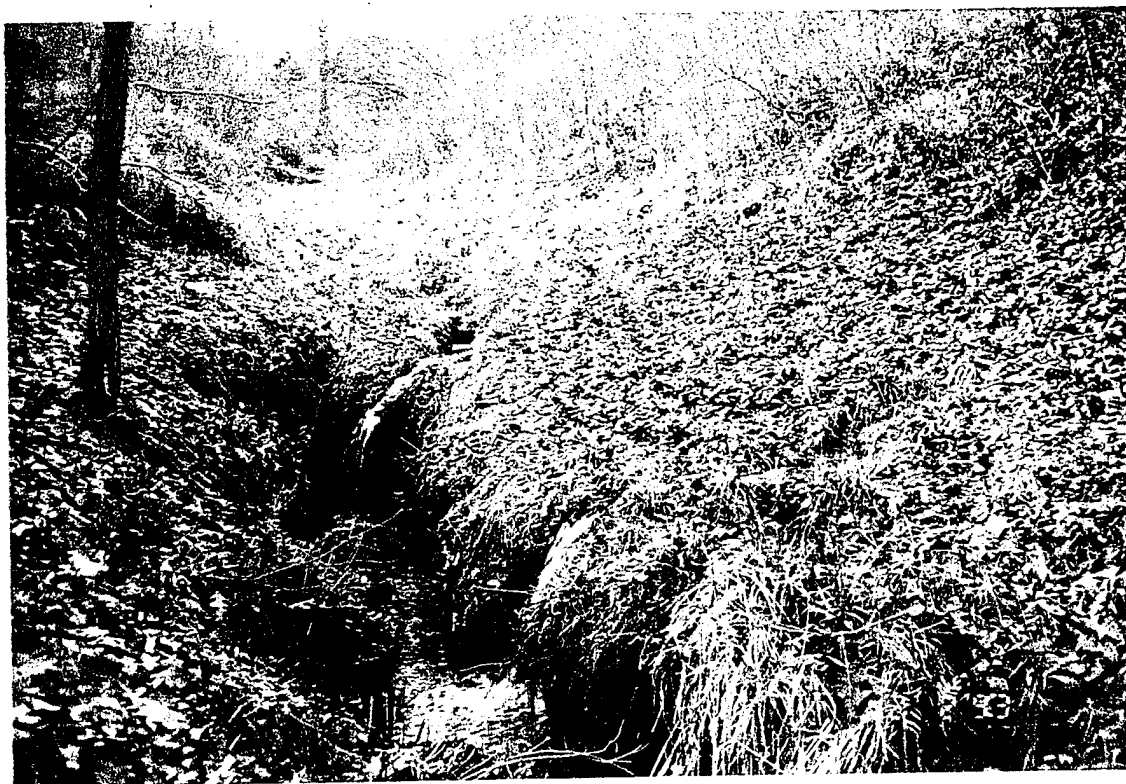
P H O T O   N o .   15

Seepage flow in area SA-1,  
before construction of cutoff wall  
(December 1993)
