**DEBRIS CONTROL AT HYDRAULIC
STRUCTURES IN SELECTED AREAS
OF THE USA**

January 1996

Second Interim Report

US ARMY RESEARCH DEVELOPMENT &
STANDARDIZATION GROUP-UK
LONDON

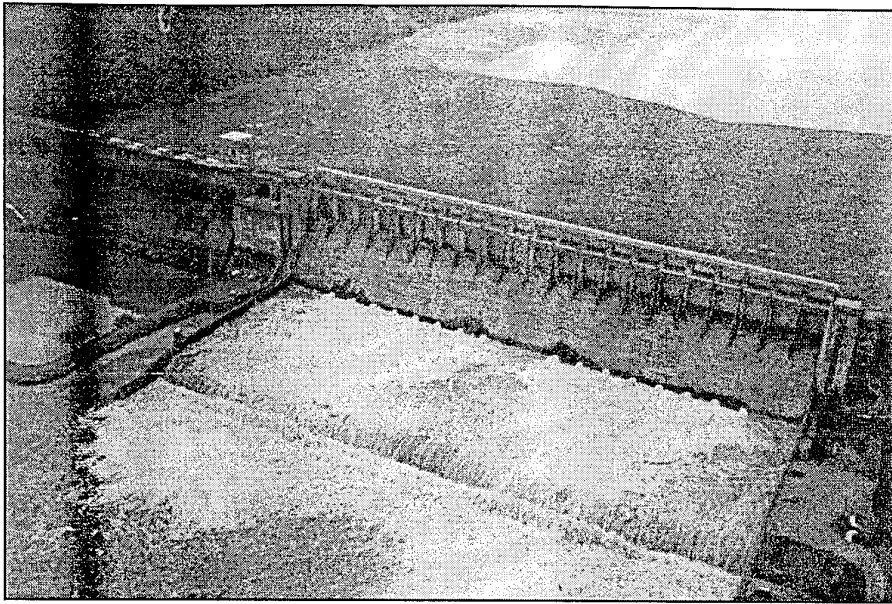
The larger debris accumulations span the width of the river valley and wedge against the dam face. A photograph of the March 1993 flood event is presented in Enclosure 3. Approximately 40 acres of drift and debris are observed prior to passage. In addition, a photograph illustrating the January 1995 event demonstrates how the debris compacts against the dam face. Approximately 35 acres of debris accumulated during the January flood.

Bluestone Dam, March 1993, Flood Event

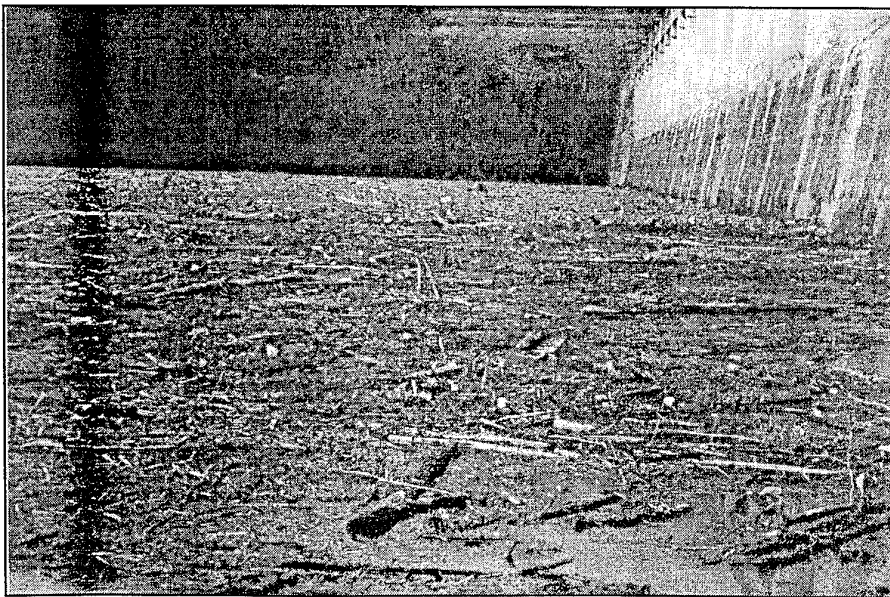
Bluestone Dam, January 1995, Flood Event

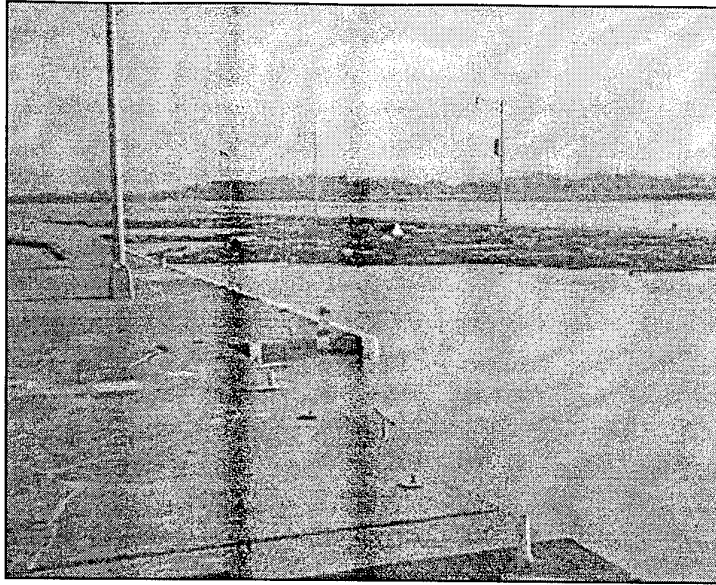
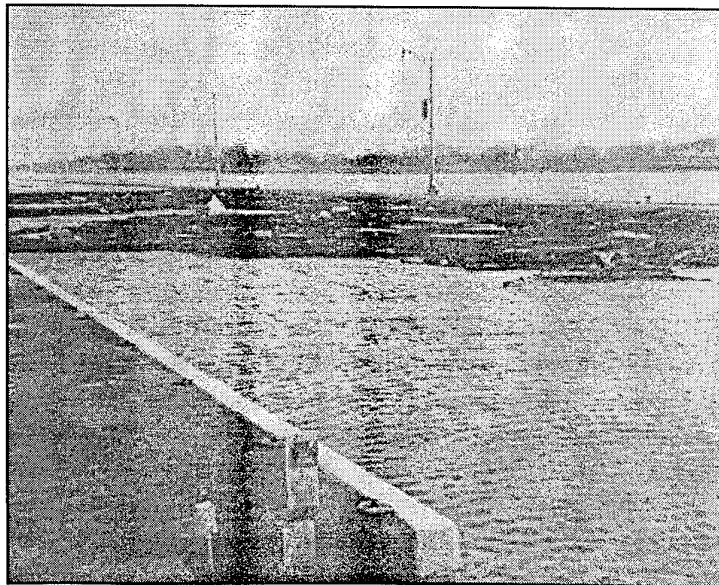
Enclosure 4 illustrates a typical debris jam in the Jonesville Lock (March 21, 1995). Drift has been observed to nearly fill the 600-foot lock.

Black River, March 1995

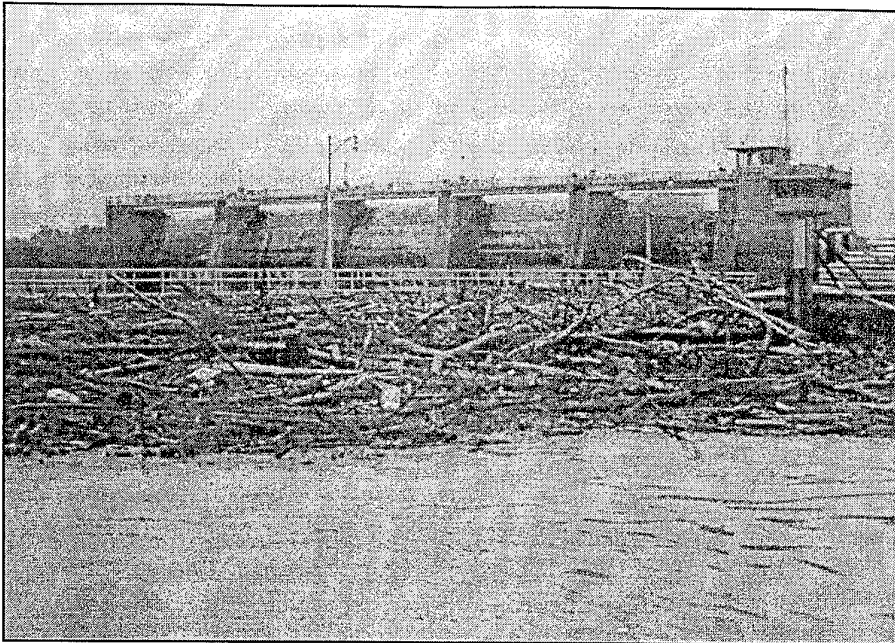
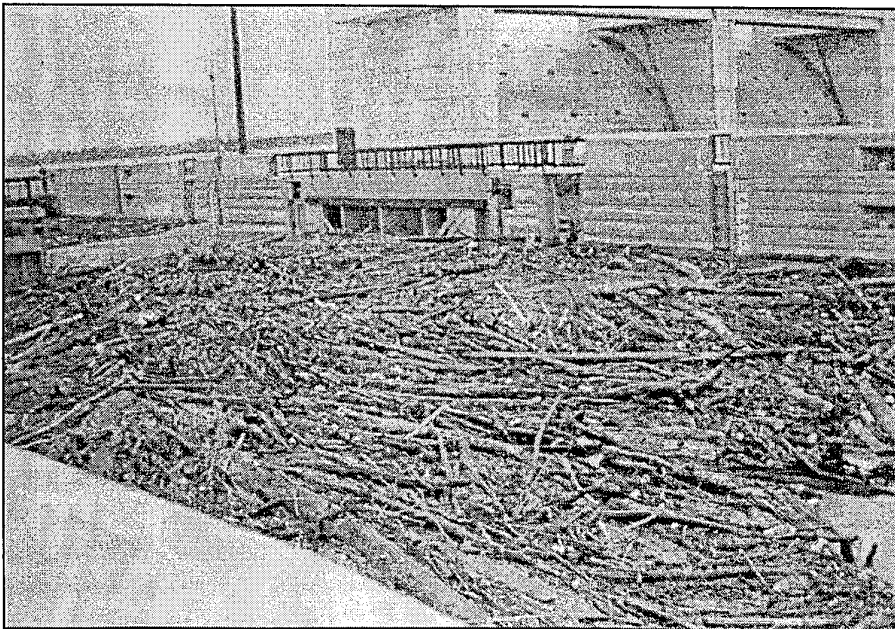
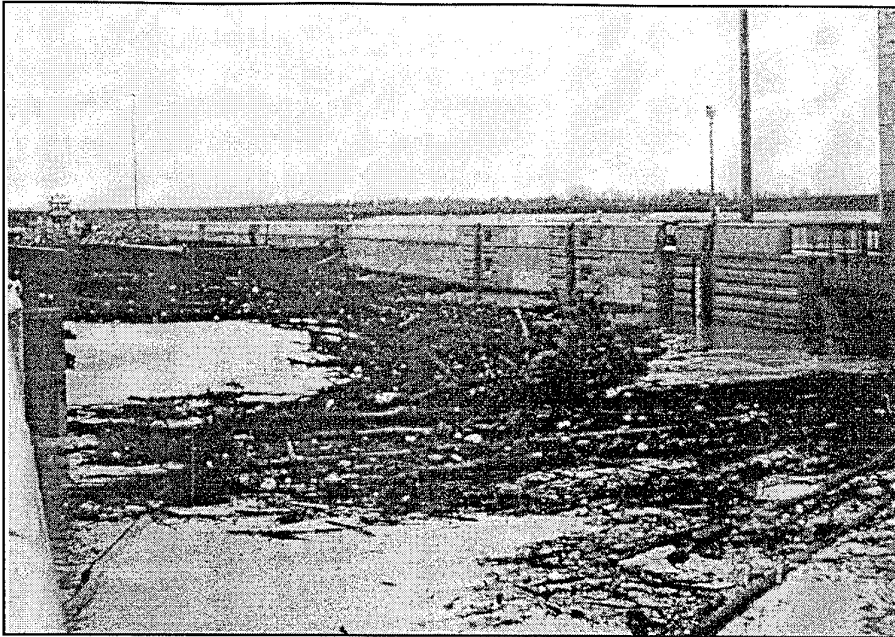
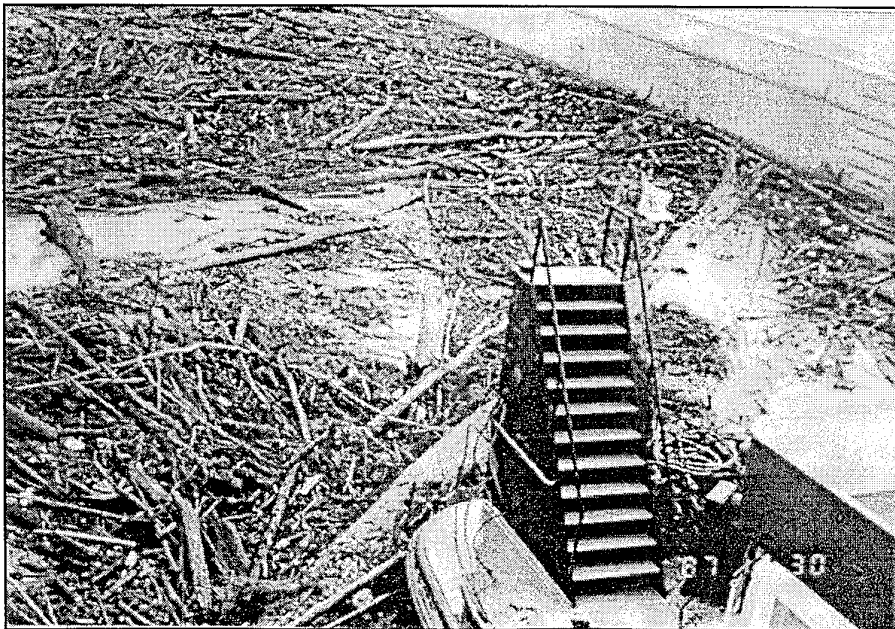
Typical log jam, Lock and Dam Operation

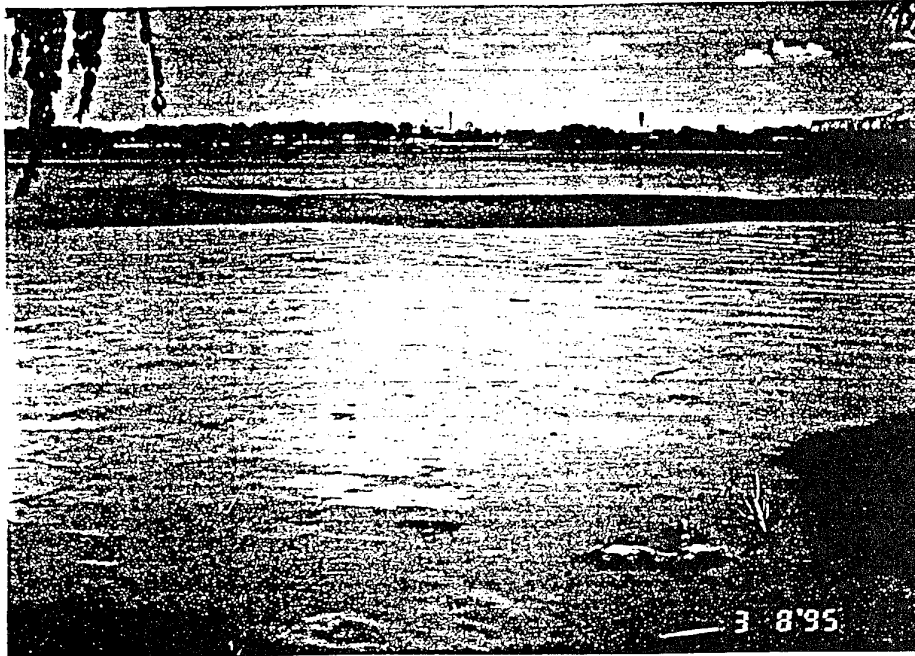
FIGURE A - MUD FLATS UPSTREAM OF MCALPINE L&D
(looking toward Indiana shore)

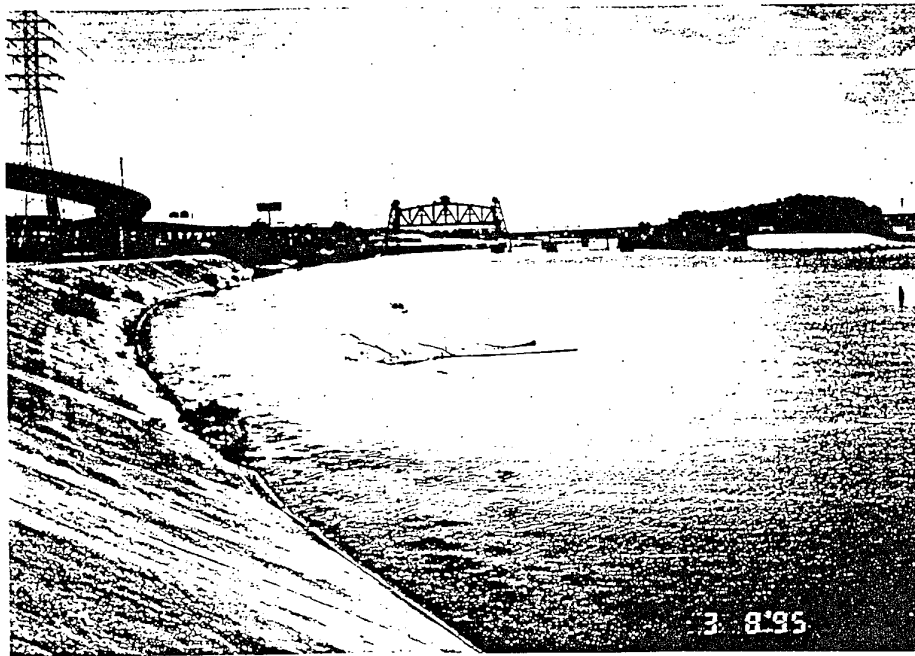
FIGURE B - MUD FLAT UPSTREAM OF MCALPINE WITH DEBRIS ACCUMULATION
(looking downstream toward canal)

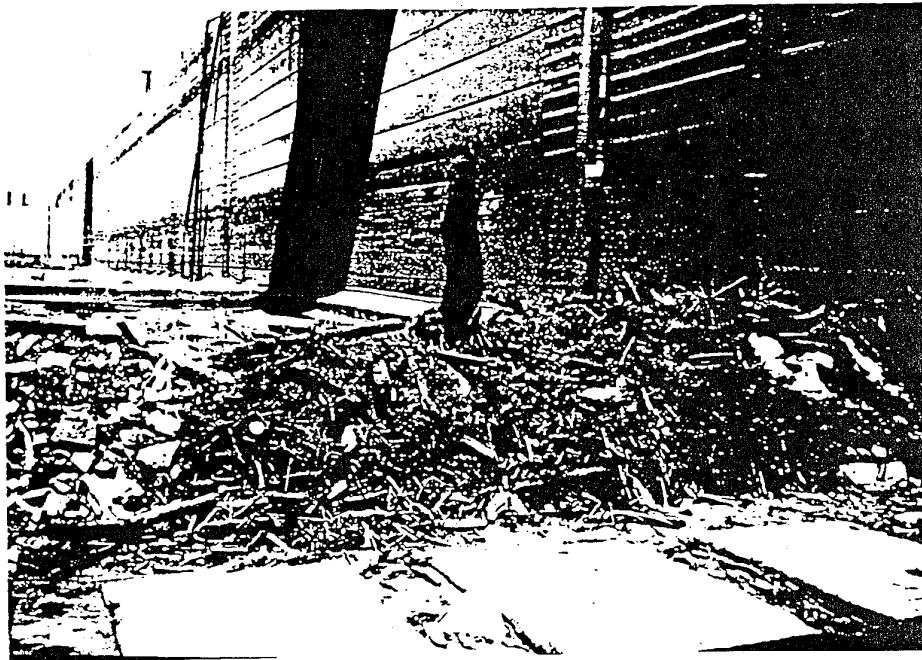
FIGURE D - DEBRIS ACCUMULATION - MARKLAND 600-FT LOCK CHAMBER
(view from down in the lock chamber)
