NASA Contractor Report 145326

Flight Service Evaluation of
Kevlar-49 Epoxy Composite
Panels in Wide-Bodied
Commercial Transport
Aircraft - Fourth Annual
Flight Service Report

LOCKHEED-CALIFORNIA COMPANY
BURBANK, CA 91520

April 1978

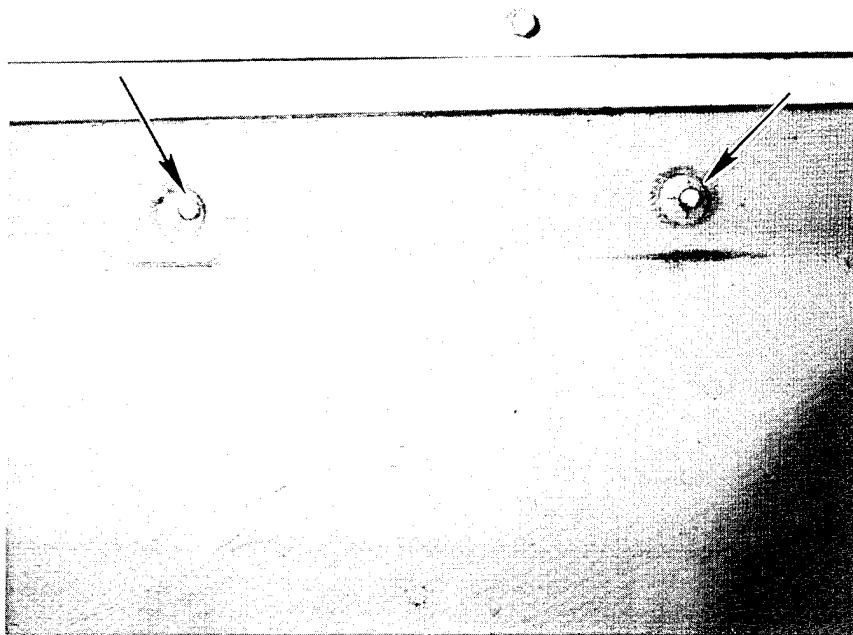
- 5) Slight fraying of the fastener holes was visible from the exterior on all four edges, with more fraying noted on the bottom edge. Heavier fraying was noted on three holes, one on the top edge and two on the aft edge. (Figure 12)

Figure 12. Eastern LH Wing-Body Fairing - Frayed Fastener Holes, Lower Aft Edge on Inner Surface

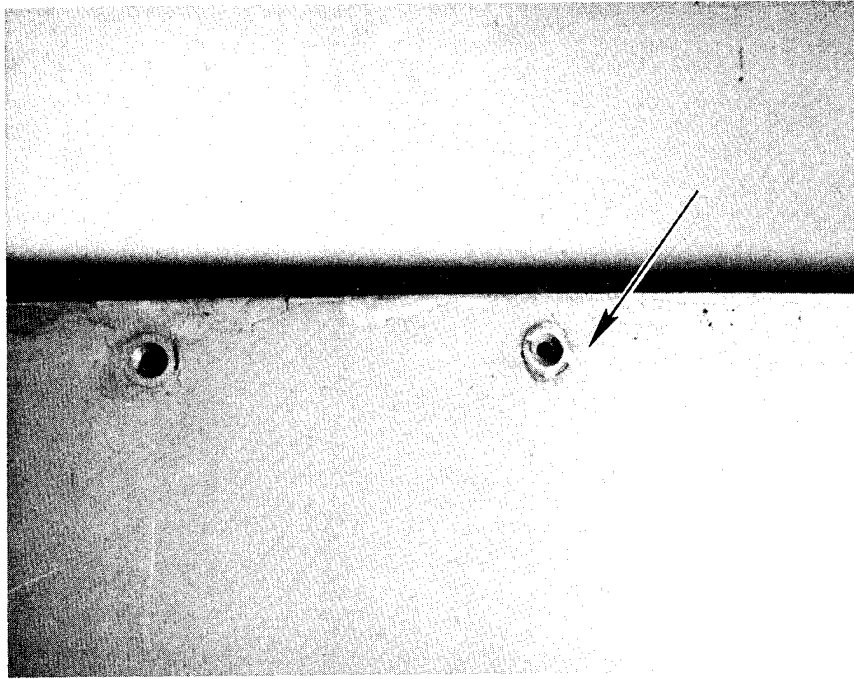
- 7) Considerable paint chipping and re-painting was noted around the fastener holes. (Figure 13)
- 8) No evidence of Skydrol contamination.

Figure 13. Eastern LH Wing-Body Fairing - Paint Loss Areas Around Fastener Holes, Exterior

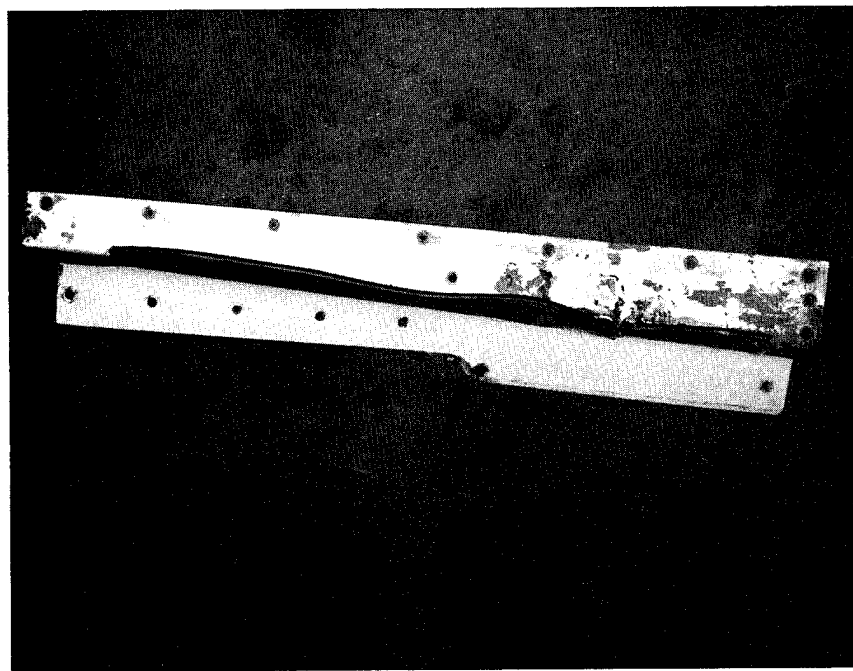
- 1) The panel weight was 1.02kg. (2 1/4 lbs.)
- 2) Paint is missing, with the Kevlar-49 surface exposed in extensive areas of the upper fillet. (Figure 14)
- 3) Fraying of fastener holes is visible from the exterior, but more noticeable viewed from the inner surface. Several elongated holes were noted which were the same ones observed in the 1975 inspection. No increase in elongation was noted. Fraying was more pronounced on the elongated holes. (Figures 15, 16, 17)
- 4) A slight gouged spot was noted on the upper forward area of the inner surface.

Figure 14. Eastern LH Underwing Fillet - Exterior Surface

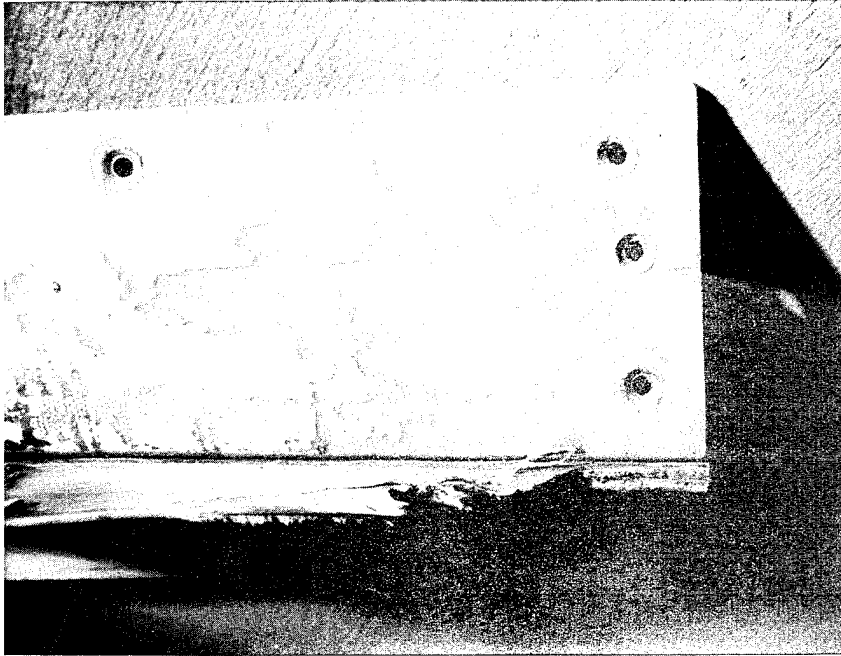
Figure 15. Eastern LH Underwing Fillet - Fastener Holes, Upper Aft Corner, from Exterior

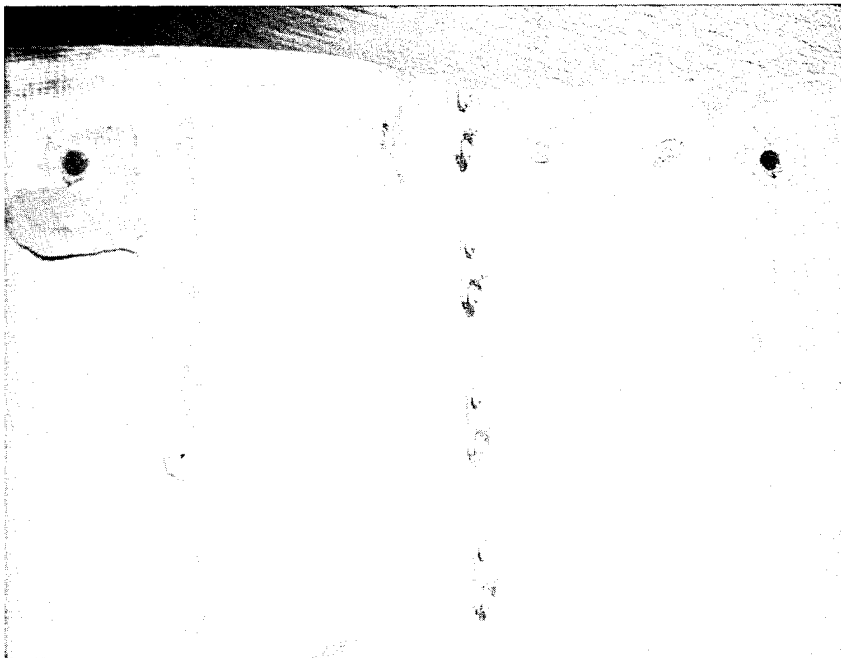
Figure 16. Eastern LH Underwing Fillet - Fastener Holes, Upper Aft Corner, from Inner Surface

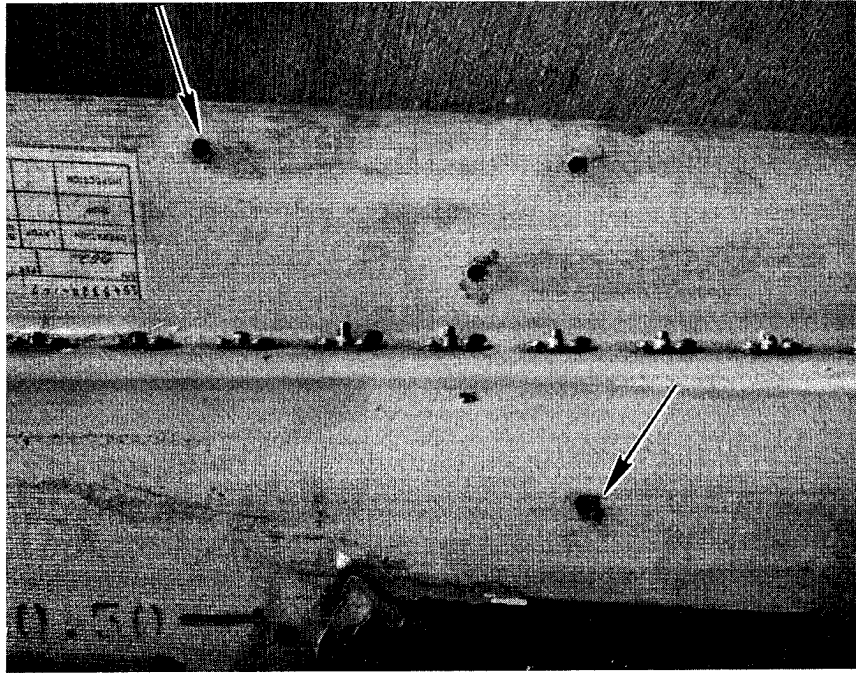
Figure 17. Eastern LH Underwing Fillet - Frayed Fastener Holes from Inner Surface

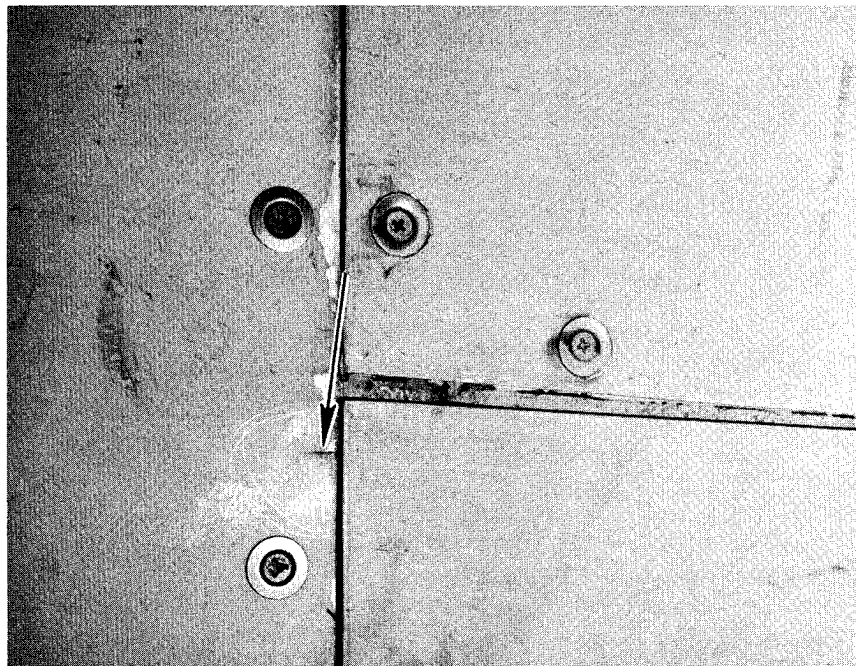
- 1) The following cracks observed in previous inspections were unchanged in appearance or extent:
 - 1.3 cm. (1/2 in.) crack at forward edge between 5th and 6th holes. No associated delamination. (Figure 18)
 - 0.6 cm. (1/4 in.) crack near exact center (may or may not be into skin) with scratch through paint to flame spray extending upward 20.3 cm. (8 in.). No delamination.
 - 0.3 cm. (1/8 in.) ding lower center - definitely into skin. No delamination.
 - 0.8 cm. (5/16 in.) crack in lower forward area - with slight associated delamination. 1.6 cm. (5/8 in.)
 - 0.3 cm. (1/8 in.) crack aft center - no associated delamination.

Figure 18. Eastern RH Wing-Body Fairing - Crack in Forward Edge 0.3 cm. (1/8 in.) Length

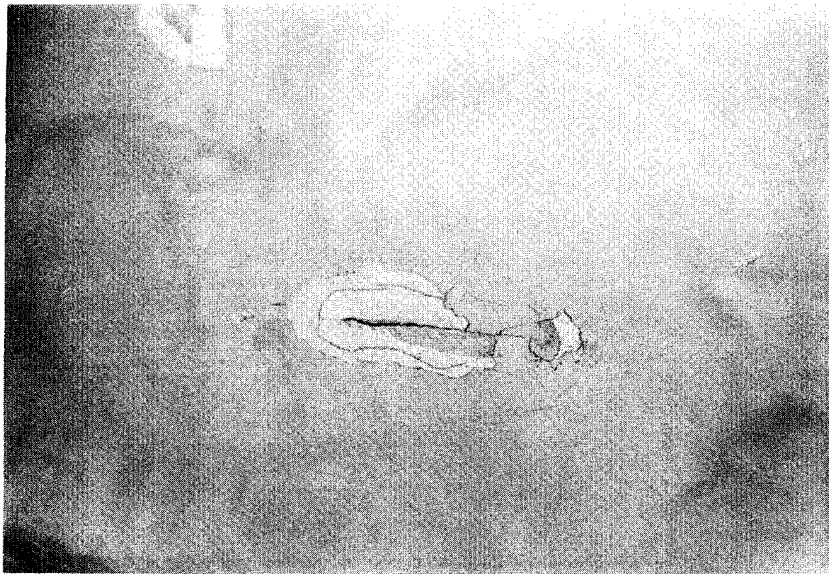
- 1) The panel weight was 697 kg (15 3/8 lbs.). Previous panel weight measured in 1976 was 672 kg (14.81 lbs.).
- 2) A 3.2 cm. (1 1/4 in.) crack was noted in the upper, aft area. (Figure 19). This crack has not grown or delaminated further since it was first observed in 1975. No other cracks were observed, and a 1.3 cm. (1/2 in.) crack observed in 1976 was apparently only in the original paint layer and had been repainted.

Figure 19. Air Canada LH Wing-Body Fairing - Crack, Exterior Surface, 3.2 cm (1-1/4 in.) Length

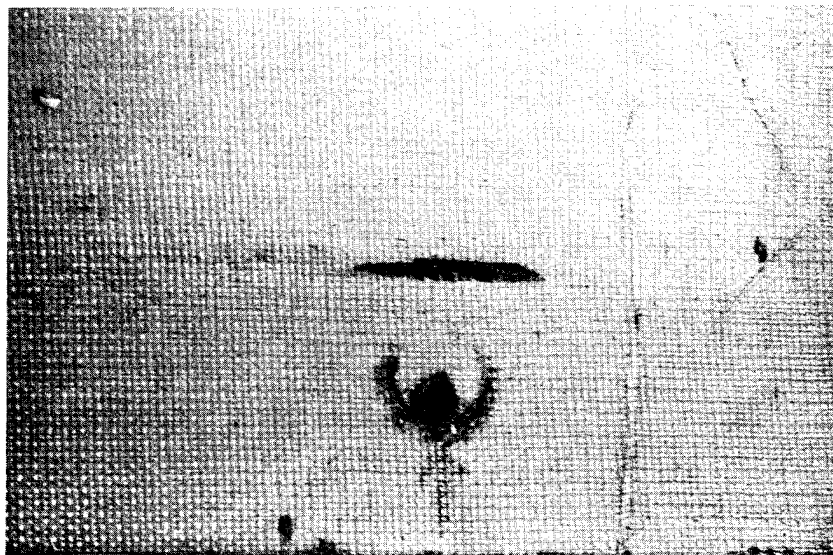
- 3) Fastener holes appeared slightly frayed as viewed from exterior and inner surfaces, with a greater degree of fraying noted on the bottom edge holes as viewed from the inner surface. (Figure 20). Slight hole elongation was observed on all fastener holes on the bottom edge, plus two other holes on the forward and top edges.

Figure 20. Air Canada LH Wing-Body Fairing - Close-Up of Fastener Holes on Bottom Edge, Inner Surface

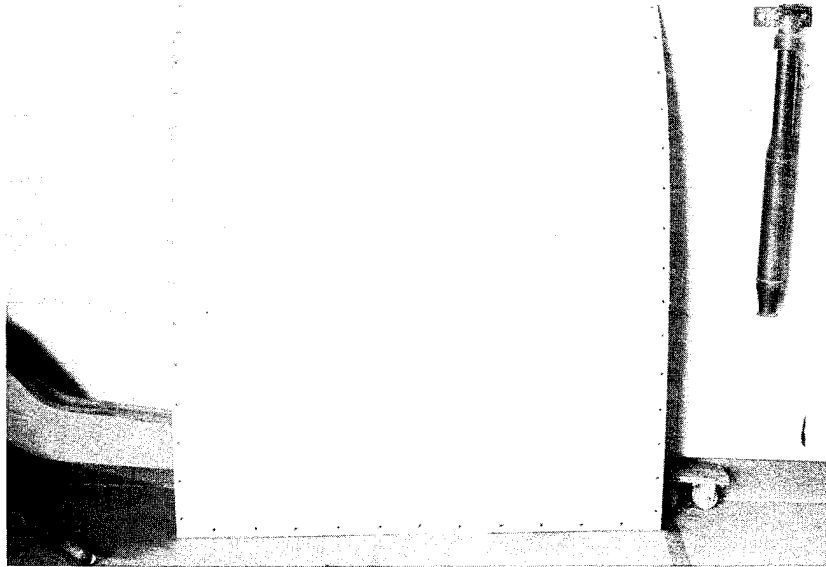
- 4) Extensive paint loss was observed on edges and upper forward area, but no associated damage in the part. (Figure 21).
- 5) No defects or damage were observed on the inner surface.

Figure 21. Air Canada LH Wing-Body Fairing - Exterior

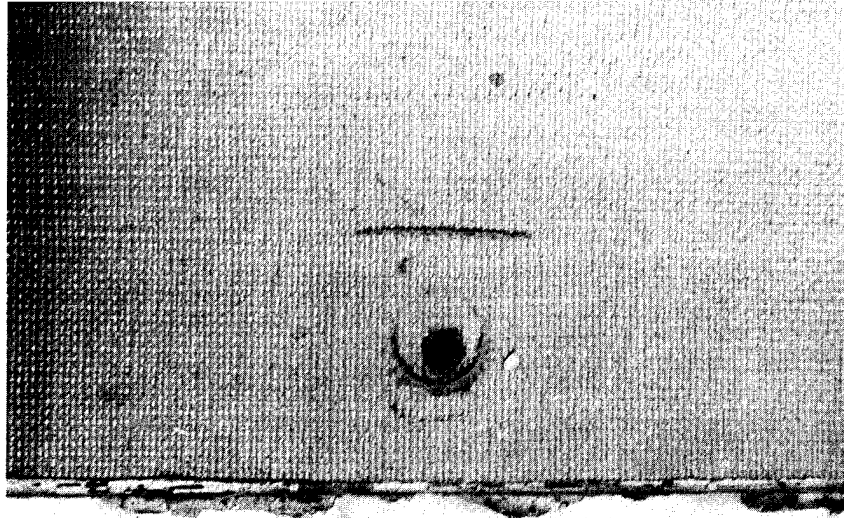
Figure 23. Air Canada RH Wing-Body Fairing - Close-Up of Fastener Holes, Bottom Edge, from Inner Surface

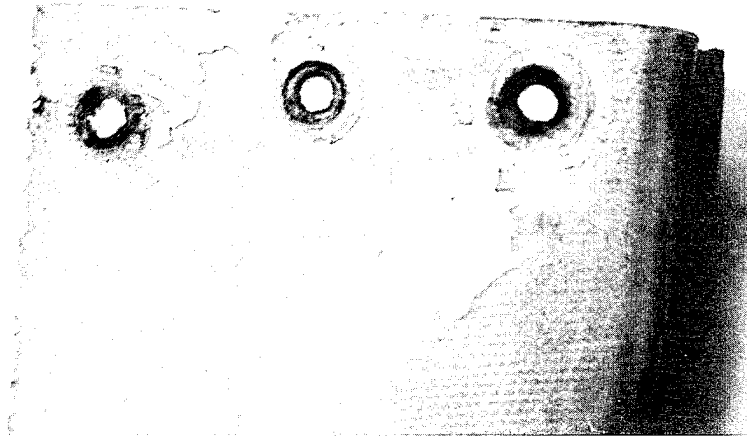
Figure 25. Air Canada LH Underwing Fillet - Fastener Holes, Upper Aft Area, from Exterior

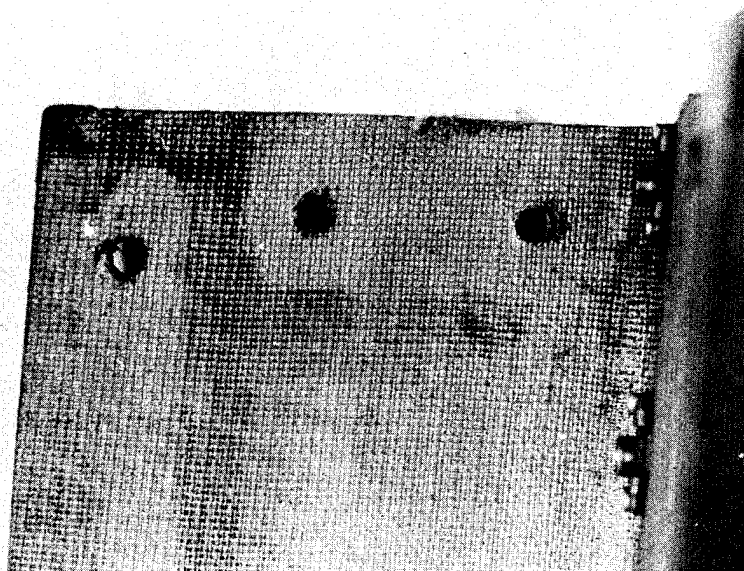
Figure 27. Air Canada RH Underwing Fillet - Fastener Holes, Upper Aft Area, from Inner Surface

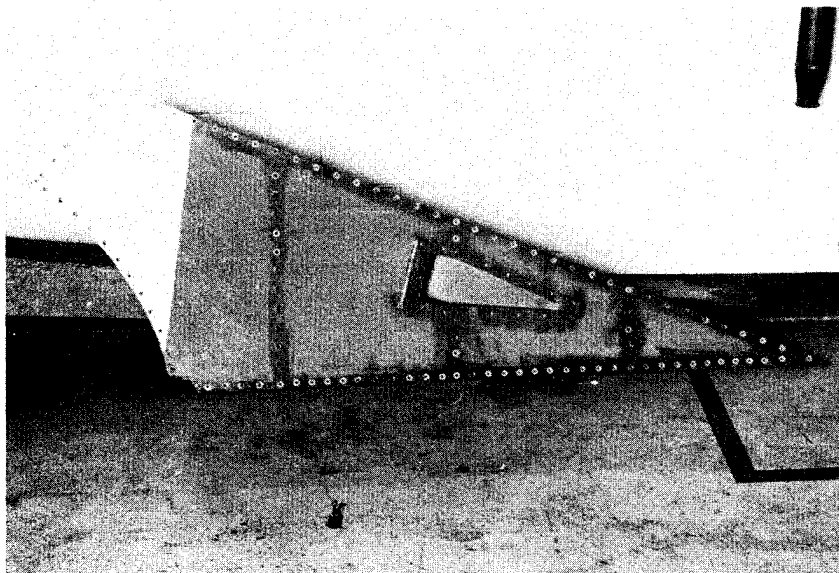
- 1) The panel weight was 2.89 kg (6 3/8 lb.).
- 2) No surface damage or defects were noted. (Figure 28).
- 3) Extensive fraying of fastener holes was observed on all edges as viewed from both surfaces. (Figure 29). Loose Kevlar-49 fibers were noted inside holes. The intercostal holes through the core area were more frayed than holes in the edge laminate. (Figure 30). Elongation was noted only to a very slight degree on three holes along the bottom edge.

Figure 28. Air Canada LH Aft Engine Fairing - Exterior Surface

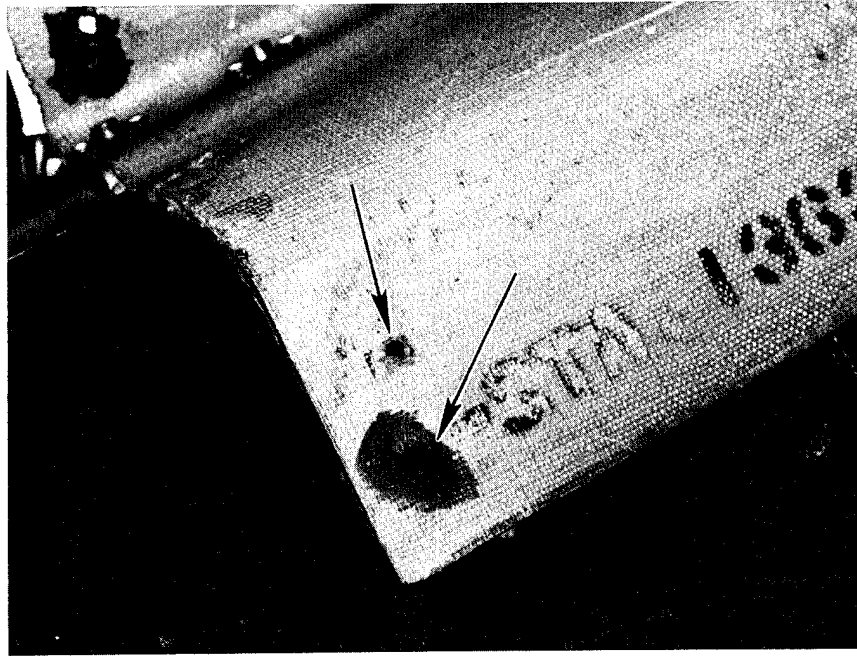
Figure 35. TWA LH Underwing Fillet - Filled and Relocated Fastener Holes

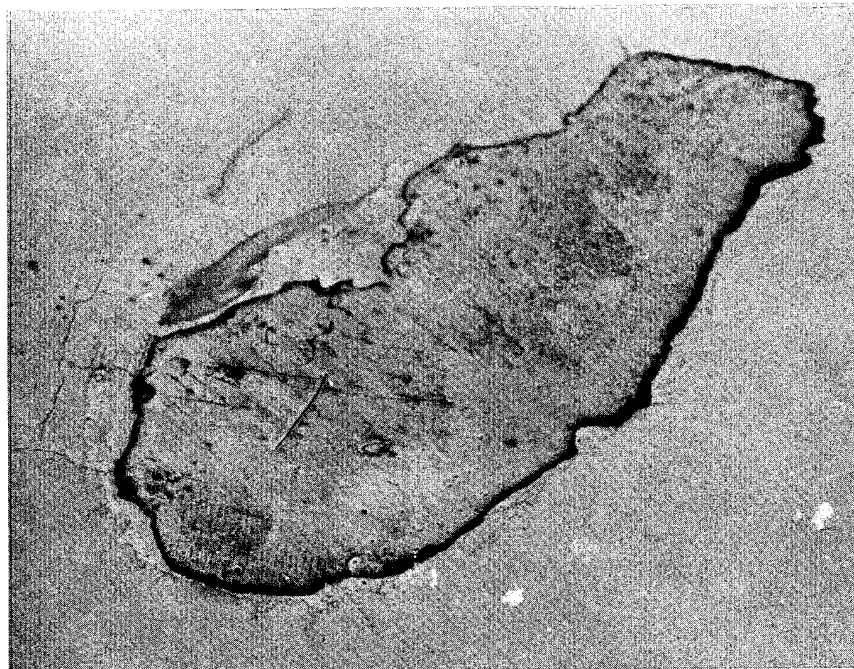
Figure 36. TWA RH Aft Engine Fairing - Repainted Area with Possible Skin Damage

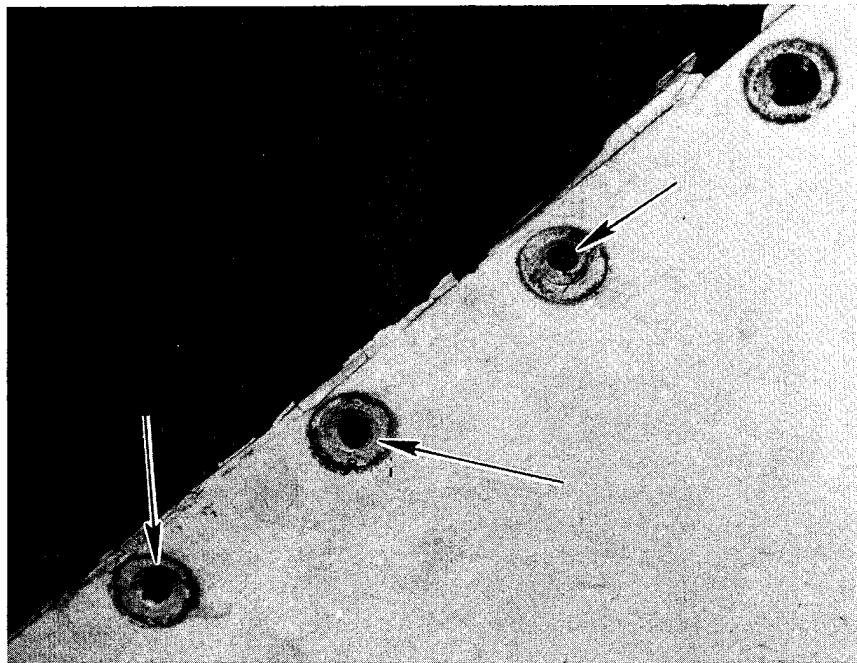
In one instance, hole deformation has been observed on parts other than the underwing fillets, and these are the TWA aft engine fairings. These fairings, as described in the Second Annual Report (Ref. 3), required relocation of all fastener holes during reinstallation. The holes were filled with a chopped glass filled epoxy, and a layer of epoxy impregnated 120 glass cloth was applied to both surfaces. Many holes were redrilled through the filled area, and these holes show a significantly greater degree of elongation than any holes drilled through a solid Kevlar-49 laminate. This condition, while not affecting part performance or requiring corrective maintenance, does indicate an inadequacy of the repair; and does not reflect on the performance of Kevlar-49.

Figure 39. TWA RH Aft Engine Fairing - Fastener Holes Viewed from Exterior, Showing Elongation

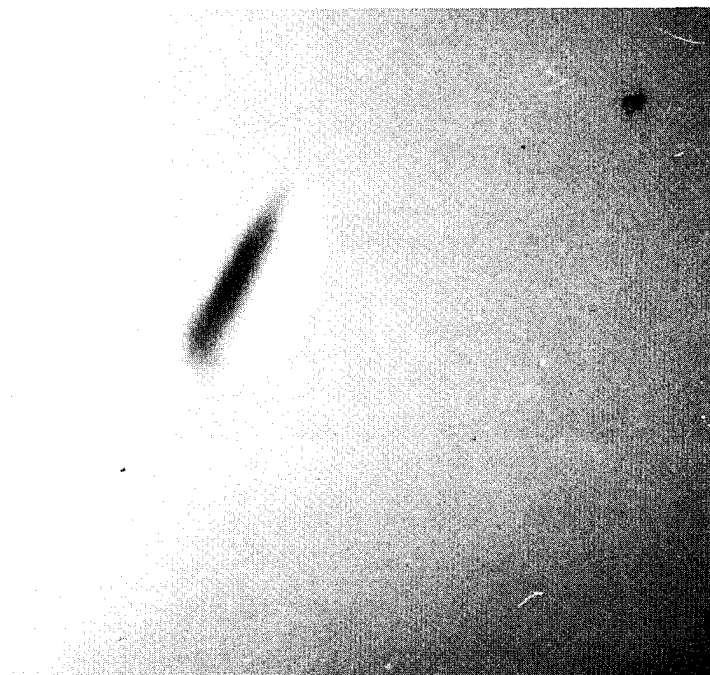
A more extensive damage condition was observed on the TWA right-hand wing-body fairing. This is a fairly deep concave depression and skin-core disbond, but with no associated crack or surface damage, which does not appear to be the result of impact damage. This condition is probably related to a repair made in this part during its reinstallation on Ship 1111 (Ref. 3). This repair was not documented, but apparently consisted of replacement of a damaged core area, extending partially through the core thickness, with a microballoon filled potting compound. Crushing of this potting compound under in-service conditions is a possible explanation of this condition. In any case, this does not appear to be a Kevlar-49 related problem, but as it is highly visible it will be carefully monitored in future inspections.

Figure 40. TWA RH Wing-Body Fairing - Concave Depression with Disbond, Exterior Surface

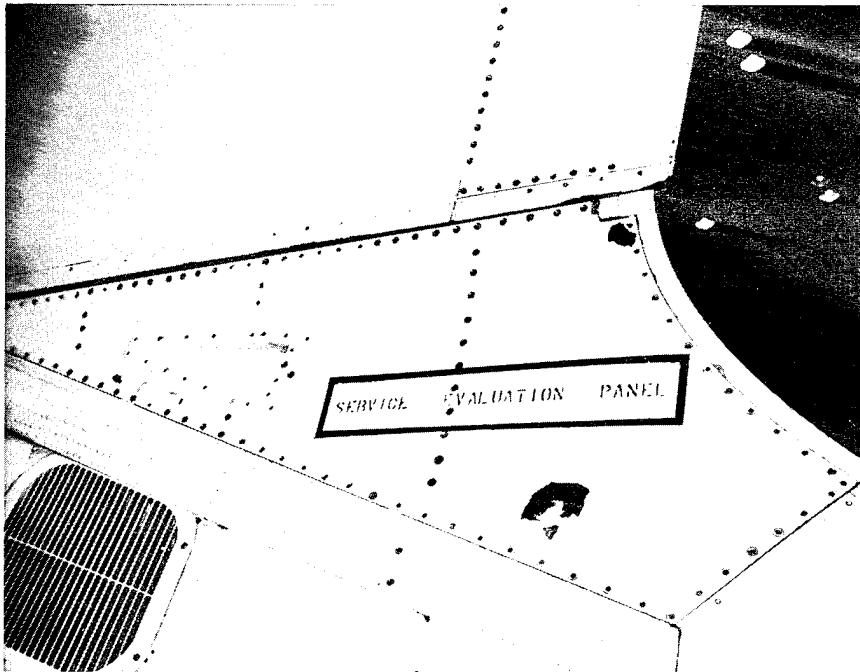
- 1) No disbonds were detected. However only the lower aft area could be reached for coin tapping. No damage or defects were visible. No fastener misalignment was visible.
- 2) An area of paint loss and Flame spray loss had increased since the 1976 inspection, and Kevlar-49 surface was exposed to UV. (Figure 42). The exposed areas showed no signs of discoloration or other damage. Some of the exposed Kevlar-49 areas had been repainted.

Figure 42. TWA LH Aft Engine Fairing - Exterior Surface on Aircraft Showing Paint Loss Areas
