# THE IMPACT RESISTANCE OF CURRENT DESIGN COMPOSITE FAN BLADES TESTED UNDER SHORT-HAUL OPERATING CONDITIONS

INTERIM REPORT

GENERAL ELECTRIC COMPANY  
Advanced Engineering and Technology  
Programs Department

NASA Lewis Research Center  
Contract NAS3-16777

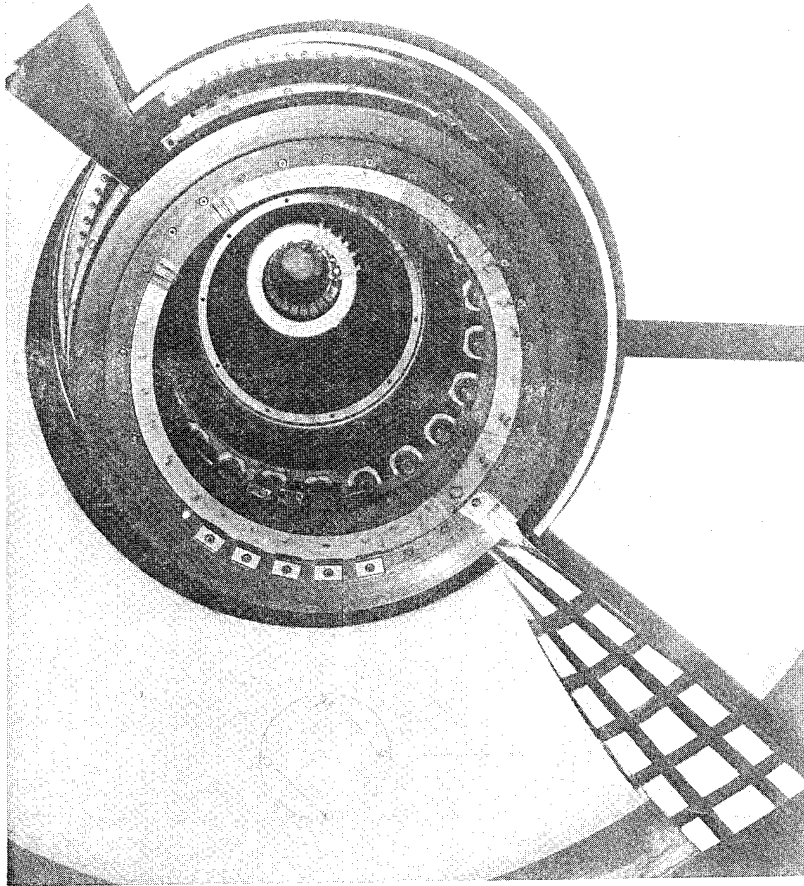
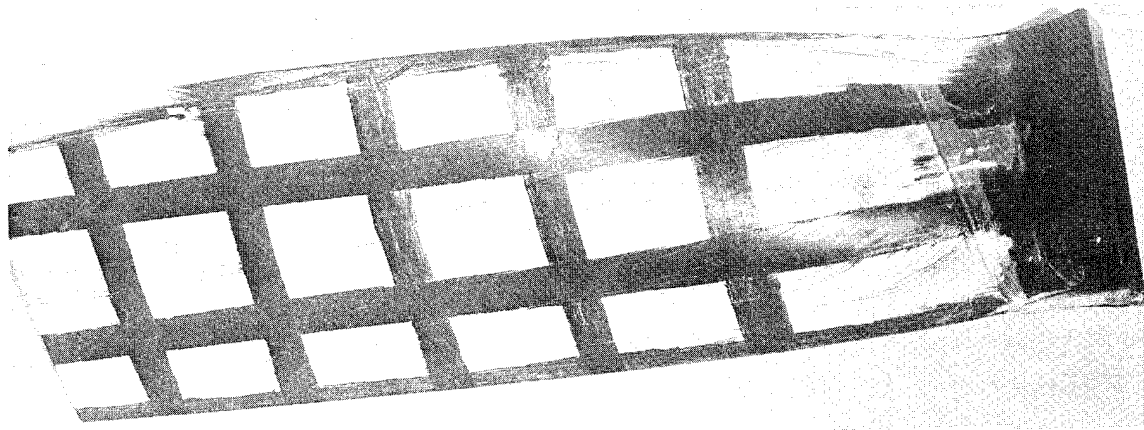
Figure 6. Blade S/N-NG1 after Impact.

Blade S/N	Bird Size	Bite Size	Damage*
NG1	12 Oz Simulated Bird	6 Oz	Loss of sliver and delamination at trailing edge of blade tip. Crack in dovetail.
NB2	12 Oz Simulated Bird	6 Oz	Radial crack in tip. Very small crack in dovetail at leading edge.
NG3	28 Oz Simulated Bird	12 Oz	Blade broke off at root.
NB4	28 Oz Simulated Bird	12 Oz	Blade broke off at root.
NG4	16 Oz Real Pigeon	11 Oz	Crack in root, as indicated by dye penetrant. Delamination in tip area.
NB3	16 Oz Real Pigeon	10 Oz	Delamination at base of leading edge, piece out of tip at leading edge. Delamination across tip.
Ti	16 Oz Real Pigeon	8 Oz	No damage.

- Photographs - The after impact photos show the details and extent of damage for each blade. One of the consistent results is the crack which goes along the bottom of the dovetail and up both faces. This crack appears in each of the G/E blades (NG1, NG3, NG4) impacted with birds or simulated birds but only shows up for the one B/E (NB4) blade which broke off at the root. Otherwise for the blades which didn't break off, damage was fairly typical. Damage consisted of radial cracks and splinters at the blade tip with an occasional small crack at the dovetail root.

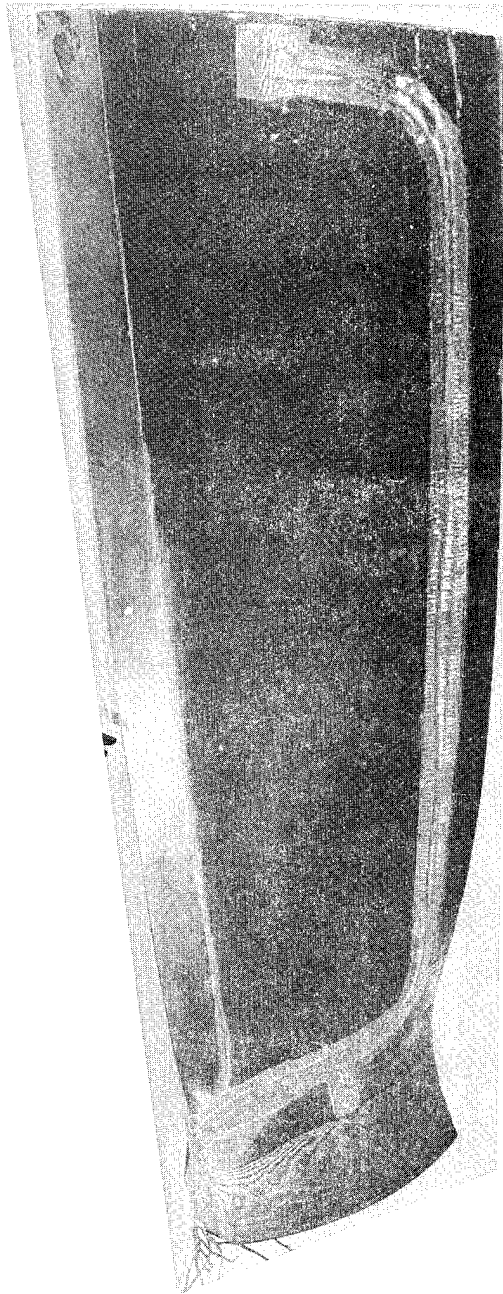
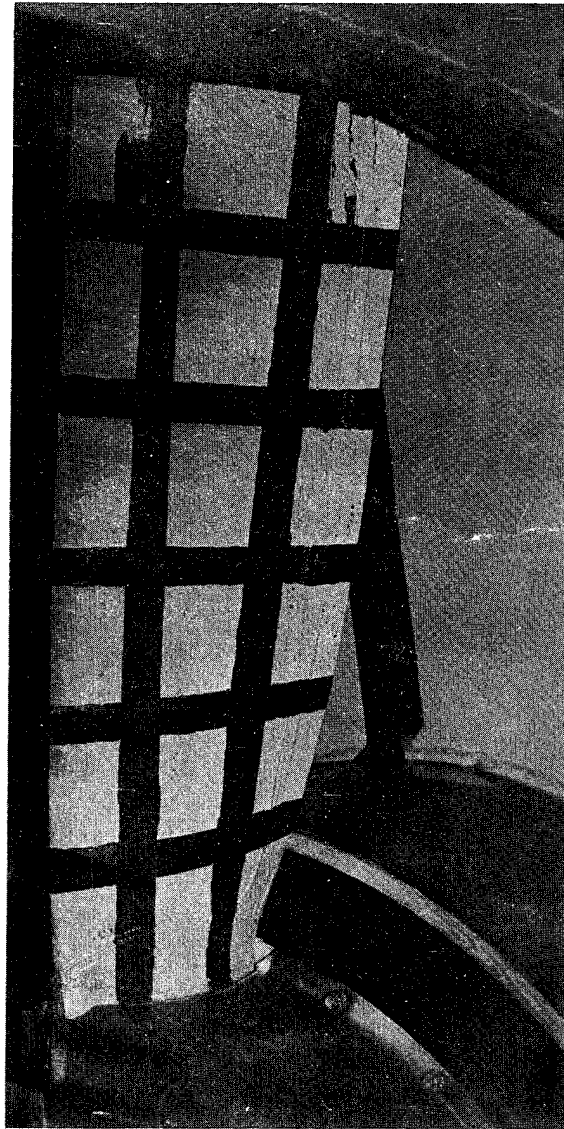
Figure 7. Blade S/N-NB2 after Impact.

NASA-FOD Impact Resistance Test  
Blade S/N NB2  
Boron/Epoxy  
Tip Speed: 800 ft/sec  
12 oz RTV Bird  
6 oz Slice  
22° Incidence Angle

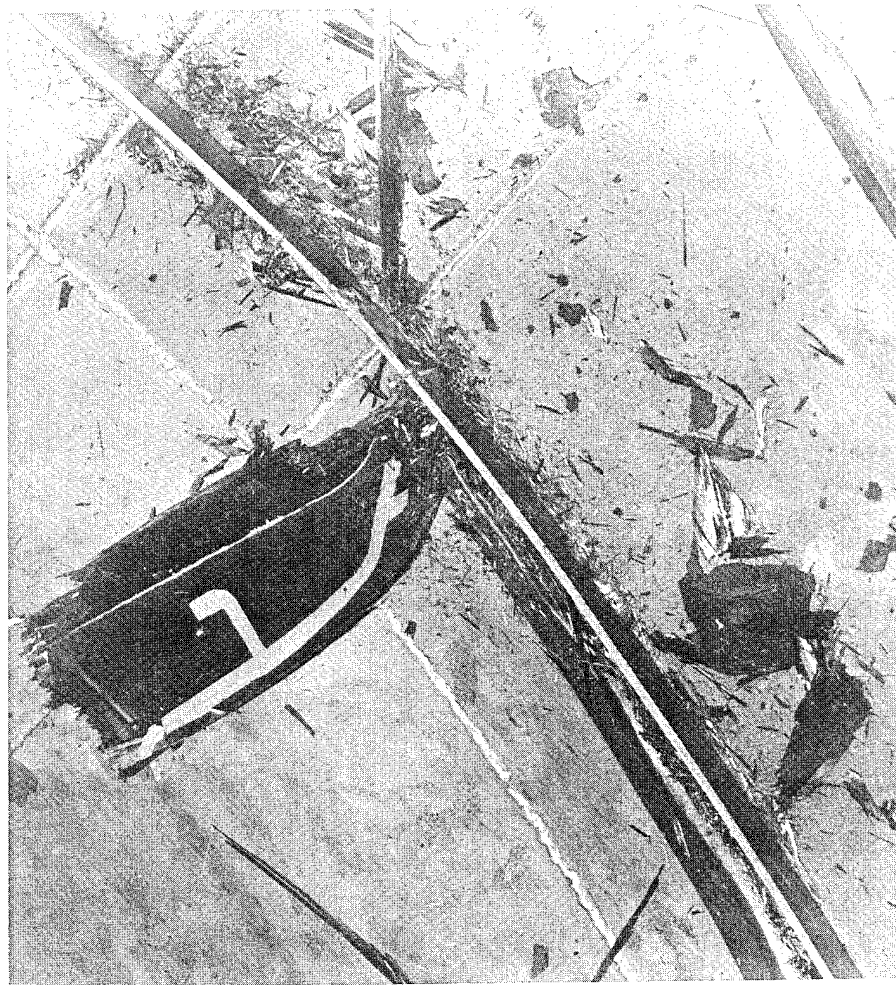
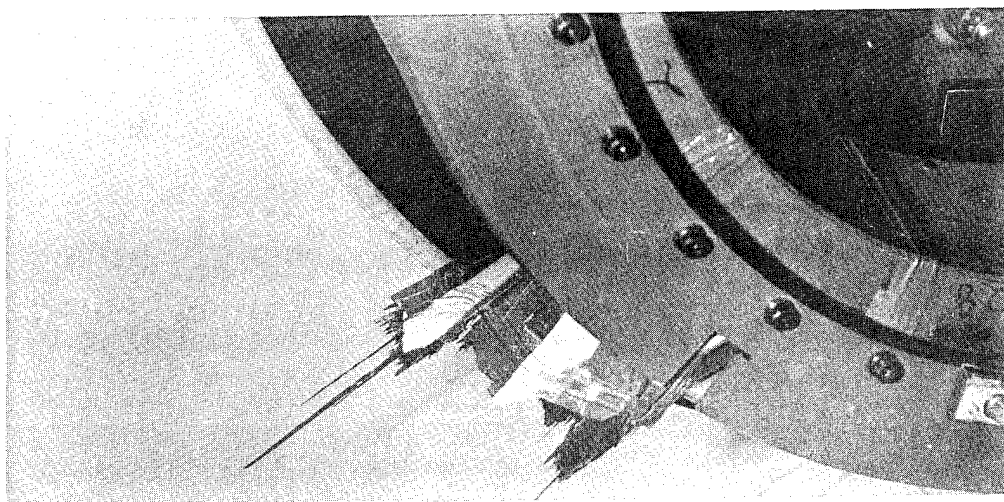
Figure 8. Blade S/N-NG3 after Impact.

A 12 oz bite off a 28 oz simulated bird caused blade failure, apparently resulting from high bending stresses, in both Gr/E and B/E blades at the airfoil root. The blades were contained easily and broke into relatively small pieces.

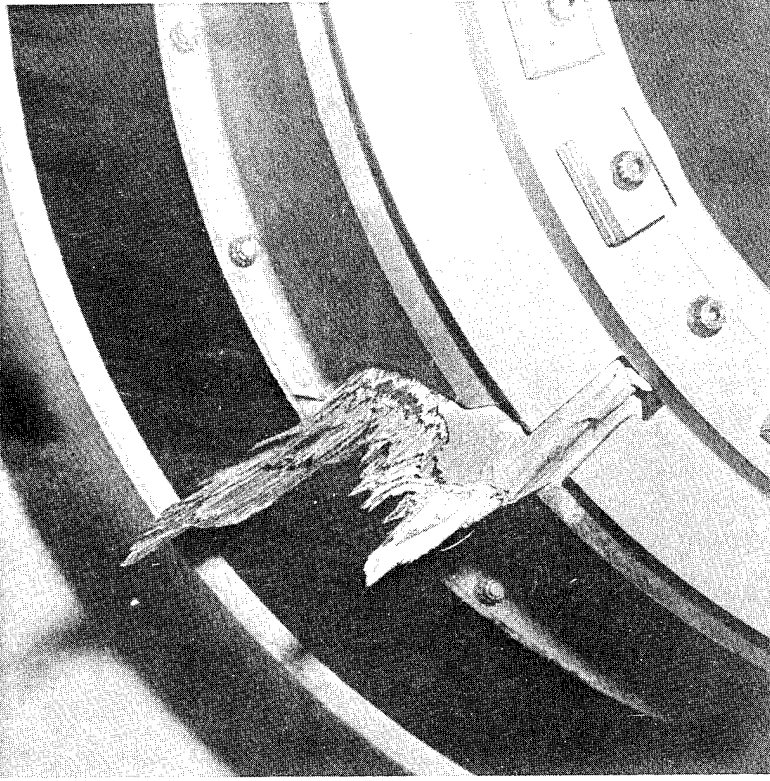
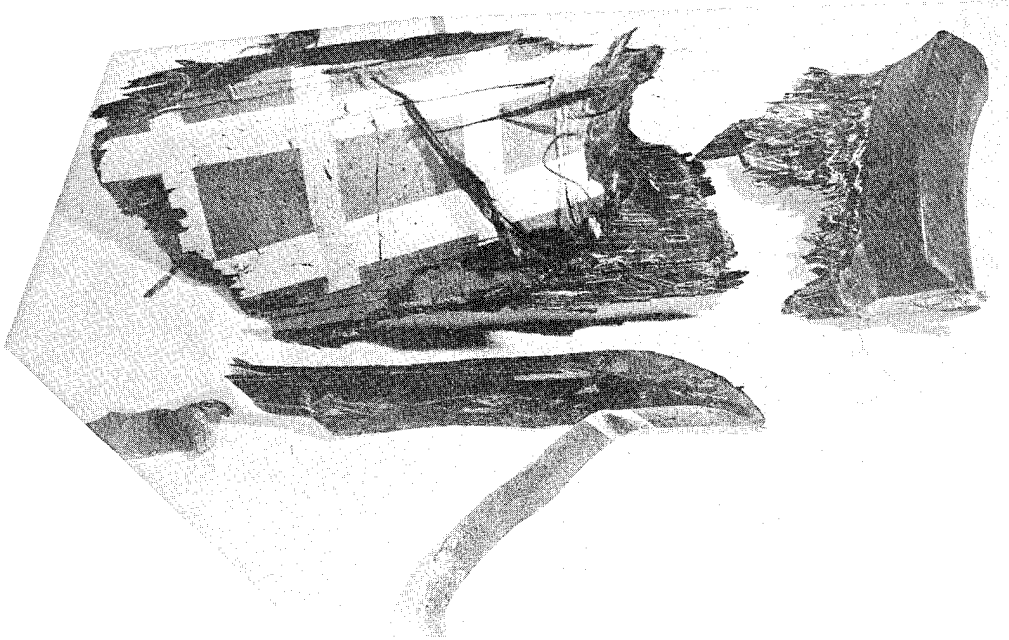
Figure 9. Blade S/N-NB4 after Impact.

NASA-FOD Impact Resistance Test  
Blade S/N NB4  
Boron/Epoxy  
Tip Speed: 800 ft/sec  
26 oz RTV Bird  
12 oz Slice  
22° Incidence Angle

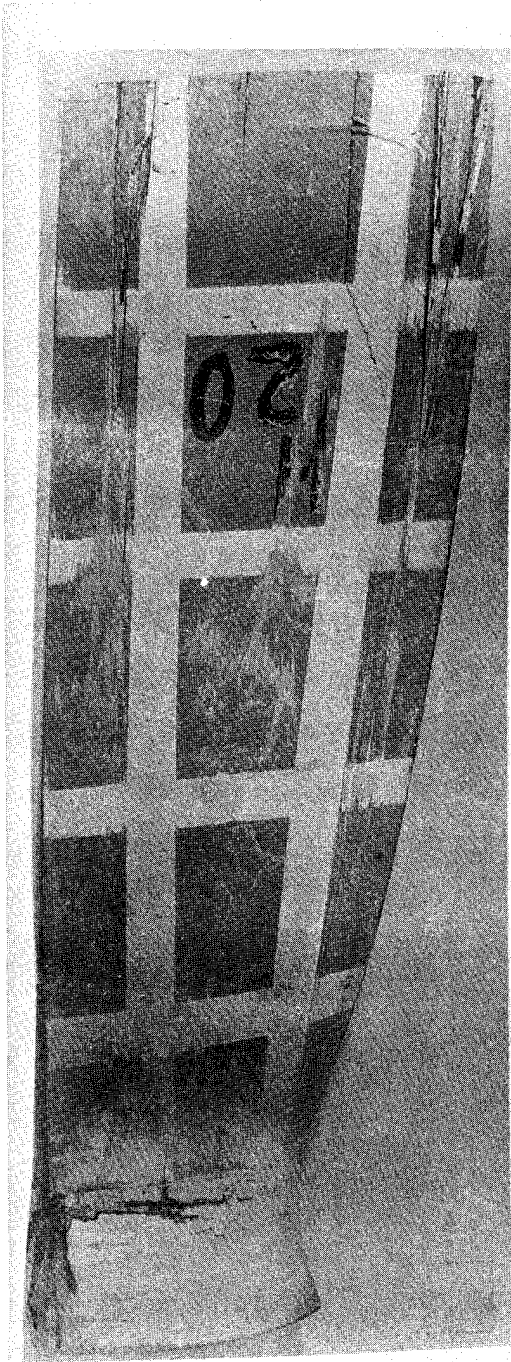
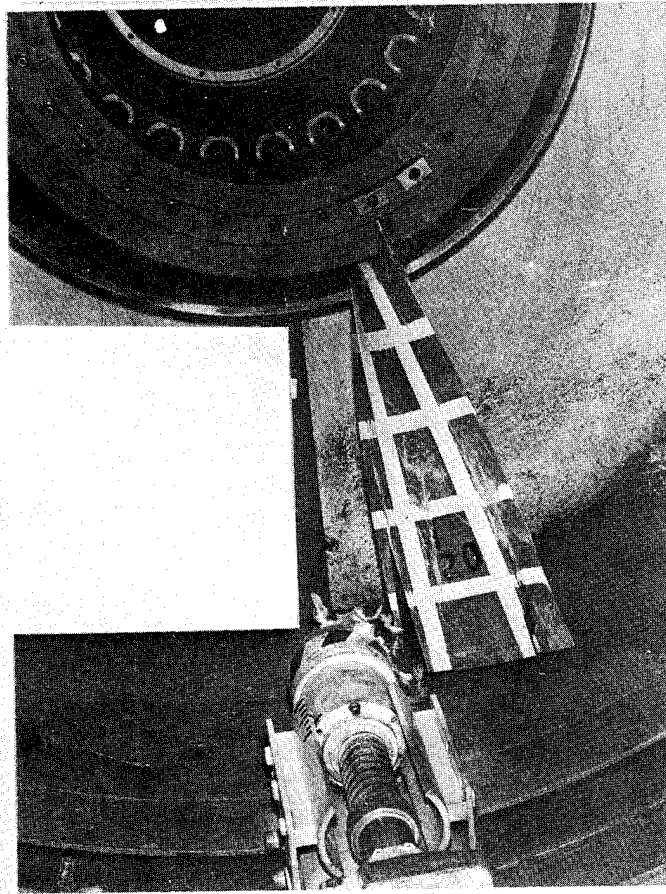
Figure 10. Blade S/N-NG4 after Impact.

For the 11 oz bite off of the 16 oz real pigeon, both blades were damaged as revealed by NDE results. The extent of damage resulting from this impact suggests the upper limit on the bird size which can impinge upon the composite blades under the test conditions described without failure at the root.

- Bench Frequency Check - The bench frequencies for the first three modes of all blades are shown in Table I. In addition, the after test frequencies for the first flex only are presented due to the extent of damage. These data show that for the most part, 1F frequencies remain the same. The biggest change in frequency occurred on graphite blade NG4 which was impacted with an 11 oz slice of a 16 oz pigeon.

NASA-FOD Impact Resistance Test  
Blade S/N NG4  
Graphite/Epoxy  
Tip Speed: 800 ft/sec  
16 oz Real Pigeon  
11 oz Slice  
22° Incidence Angle

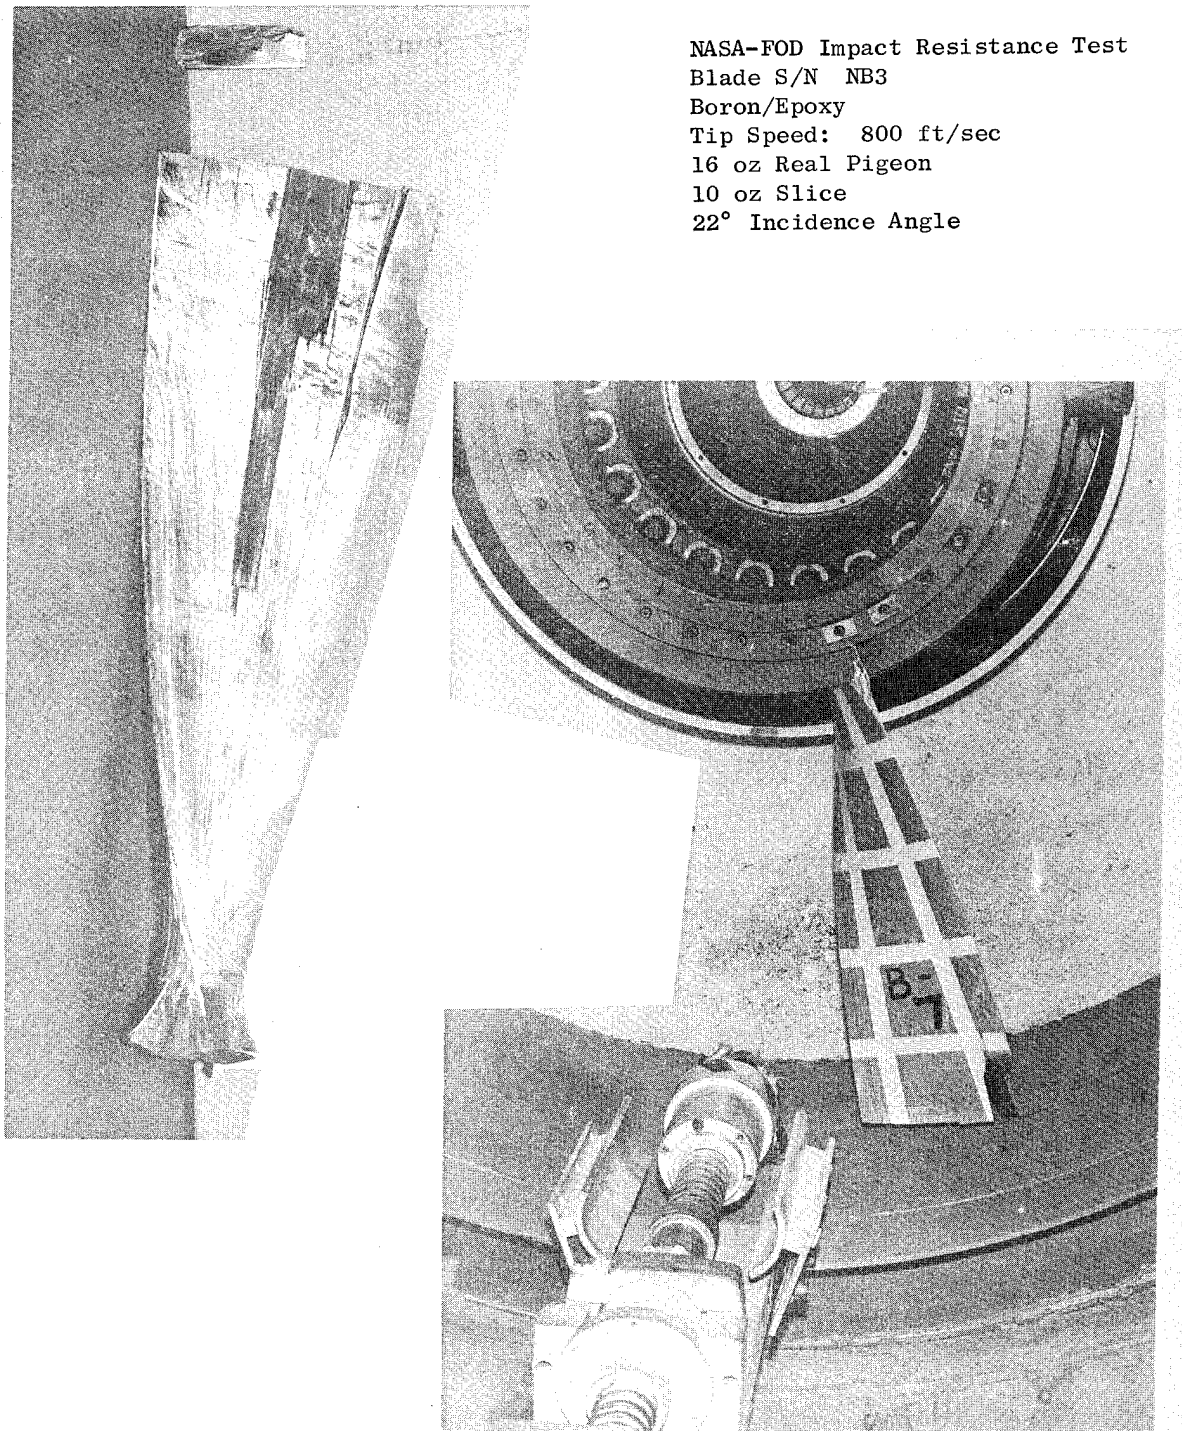
Figure 11. Blade S/N-NB3 after Impact.

NASA-FOD Impact Resistance Test  
Blade S/N NB3  
Boron/Epoxy  
Tip Speed: 800 ft/sec  
16 oz Real Pigeon  
10 oz Slice  
22° Incidence Angle

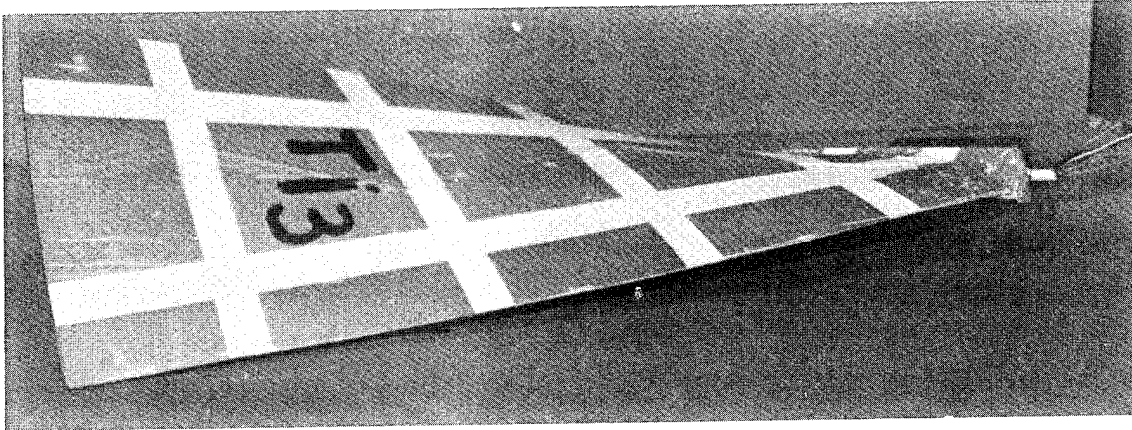
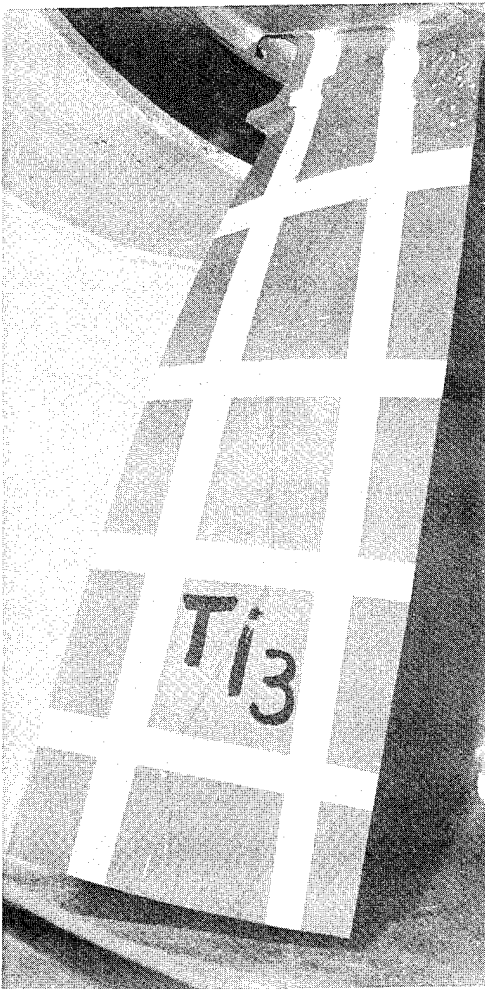
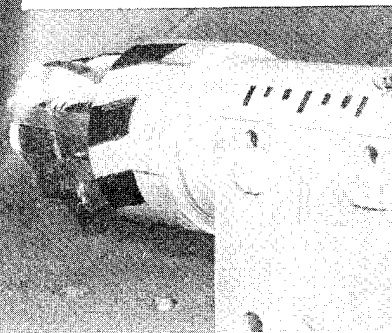
Figure 12. Titanium Blade after Impact.

There was no visible damage to the titanium blade when impacted with an 8 oz bite from a 16 oz pigeon. There was considerable deflection.

NASA-FOD Impact Resistance Test  
Blade S/N Ti3  
Titanium  
Tip Speed: 800 ft/sec  
16 oz Real Pigeon  
8 oz Slice  
22° Incidence Angle

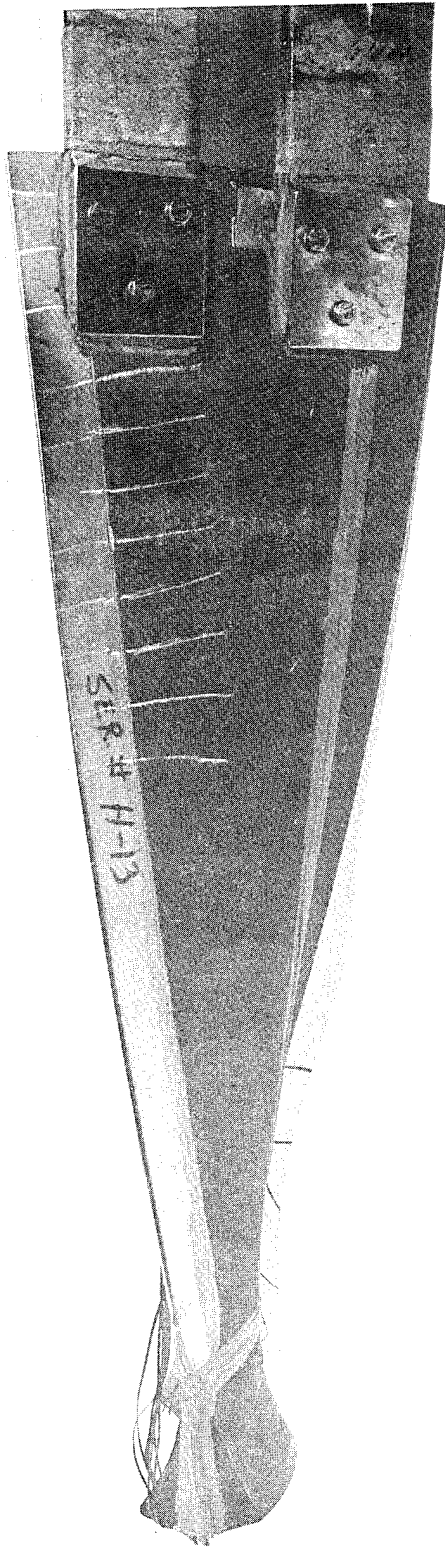
Figure 19. NG5 Graphite/Epoxy Blade  
after Impact (Convex Surface),  
Test No. STOL 1.

The specimen is shown in Figure 19 (convex view) and 20 (concave view). The only visible damage to the blade was a rather clean crack extending down from the tip section a distance of less than three inches. The chalk coating can still be seen adjacent to the projectile path (Figure 19) which extended across the entire blade chord. The convex surface of the blade was marked only with short line segments extending back from the leading edge. The lines can be seen clear to the leading edge, demonstrating thereby that no projectile interaction has taken place on the convex surface. The axial load measured after the test showed the same level as before the test.

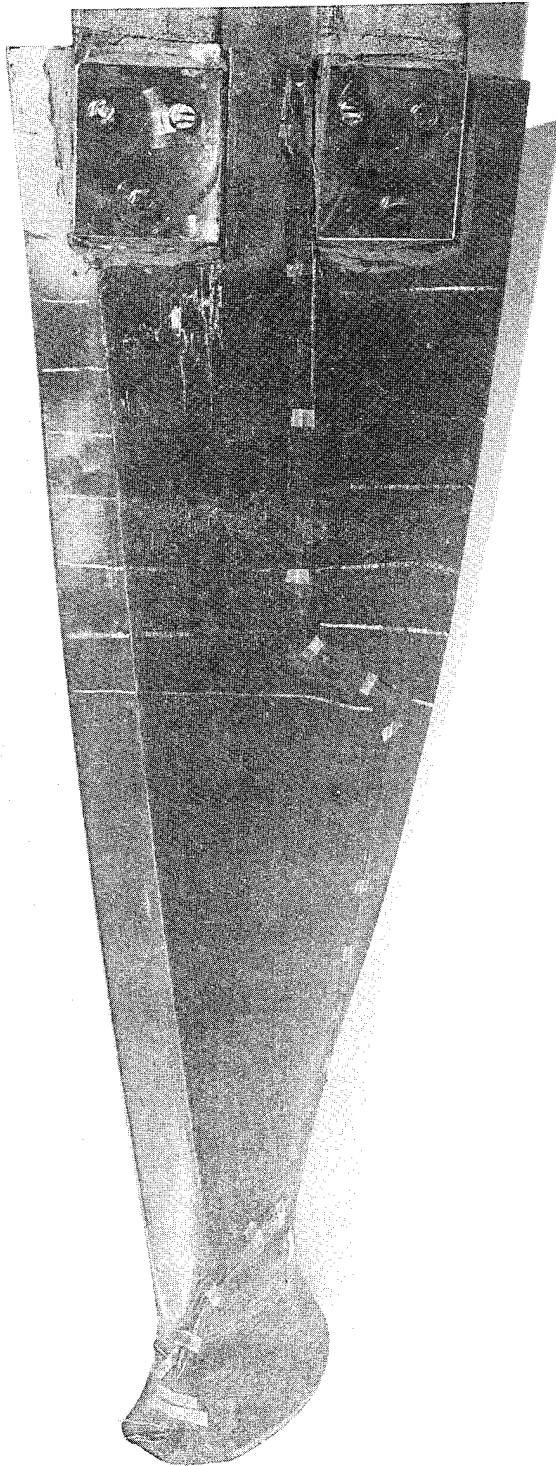
Figure 21. NB5 Boron/Epoxy Blade after Impact (Convex Surface), Test No. STOL 2.

The boron/epoxy blade is shown after impact in Figures 21 (convex) and 22 (concave). This blade was damaged much more severely than the graphite blade. The principal damage consisted of cracks and multiple delaminations extending down from the tip section and situated again between the loading straps. The damage is especially clear in Figure 22. Similar indications of projectile interaction can be seen here as well.

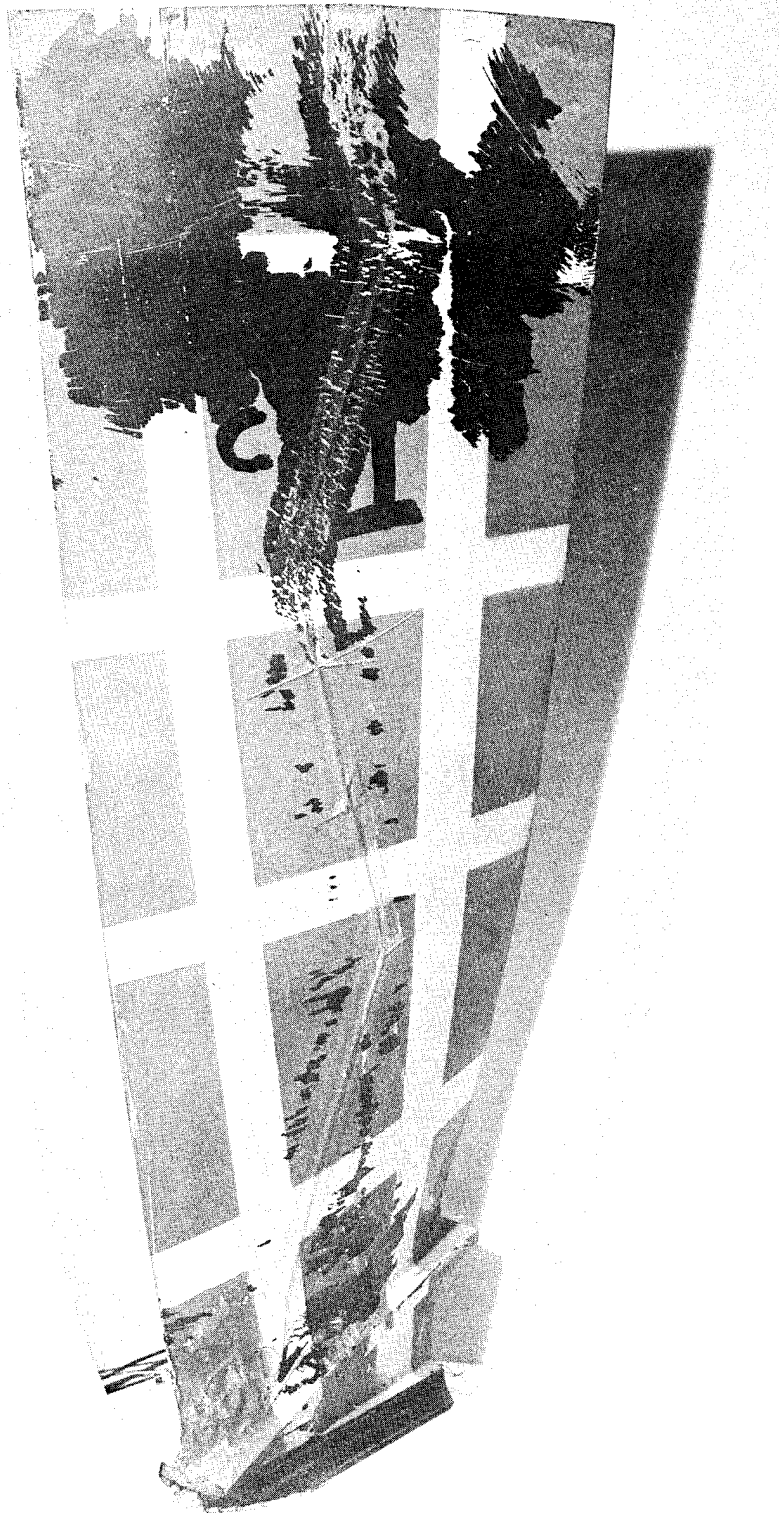
Figure 23. Titanium Blade after Impact  
(Convex Surface), Test No.  
STOL 3.

The titanium blade impacted in the third test is shown in Figures 23 (convex) and 24 (concave). The blade was not fractured but was perceptively deformed at the leading and trailing edges along the projectile path.
