The Significance of Defects in CFRP Bonded Honeycomb Structures  
and Non-Destructive Test Methods for Their Destruction

R. L Crocker, et al

Fulmer Research Institute  
Stoke Poges, England

R736/4/May, 1978

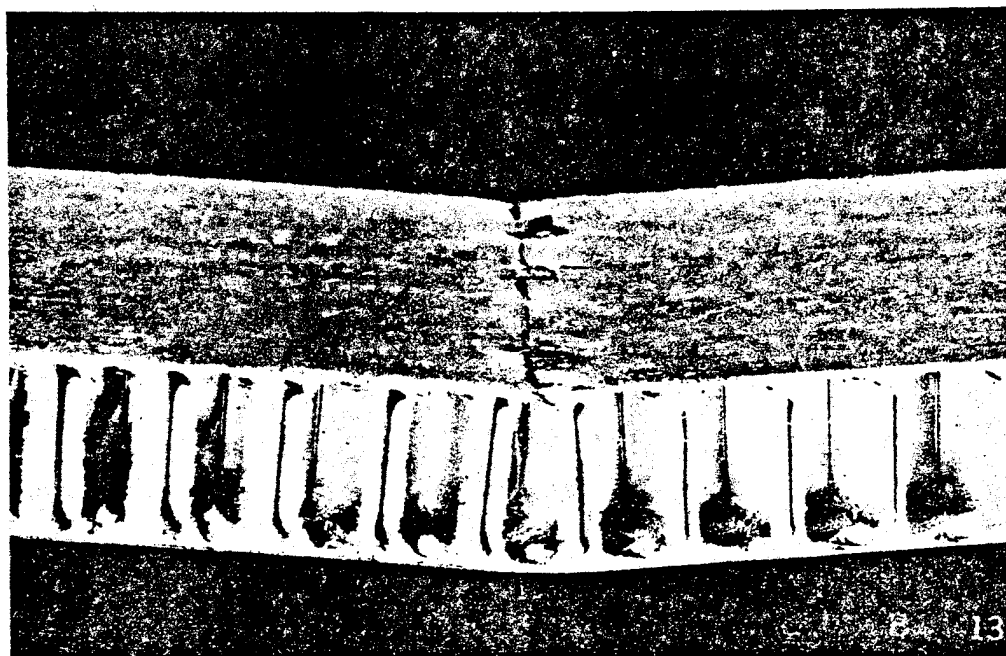
Figure 14 0/90/90/0 flexural test specimen with fibre directions  $\parallel$  and  $\perp$  to beam axis showing compressive failure of upper face skin and undamaged honeycomb core. (Specimen 13B)

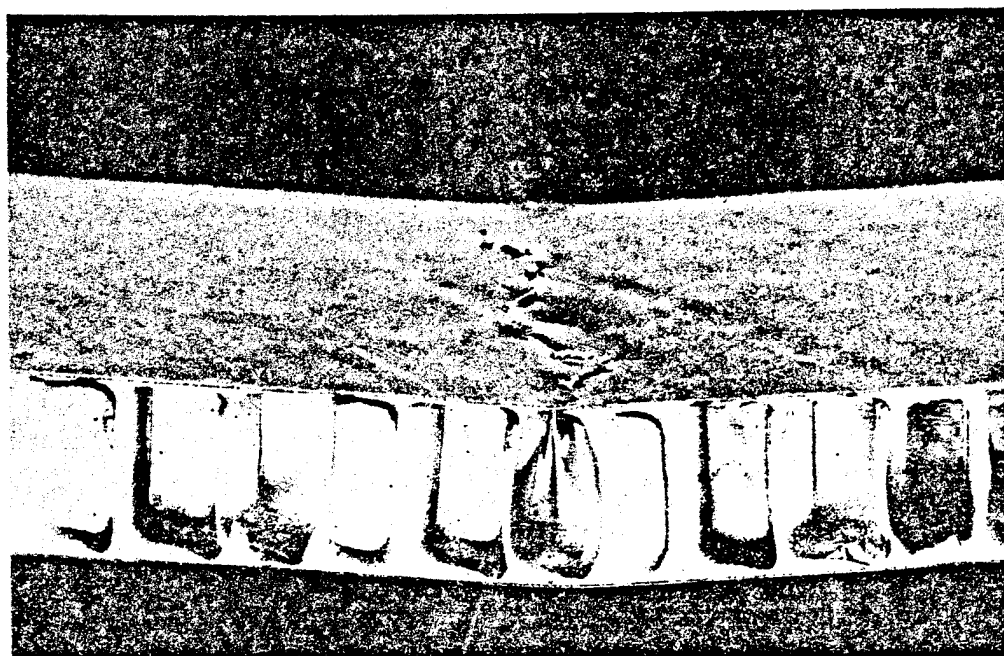
Figure 15 0/90/90/0 flexural test specimen with fibre directions at  $45^\circ$  to beam axis showing compressive failure of upper face skin.

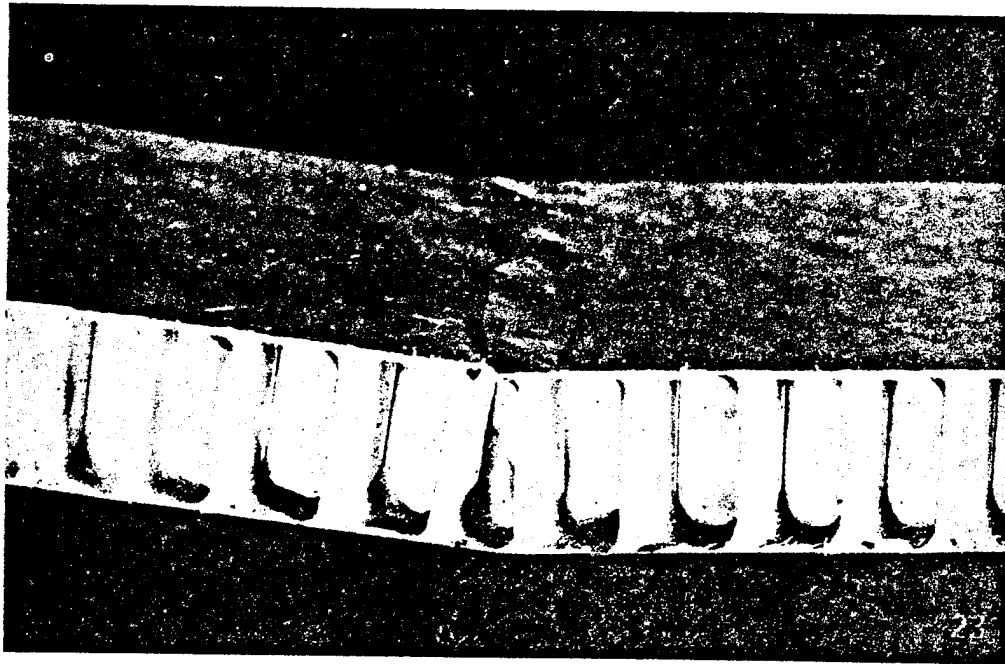
Figure 16 O/60/l20 flexural test specimen showing compressive failure of upper face skin and undamaged honeycomb core.  
(Specimen 23C)

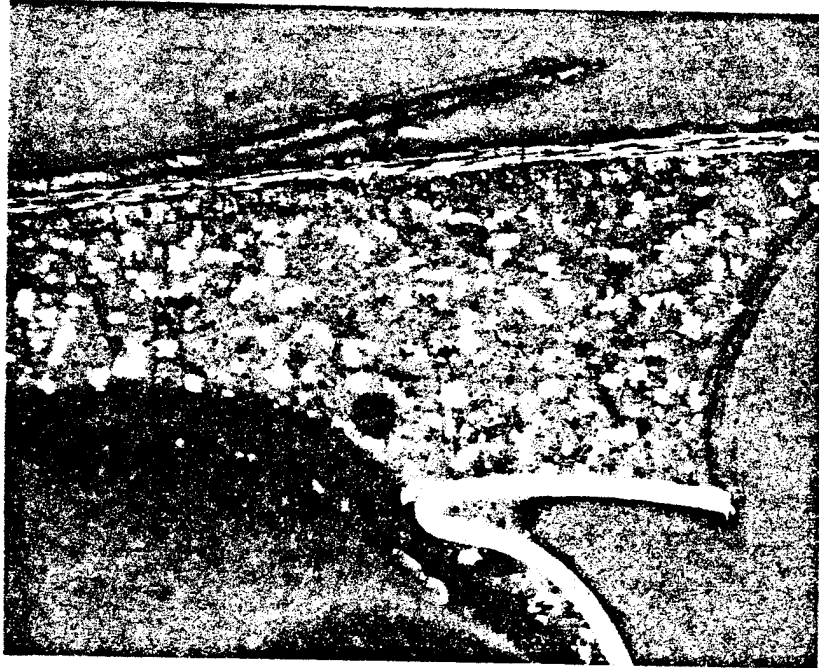
Figure 18 Micrograph of fracture showing delamination of face skin and adhesive and deformation of the honeycomb core.  
(Specimen 13C x 50)

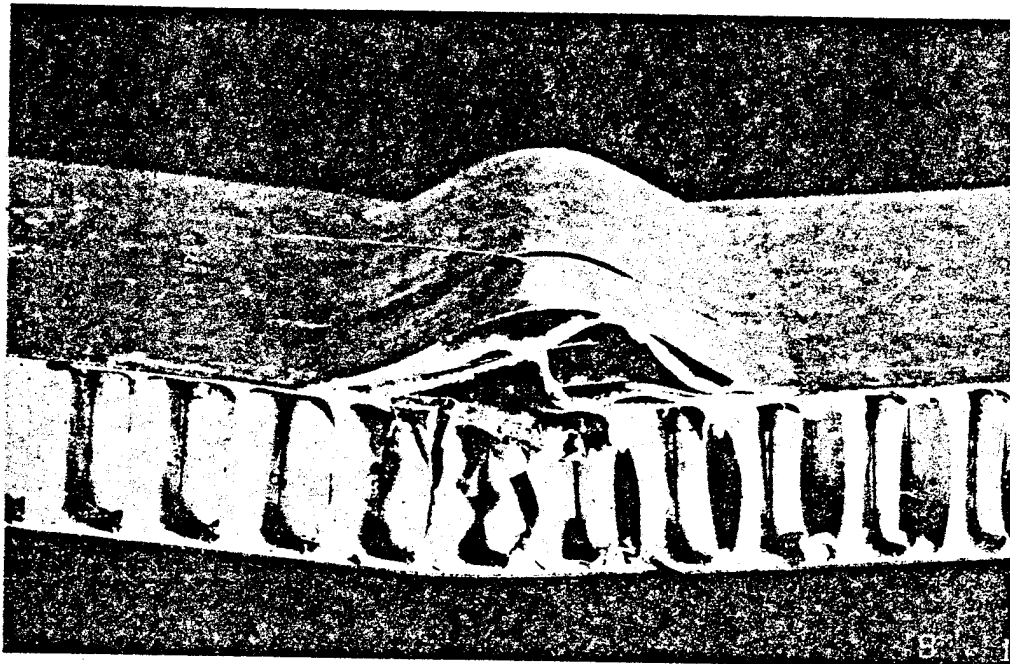
Figure 19 Fractured beam containing a backing sheet contamination defect showing delamination but not fracture of the face skin and local collapse of the honeycomb core.

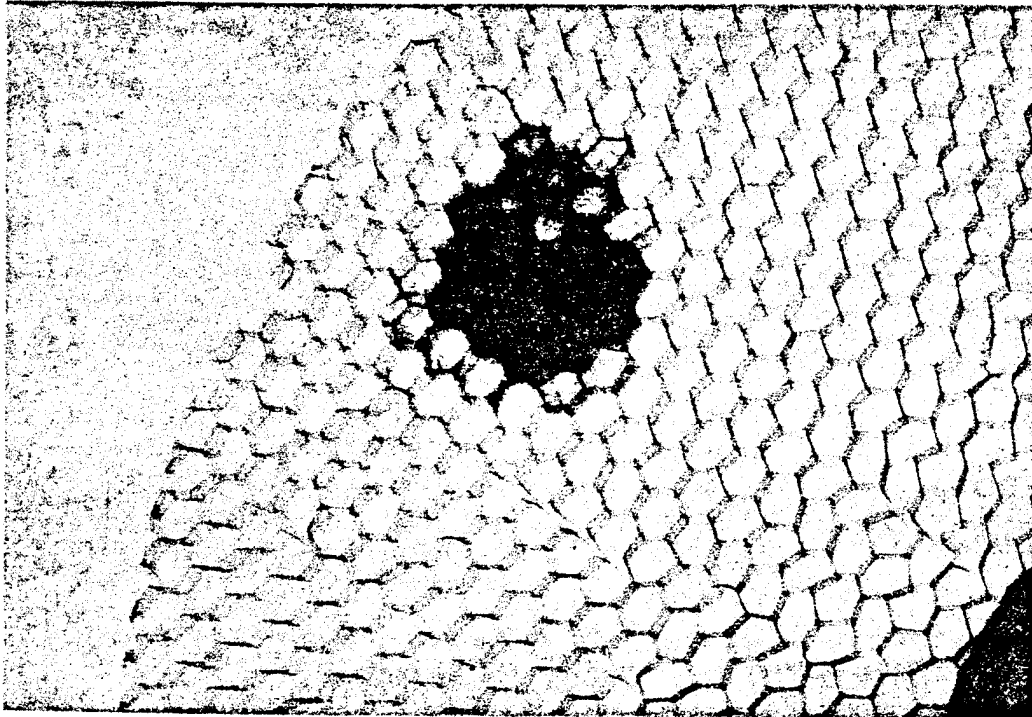
Figure 24 Conventional x-radiograph using a contact technique and 50kV x-rays showing clear visualisation of the aluminium honeycomb and encapsulation compound. Some local damage to the core is seen above the dark area of encapsulation compound. (Section 3.3. & 5.1.4)

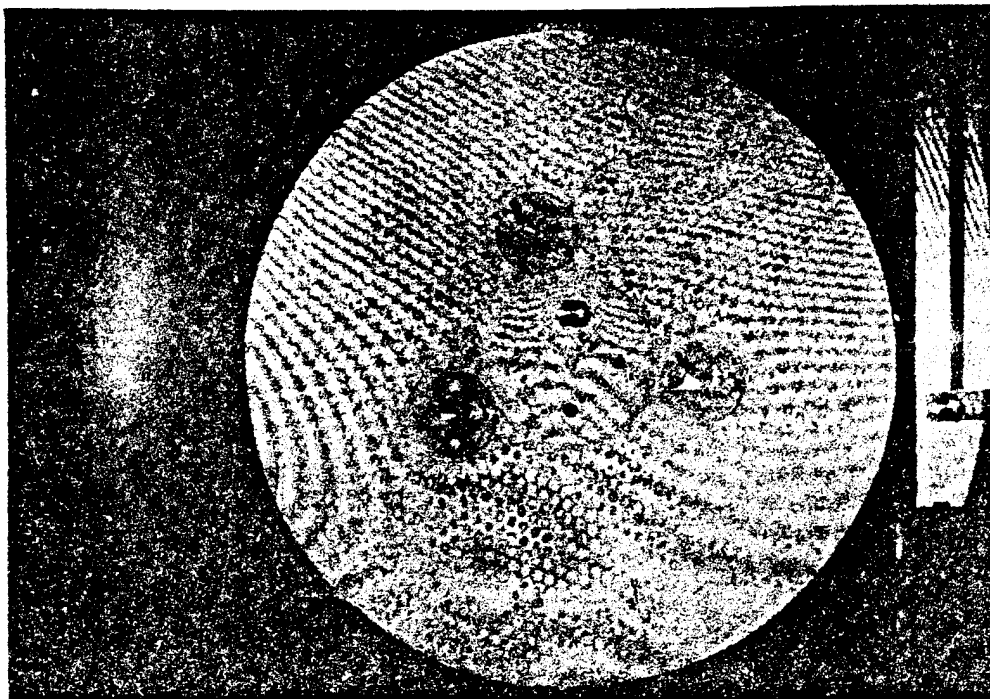
Figure 28 An interferogram of a CFRP/Al honeycomb dish specimen and its superimposed holographic image. Four circular areas of perturbed fringe pattern can be seen and right of centre towards the lower edge of the dish, the fringe pattern caused by hole cut in the skin/core film adhesive is visible.

Note the visualisation of the honeycomb cells, and also the regular fringe pattern on the stand to the right of the dish. Closely spaced fringes around the central fixing bolt indicate an area of high strain. (Sections 3.6 and 5.1.7.)
