FOREWORD

FLIGHT SERVICE EVALUATION BY KEVLAR-49
FIBRE COMPOSITE PANELS ON ALGA-80000
COMMERCIAL TRANSPORT AIRCRAFT

South Atlantic Wings - Summary Report

APPENDIX A
DETAIL OBSERVATIONS OF
KEVLAR-49 FAIRING PANELS -
AIR CANADA SHIP CF-TNB-502 (SERIAL 1021) -
MAY 1979

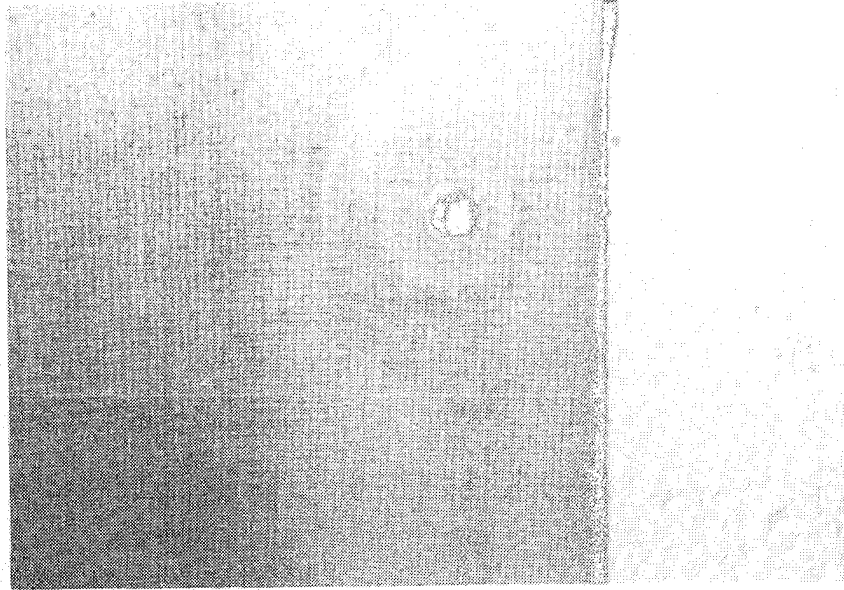
Figure 6. - Air Canada right-hand wing-body fairing - typical fastener hole.

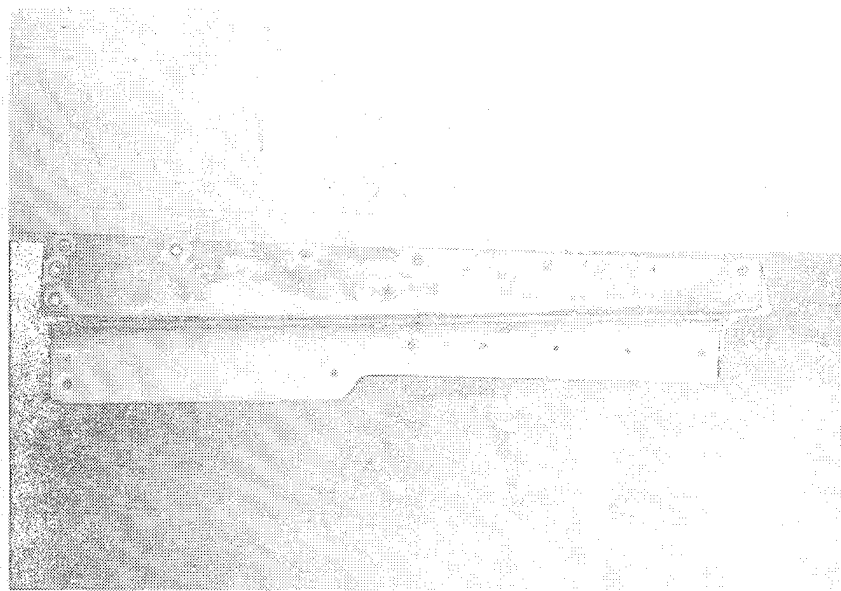
1. No surface damage or defects were noted on either surface although there was considerable paint loss with exposed Kevlar-49. (Figure 9). The location of the exposed Kevlar-49 is such that very little ultraviolet exposure can occur.
2. Fraying was noted on most of the fastener holes, (Figure 10), with four holes more frayed than the others. About half the holes had a significant degree of elongation, with seven holes elongated to 0.55 cm (7/32 in.) maximum dimension from the original 0.5 cm (3/16 in.) diameter, and two holes elongated to 0.6 cm (1/4 in.). There was no correlation between the frayed and elongated holes.

Figure 9. - Air Canada right-hand underwing fillet - exterior surface showing paint loss and exposed Kevlar-49.

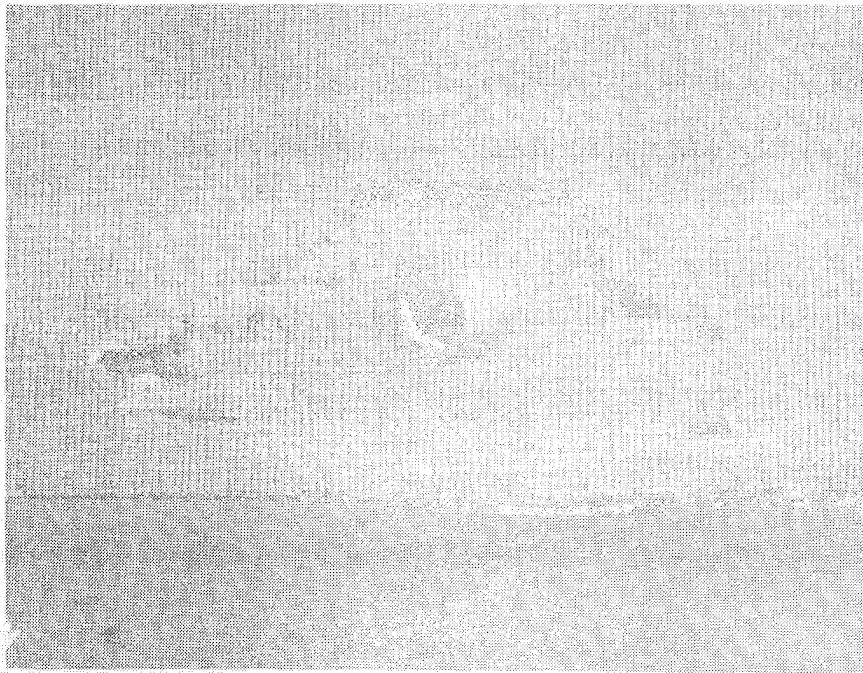
5. Slight fraying was observed on all the fastener holes. All holes on the lower edges had slight elongation and noticeable mark-off of the washers, with a convex deformation of the laminate around the holes. (Figure 13). Several holes on the other edges were slightly elongated. Two holes on the top edge at the forward end were badly frayed and elongated to a 0.6 cm ($\frac{1}{4}$ in.) maximum dimension. (Figure 14).

Figure 13. - Eastern left-hand wing-body fairing - fastener hole on lower edge with mark-off.

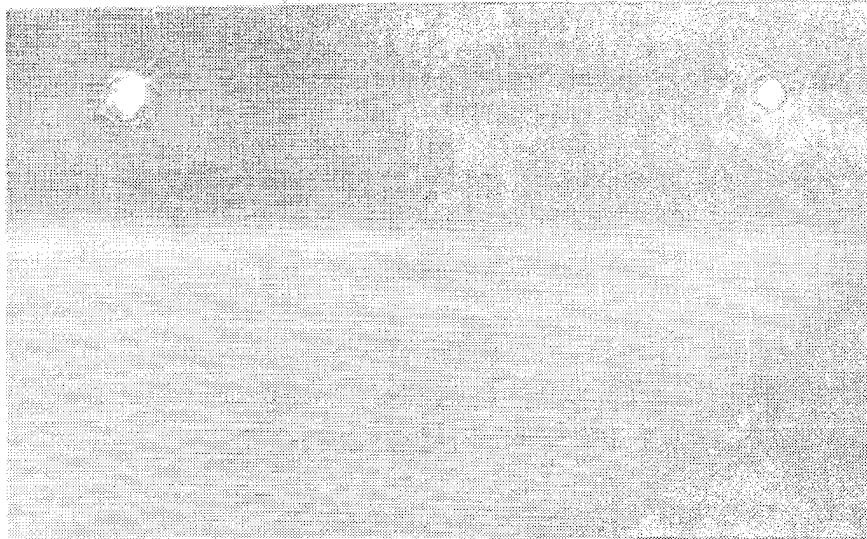
Figure 14. - Eastern left-hand wing-body fairing - frayed and elongated holes on top edge.

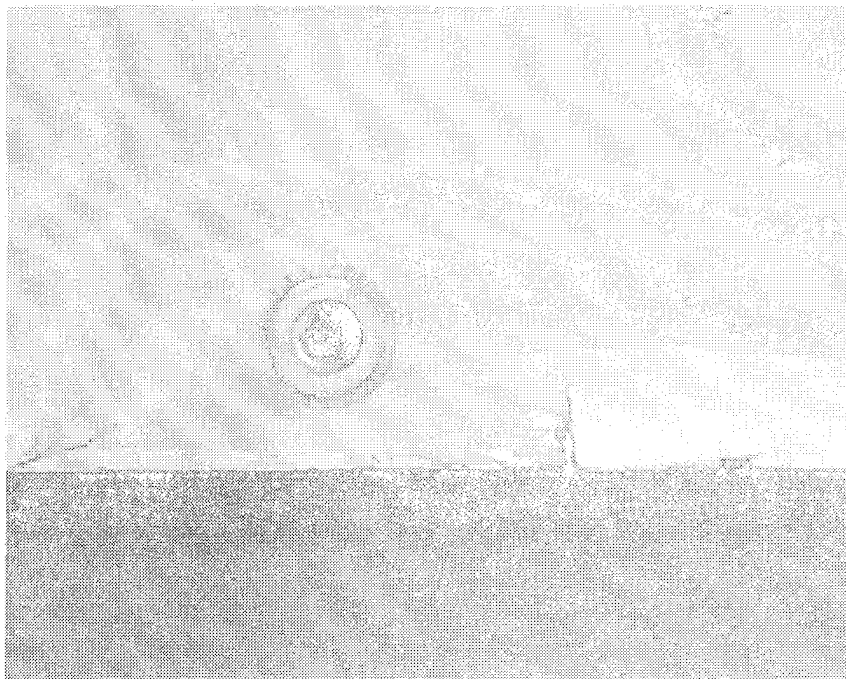
1. Several exterior surface cracks observed in previous inspections had not propagated or changed in appearance:
 - A 1.3 cm ($\frac{1}{2}$ in.) crack in the forward edge between the fifth and sixth holes from the top. (Figure 15).

Figure 15. - Eastern right-hand wing-body fairing - crack in forward edge.

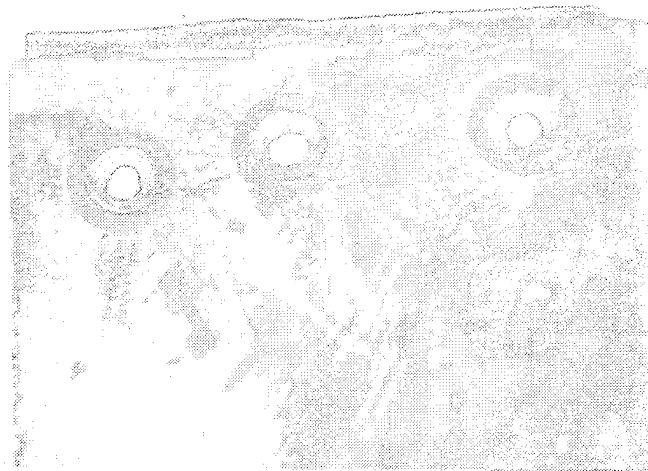
1. No defects or damage was noted on the outer surface except for extensive paint loss with some exposed Kevlar-49 surface. A slight gouged spot on the inner surface, observed in previous inspections, was unchanged in appearance with no associated delamination.
2. All fastener holes were frayed to a greater extent than observed on the wing-body fairings, with several holes frayed noticeably more than the others. (Figure 17). Slight elongation was observed on several holes (Figure 17) with two holes significantly elongated to 0.55 cm (7/32 in.) from the original 0.5 cm (3/16 in.) diameter. There was no definite correlation between fraying and elongation.

Figure 17. - Eastern left-hand underwing fillet - frayed
and elongated fastener holes from exterior.

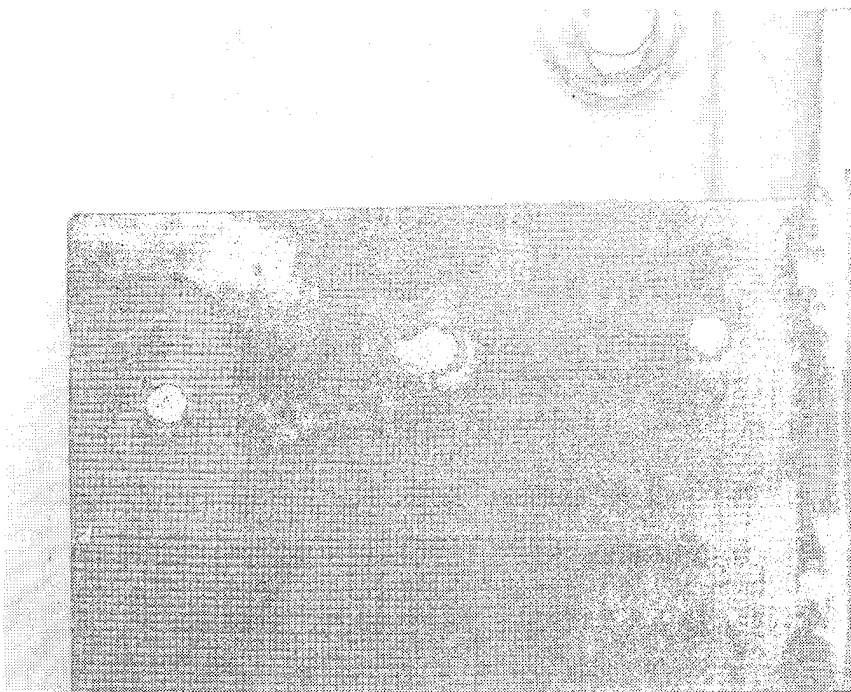
1. No damage or defects were noted on either surface except for the paint loss which left some exposed Kevlar-49 surface in the upper area.
2. All fastener holes were frayed, but to a lesser degree than the left-hand fillet described above. Several holes were more frayed than the others. (Figure 18). Three holes were slightly elongated; while three holes were significantly elongated, two to 0.55 cm (7/32 in.) and one to 0.6 cm (¼ in.). In this case, the elongated holes were more frayed than the other holes.

Figure 18. - Eastern right-hand underwing fillet - frayed and elongated holes from inner surface.

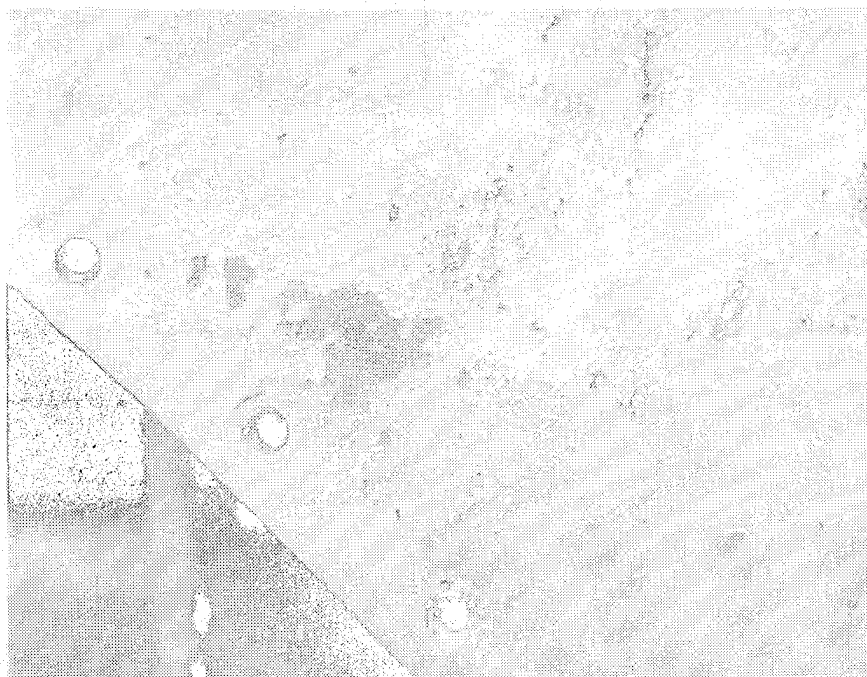
1. No damage or defects were noted on the inner surface, but there was loss of paint and flame spray in two exterior surface areas with the Kevlar-49 surface exposed to ultraviolet. (Figure 19). These areas were relatively small, with the largest 15 cm (6 in.) diameter in the upper aft corner area. There was a slight associated abrasion in the center of this area with a few exposed Kevlar-49 fibers. This part had been inspected by Eastern Maintenance in 1977 and a puncture in this area covered by tape was observed at that time. This abrasion appears to be the same as the previously reported puncture, but there was no longer any tape, and any full skin penetration had been filled in some manner and repainted. In 1978, the

paint was still intact in that area preventing any observation of this defect.

Figure 19. - Eastern left-hand aft engine fairing - paint and flame spray loss with exposed Kevlar-49 laminate.

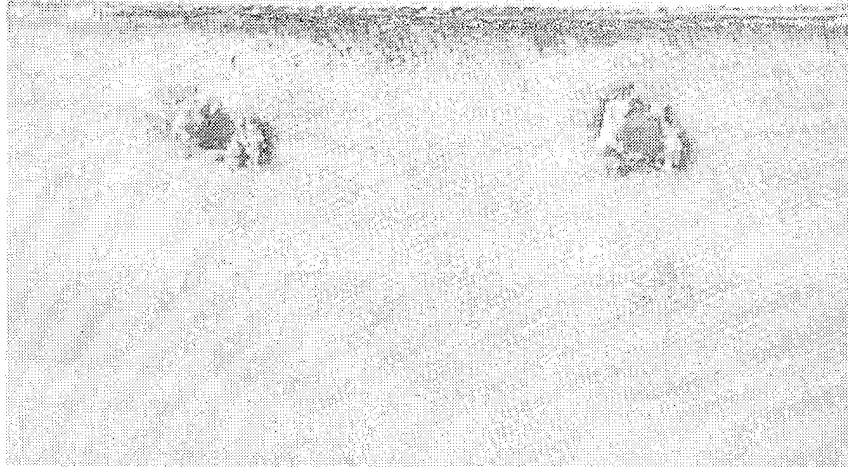
2. Fraying was observed on all fastener holes. This fraying was more severe than on the wing-body fairing and under-wing fillet panels. (Figure 20). The intercostal holes were less frayed than the holes in the solid laminate edge member. Slight elongation was observed on about 10% of the holes.

Figure 20. - Eastern left-hand aft engine fairing - fastener holes with severe fraying.

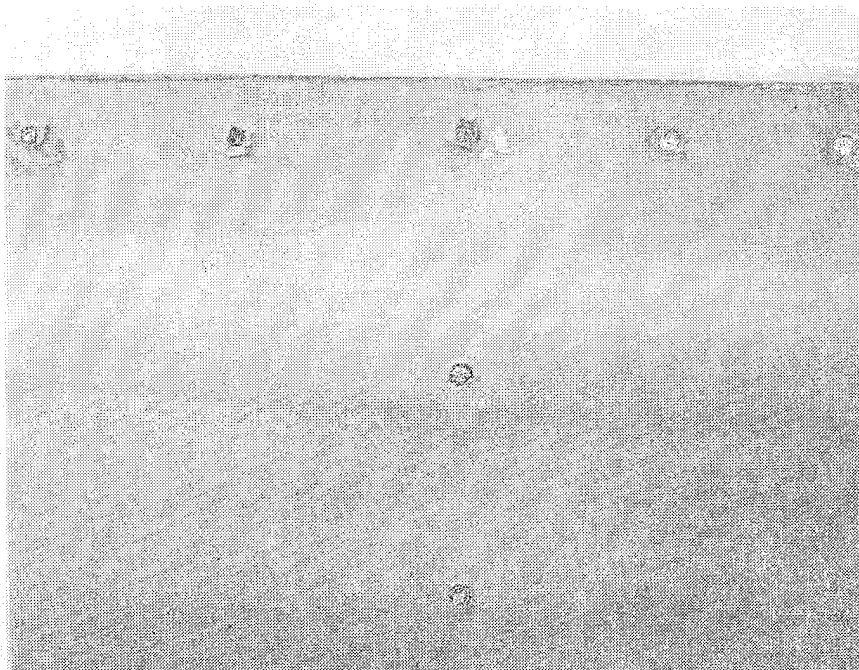
1. No damage or defects were noted on either surface, but there was some loss of paint and flame spray with exposed Kevlar-49.
2. Fraying was observed on all fastener holes with relatively slight fraying on the aft edges and greater fraying on the upper and lower edges. The intercostal holes were also frayed except for the forward intercostal. (Figure 21). Fraying was generally less severe and more variable than on the left-hand part. Several holes on the lower edge had a slight elongation. Four holes on the center intercostal were significantly elongated, one to maximum dimension of 0.6 cm ($\frac{1}{4}$ in.), one to 0.55 cm ($\frac{7}{32}$ in.) dimension, and two others to 0.95 cm ($\frac{3}{8}$ in.) from the original 0.5 cm ($\frac{3}{16}$ in.) diameter.

Figure 21. - Eastern right-hand aft engine fairing - fastener holes with moderate fraying.

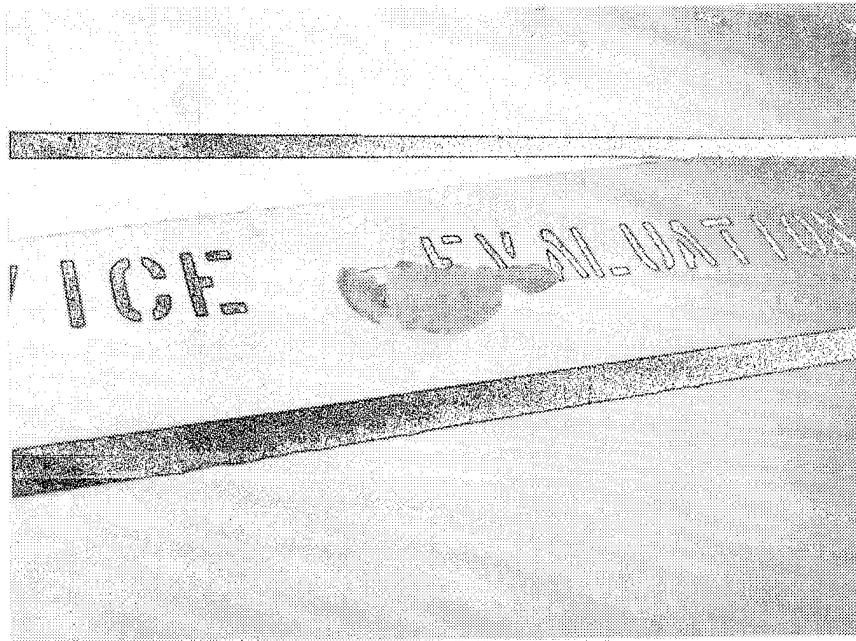
1. Two exterior surface defects observed in previous inspections had not increased in area. These were a deep gouge 1.3 cm ($\frac{1}{2}$ in.) length in the upper forward area (Figure 22) with a disbond area extending forward of the gouge in a 1.3 cm ($\frac{1}{2}$ in.) radius arc; and a small 0.3 cm ($\frac{1}{8}$ in.) crack in the upper aft area, which had been painted over in the previous inspection. The crack was first observed in 1977, and the gouge was first observed in 1978.

Figure 22. - TWA left-hand wing-body fairing - 1.3 cm ($\frac{1}{2}$ in) crack on exterior surface.

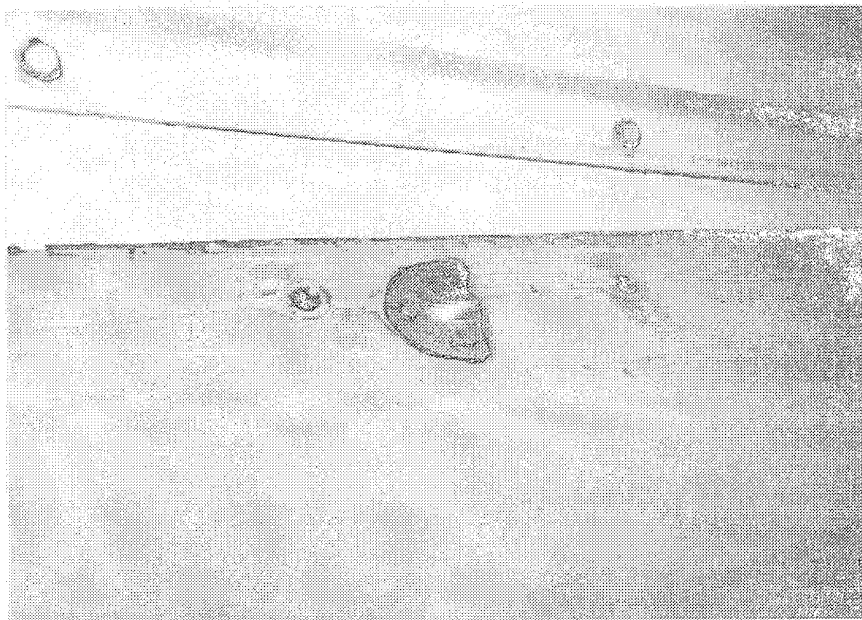
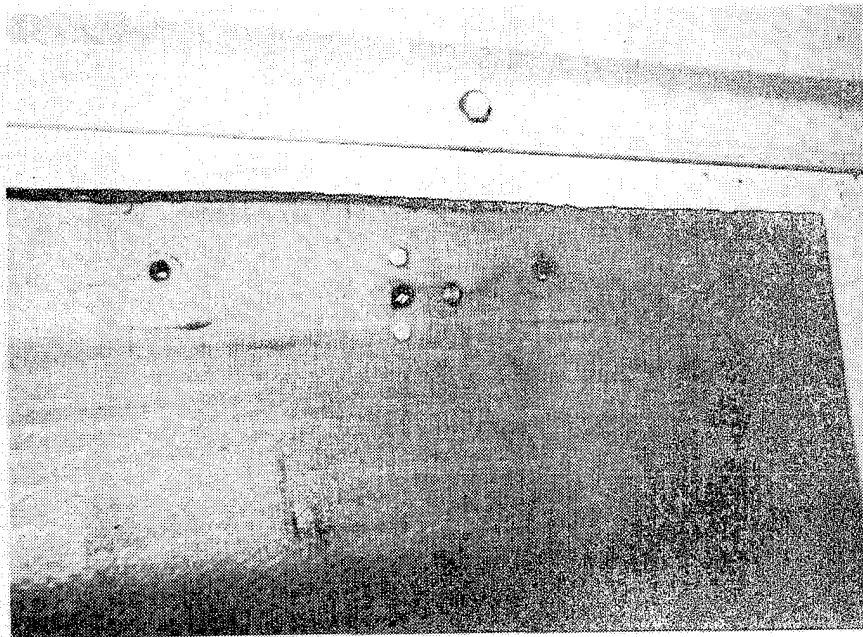
4. A bolted metal attachment covering a filled fastener hole was observed on the lower edge between the two aft holes. (Figures 23 and 24). When the panels were reinstalled, there was no record of hole relocation on the left-hand fairing

Figure 23. - TWA left-hand wing-body fairing - metal attachment from exterior.

Figure 24. - TWA left-hand wing-body fairing - metal attachment from interior.

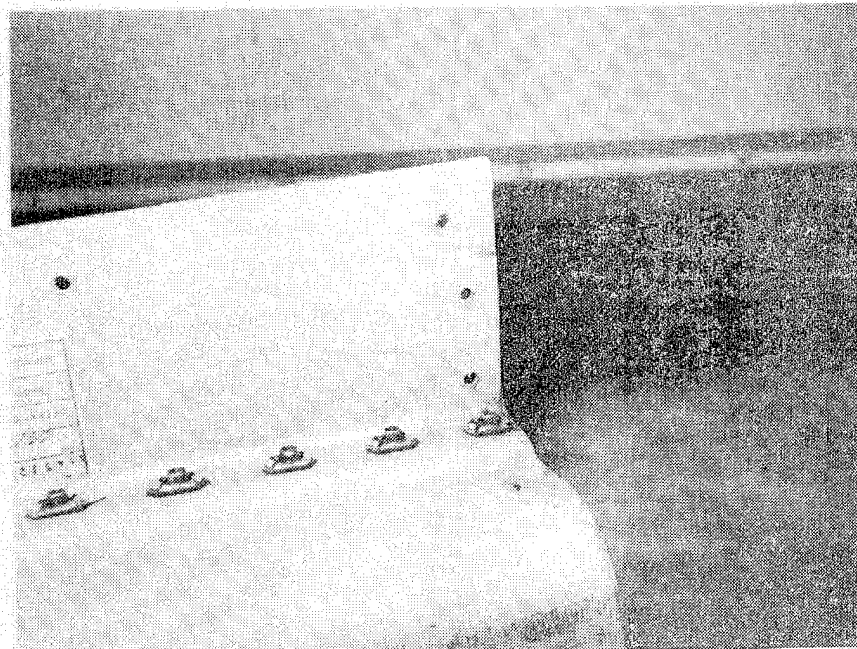
Figure 25. - TWA right-hand underwing fillet - fastener holes with frayed condition.

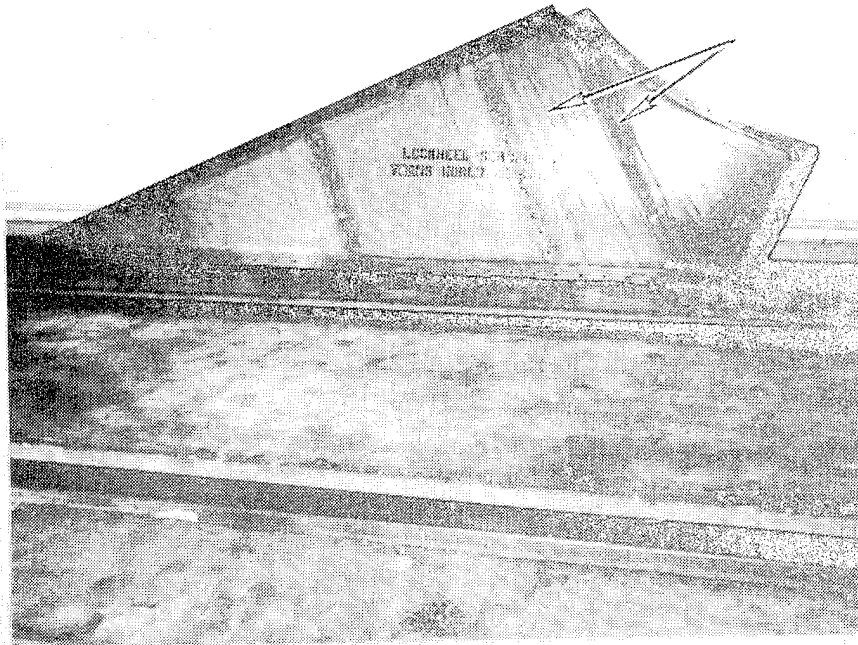
1. There was no damage to either surface. Loss of paint and flame spray had left some exposed Kevlar-49 surface. The vapor barrier coating, which had been applied to the inner surface during reinstallation to replace the Tedlar film, had been chemically attacked in several areas, probably by Skydrol. (Figure 26).

Figure 26. - TWA right-hand aft engine fairing - inner surface with vapor barrier coating showing chemical attack.

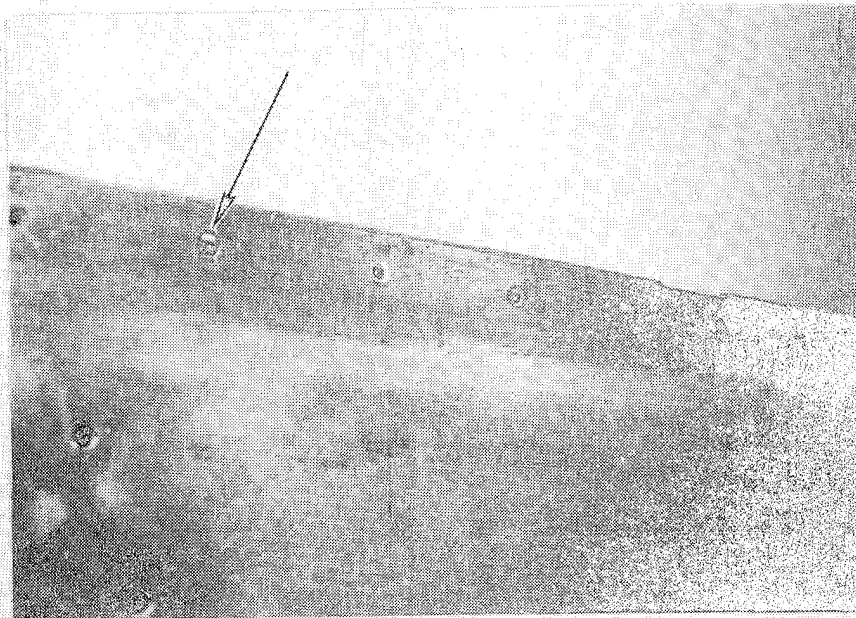
Figure 27. - TWA right-hand aft engine fairing - showing unfrayed fastener holes and an elongated hole.

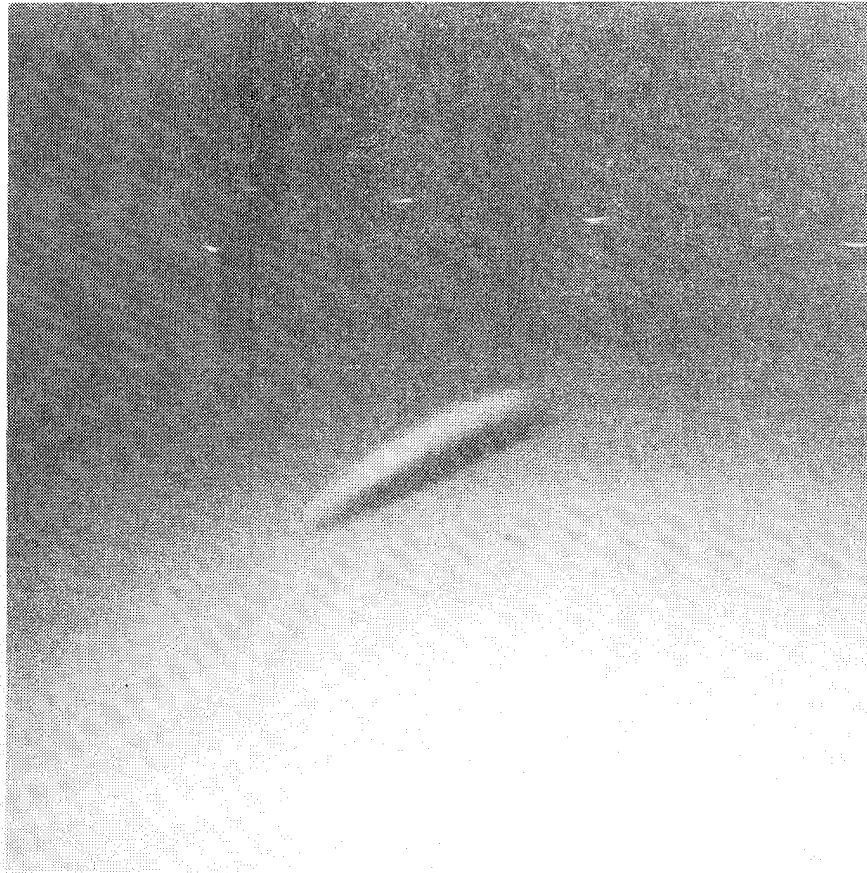
A different type of damage was initially observed in 1977 on the right-hand TWA wing-body fairing. This was a large teardrop shaped disbond area 11.4 by 2.5 cm (4.5 by 1 inch) in area with an associated deep concave depression indicative of core crushing. The paint and flame spray were intact with no cracks or crazing. This disbond has not increased in area or depth since the 1977 inspection. A similar but smaller disbonded and depressed area was initially observed in 1976, and has not grown since the 1977 inspection. These occurrences, which are unique to this particular fairing, are probably related to a repair made when the part was reinstalled on Ship 1111 (ref.3). This repair was not documented, but apparently consisted of replacement of a damaged core area, extending partially through the core thickness, with a microballoon-filled potting compound. This is not therefore a Kevlar-49-related problem, but as it is a highly visible condition it will be monitored in future inspections.

1. A large teardrop-shaped disbond and crushed area 11.4 by 2.5 cm (4½ by 1 inch) first observed in 1977, was unchanged in appearance or extent. (Figure 28). This was in the lower forward area of the exterior surface. Another delamination in the lower forward area 5.1 by 1.3 cm (2 by ½ in.) first observed in 1976 had not increased in area since the 1977 inspection. A small crack 0.3 cm (1/8 in.) also had not increased in length since first observed in 1976. No other damage was noted.

Figure 28. - TWA right-hand wing-body fairing -
disbonded and crushed area on exterior.
