NASA TN D-8411

EFFECT OF LOW-VELOCITY IMPACT DAMAGE  
ON THE COMPRESSIVE STRENGTH OF  
GRAPHITE-EPOXY HAT-STIFFENED PANELS

*Marvin D. Rhodes, Jerry G. Williams,  
and James H. Starnes, Jr.*

*Langley Research Center  
Hampton, Va. 23665*

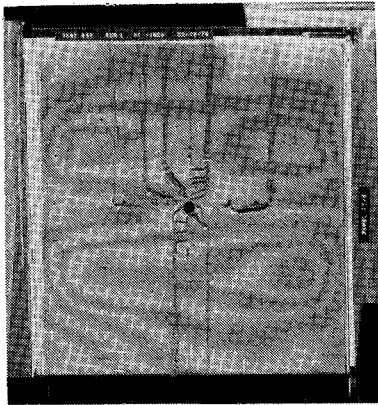
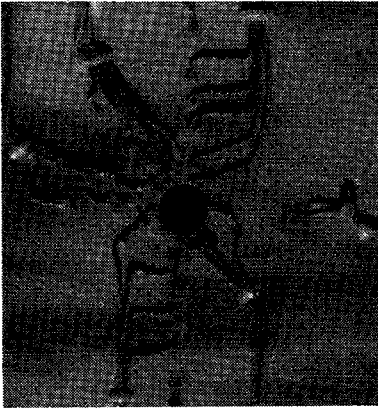
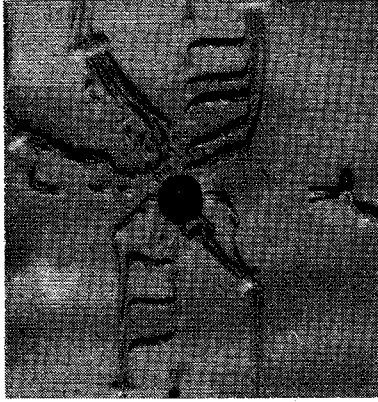
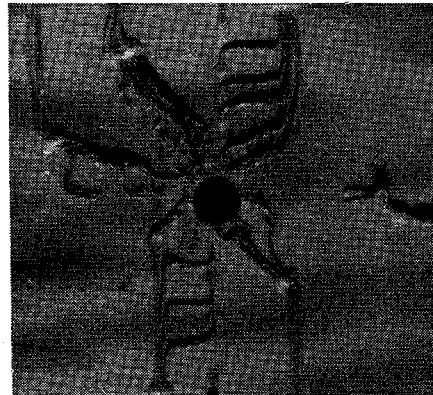
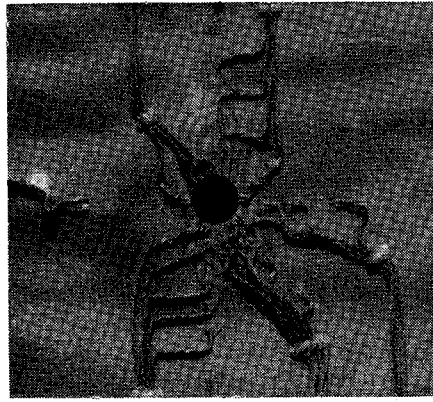
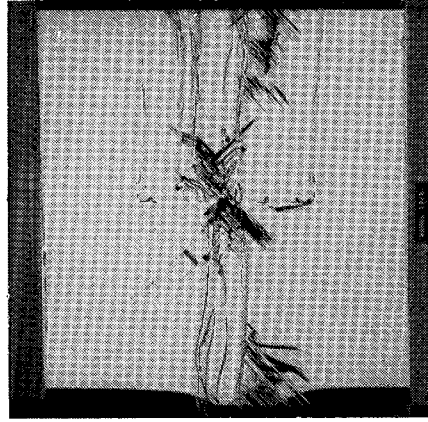
At applied strains near 0.0049 large changes in strain were recorded near the cutout and noticeable panel displacements began to develop in the vicinity of the cutout. Moiré-fringe patterns representing the normal displacement field near the cutout are shown in figure 6 for several values of applied strain. A representative moiré-fringe pattern for an applied strain of 0.0048 is shown in figure 6(a) and a closeup of the cutout region for this applied strain is shown in figure 6(b). At an applied strain of approximately 0.0049 a local buckling displacement field began to develop at the cutout edge about 60° counterclockwise from the loading axis. This displacement field was about 1.0 cm long for an applied strain of 0.0050 and is shown in figure 6(c). As the applied strain was increased, the extent of the displacement field increased to a length of about 1.8 cm for an applied strain of 0.0055 as shown in figure 6(d). At an applied strain of 0.0057, the displacement field had rotated counterclockwise to a position 90° from the loading axis (fig. 6(e)) and extended on both sides of the cutout. This displacement field extended about 2.5 cm on the left side and about 2.4 cm on the right side of the cutout which makes the total length of this displacement field approximately equal to the width of the 0° fibers in the skin under the stiffener. The local displacement field propagated across the panel (fig. 6(f)) at an applied strain of 0.0058 which indicates that the local behavior precipitated panel failure.

Figure 6.- Photographs of moiré-fringe patterns of panel B5 at several values of applied axial strain  $\epsilon_a$ .  
L-77-143

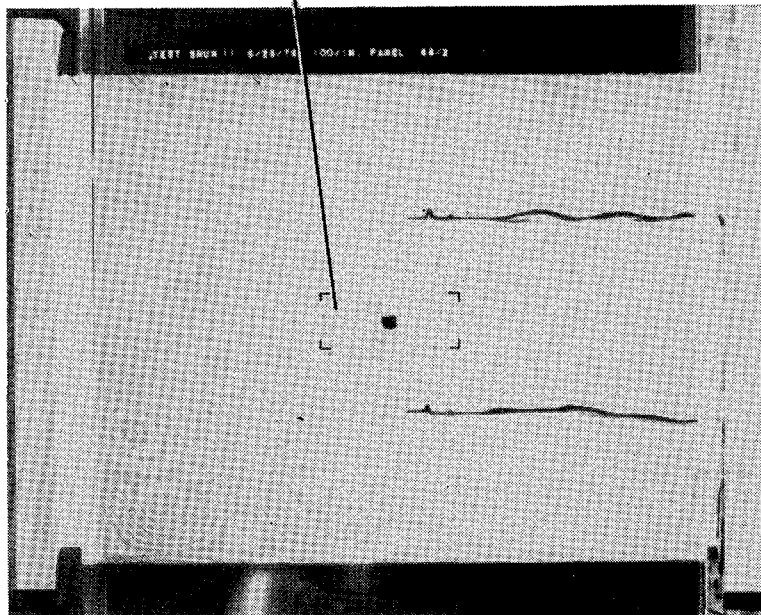
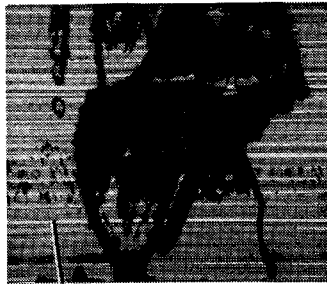
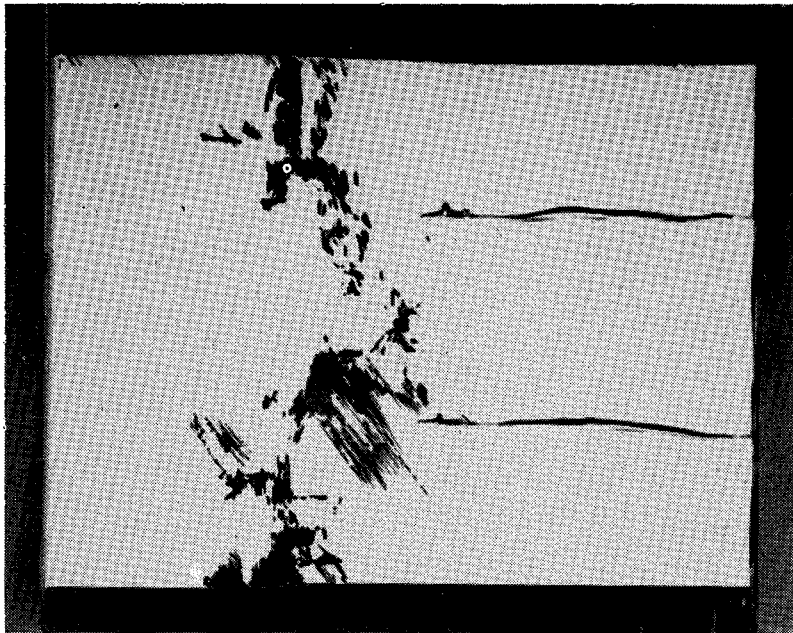
Photographs of the moiré-fringe pattern of panel A4 loaded prior to failure and of the failed panel are shown in figure 7. The moiré-fringe pattern (fig. 7(a)) is similar to that of the undamaged panel A1 (fig. 3(a)). The dark

spot in the center of the panel is the impact location where the paint has been removed for post impact inspection. Figure 7(b) indicates that the panel failure region is extensive and includes the impact location. The panel was inspected ultrasonically prior to failure, and a photograph of the oscilloscope record for the region in the vicinity of the impact location is shown in the insert of figure 7(a). The area represented by the insert is outlined on the photograph. The dark area shown in the insert indicates subsurface damage in the panel. This area is about 6.35 cm long and about as wide as the region beneath the hat which contains 0° plies. The results of tests on panels A4 and A5 were similar and both panels failed at applied strains near their design strain level (0.0034).

(a) Photograph of moiré-fringe pattern of buckled panel at applied axial strain of 0.0035. Insert shows region of subsurface damage.

(b) Panel after failure.

Figure 7.- Panel A4 (after impact in high-axial-stiffness region while at zero applied axial strain) before and after failure.

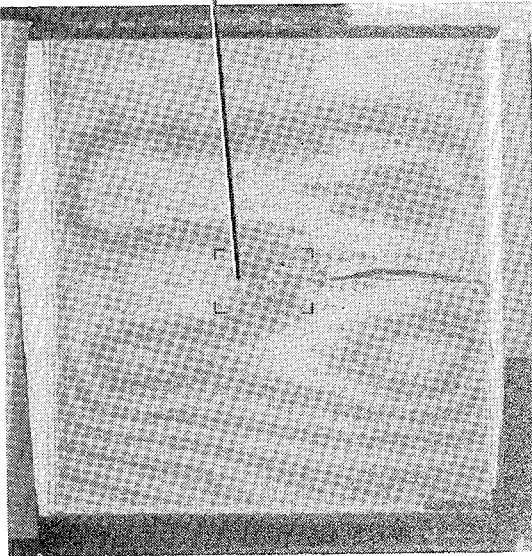
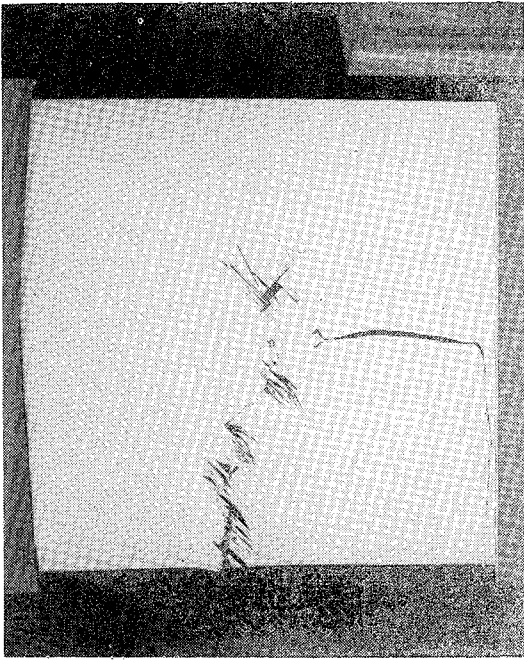
Photographs of the moiré-fringe pattern prior to failure and of the failed panel B6 are shown in figure 8. A small circular pattern in the region of impact was observed with the moiré-fringe technique indicating the presence of local damage. The development of this fringe pattern and an examination of the panel failure indicate that the impact damage precipitated the panel failure. Failure occurred at an applied strain of 0.0043 which is about 54 percent of the design value.

(a) Photograph of moiré-fringe pattern at applied axial strain of 0.0041 showing development of fringe pattern near point of impact. Insert shows region typical of subsurface damage in similar test panel.

(b) Panel after failure.

Figure 8.- Panel B6 (after impact in high-axial-stiffness region while at applied strain of 0.0003) before and after failure.

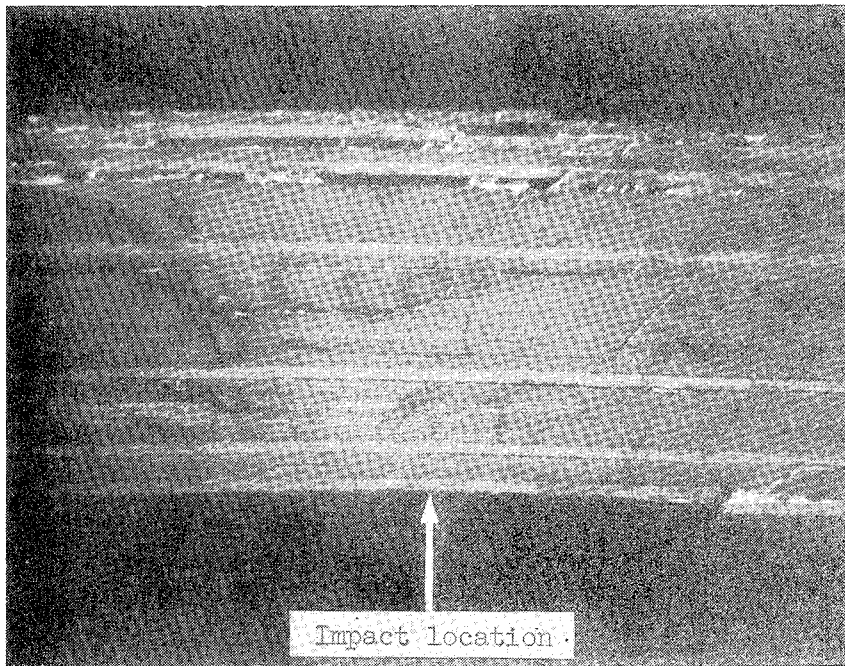
L-77-146

Two stiffener sections, typical of those of panel B6, were damaged by impact at zero applied axial strain and ultrasonically inspected. Identical results were obtained for these two sections. A photographic record of the ultrasonic inspection is shown in the insert of figure 8(a). The subsurface-damage region is oval shaped and is about 2.54 cm wide by 3.81 cm long. One of the stiffeners was cross-sectioned in the region of impact damage and examined microscopically. A photomicrograph of the cross section at a low level of magnification is shown in figure 9. This photomicrograph reveals delamination in the cross section with the most severe delamination occurring on the back surface of the laminate. Striations or hairline crack patterns through the thickness can also be observed. These cracks converge on the point of impact and are similar to those patterns observed for impact-damaged glass panels. Both the cracking and the delamination are probably the result of stress waves generated by the projectile impact.

The results of this investigation suggest that impact causes considerable delamination, and examination of the panel cross section showed that the delamination occurred primarily at the interface between the 0° and 45° plies (fig. 9). The discrete layers formed by delamination may not be midplane symmetric and, therefore, exhibit anisotropic coupling effects. The boundaries of these discrete layers are highly irregular (fig. 10) and are subjected to high interlaminar normal and shear stresses. Also, delamination reduces the local cross-sectional bending stiffness and causes locally eccentric loading which introduces transverse shear forces and moments not present in the undamaged panel. These local eccentric forces and anisotropic effects cause

Figure 9.- Photomicrograph of cross section of high-axial-stiffness region of panel similar to B6 after being subjected to impact damage at zero applied axial strain.

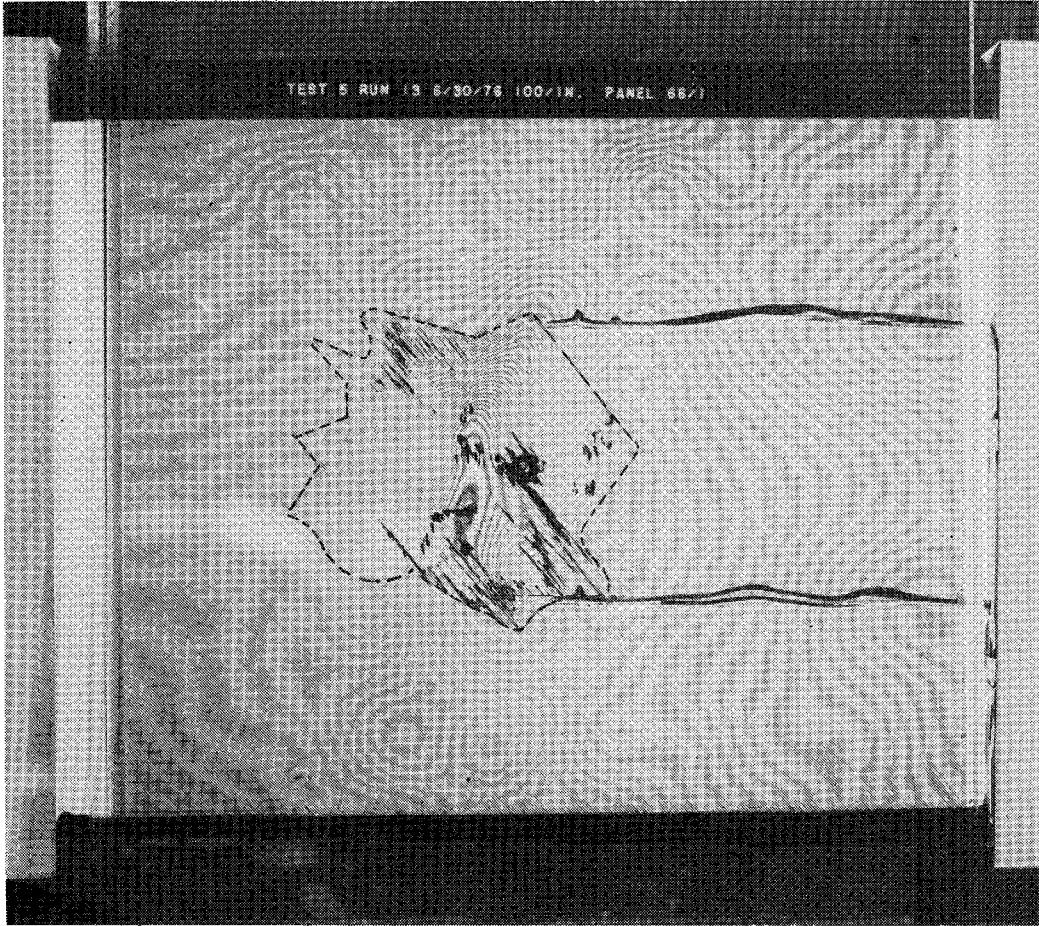
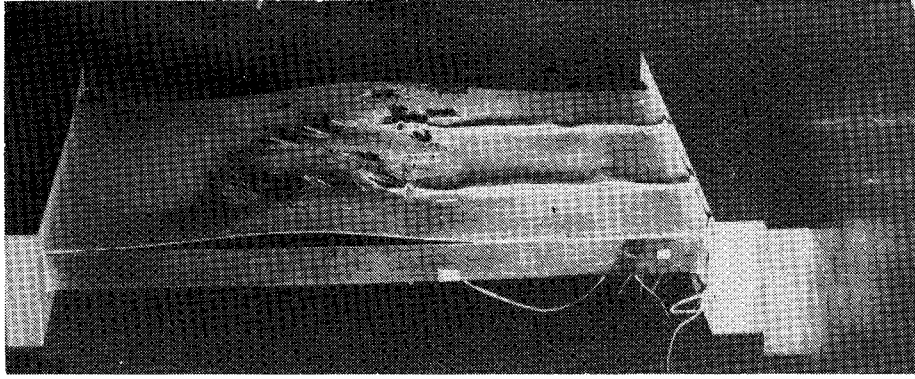
High axial strain at impact: Test panels A3, B7, and B8 were damaged by impact with a high axial load applied. (See table II.) Panels A3 and B7 which had an applied axial strain of 0.0034 and 0.0030, respectively, had a large region of visually detectable damage in the impact area. Instrumentation monitoring applied load indicated both panels had significant load reductions at impact due to loss in panel stiffness (table II). Both were subsequently loaded to failure to determine the panel residual strength. Panel A3 was ultrasonically inspected prior to the residual strength test and an extensive region of subsurface damage was detected. A photograph of the moiré-fringe pattern of the panel loaded prior to failure is shown in figure 10(a) where the subsurface-damage region is outlined. Even though the damage in panel A3 is extensive, it buckled at an applied strain near the design level and carried additional load after buckling similar to the undamaged panels. The panel failed in the region of the impact damage (fig. 10(b)) at an applied strain of 0.0037. Comparison of panel A3 with panels A4 and A5, all of which were designed for a load of 0.53 MN/m at an axial strain of 0.0034, indicates that

(a) Photograph of moiré-fringe pattern of buckled panel at applied axial strain of 0.0031.

(b) Panel after failure.

Figure 10.- Panel A3 (after impact in high-axial-stiffness region while at applied strain of 0.0034) before and after failure.

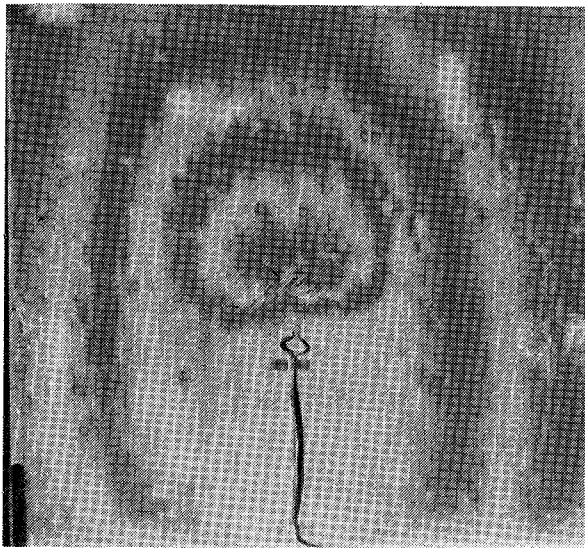
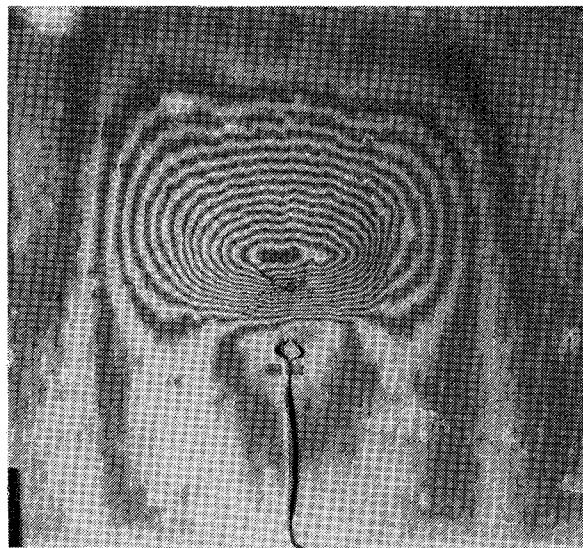
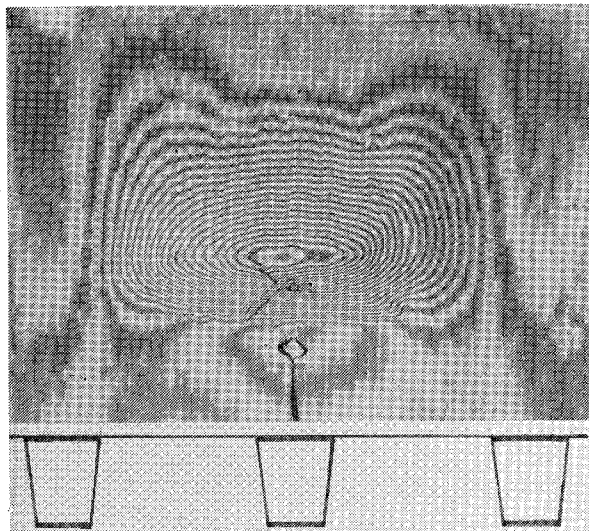
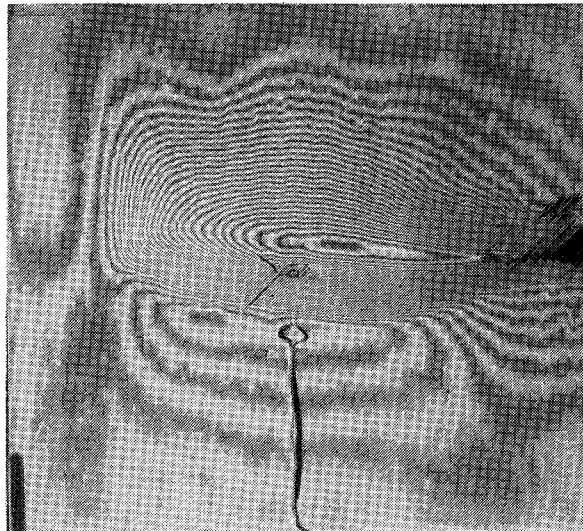
Several photographs of the moiré-fringe pattern taken during the residual strength test of panel B7 are shown in figure 11 along with a photograph of the failed panel. The moiré-fringe pattern shows considerable lateral deformation of the panel center, which may be due to impact-induced delamination or skin buckling. When the panel was damaged by impact, a reduction in applied load of 28.9 kN was measured. The 28.9-kN load reduction approximately corresponds to the load which the high-axial-stiffness region beneath the center stiffener is calculated to carry for an imposed strain of 0.0030. The panel failed at an applied strain of 0.0046 which is 58 percent of the design value.

Figure 11.- Panel B7 (after impact in high-axial-stiffness region while at applied strain of 0.0030) before and after failure.

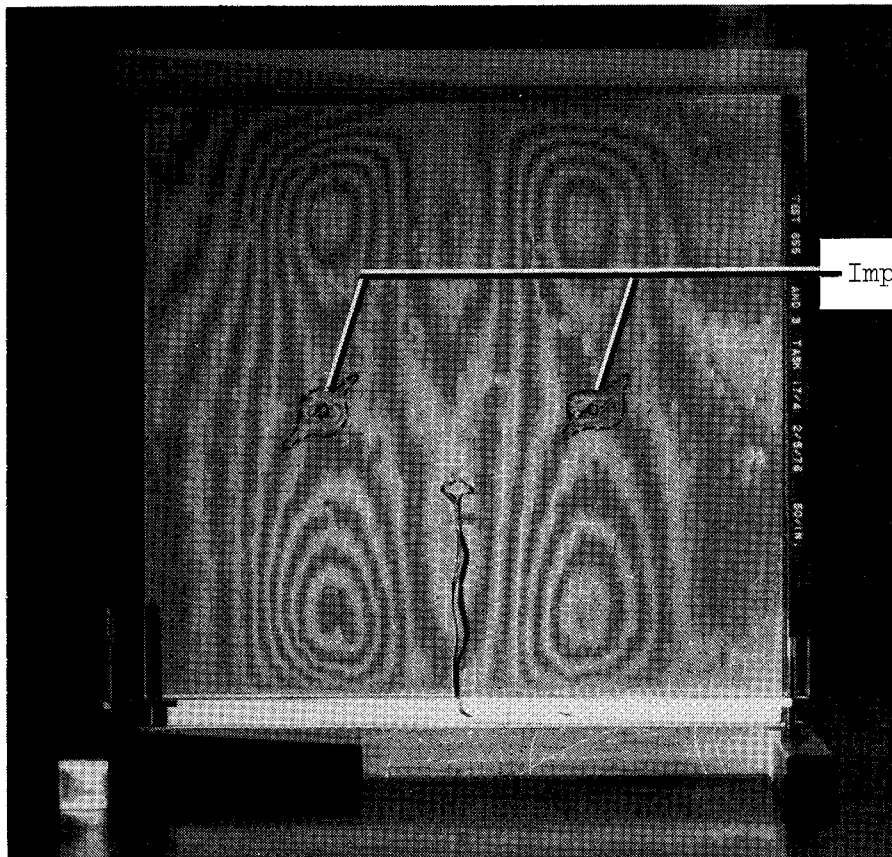
L-77-149

Impact damage in the low-axial-stiffness region.- In order to evaluate the effect of damage in the angle-ply, low-axial-stiffness region, panel B9 was damaged by impact in the skin region between stiffeners ( $\pm 45^\circ$  for the design B panels). The panel was loaded to an applied axial strain of 0.0040 when impact occurred. (See table II.) No reduction in the applied load upon impact was observed and no increase in axial strain was noted in the gage near the point of impact. Although some local fiber failure and delamination was observed, the failure did not propagate. After impact the panel was loaded to an applied strain of 0.0054 without propagation of local damage. At this load the panel was damaged in the remaining  $\pm 45^\circ$  skin region between stiffeners. (See table II.) No loss in load nor increase in strain near the point of impact was detected. This panel was subsequently loaded to an applied strain of 0.0062 at which a moiré-fringe pattern was observed in the end regions (see fig. 13) similar to that observed for the undamaged test panel. A local fringe pattern can be seen in the figure at each impact location.

Following this test the panel was inspected ultrasonically to evaluate the extent of the damaged region. The subsurface-damage region is outlined on the panel in figure 13. The two damaged regions are about the same size, which indicates that the magnitude of the applied strain had no apparent effect on the extent of local damage. These results indicate that impact damage in the regions having high axial stiffness is significantly more detrimental than it is in regions of low axial stiffness.

Figure 13.- Photograph of moiré-fringe pattern for panel B9 at applied axial strain of 0.0062 with impact damage at two locations in low-axial-stiffness region.
