ACCEPTABLE GLASS WINDOW/WINDSHIELD REPAIR PROCESSES AND APPROVED VENDORS

RICHARD J. OLSON

BATTELLE
505 KING AVENUE
COLUMBUS, OH 43201

MATERIAL AND PROCESS SPECIFICATION REPORT FOR 09/91 - 12/31/95
CONTRACT NUMBER FO9603-90-D-2217-SD02

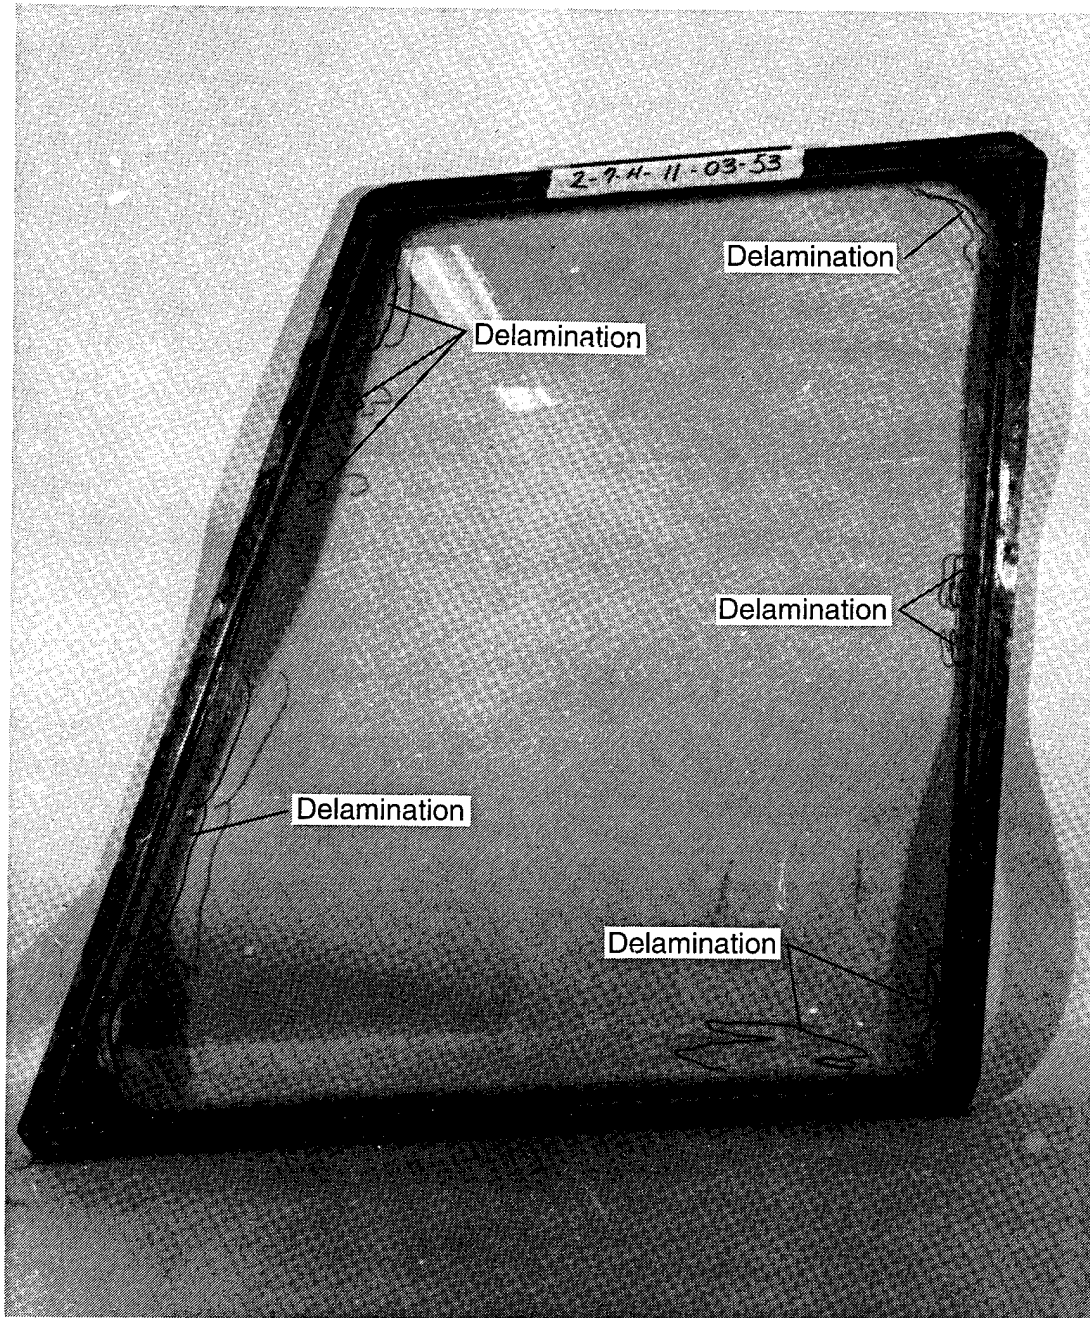
**Figure 4.1 Worst Delamination Observed in All Pressure/Thermal Cycle Tests
(B-52 #1 W/WS, S/N 7-H-11-03-53)**

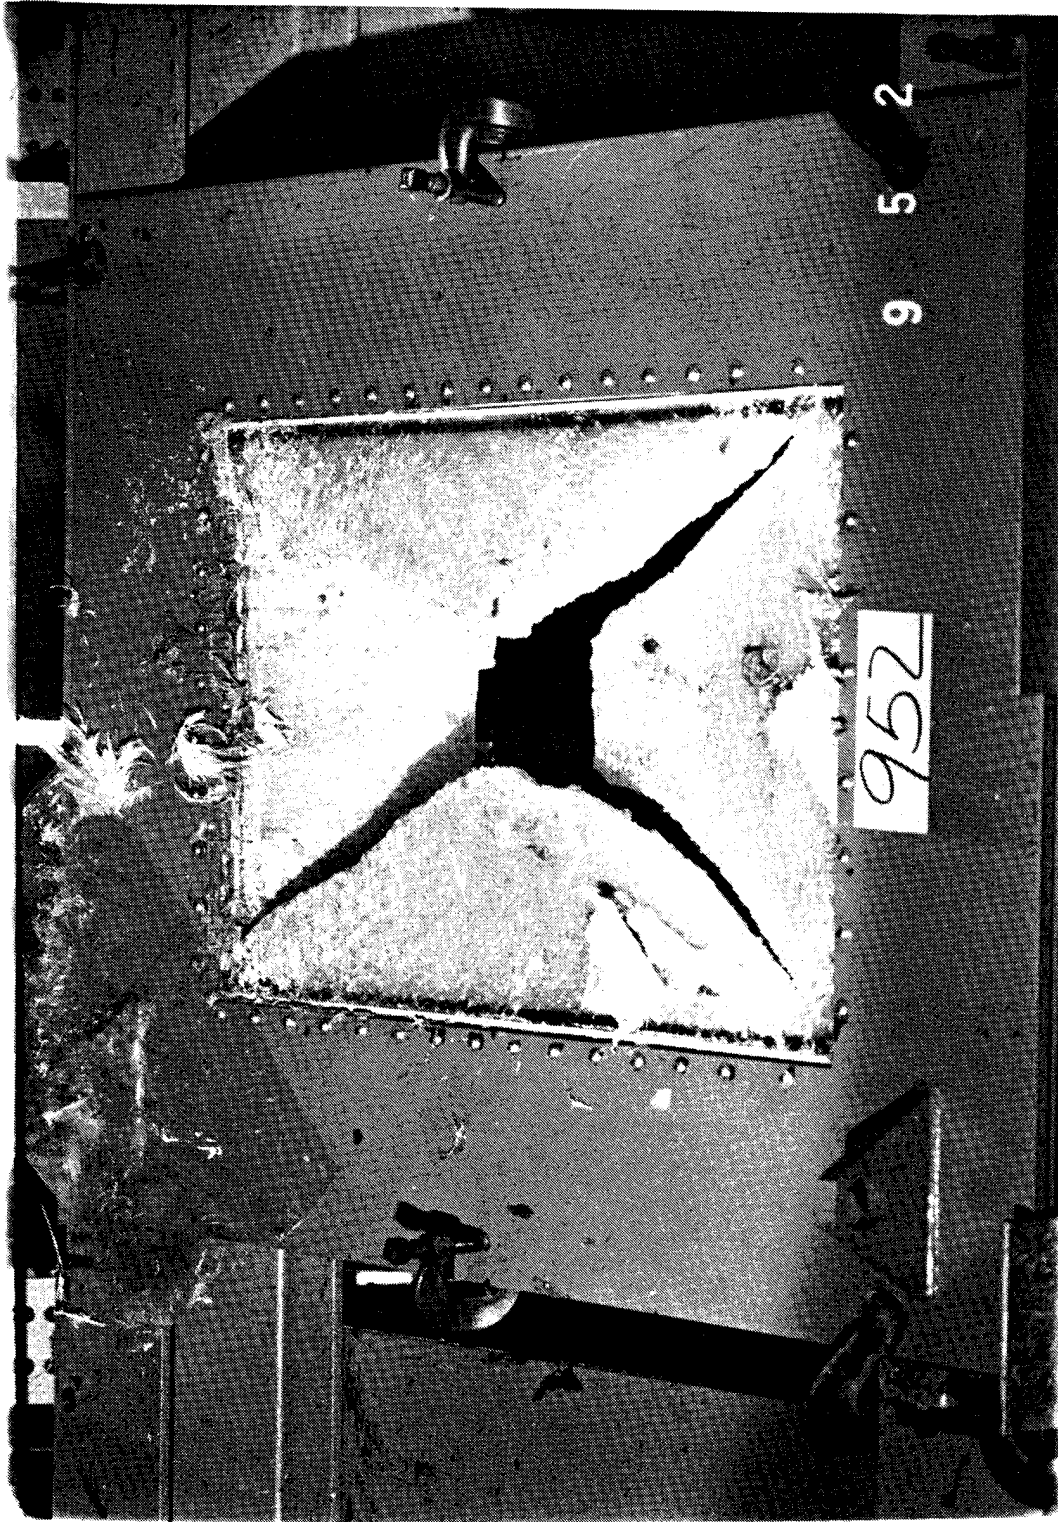
Figure 4.2 Catastrophic W/W Failure From a 4-Pound Bird Impact at 250 Knots
(B-52 #1 W/WS, S/N 86-H-04-28-693)

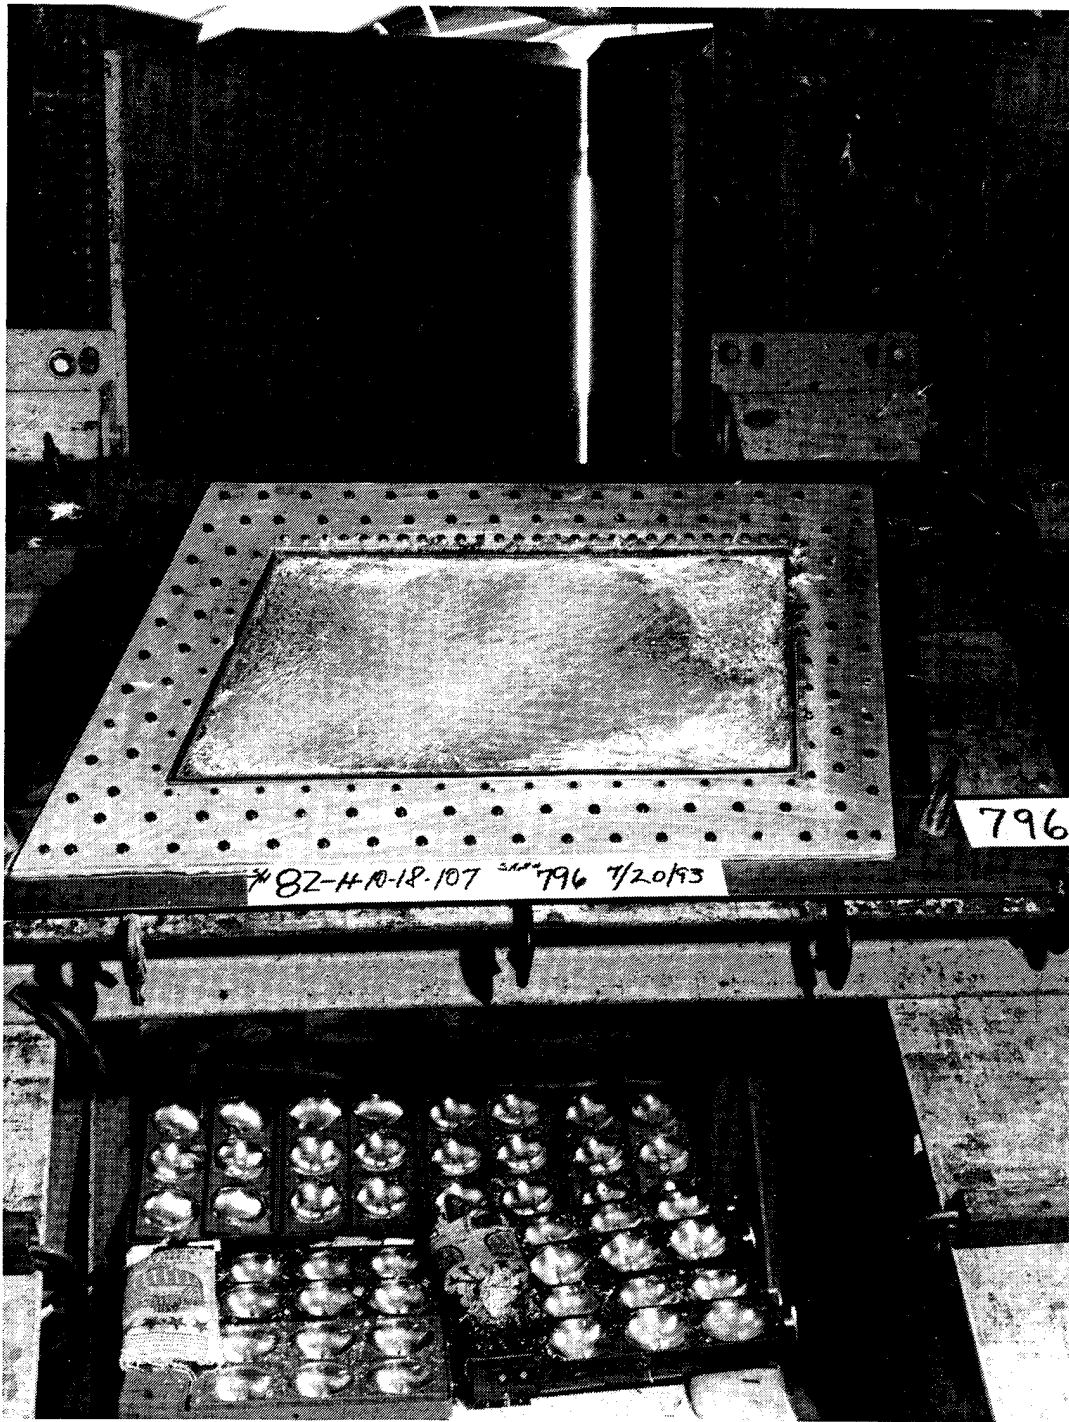
**Figure 4.3 Both Glass Plies Failure From a 4-Pound Bird Impact at 250 Knots
(C/KC-135 W/WS, S/N 83-H-11-21-325)**

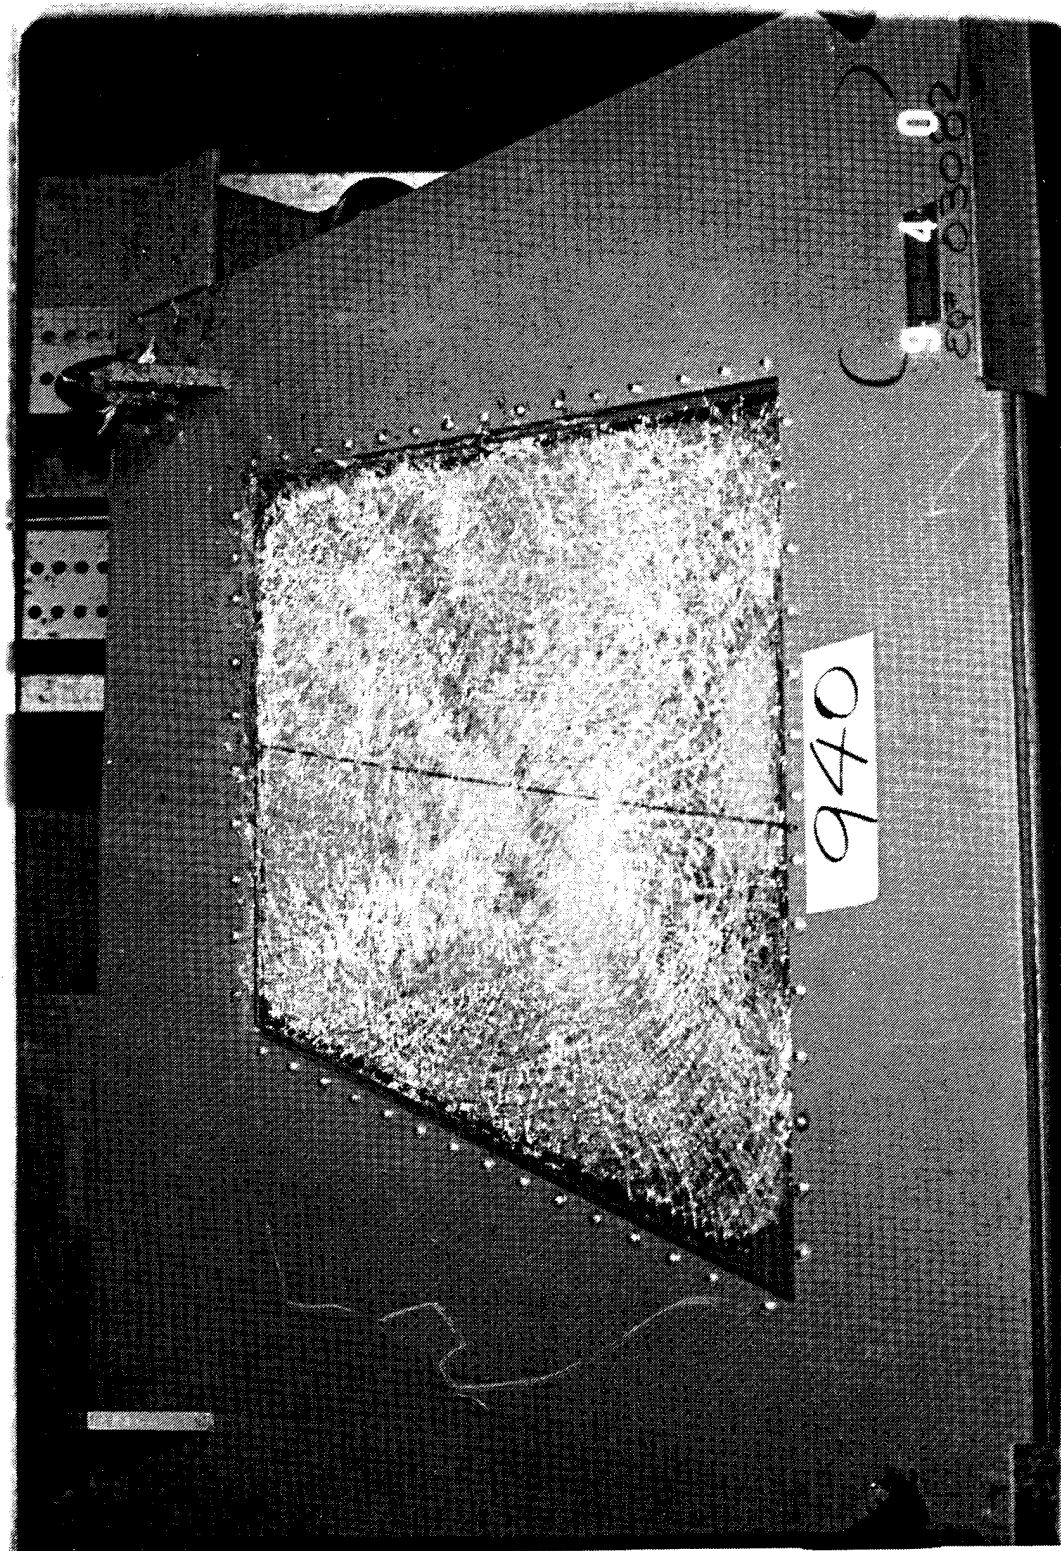
**Figure 4.4 Broken Outboard Glass Ply Failure From a 4-Pound Bird Impact at 300 Knots
(B-52 #2 W/WS, S/N 5-H-3-21-17)**
