**REPAIRED GLASS COCKPIT
W/WS SYSTEM SAFETY REPORT**

RICHARD J. OLSON

**BATTELLE
505 KING AVENUE
COLUMBUS, OH 43201**

**SYSTEMS SAFETY HAZARDS ANALYSIS REPORT FOR 09/91 - 2/96
CONTRACT NUMBER FO9603-90-D-2217-SD02**

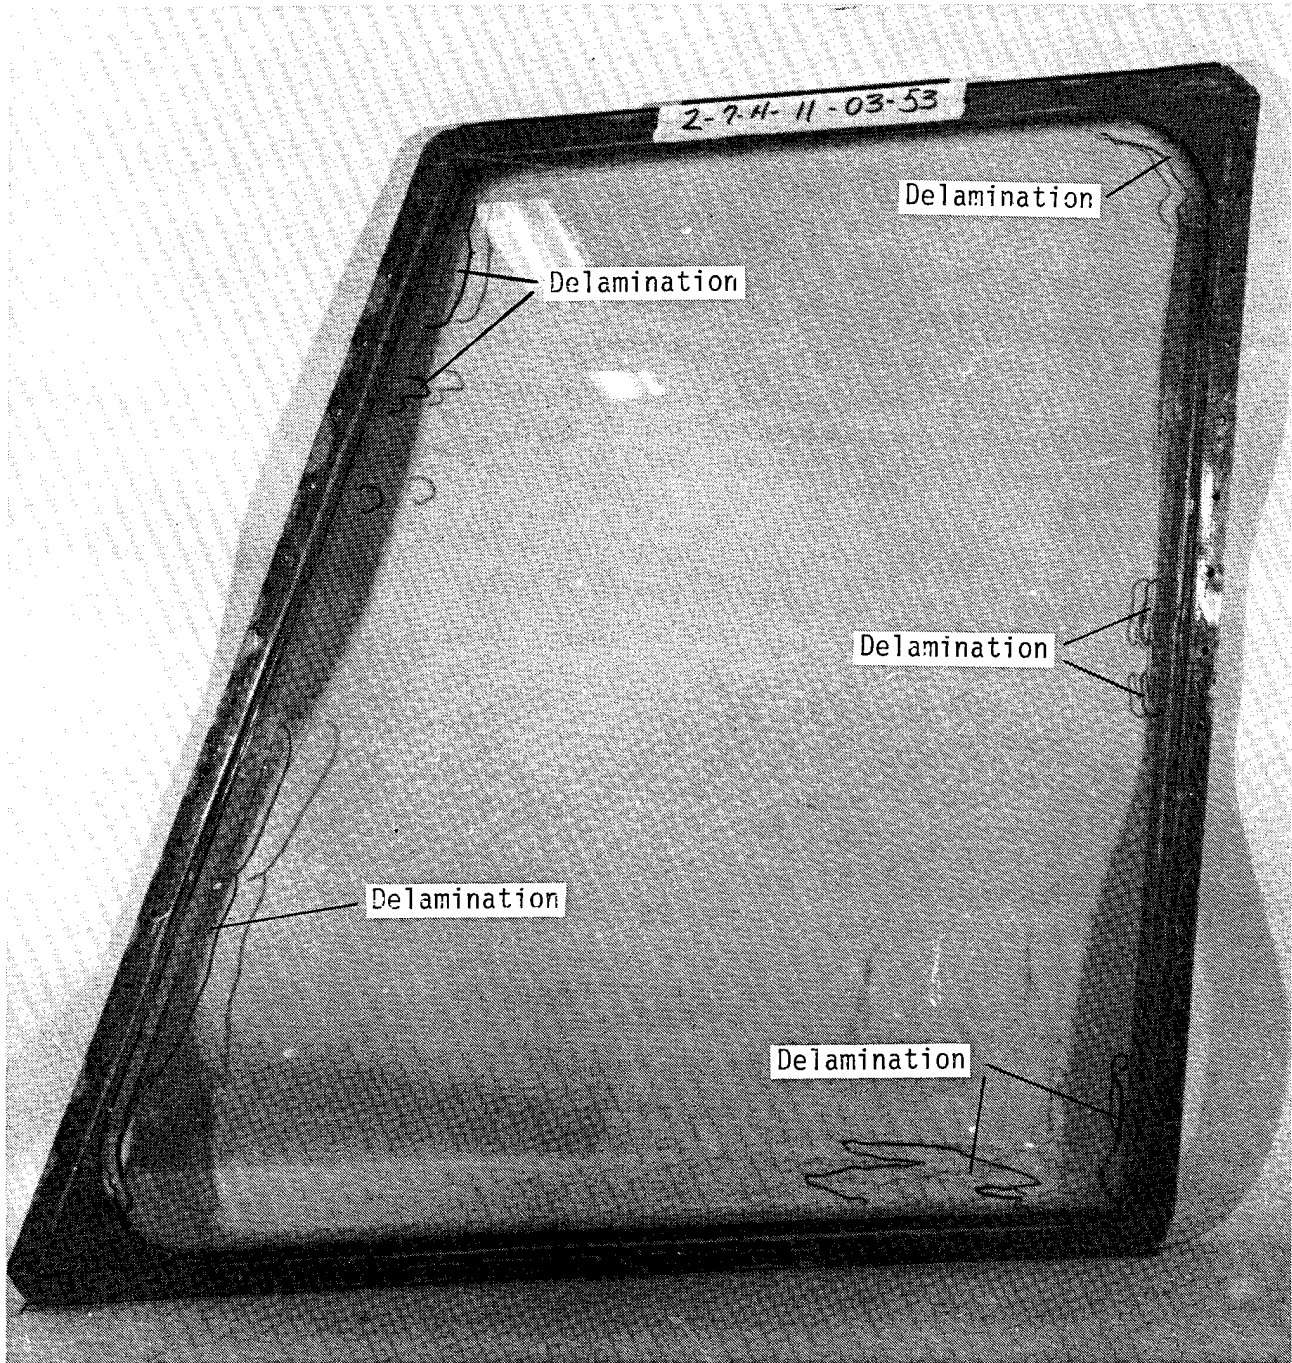
The results of the pressure integrity testing are summarized in Tables 3.13 and 3.14. None of the W/WS, repaired, not repaired, or new, exhibited any catastrophic failures. Some of the repaired W/WS did experience delaminations, and evidence of delamination was detected in the new B-52 W/WS. Figure 3.1 shows the worst delamination that occurred in

any of the W/WS tested. In this figure, the edge of the delamination has been outlined with a black marker. None of the W/WS exhibited delamination that would cause the pilot to be unable to see through the W/WS.

**Figure 3.1 Worst Delamination Observed in all Pressure/Thermal Cycle Tests
(B-52 #1 W/WS, S/N 7-H-11-03-53)**

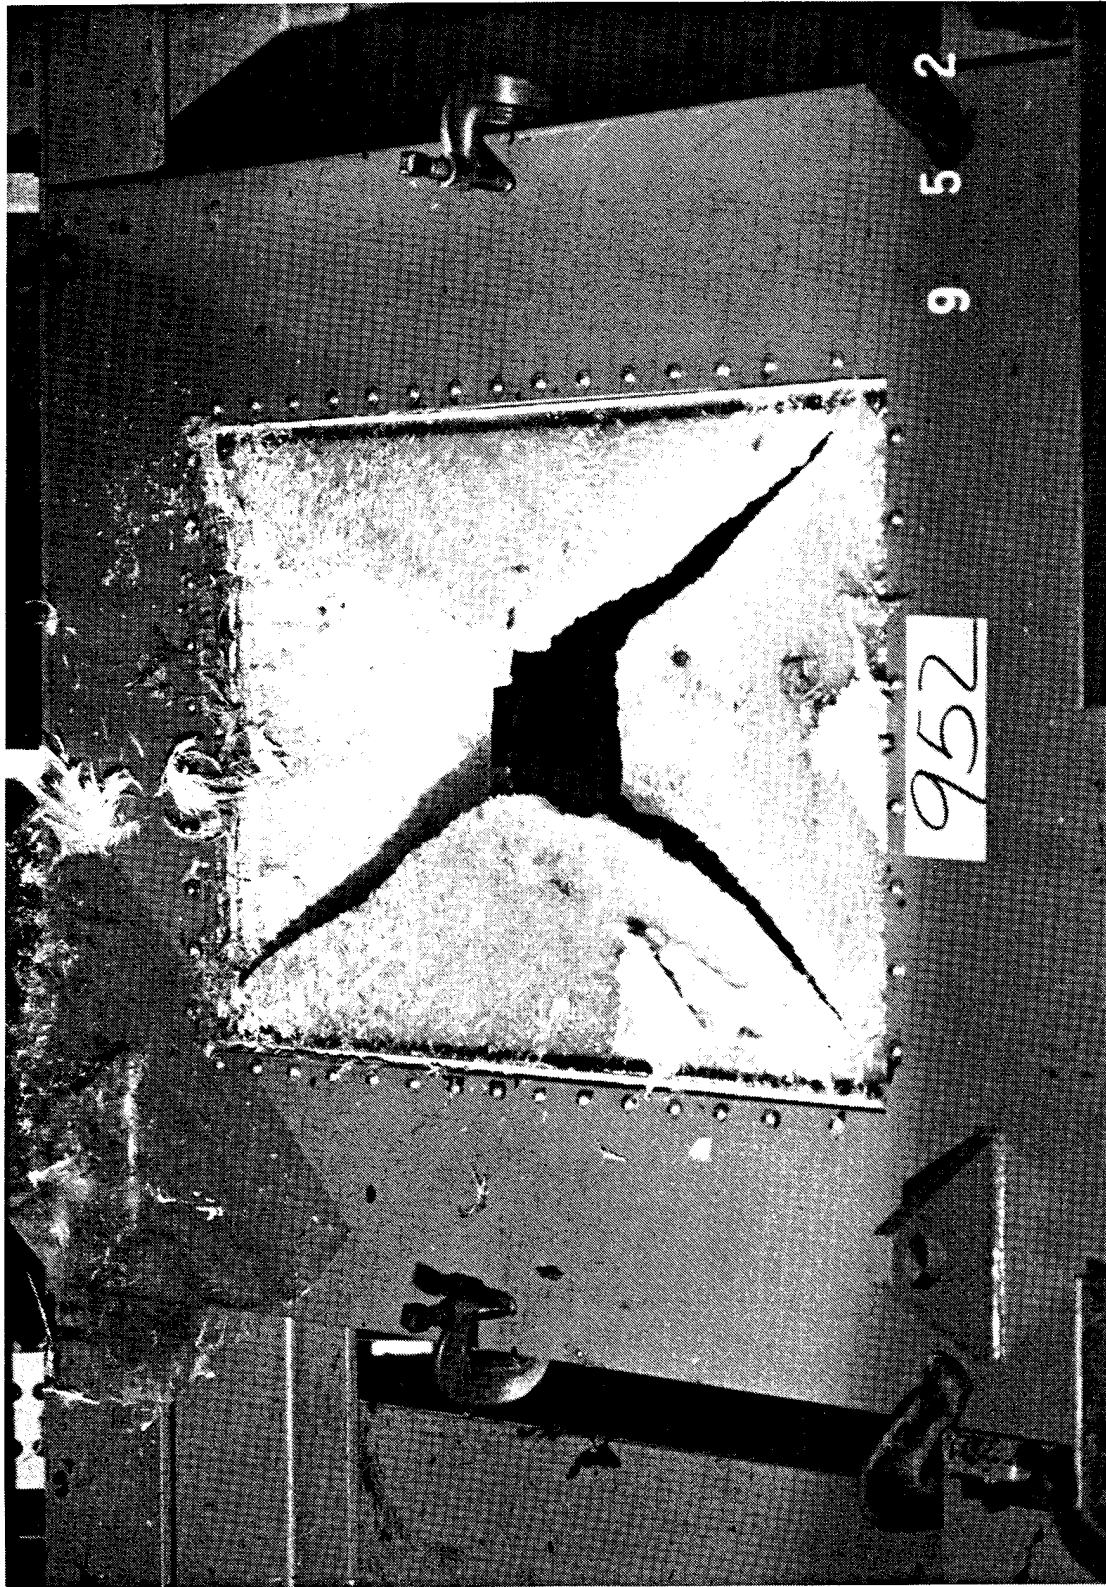
Figure 3.2 Catastrophic W/WS Failure From a 4-Pound Bird Impact at 250 Knots
(B-52 #1 W/WS, S/N 86-H-04-28-693)

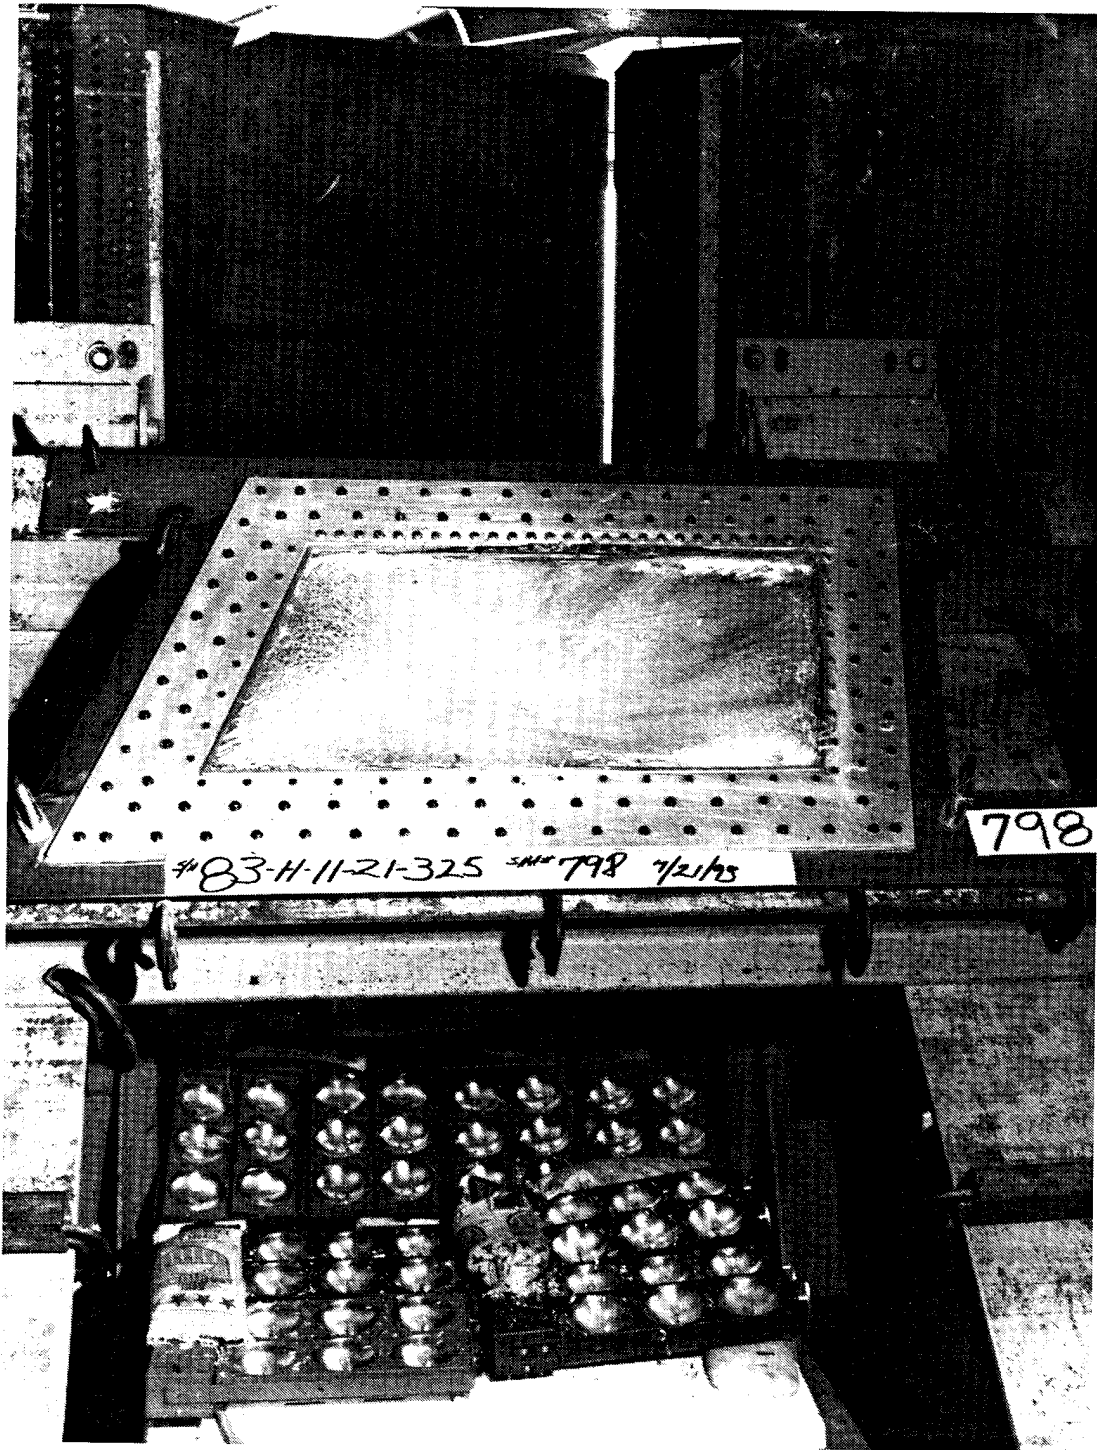
Figure 3.3 Both Glass Plies Failure From a 4-Pound Bird Impact at 250 Knots
(C/KC-135 #1 W/WS, S/N 83-H-11-21-325)

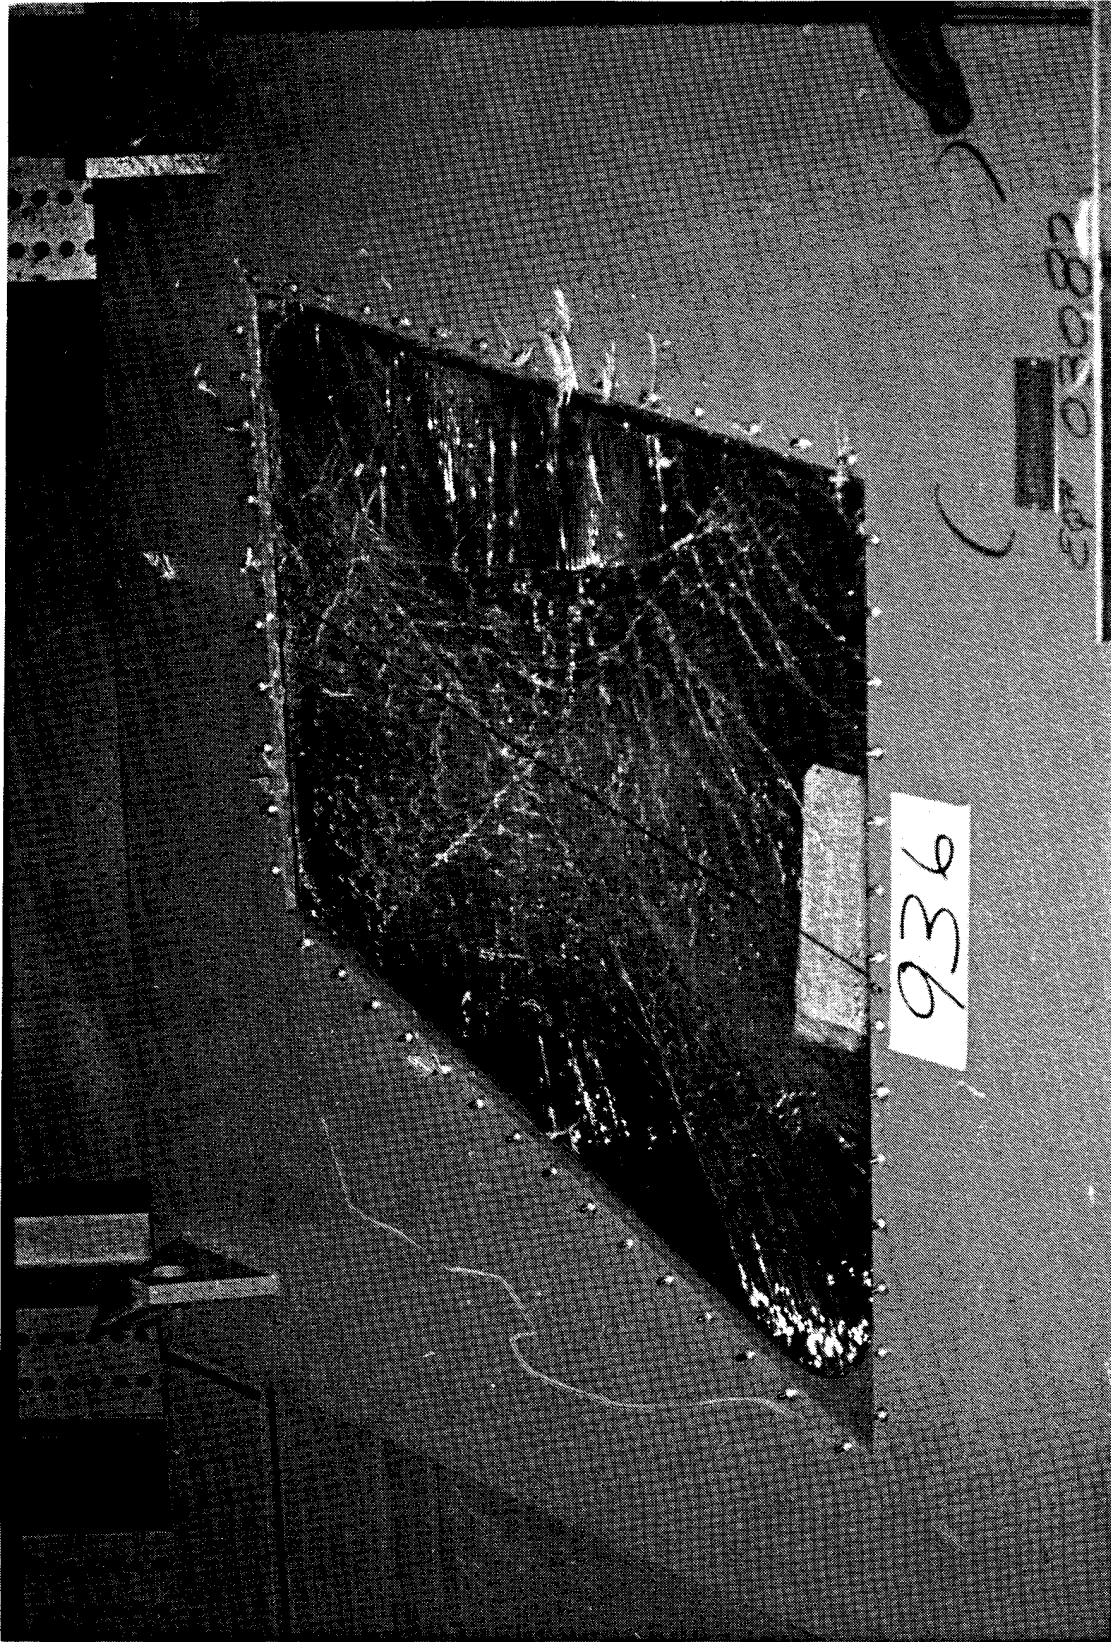
Figure 3.4 Broken Outboard Glass Ply Failure From a 4-Pound Bird Impact at 300 Knots
(B-52 #2 W/WS, S/N 5-H-3-20-17)
