BOEING AIRPLANE COMPANY
WICHITA 1, KANSAS

DOCUMENT NO. D3-2780 DATE 1-13-60
MODEL ALL CONTRACT NO. _____
TITLE SUMMARY OF TESTING: BMS 10-39 FUEL AND MOISTURE
RESISTANT FINISH FOR FUEL TANKS
ISSUE NO. _____ TO _____ DATE _____
SHORT TITLE _____
(FOR CLASSIFIED DATA)

**D3-2398, LABORATORY INVESTIGATIONS OF
CORROSION PROTECTION IN B-52G INTEGRAL
FUEL TANKS**

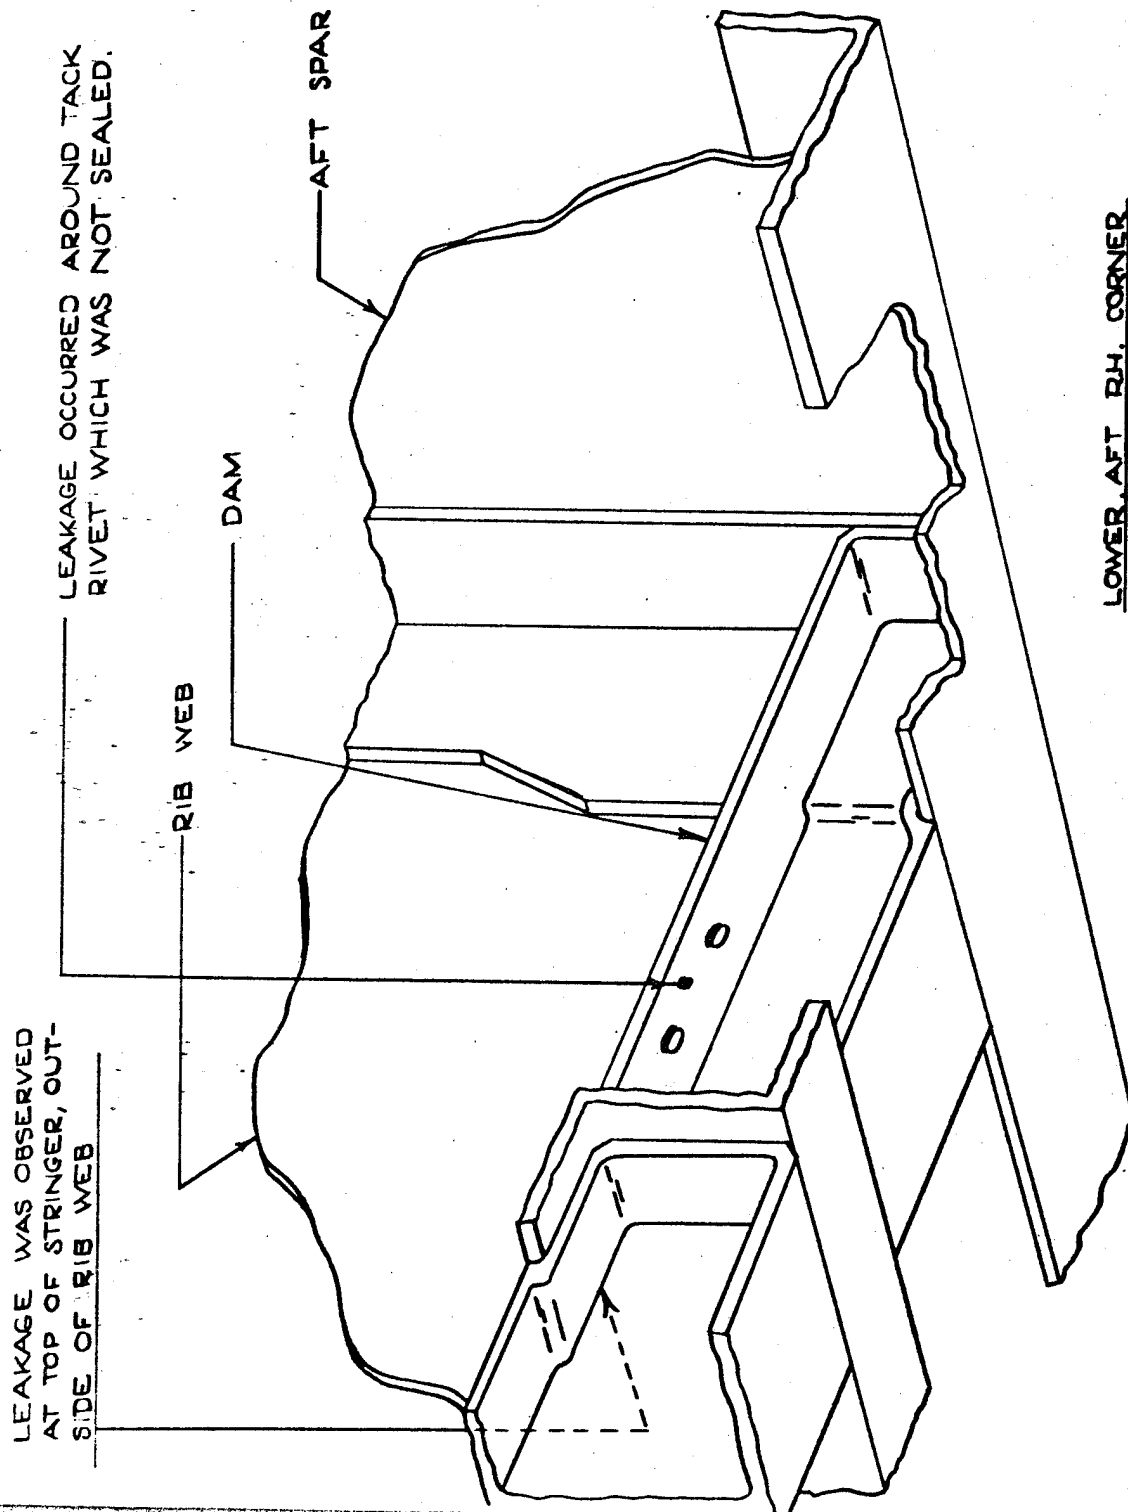
ILLUSTRATION NO. 1
TACK RIVET LEAK

LOWER, AFT R.H. CORNER

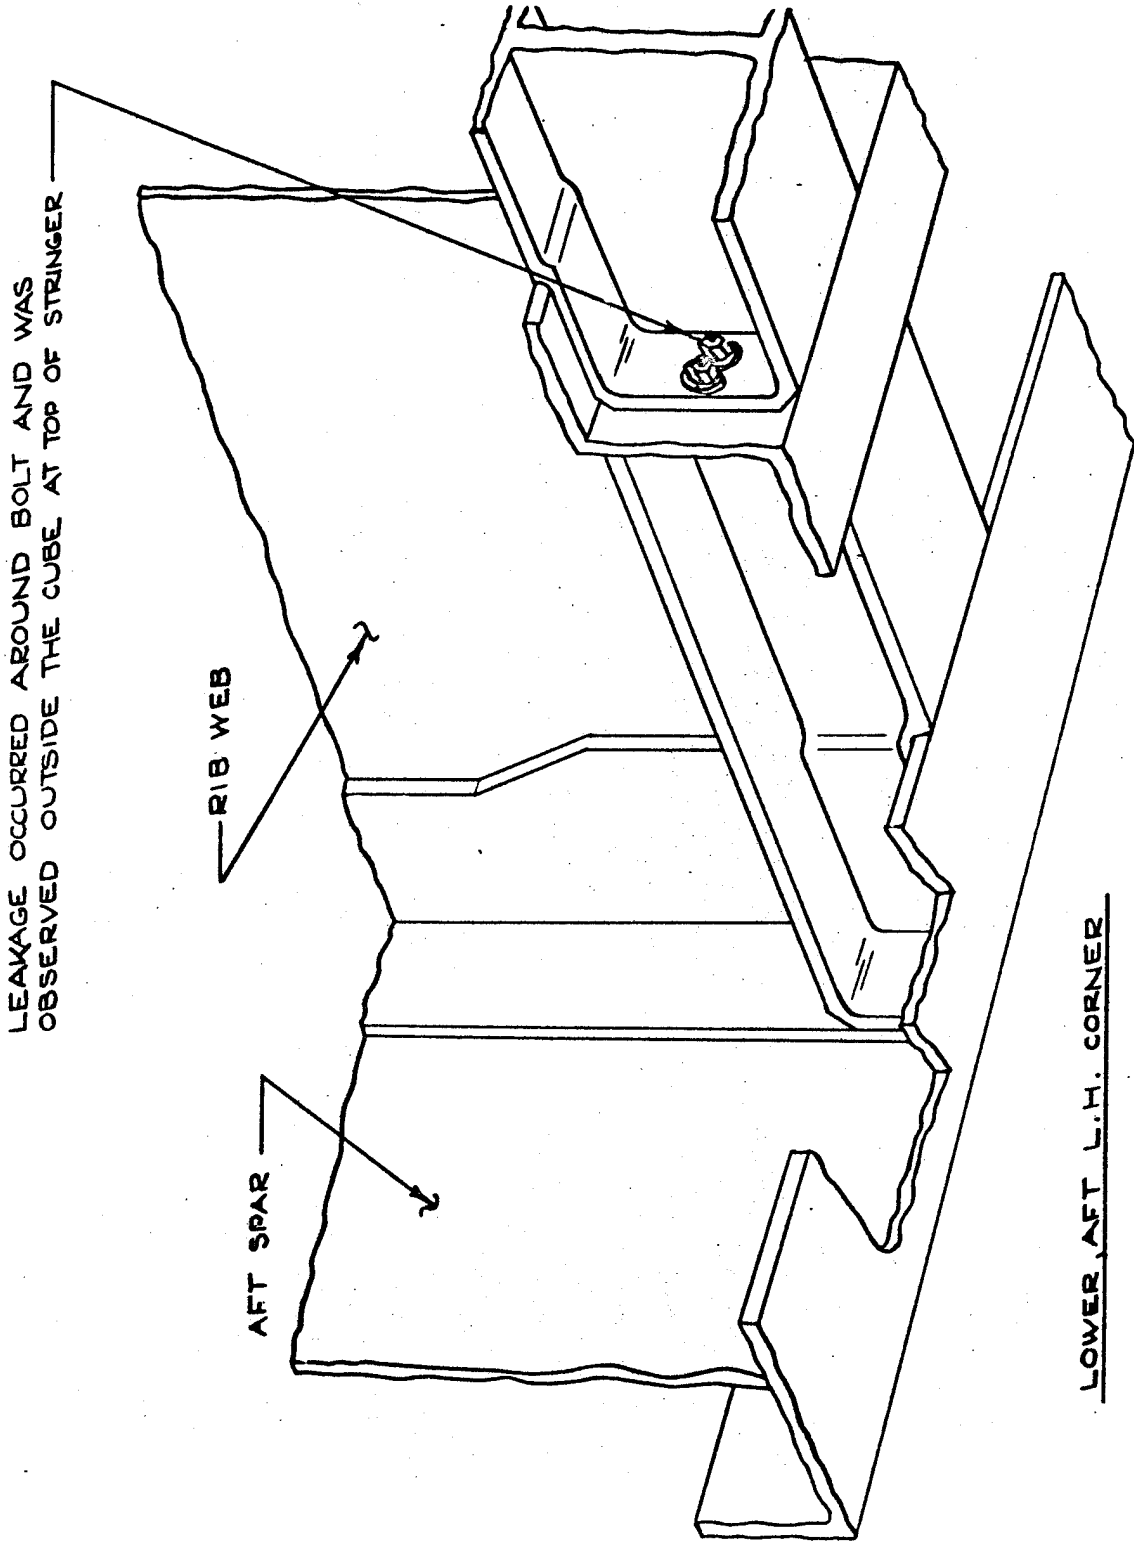
ILLUSTRATION NO. 2
AN BOLT LEAK

LEAKAGE OCCURRED AROUND BOLT AND WAS
OBSERVED OUTSIDE THE CUBE AT TOP OF STRINGER

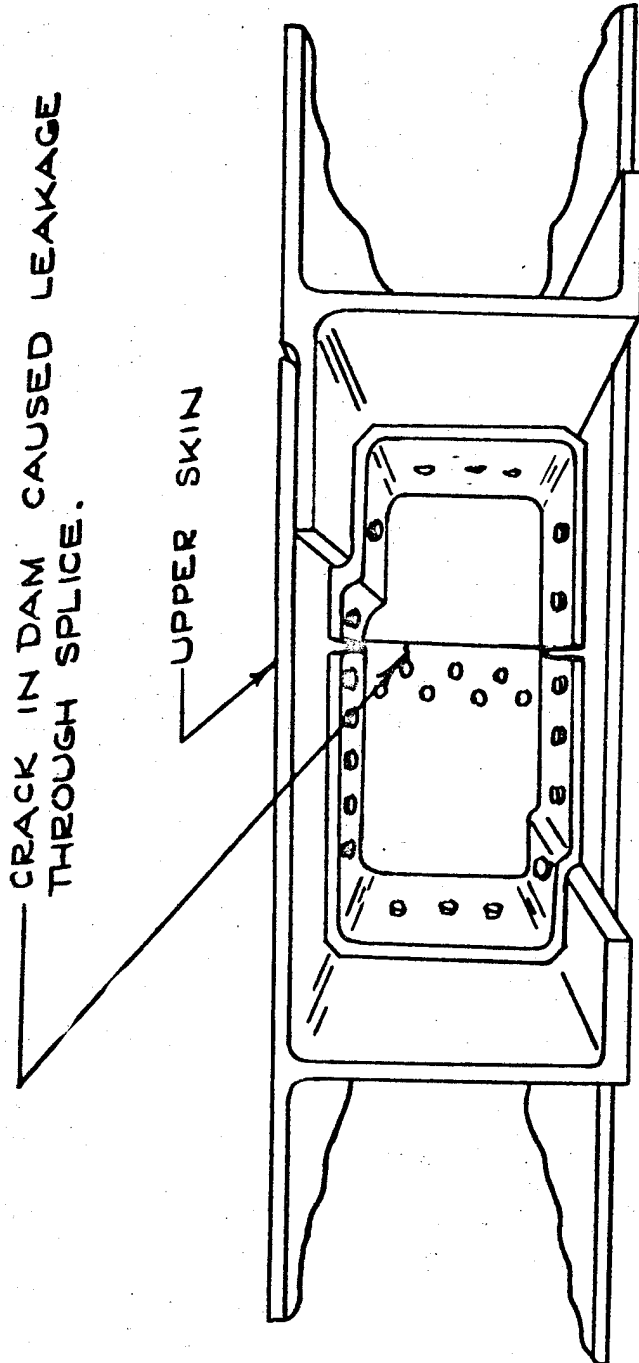
ILLUSTRATION NO. 3
CRACK IN FUEL DAM

MIDDLE DAM UPPER L.H. SIDE

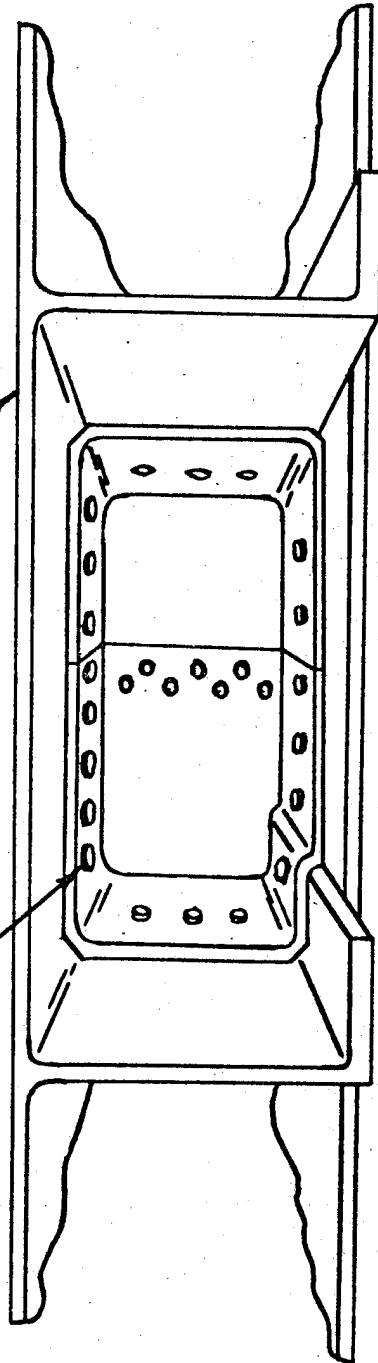
ILLUSTRATION NO. 4
NACA RIVET LEAK

LEAKAGE OCCURRED AT FLUSH SEAL
RIVET. THE LEAK TRAVELED TO THE
SPLICE IN DAM WHERE IT WAS LOCATED
OUTSIDE THE CUBE.

UPPER L.H. SIDE
