**DEVELOPMENT OF REPAIR PROCESSES  
AND SOURCES FOR B-52 AIRCRAFT  
WINDOWS/WINDSHIELDS**

# REPORT

**FEBRUARY 1996**

**TECHNICAL REPORT FOR 09/91 - 12/31/95  
CONTRACT NUMBER FO9603-90-D-2217-SD02**

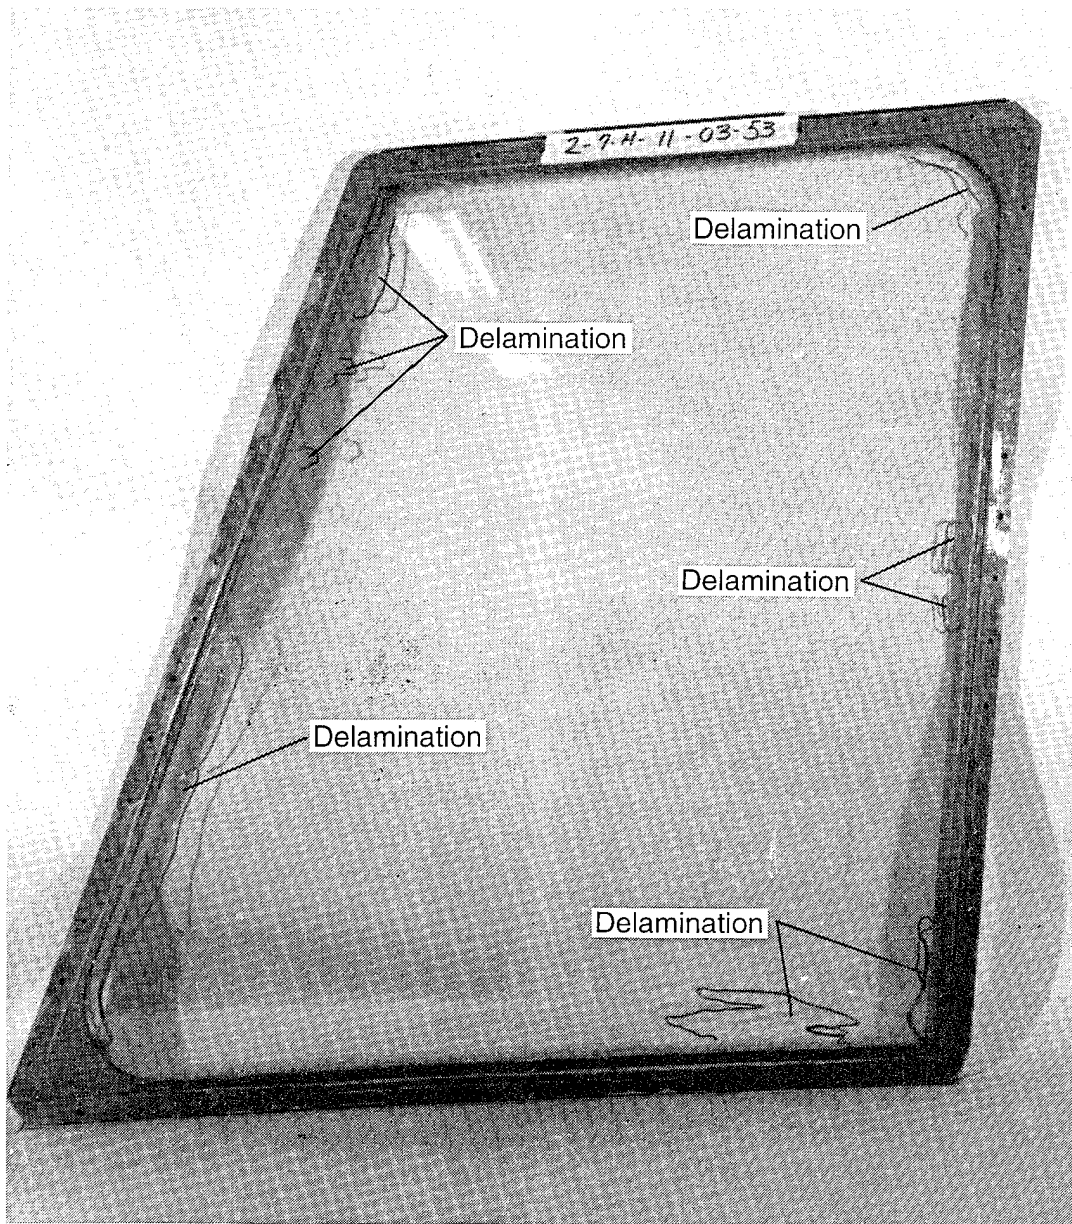
**Figure 4.7 Worst B-52 #2 W/WS Delamination (S/N 7-H-11-03-53)**

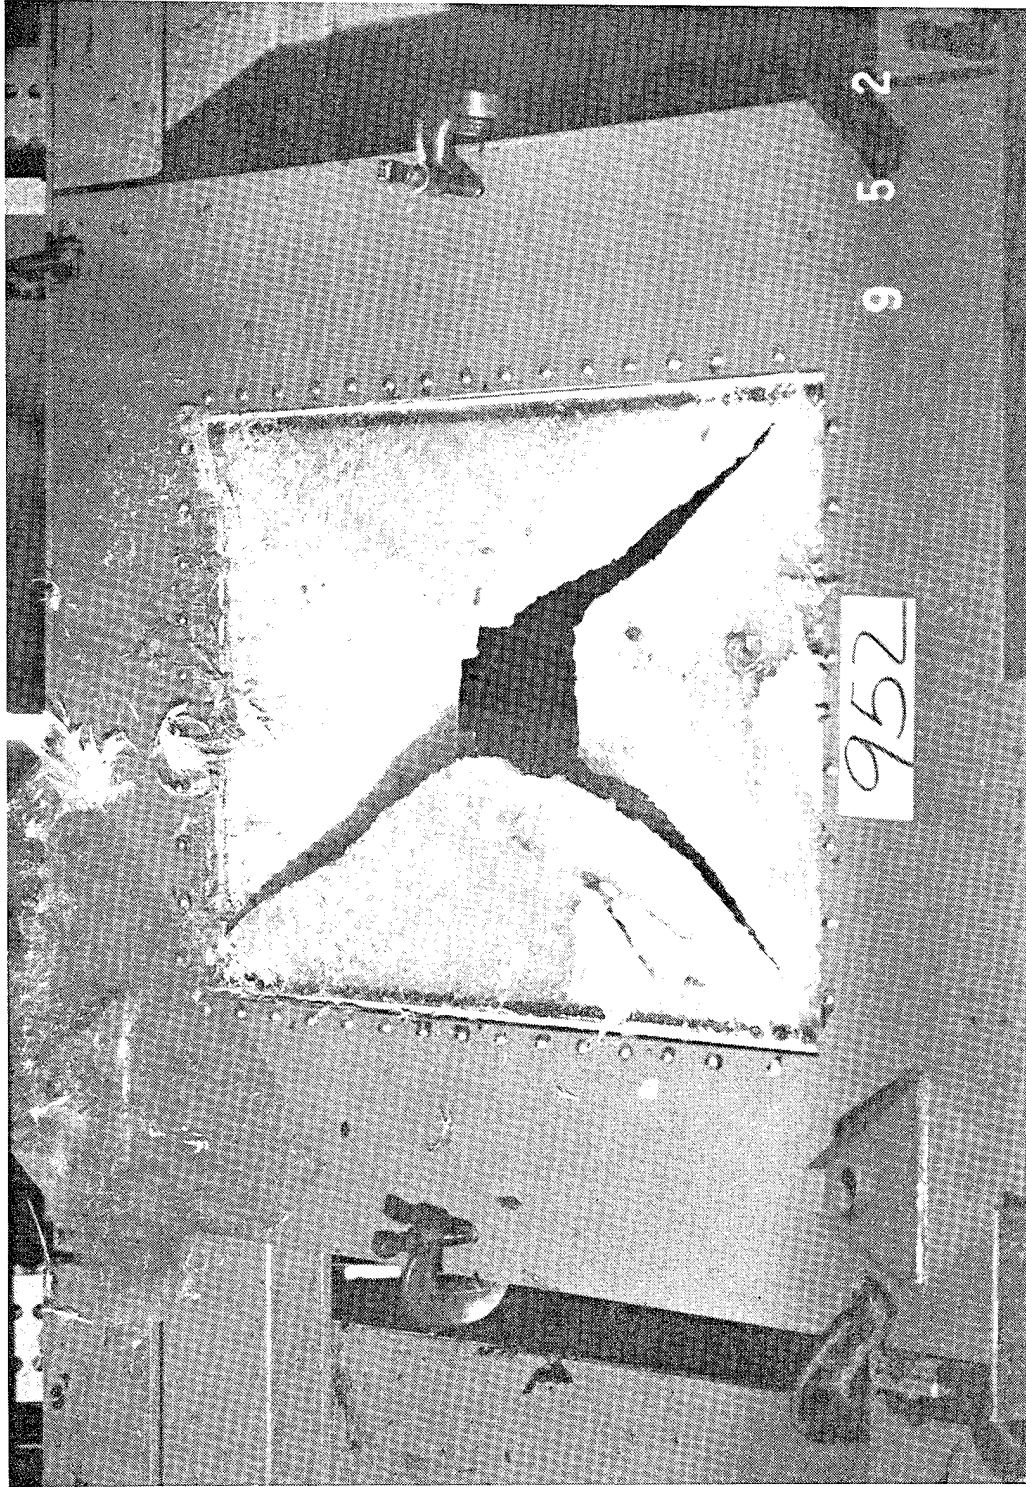
Figure 4.14 B-52 #1 W/WS Showing Worst Damage ( Complete Transparency Failure) From a 4-Pound Bird Impact at 250 knots (S/N 86-H-04-28-693 )

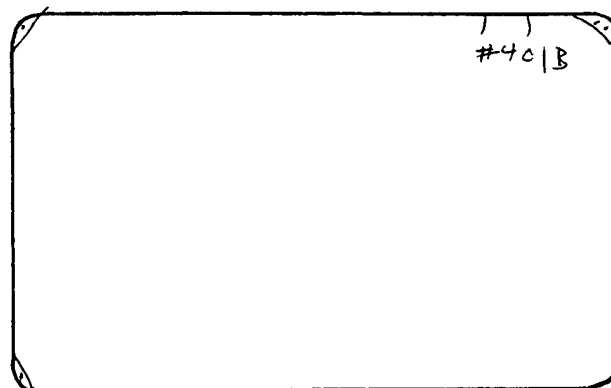
BAC-061

Air in slip plane  
Scratches #4 O/B

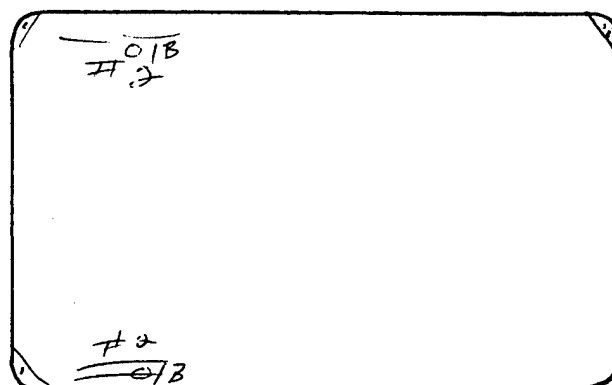
BAC - 061

Air in S/E  
light scratches

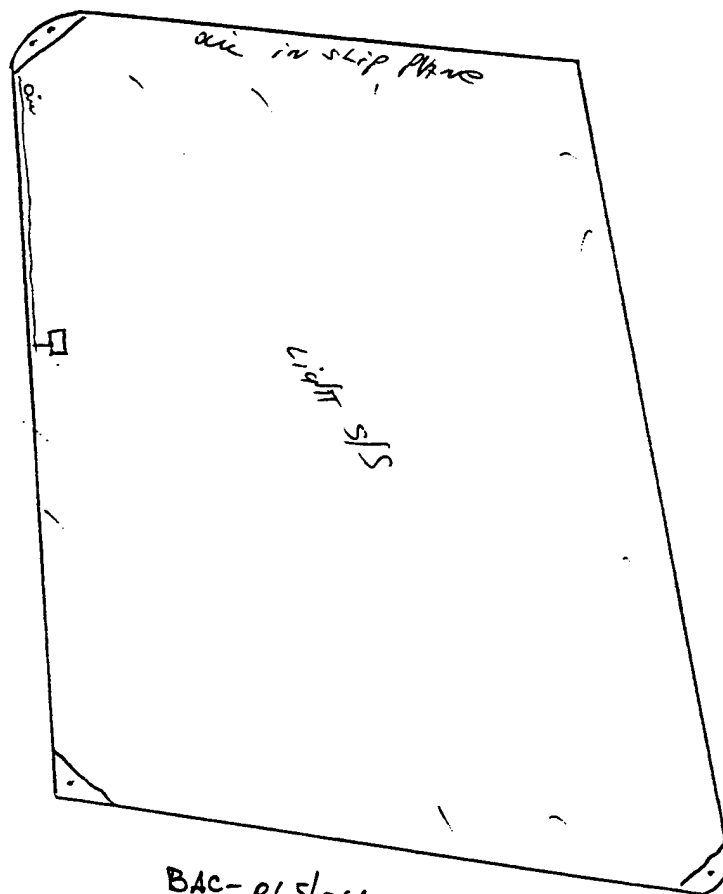
Air in S/P ? Light S/S Around Edge.

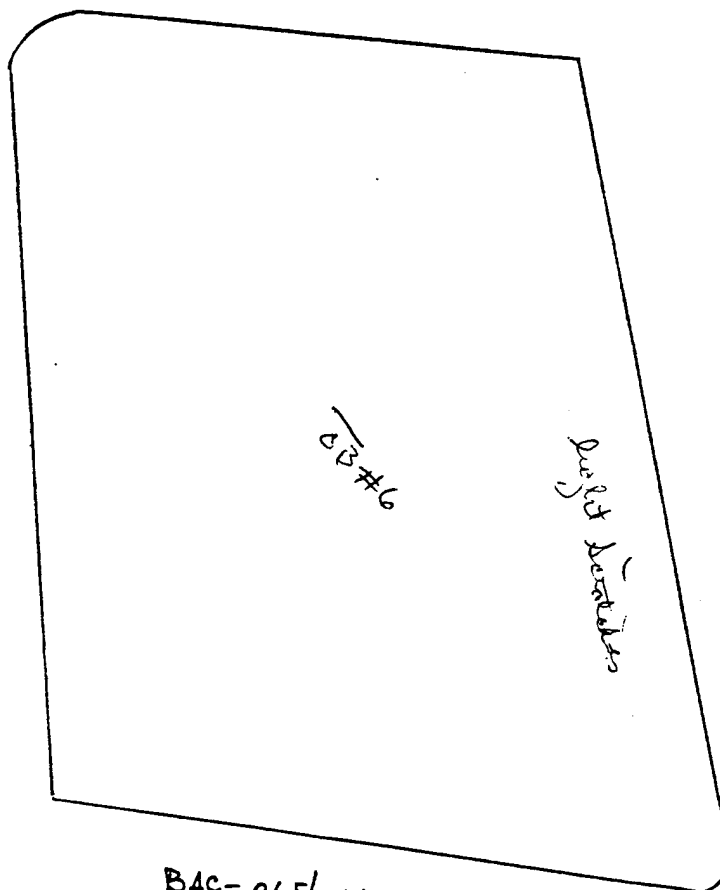
Air in Slip Plane  
light scratches at top of unit 1 small #6 O/B middle  
of unit
