**IMPACT RESISTANCE OF
COMPOSITE FAN BLADES**

**E. J. PREMONT
K. R. STUBENRAUCH**

**PRATT & WHITNEY AIRCRAFT
DIVISION OF UNITED AIRCRAFT CORPORATION**

1. Report No. NASA CR-134515	2. Government Accession No.	3. Recipient's Catalog No.	
4. Title and Subtitle Impact Resistance of Composite Fan Blades Final Report		5. Report Date May 1973	6. Performing Organization Code

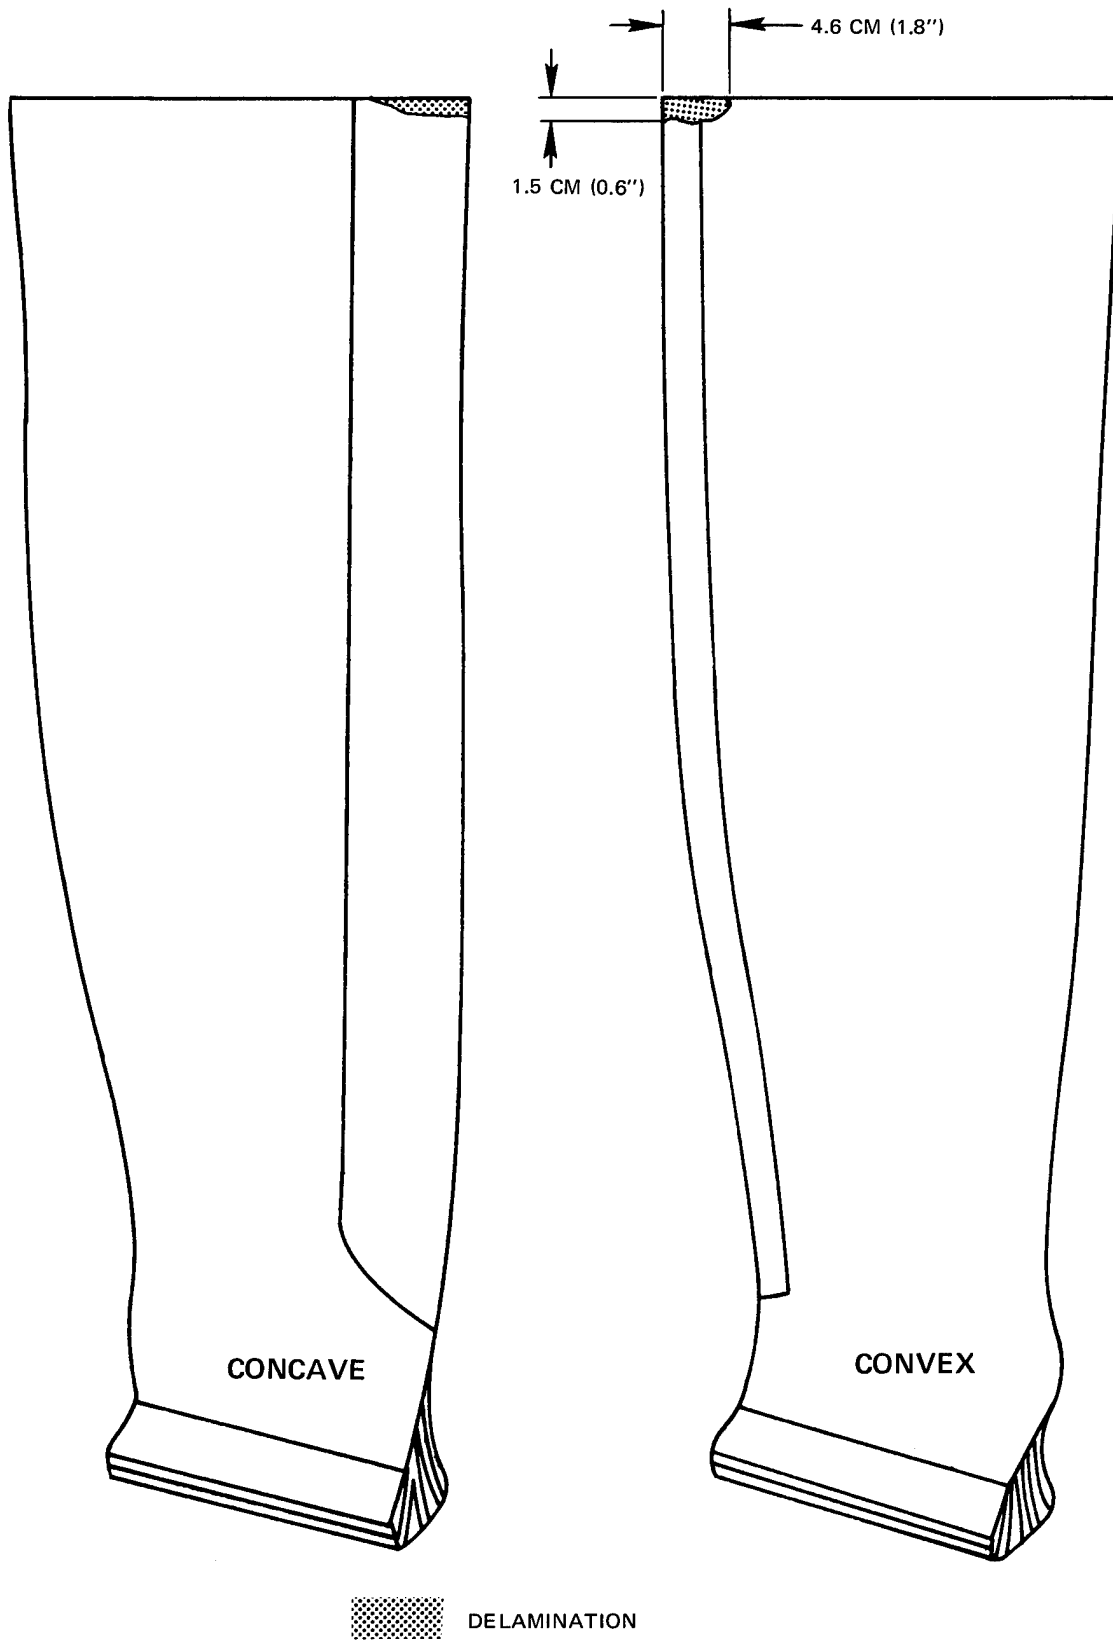
Figure 23 Visual Damage to Graphite/Epoxy Blade C-1 Following Impact with Ice Ball

In the 5.1 cm (2.0 in) diameter ice ball impact tests of blades C-1 and B-1, the high speed movies showed that the ice ball shattered upon contact with the blade leading edge in each case. Visual damage to the two blades after impact with the 75g (2.6 oz) ice balls is shown schematically in Figures 23 and 24 and pictured in Figures 25 and 26. The small area of composite delamination on blade C-1 was in the area where ultrasonic indications of poor consolidation was found during pre-test NDI. This ultrasonic area grew during testing, as shown in Figure 27. The tip deflection caused by the impact tends to further loosen any existing delamination. Due to the designed thinness of the composite at the blade tip leading edge, the impact has an increased effect on this area.

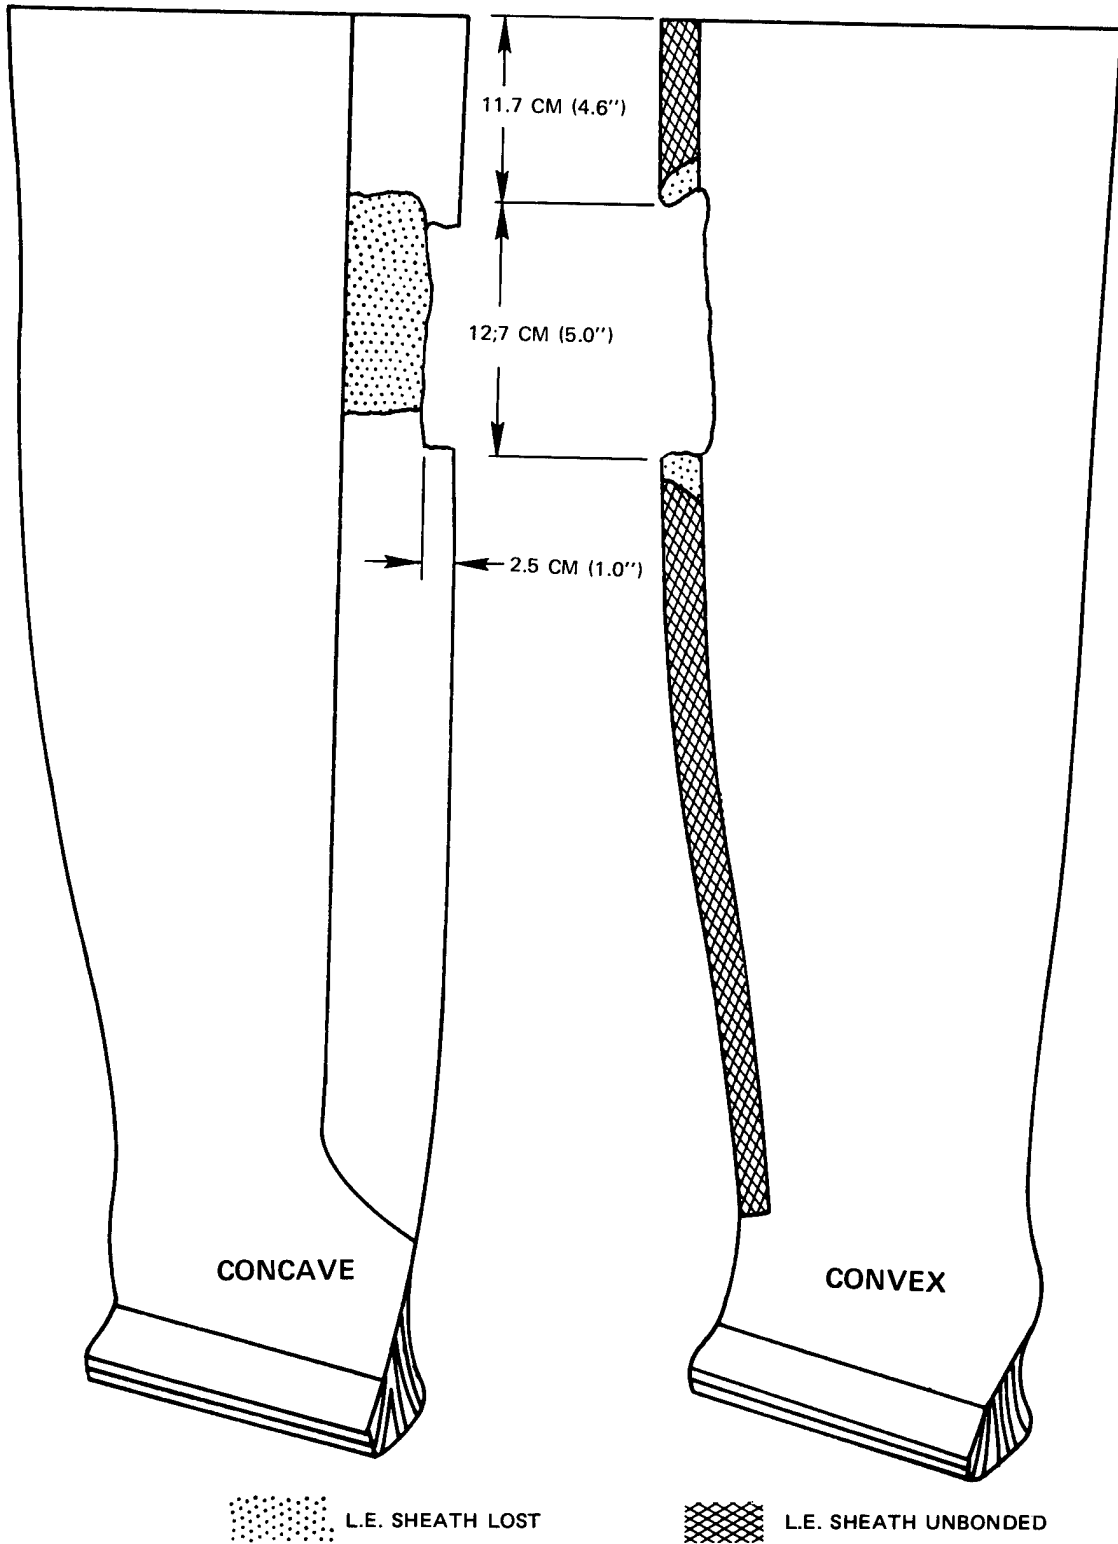
Figure 24 Visual Damage to Boron/Epoxy Blade B-1 Following Impact with Ice Ball

The damage to blade B-1 from the ice ball impact was more severe, however, no post-test ultrasonic indications were found. High speed movies show that blade B-1 took a large slice of the ice ball (approximately three-quarters of the ball), whereas blade C-1 hit the ice ball at its mid-point. This seems to be the only factor which affected the amount of damage sustained by each blade. The difference in FOD was not expected due to the composite material differences. The FOD threshold is very likely close to the ice ball weight of 75g (2.6 oz).

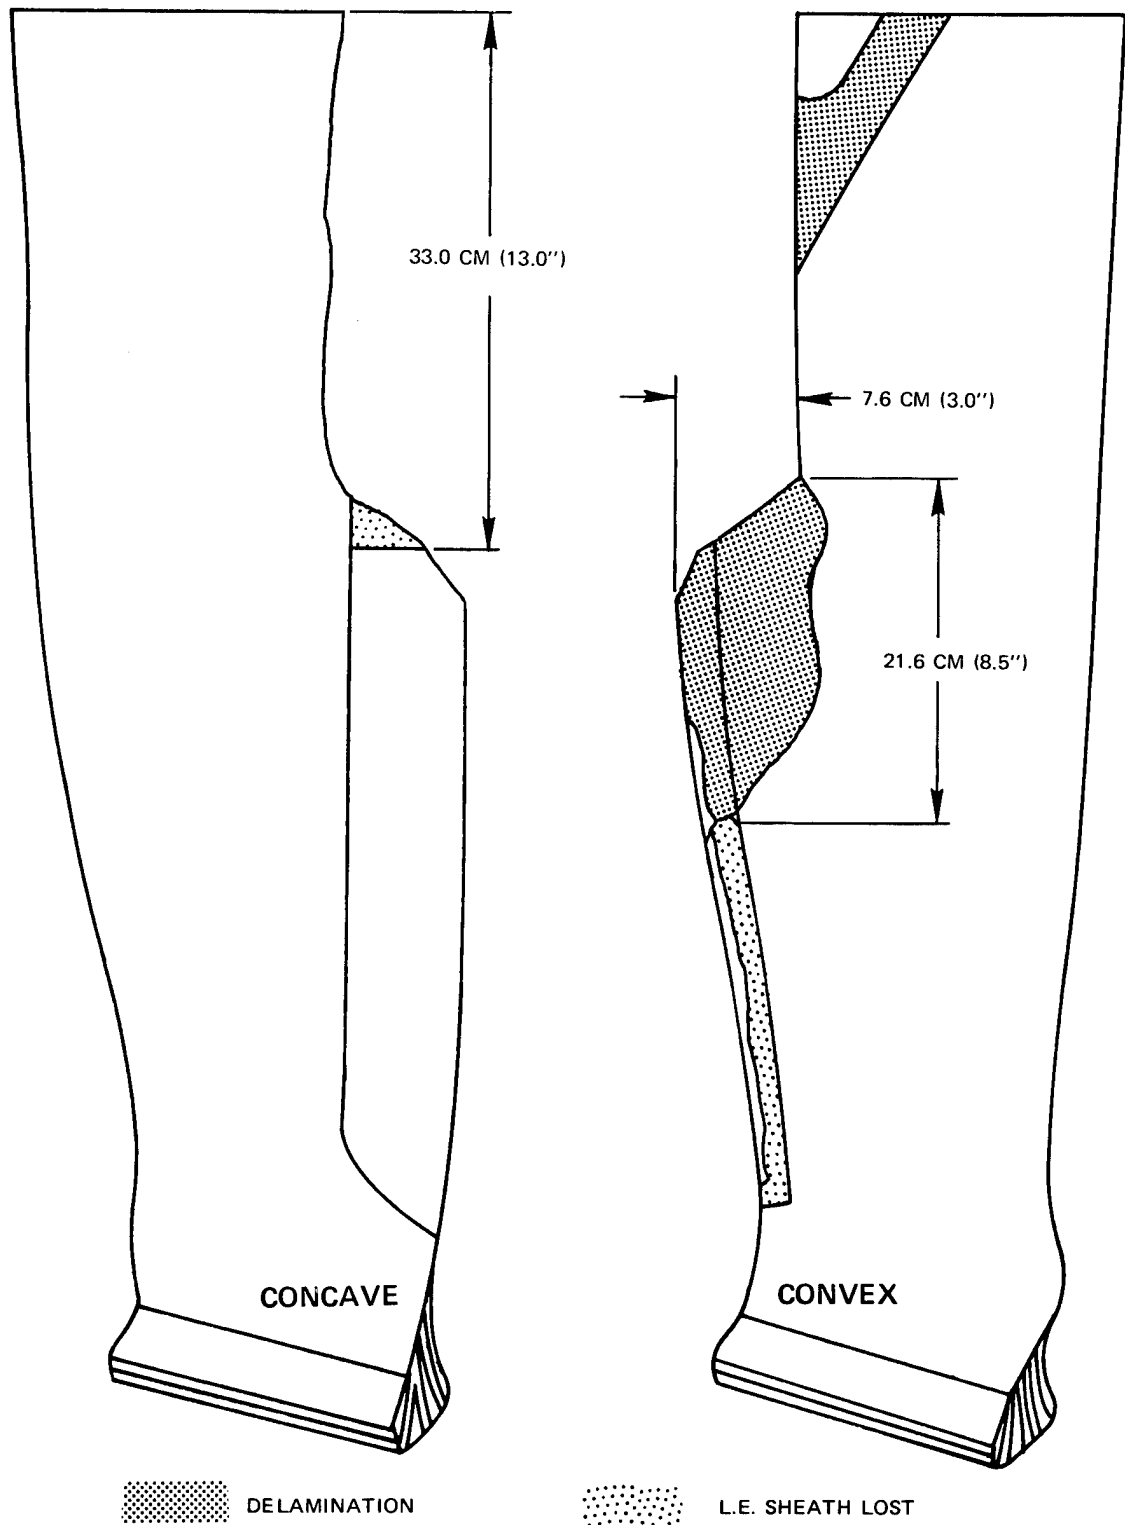
Figure 32 Visual Damage to Graphite/Epoxy Blade C-3 Following Impact with 165g Gelatin Ball

Blade C-3 sliced 105g (3.7 oz) from the 165g (5.8 oz) gelatin ball which impacted the blade leading edge at Section K-K. Visual damage is shown in Figures 32 and 33. Ultrasonic indications after testing were in the areas labeled as delamination in Figure 32.

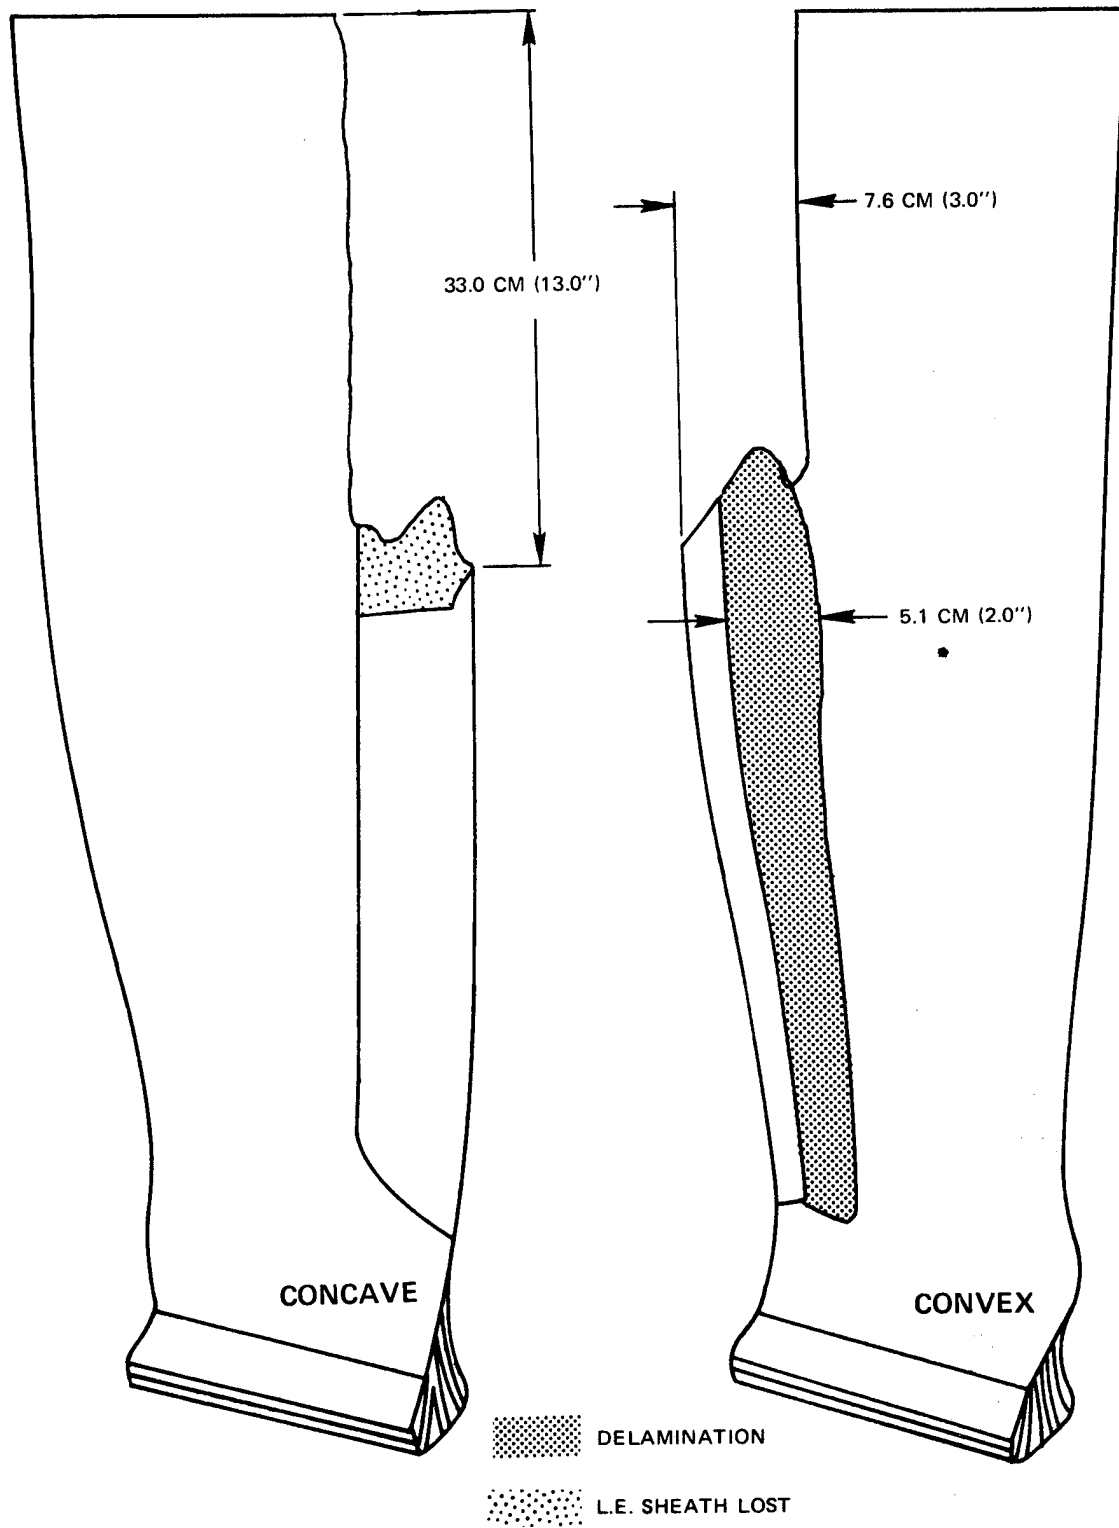
Figure 34 Visual Damage to Boron/Epoxy Blade B-2 Following Impact with 320g Gelatin Ball

In the test of boron/epoxy blade B-2, a slice greater than one-half of the 320 g (11.2 oz) gelatin ball was taken. The 210g (7.4 oz) slice impact caused the damage shown in Figures 34 and 35. No ultrasonic indications were found on blade B-2 following testing.

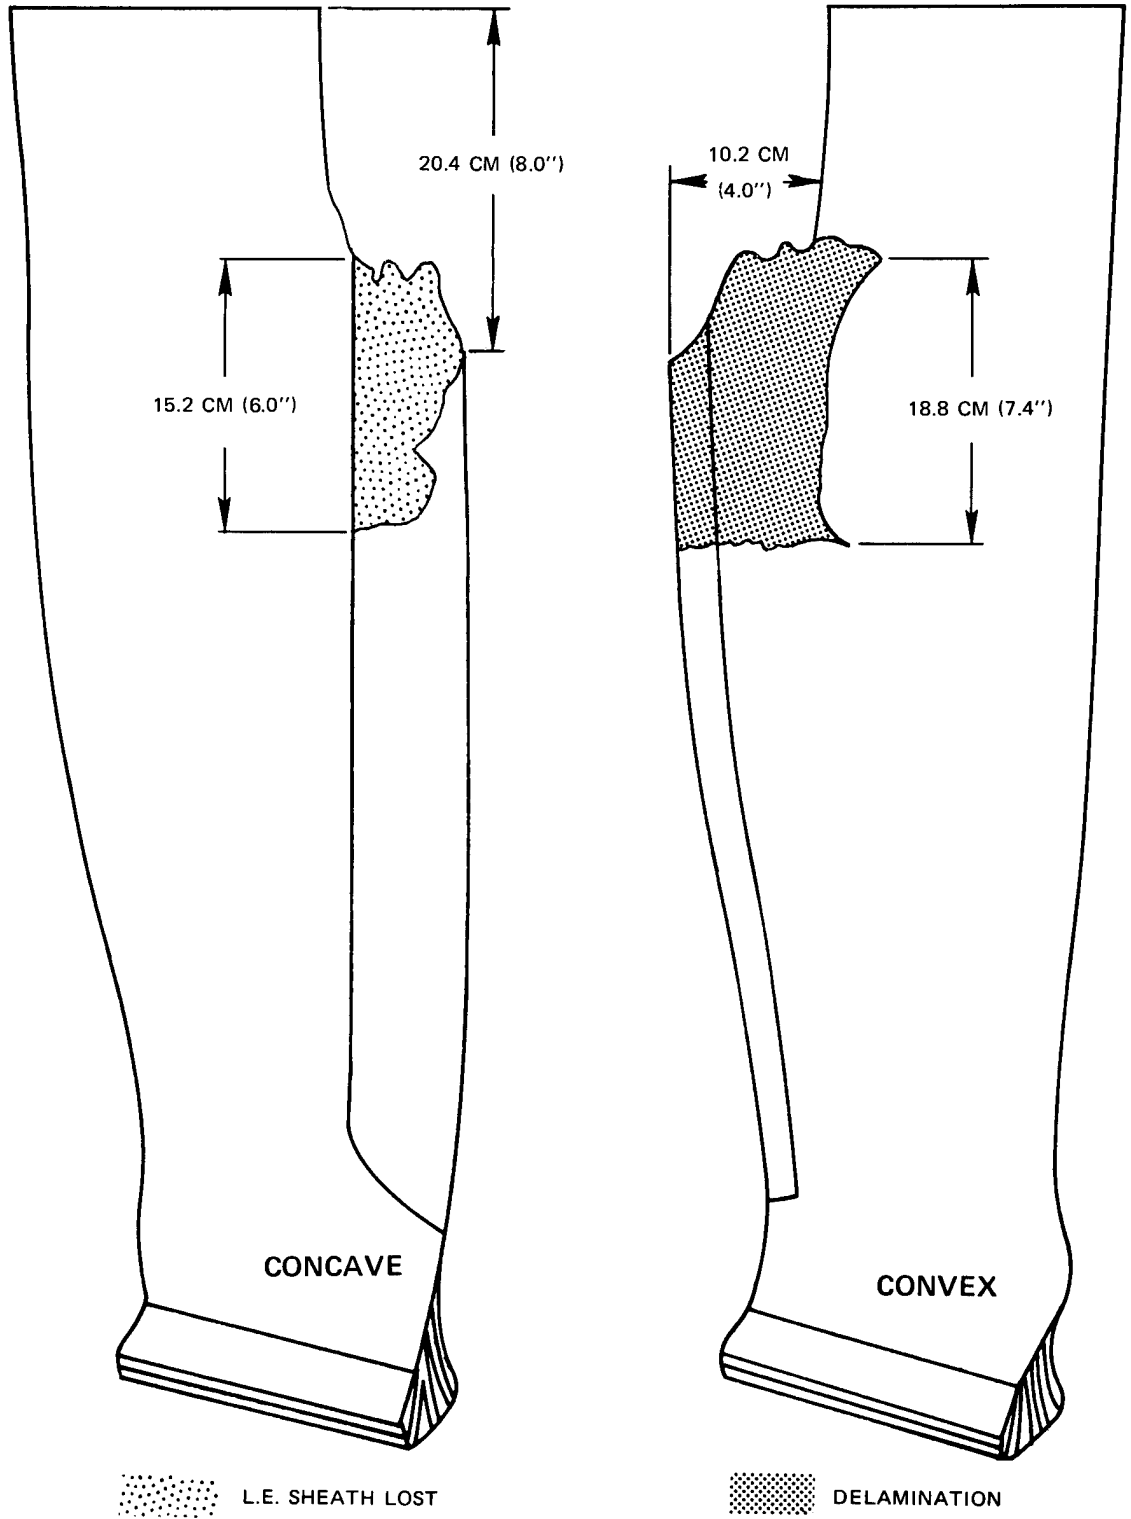
Figure 36 Visual Damage to Boron/Epoxy Blade B-3 Following Impact with 165g Gelatin Ball

Boron/epoxy blade B-3 was impacted with a 165 g (5.8 oz) gelatin ball, however, a malfunction in the drop mechanism caused only a 25g (.9 oz) slice to be taken. The blade was visually and ultrasonically inspected following this impact and found to be undamaged. Blade B-3 was then retested with a new 165g gelatin ball. A 130g (4.6 oz) slice was cut from this ball and blade damage did occur as shown in Figures 36 and 37. Post-test ultrasonic indications correspond to the area shown as delaminated in Figure 36.

The FOD threshold for boron/epoxy blades was determined to be below a 130g (4.6 oz) gelatin ball slice size from the B-3 impact test. However, the severity of damage with the 210g (7.4 oz) slice taken by blade B-2 was not significantly worse than the B-3 damage.

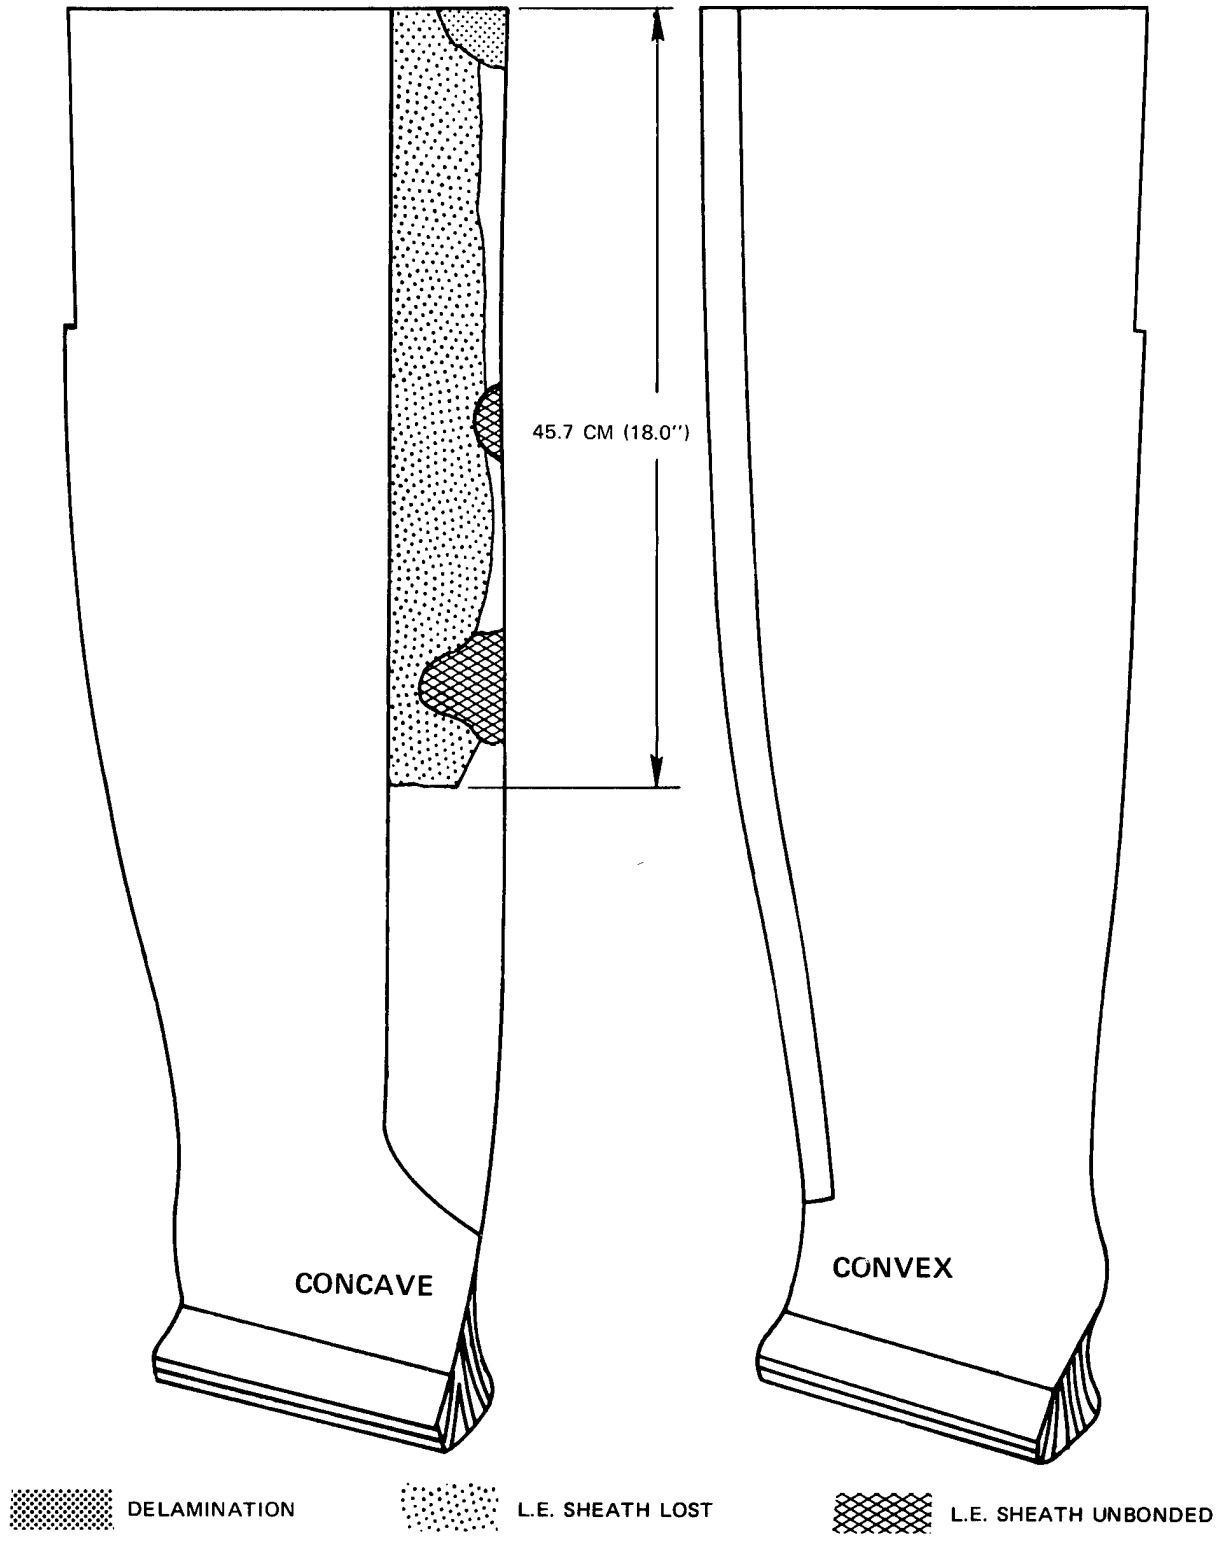
Figure 44 Visual Damage to Graphite/Epoxy Blade C-4 Following Impact with Gravel

Blade C-4 and B-4 were each impacted with 30g (1.1 oz) of gravel. The leading edge sheath on the concave side of C-4 came off the blade as shown in Figures 44 and 45. This failure indicates the possibility of a poor bond between the blade and sheath, although pre-test NDI showed no lack of bonding. Post-test ultrasonic inspection showed indications in the two areas illustrated in Figure 46.

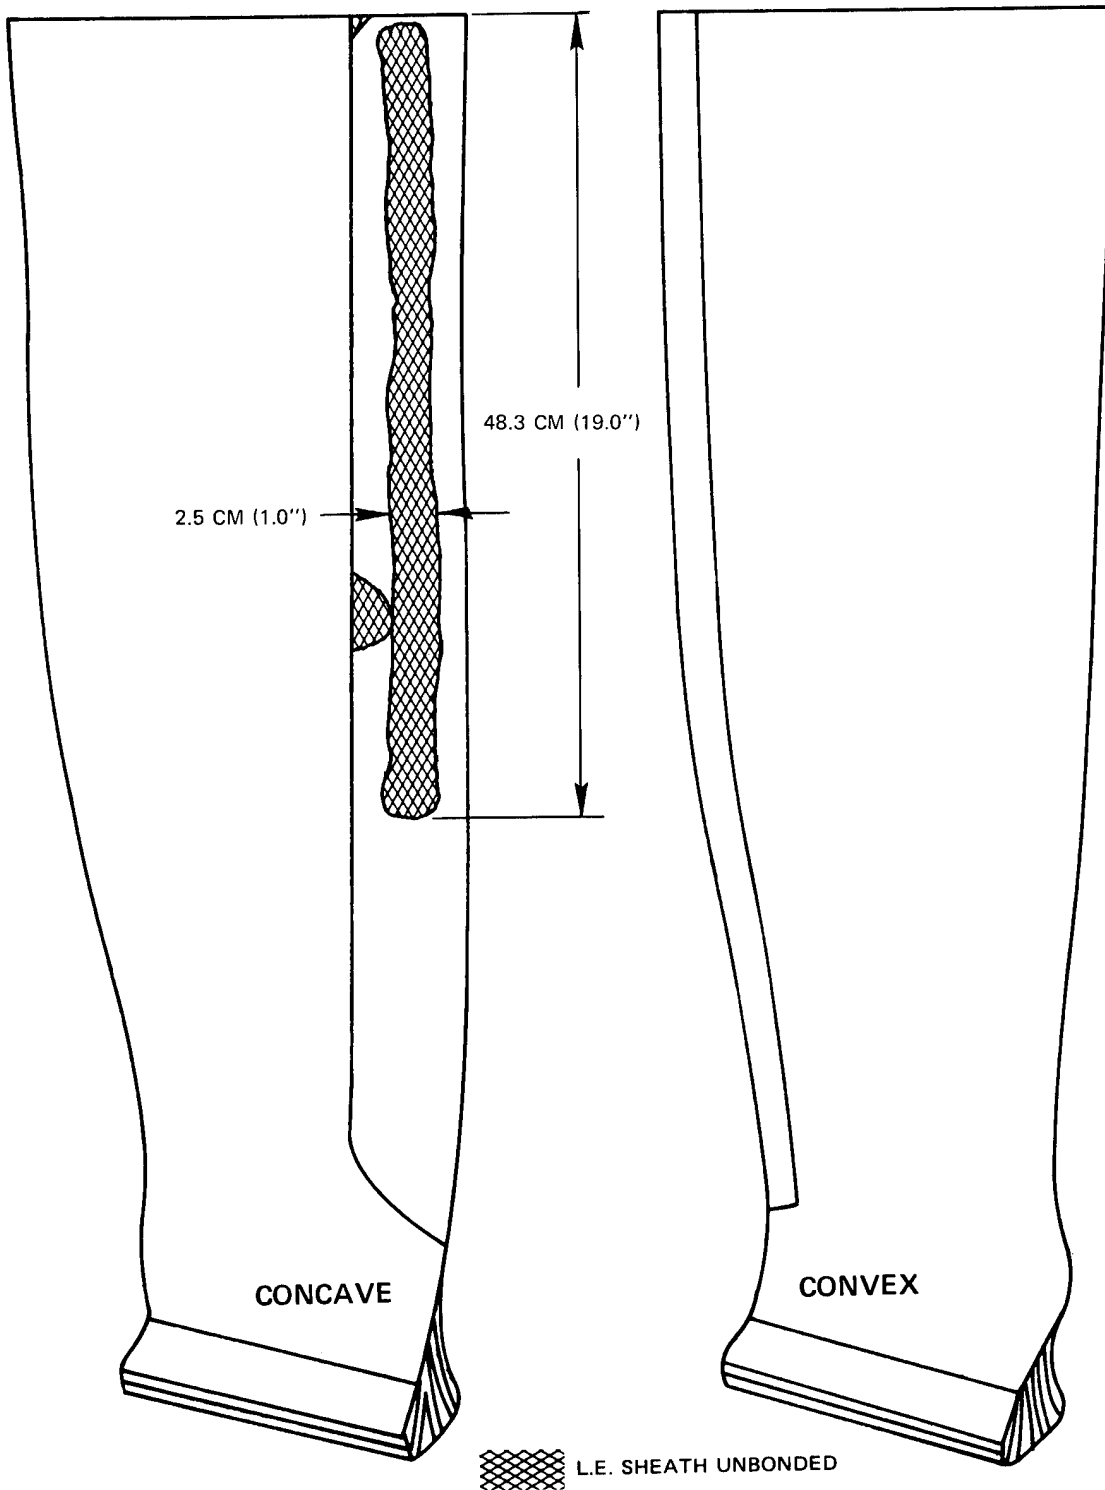
Figure 47 Visual Damage to Boron/Epoxy Blade B-4 Following Impact with Gravel

The gravel impact results on blade B-4 are shown in Figures 47 and 48. No ultrasonic indications were found after testing. Damage at the leading edge is negligible, even though the high-speed movies show that impacts did occur at this location. However, the concave side sheath, aft of the leading edge, was nicked, gouged, and unbounded, as pictured in Figure 49. The gravel apparently strikes the sheath causing compressive stresses on the sheath exterior surface. The stress differential within the sheath is great enough to break the sheath-to-blade bond and then lift the sheath from the surface of the blade. Therefore it is concluded that with a better bond between sheath and blade, the leading edge sheath could offer satisfactory protection from small amounts of gravel ingestion.

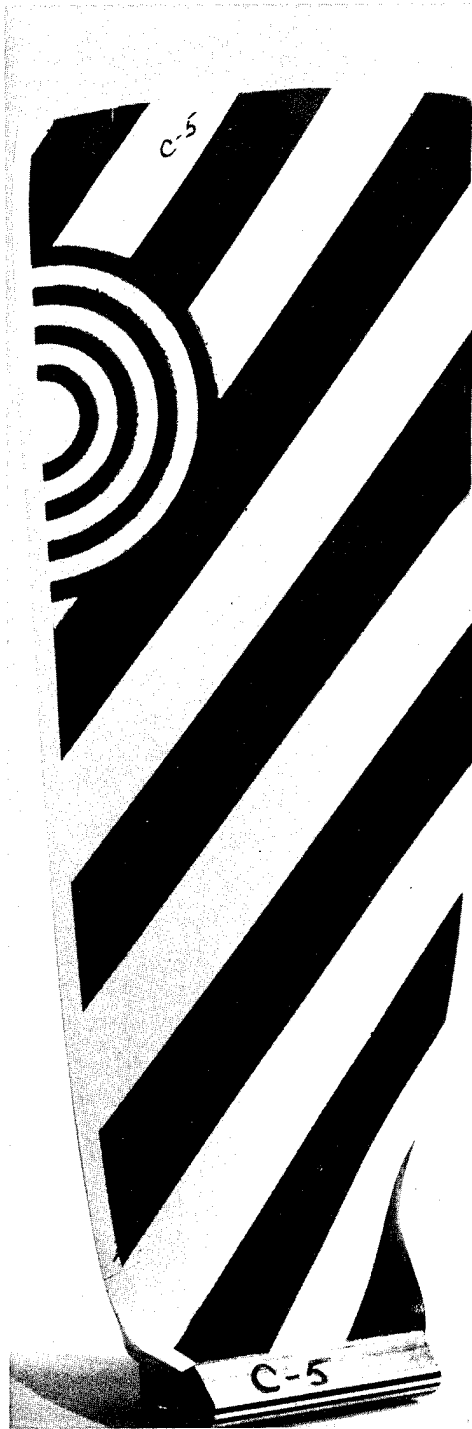
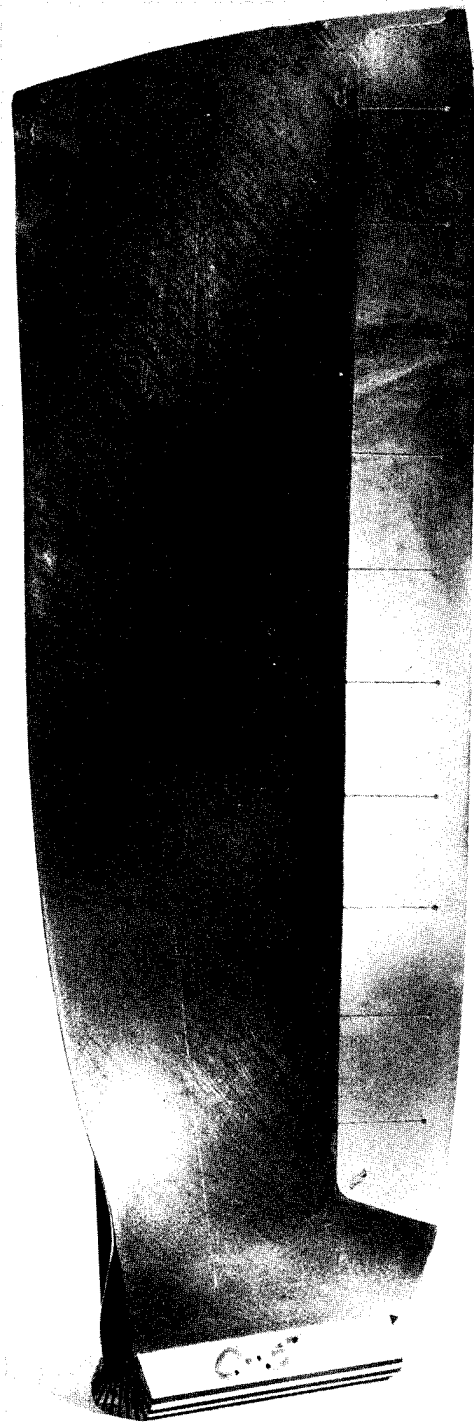
Figure 50 Graphite/Epoxy Blade C-5 Following Impact with 75g Starling

Blade C-5 and B-5 were impacted with 75g (2.6 oz) and 80 g (2.9 oz) starlings, respectively. The 40g (1.4 oz) slice taken by C-5 and the 45g (1.6 oz) slice cut by B-5 caused only slight damage in each case. The damage which occurred seems to be related to blade fabrication problems. Both blades are pictured in Figures 50 and 51 respectively.

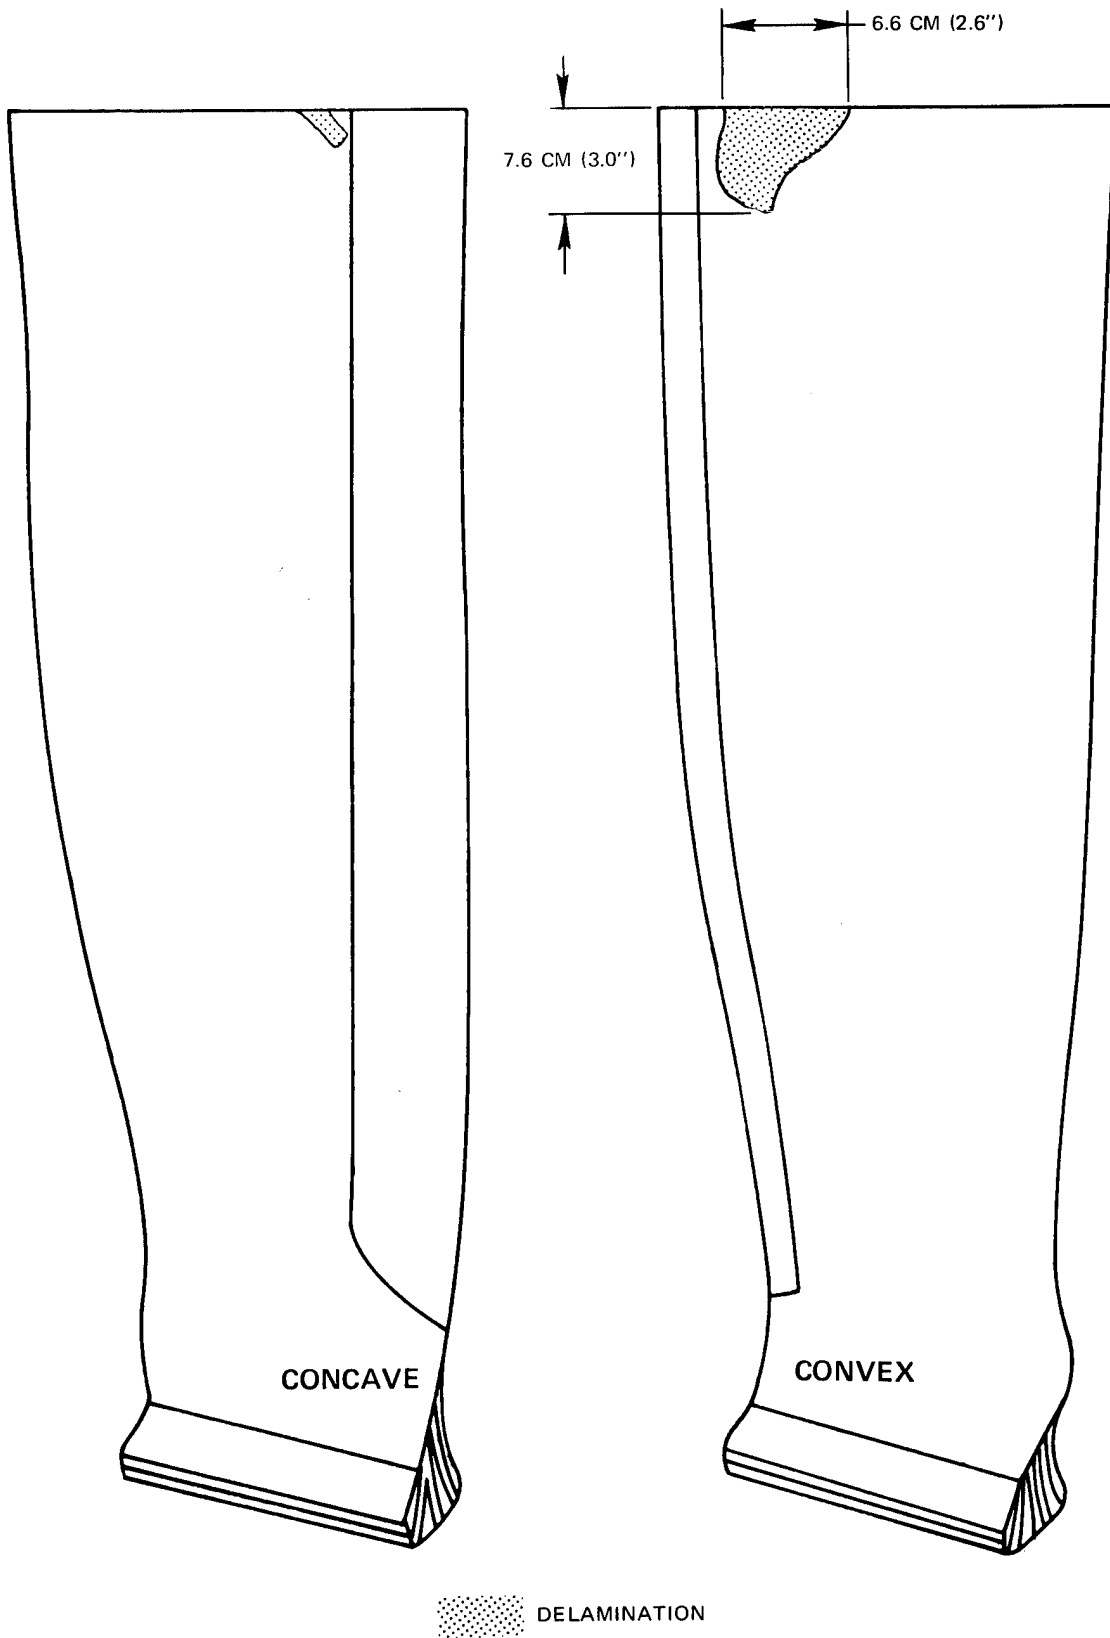
Figure 52 Visual Damage to Graphite/Epoxy Blade C-5 Following Impact with Starling

The visually delaminated area of C-5 shown in Figure 52, which also corresponds to post-test ultrasonic indications, is in a location where a pre-test ultrasonic indication was present. The starling impact caused this area of delamination to grow. If the blade had been well consolidated in this area, possibly no damage would have occurred from the impact.

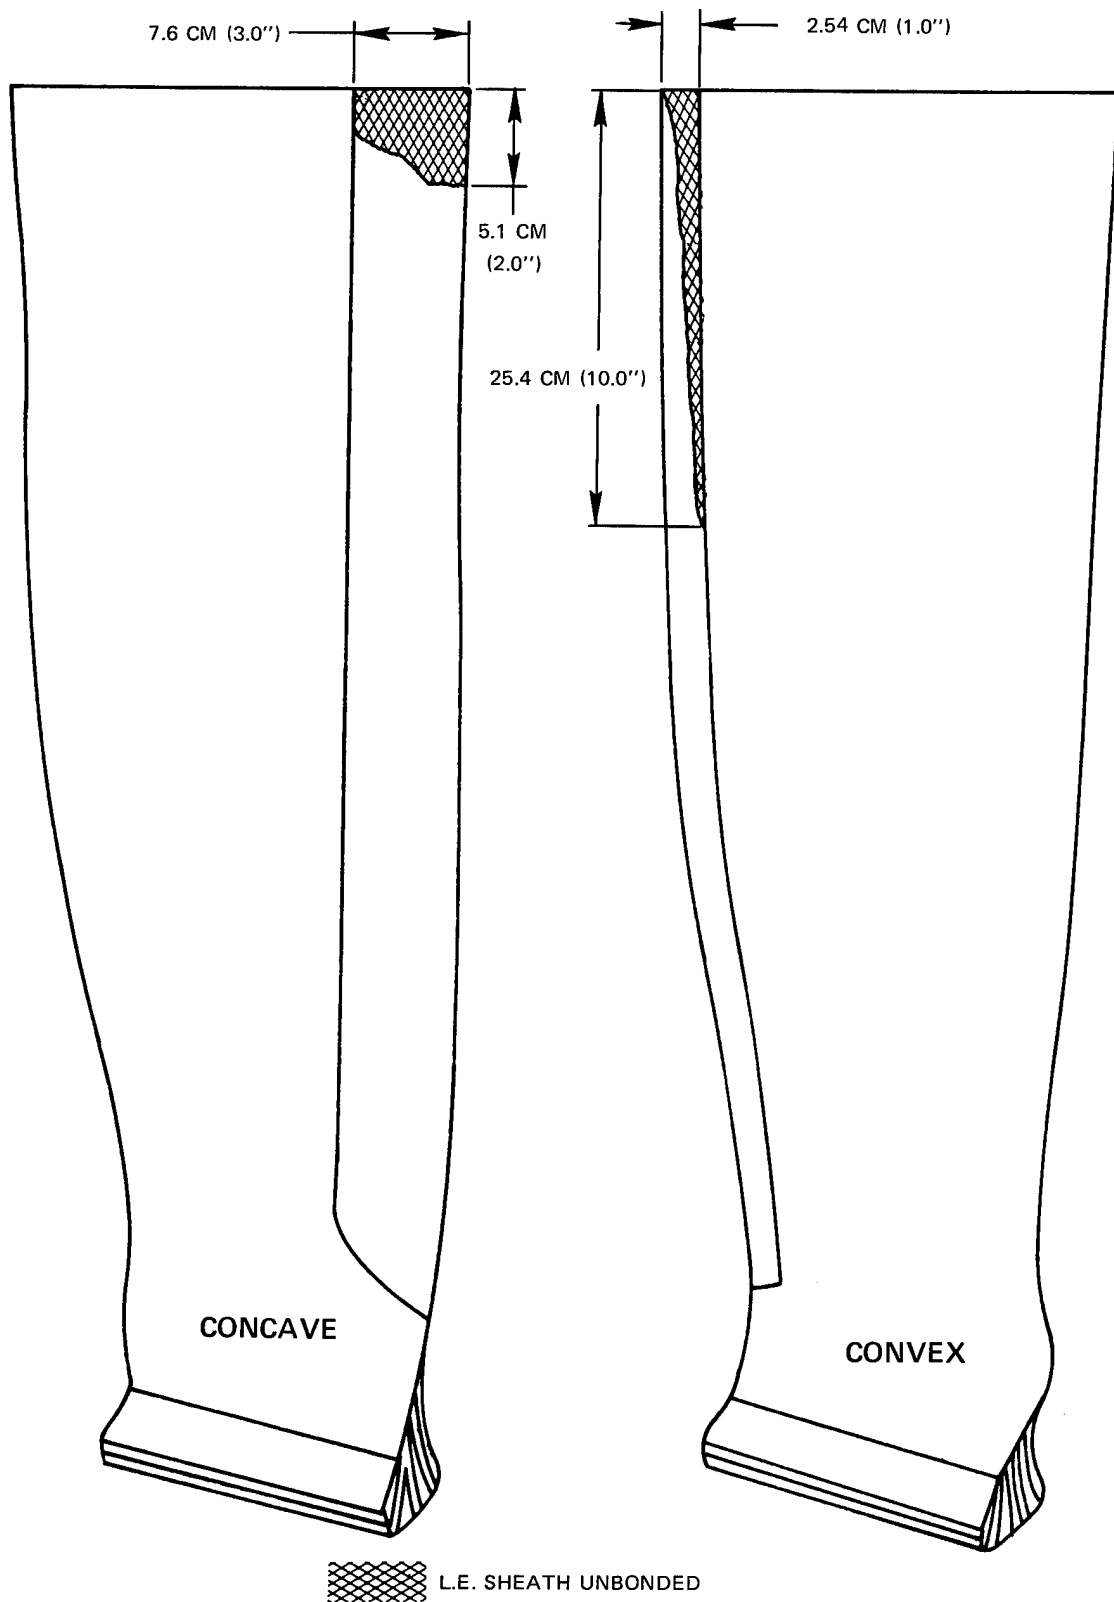
Figure 53 Visual Damage to Boron/Epoxy Blade B-5 Following Impact with Starling

Only a small amount of leading-edge sheath unbonding, as shown in Figure 53, resulted from B-5 starling impact. Better bonding of the sheath to the blade could perhaps prevent such damage. No post-test ultrasonic indications were found on this blade.

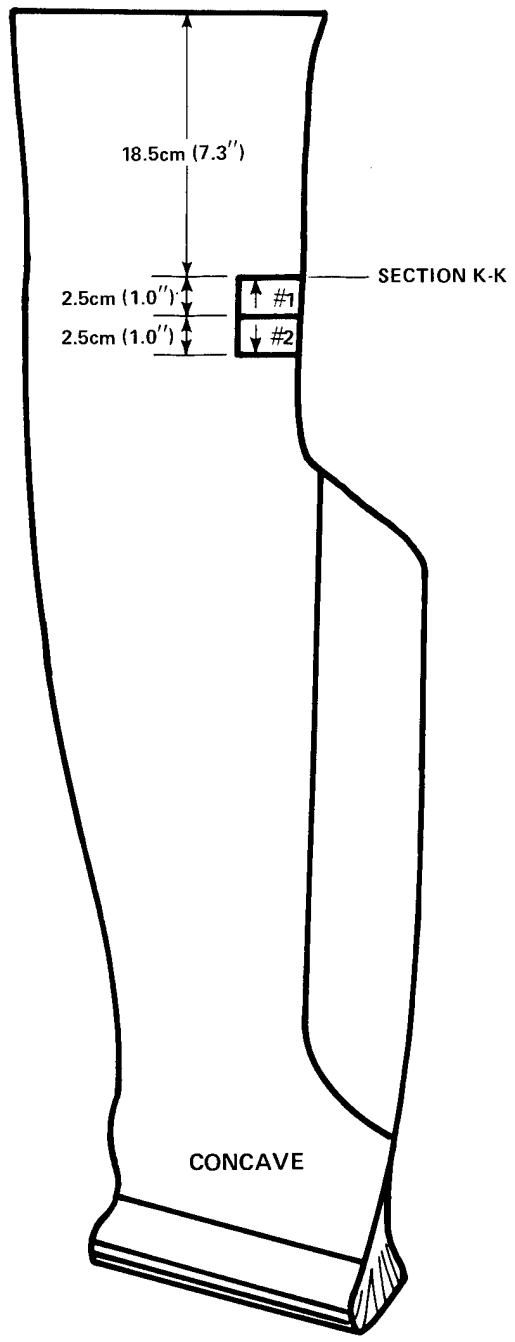
Figure 54 Metallographic Section Locations - Graphite/Epoxy Blade C-3

Graphite/epoxy blade C-3 was sectioned in the area of the impact damage for metallographic study. Two chordwise sections were examined, as illustrated in Figure 54. Section 1 revealed a shear crack of approximately .41 cm (.16 in) length angled at 40° from the concave blade surface as shown in Figure 55. Section 2, pictured in Figure 56, revealed five interlaminar separations which propagated for a length of .10 cm (.04 in) to .66 cm (.26 in) in the chordwise direction. No internal composite damage was found further away from the broken area of the blade.

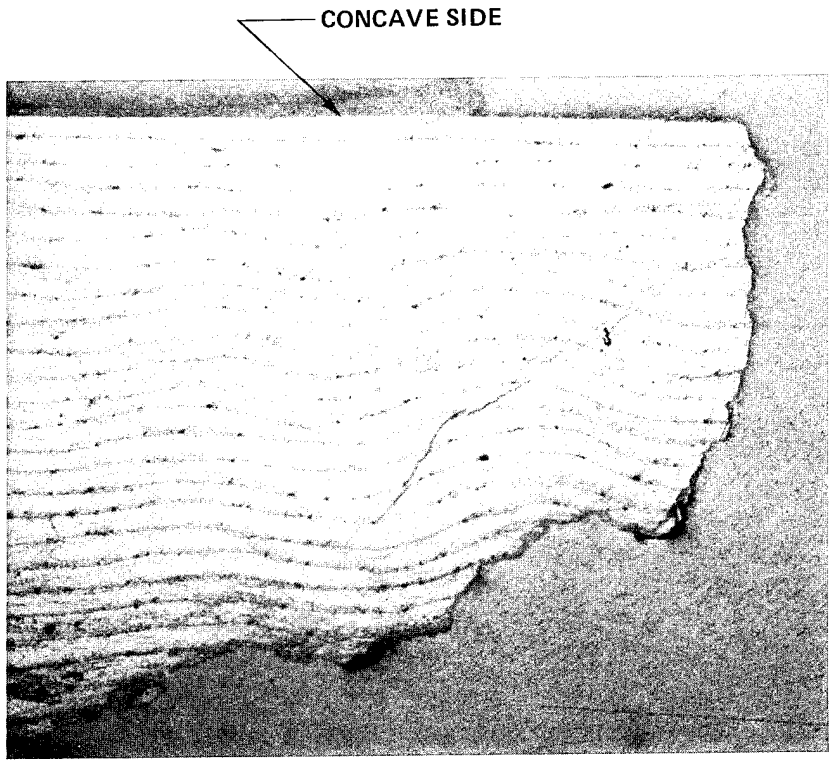
Figure 55 Photo-micrograph of Area 1, (Figure 54), of Graphite/Epoxy Blade C-3 Showing Shear Crack (15X)

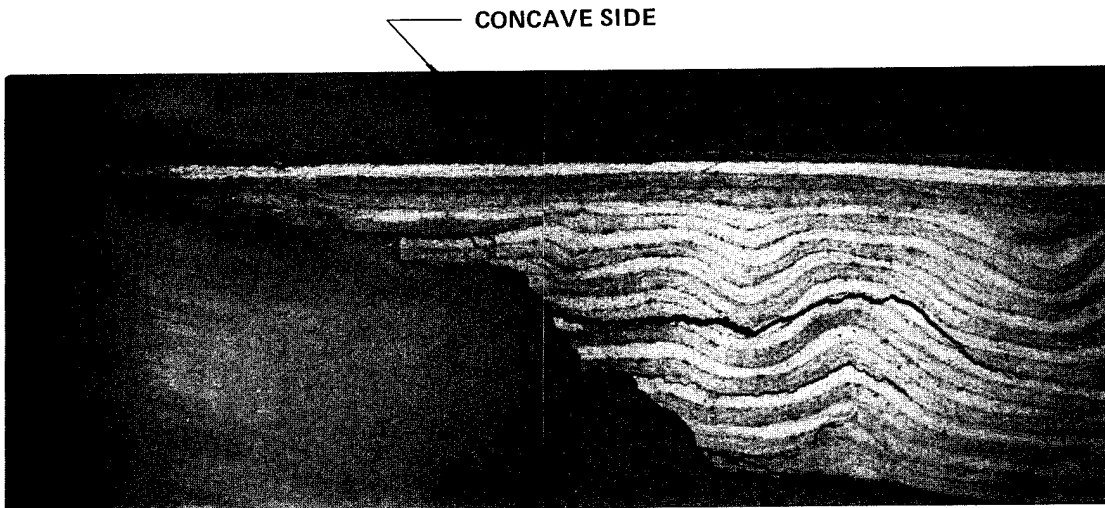
Figure 56 Photo-micrograph of Area 2, (Figure 54), Graphite/Epoxy Blade C-3 Showing Interlaminar Separations (13X)
