**United States Air Force  
611th Civil Engineer Squadron**

**Remedial Investigation Report  
Galena Airport and Campion Air Station**

March 1996

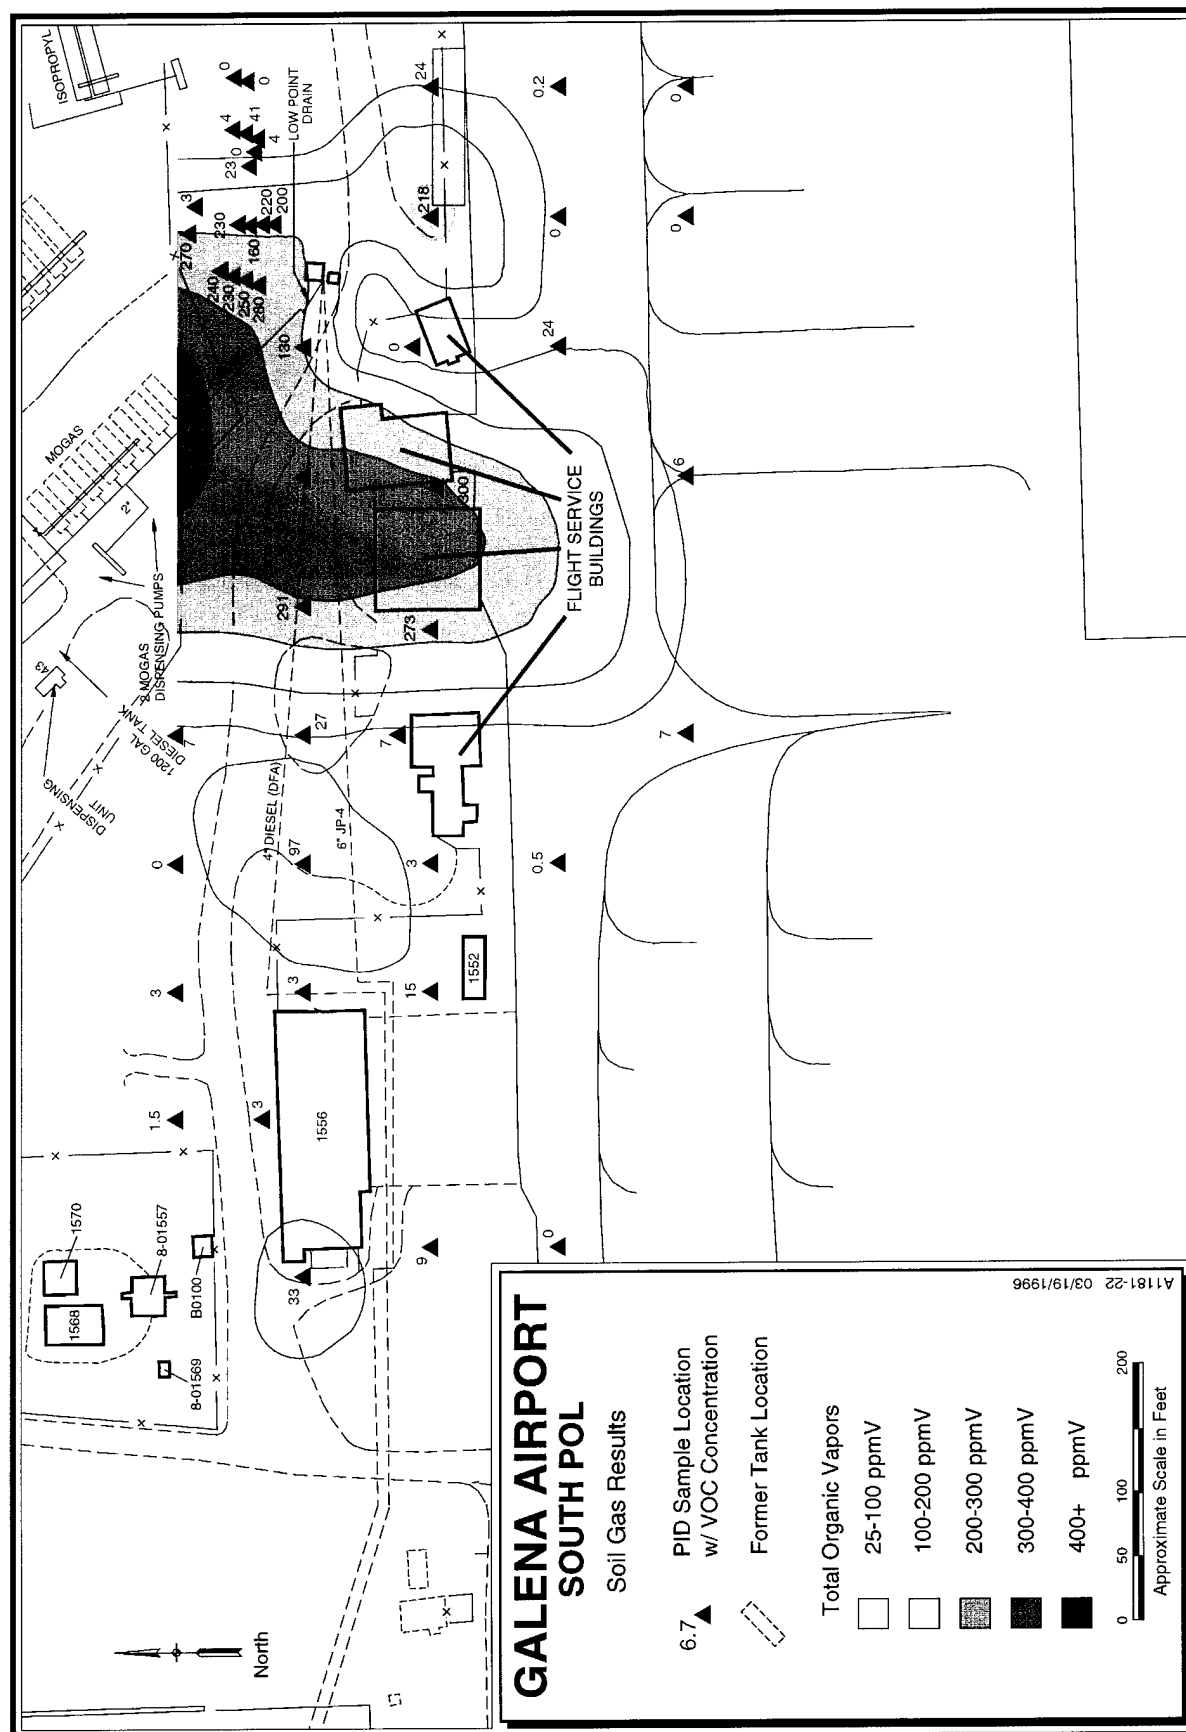
**Figure 3.3-5. Soil Gas Survey Results for the Southern POL Tank Farm Area (ST005)**

No discrete sources could be distinguished in the southeast POL Tank Farm using the soil gas results. It appears that the horizontal and vertical movements of the water table may have obscured any individual source areas. Data from 31 soil gas samples, presented in Figure 3.3-5, indicate that two lobes of elevated soil gas concentrations extend southwest from the POL Tank Farm past the air services buildings. The area between these lobes includes portions of the TS site where soil borings encountered ice lenses. These areas of permafrost may be blocking contaminant migration or interfering with soil gas measurements. Soil gas data collected by the 11 CEOS in 1993 (not shown in Figure 3.3-5) show similar distribution patterns. The soil gas results shown in Figure 3.3-5 indicate two smaller areas of hydrocarbon contamination in the southern part of the POL Tank Farm. One area is just west of Building 1556 (the fire station), and the second is north of the Tanana Air Services building. The source of organic vapors detected in these areas is uncertain. The low levels of organic

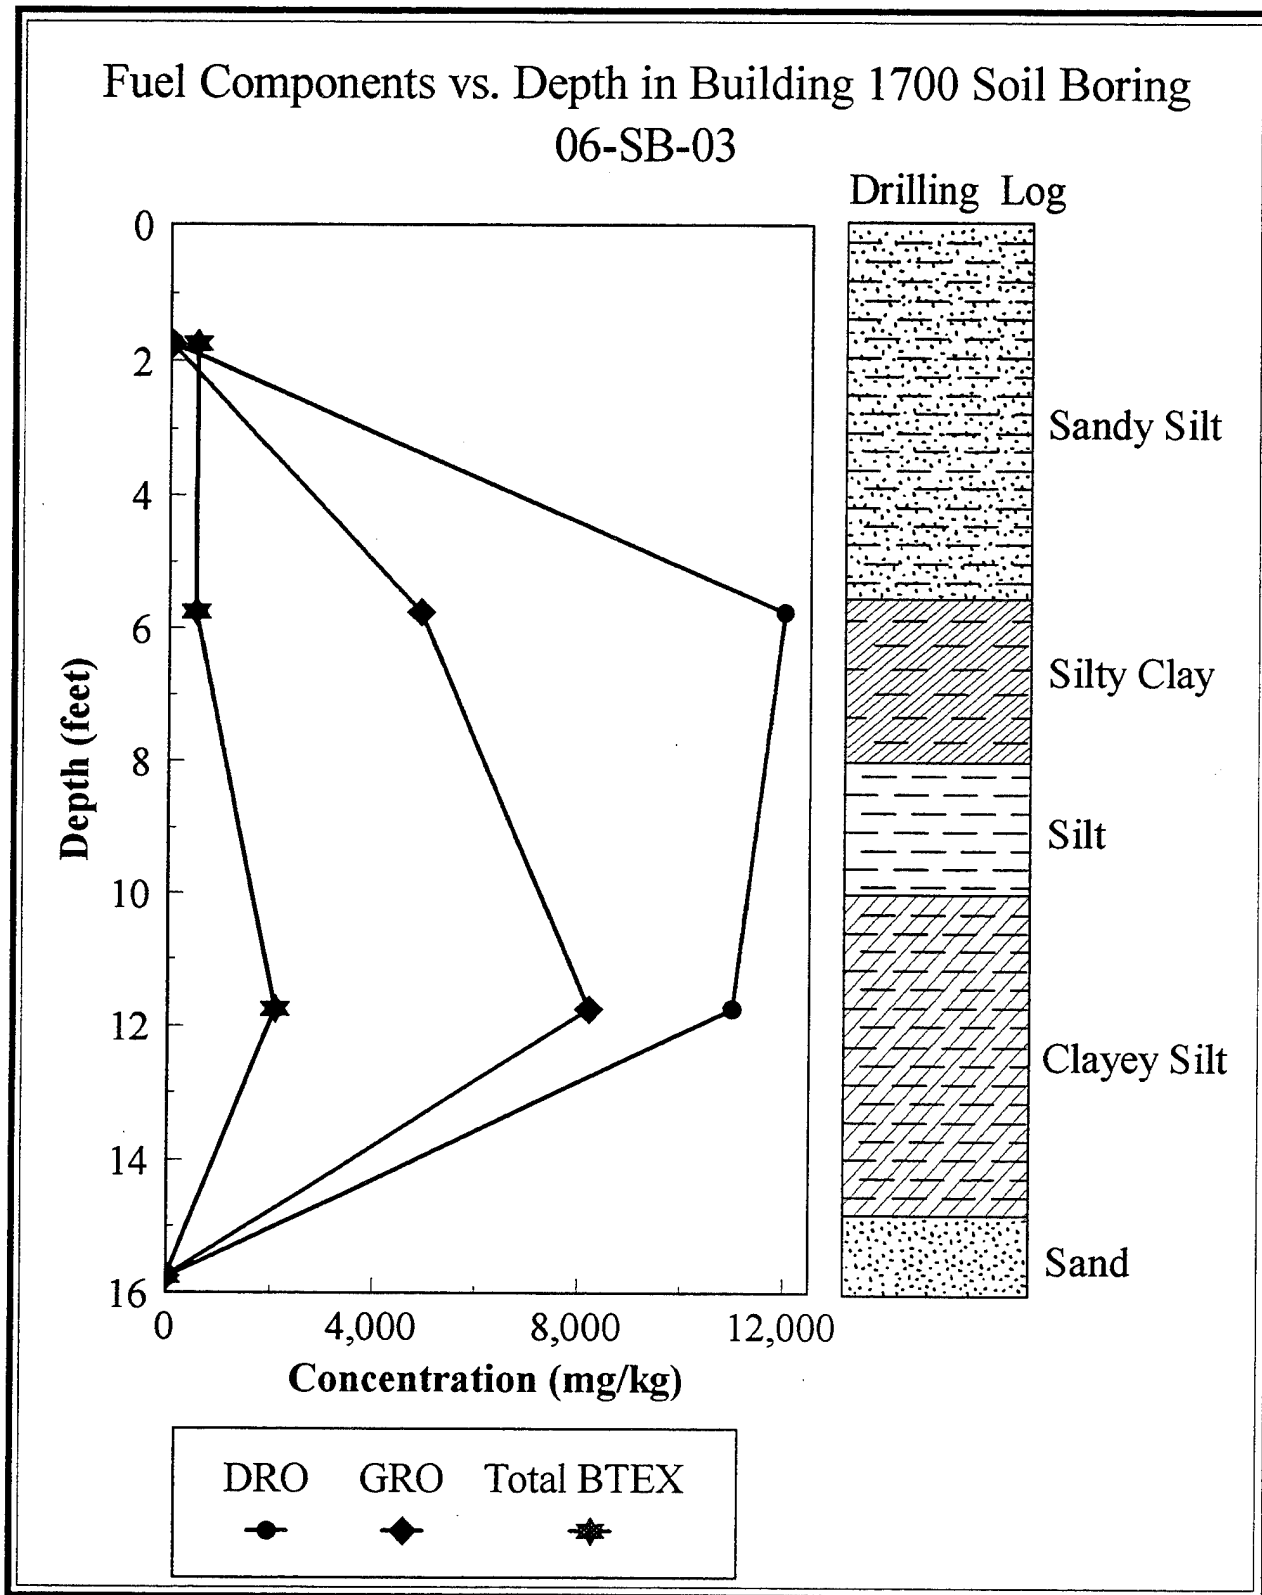
Figure 3.4-8. Concentrations of BTEX, DRO and GRO vs. Depth in Soil Boring 06-SB-03 at the Building 1700 Source Area

One soil boring, 06-SB-03, was placed at the southwest corner of Building 1700 to further investigate the nature and vertical extent of the contamination identified by field screening activities. The results, summarized in the attachment to Section 3.4, indicate the presence of fuel-related contaminants. Benzene and total BTEX concentrations gradually increase with depth up to 12 ft bgl. From the surface to approximately 10 ft bgl, the concentrations of BTEX compounds exceed the screening criteria; from approximately 4 to 10 ft bgl, DRO and GRO exceed the screening criteria. At depths of 14 to 16 ft, the contaminant concentrations drop sharply, indicating limited vertical migration. The changes in BTEX, DRO, and GRO concentrations with depth are shown in Figure 3.4-8.

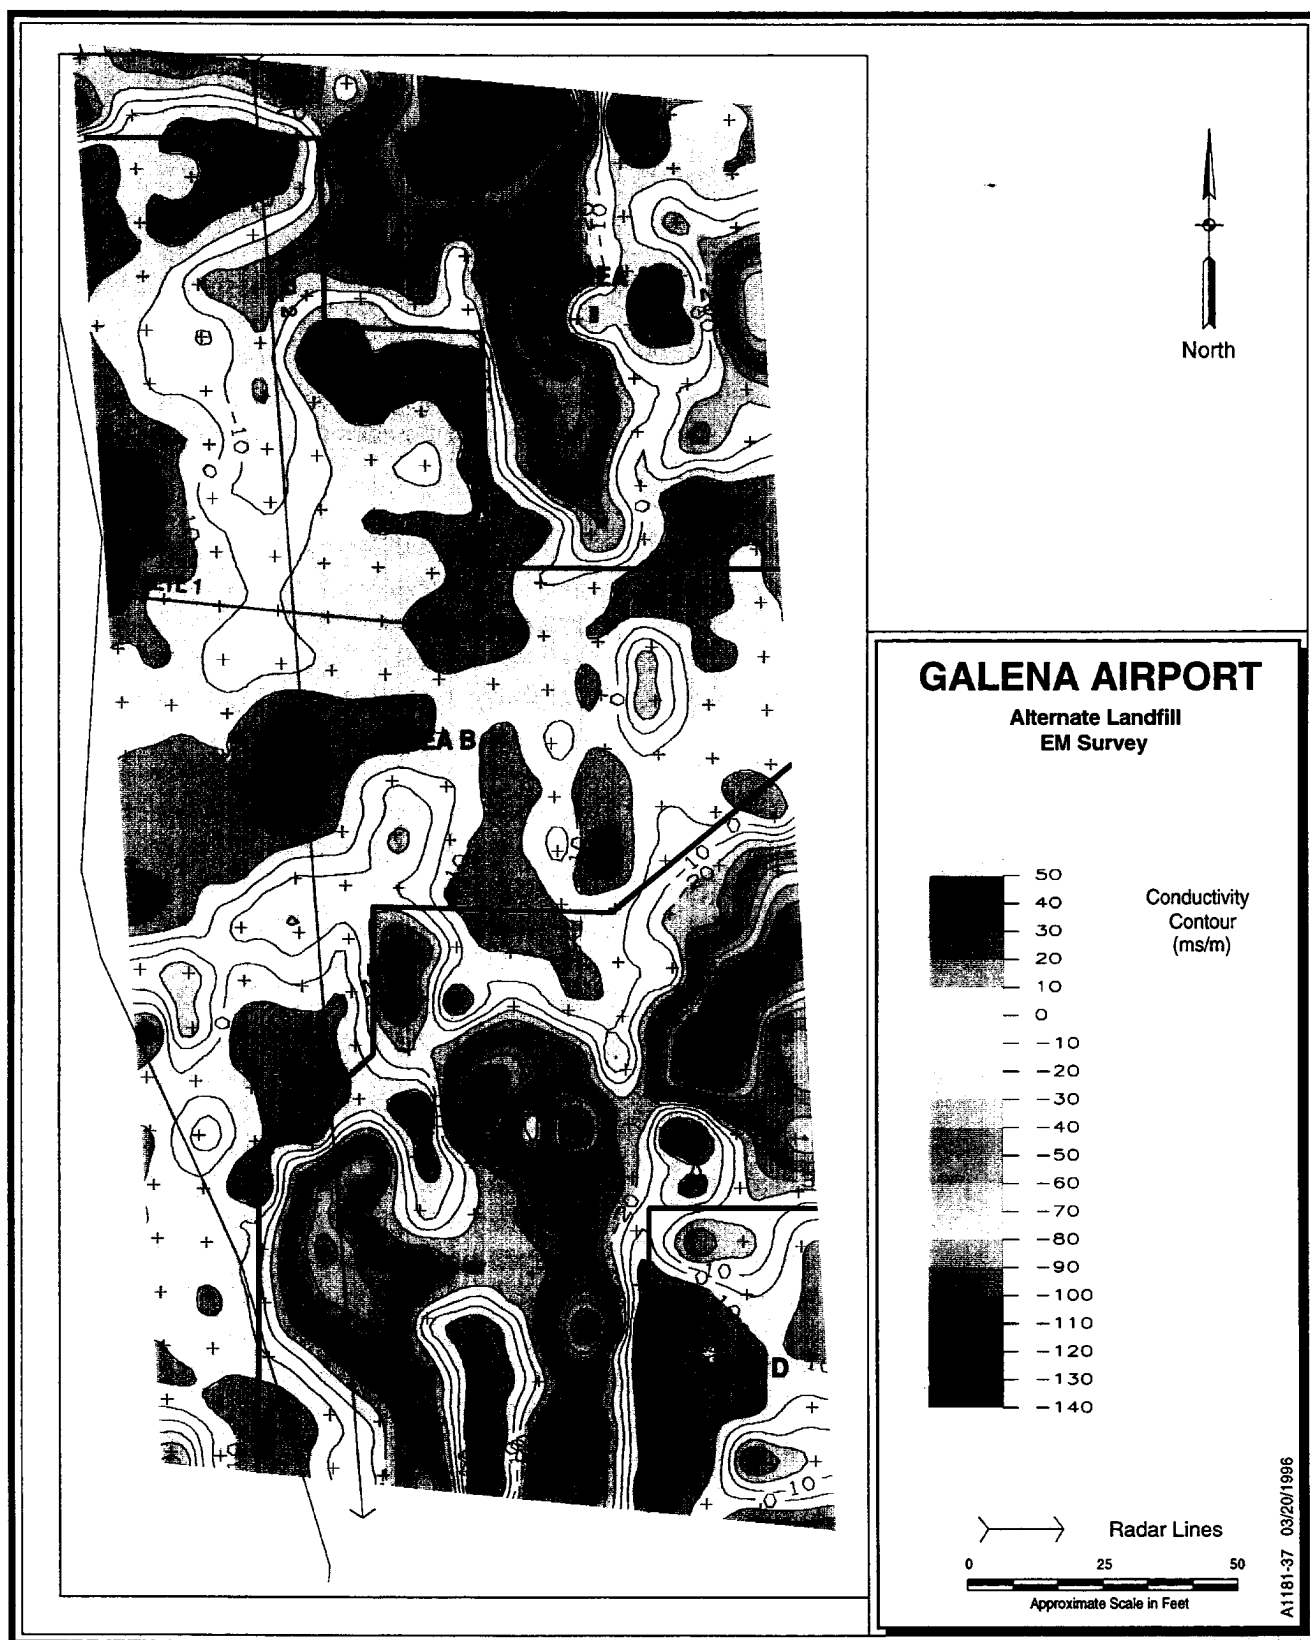
Figure 3.8-1. EM and GPR Contours at the Alternate Landfill

The EM and GPR surveys identified several areas that potentially have buried metallic objects. Figure 3.8-1 also shows contour maps of the ground conductivity data collected at the Alternate Landfill. Two main areas of EM anomalies were defined by the surveys, one in the north-
