# Naval Research Laboratory

NRL/MR/7333--96-7725

## Fungal Contamination of H-53 Aircraft

DENNIS M. LAVOIE  
BRENDA J. LITTLE

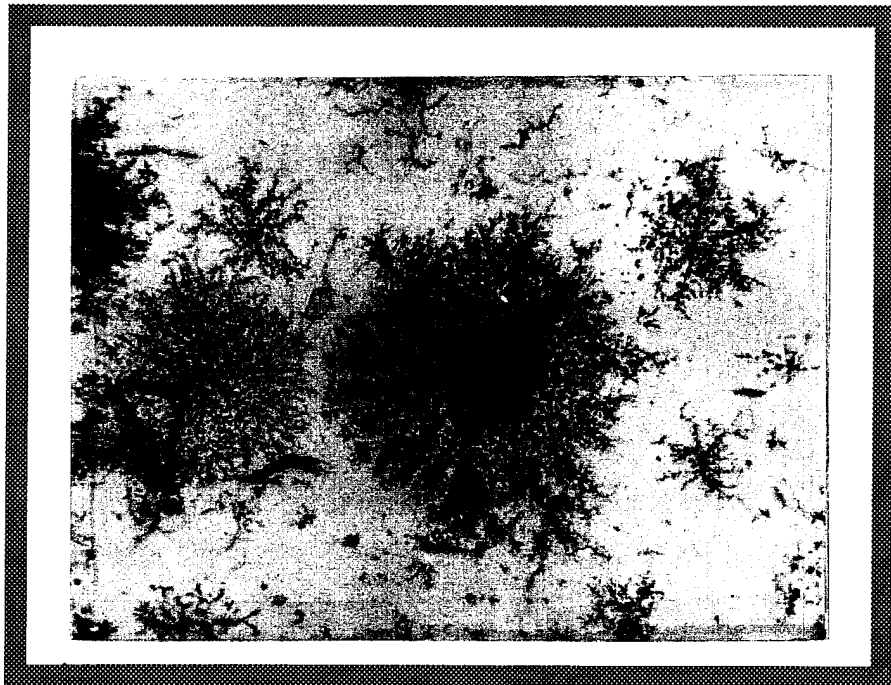
Figure 4: Dry type fungal growth on polyurethane coated aluminum (6x).

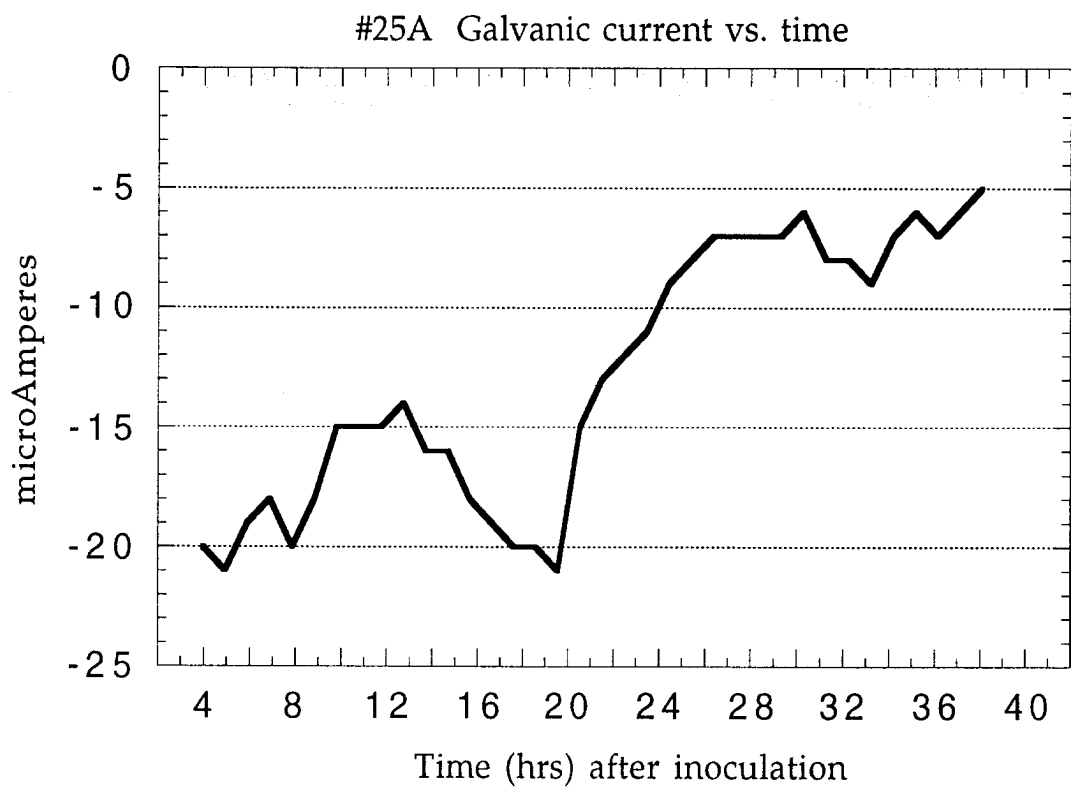
Galvanometer current and polarity results are preliminary but suggest that at least two fungal isolates are capable of causing corrosion of aluminum. Figure 7a & b. As described in Methods, cells were set up such that a positive current (i.e., anodic, giving up electrons) indicated that corrosion was occurring on the coupon inoculated with fungi. The cell inoculated with isolate 23A (*Aureobasidium*) went from cathodic (negative current) to anodic (positive current) during the course of the experiment. The cell inoculated with isolate 25A (*Trichoderma*) exhibited a trend toward anodic conditions, although a transition was never actually achieved. ESEM examination of the coupons revealed the surfaces were heavily coated with oxide with little visible evidence of mycelial growth, so the exact nature of attack could not be confirmed.

Videla (1986) demonstrated that the Deuteromycete *Cladosporium* in liquid culture caused corrosion of unprotected aluminum. Conditions similar to liquid culture might be expected in bilge compartments of helicopters when water, oil, and salt air combine with fungal spores. Our purpose in designing a non-immersion electrochemical cell was to test corrosion potential under sub-aerial conditions found in other parts of the aircraft. This design is new and conclusions drawn from its use are tentative; however, preliminary data suggest that the coupon exposed to one of the isolates (#23A) became anodic, as would be predicted if more corrosion were occurring in this coupon than in the sterile control. While the second isolate (#25A) did not have as strong an effect, the general trend in this test was toward anodic conditions, suggesting that the isolate was causing corrosion.

Figure 7: Galvanic currents in 2024 aluminum alloy in electrochemical test cells.

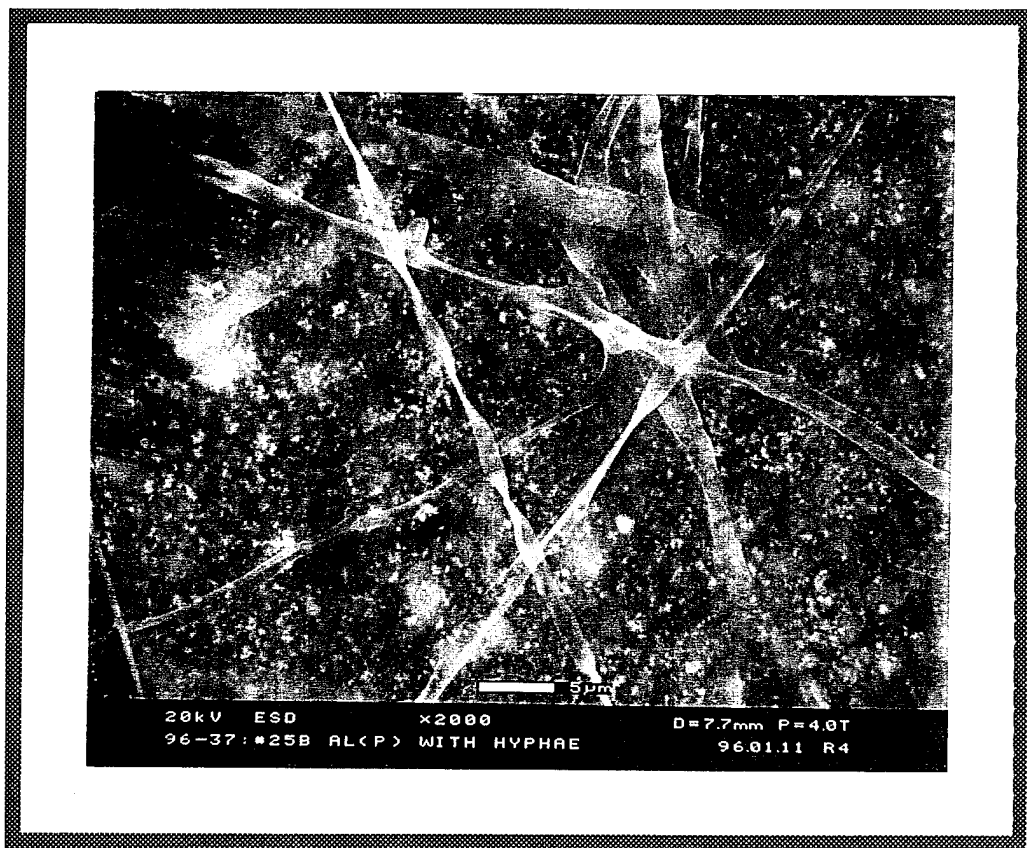
Figure 10: Hyphae attached to polyurethane coated coupon (2000x).

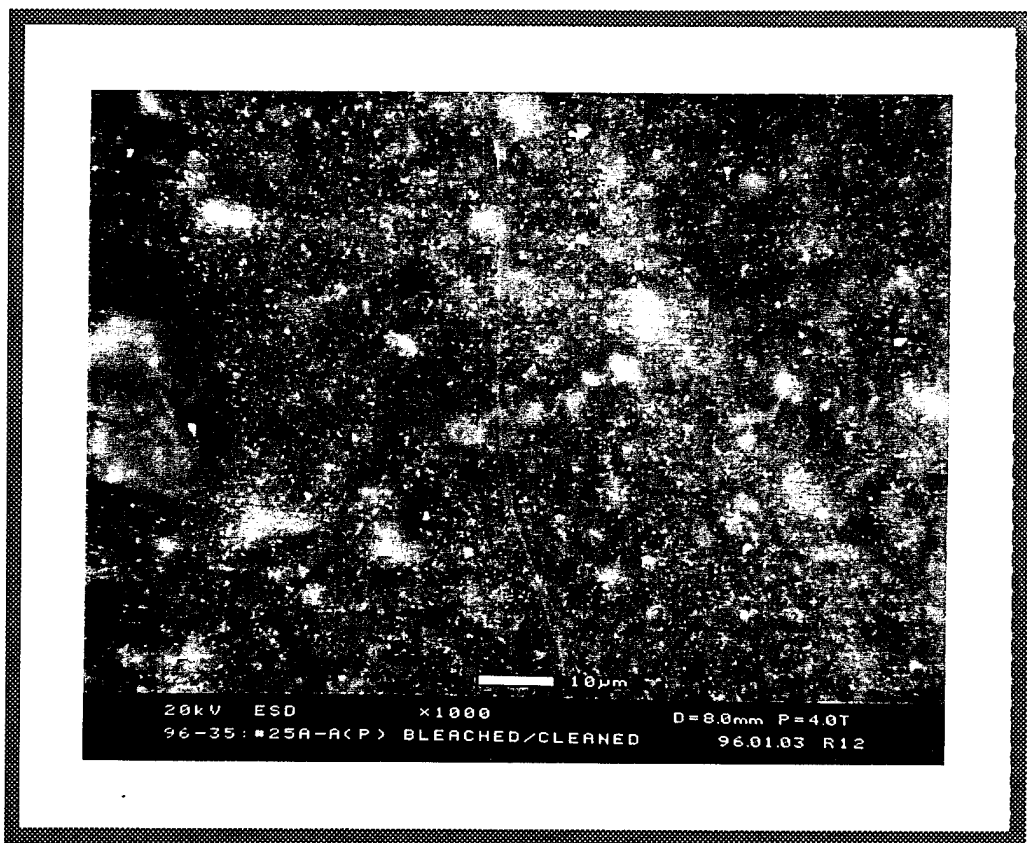
Figure 11: Polyurethane coated coupon surface after alcohol cleaning (1000x).

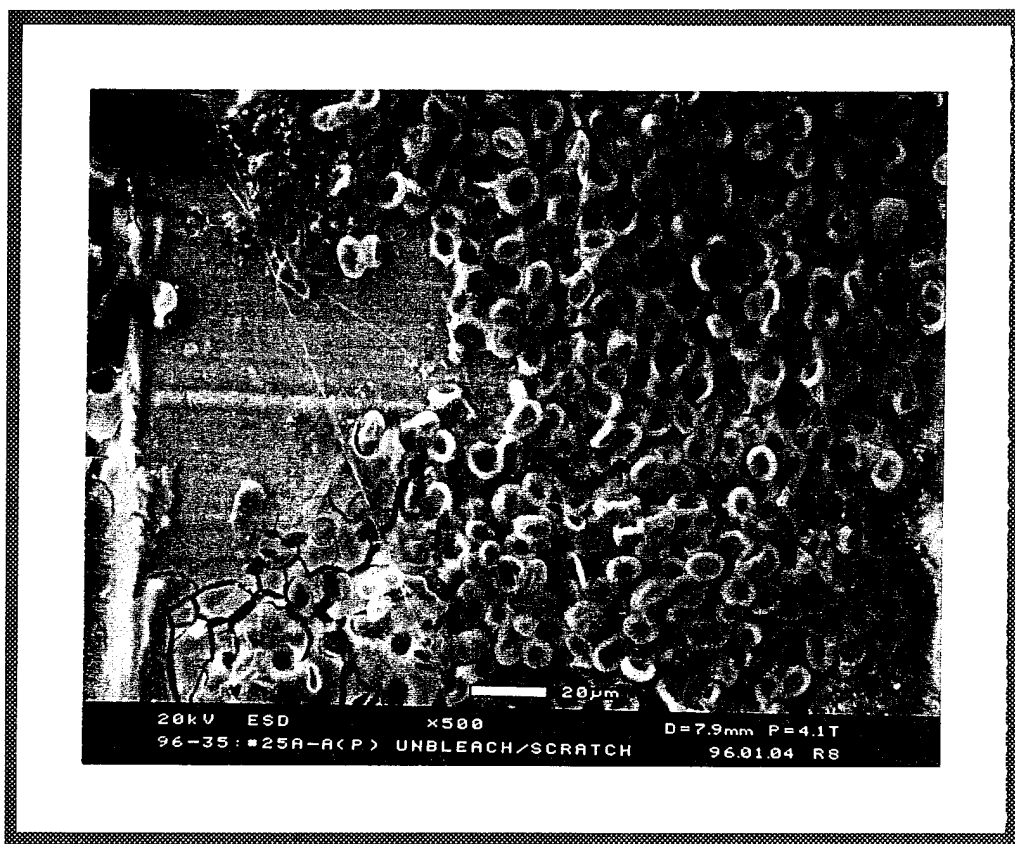
Fungi were present in the unbleached half of the scratches on many coupons, along with occasional corrosion products (Figure 12). Hyphae were also present on the bleached half of the scratches where corrosion was heavy (Figure 13), but corrosion was attributed to oxidation by sodium hypochlorite.

The mechanism for such an effect was not investigated, but Videla (1986) concluded that *Cladosporium* enhanced corrosion of aluminum by producing acidic metabolic products. There is some evidence from ESEM microscopy (Figure 12) that fungi were physically associated with corrosion products formed on aluminum exposed in scratches made in the protective coating. Paint defects are to be expected during the normal duty cycle of military helicopters and may be particularly vulnerable.

Figure 12: Fungal spores in scratch exposing bare metal, unbleached portion. Note hyphae at 11 o'clock and corrosion at 7 o'clock. (500x)

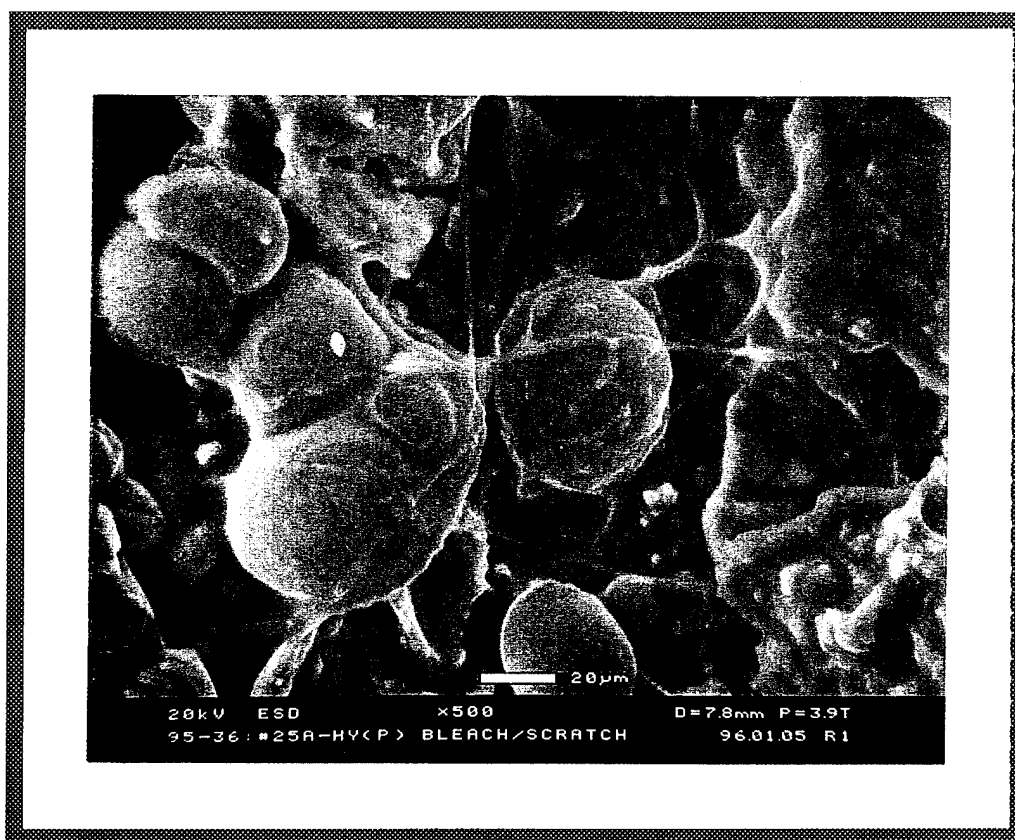
Figure 13: Hyphae on corrosion product in bleached portion of scratch (500x).
