NASA TN D-6721

# APOLLO EXPERIENCE REPORT - WINDOW CONTAMINATION

by L. J. Leger and R. W. Bricker

Manned Spacecraft Center

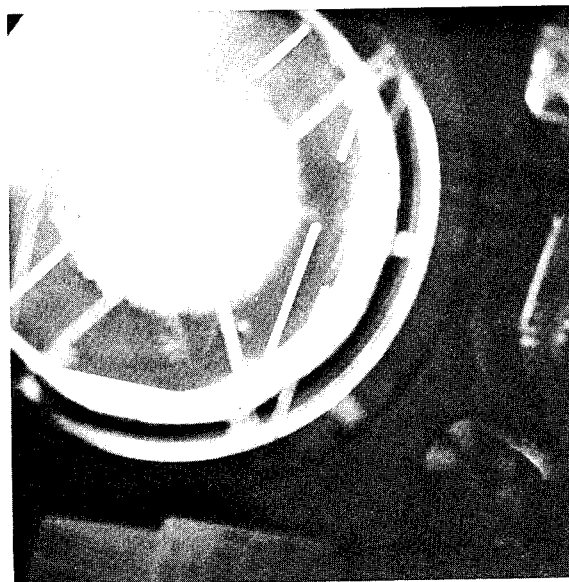
Soon after earth-orbital insertion, a film appeared on surfaces 2 and 3 of the hatch and side windows of the Apollo 7 and 8 command modules. This contamination continued to accumulate during flight and resulted in a heavy film in some locations and droplet formation in other locations. A photograph, taken with a camera focused on the hatch window during the Apollo 7 mission, is shown in figure 7. During the night pass of the spacecraft in earth orbit and during other similar cold-window conditions, the contamination seemed to crystallize and become opaque, particularly on the hatch window.

Figure 7. - Apollo 7 inflight hatch-window contamination.

In general, however, the most serious contamination was on surfaces 2 and 3 of the hatch and side windows on the Apollo 7 and 8 missions. Crewmembers from these two missions felt that, if the contaminants on these surfaces could be reduced or eliminated, the minor amount of contamination on the outer surfaces was not sufficiently serious to interfere with visual observations and photography.

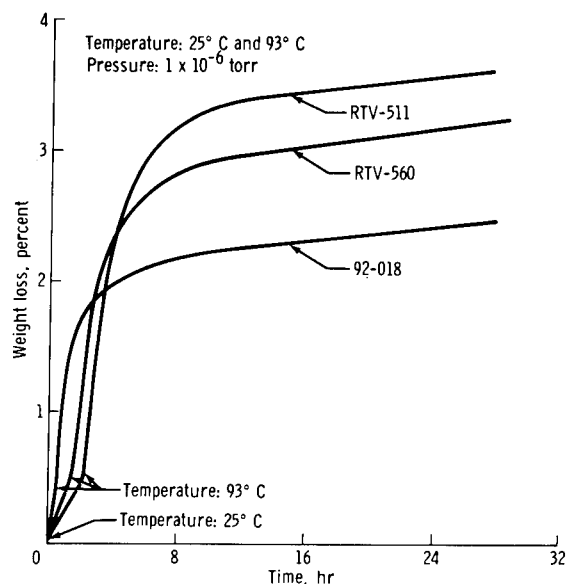
Isothermal-vacuum weight loss of the problem materials was determined by use of a continuous-recording vacuum balance. The vacuum weight loss of these materials at 93° C is shown in figure 9. This temperature was the maximum temperature expected in flight for materials that were used in the window area. Samples of all three materials had large initial weight-loss rates (approximately 1.25 percent/hr) that subsequently, after 15 hours, decreased to a much smaller rate (approximately 0.01 percent/hr).

Figure 9. - Vacuum weight loss of window materials that caused contamination on surfaces 2 and 3.
