NASA Contractor Report 178246

## Test Results for Composite Specimens and Elements Containing Joints and Cutouts

P. T. Sumida, R. C. Madan, and A. V. Hawley

Douglas Aircraft Company  
McDonnell Douglas Corporation  
Long Beach, CA 90846

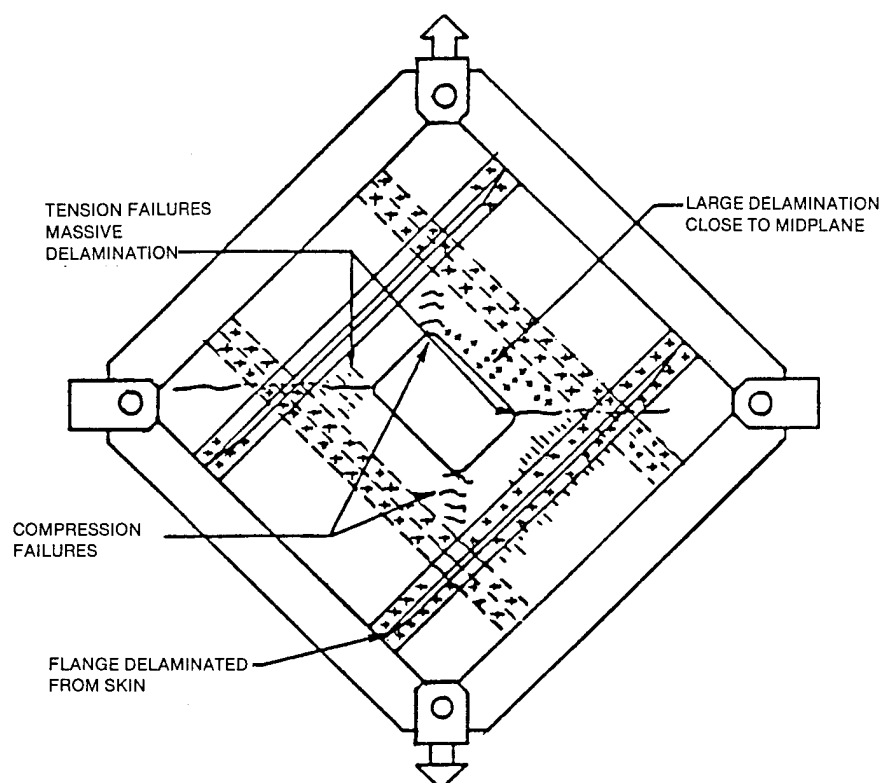
**Figure 5-28. Failure Locations for -503 Shear Cutout Panel**

Figure 5-28 is a sketch of the softened panel (-503) after failure. Strain gage data taken at the bottom corner indicate roughly linear behavior to about 60 kips. At 70 kips, measured strains at the bottom corner began to drop off rapidly with increasing load (down from  $-11,629 \mu\text{in./in.}$  at 70 kips to  $-5,360 \mu\text{in./in.}$  at 80 kips). Visual examination revealed very localized delaminations in both compression corners. These delaminations occurred on the side of the panel with the photoelastic film only a few layers from the outside surface. They were also located very close to the points of tangency of the corner radii to the straight sides. The load was then increased to 100 kips. Unlike the -501 (baseline) panel, very little growth of the delaminations was detected as the loads were increased to panel failure, which occurred at 121,110 pounds.

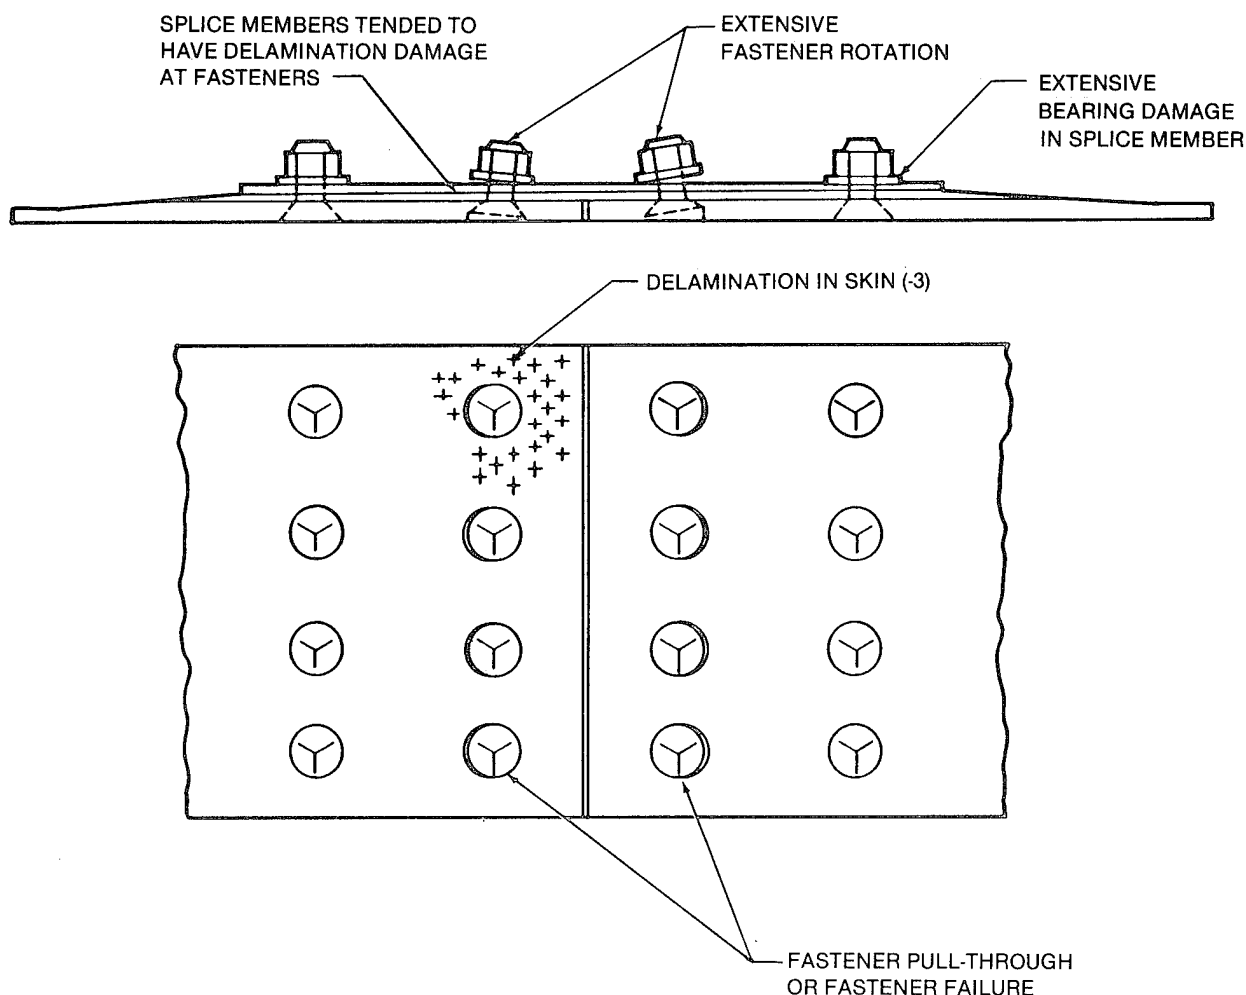
Figure 5-34. Failure Mode for Tailored Transverse Skin Splice Specimens

The presence of the sealant (for the -1 specimen) significantly reduced the strength of the tailored transverse splice specimen. The failure mode, for the most part, appears very similar to that of the -2 and -3 specimens (i.e., extensive bearing damage in the splice member at the outside rows of fasteners with the ultimate failure occurring at one of the inside rows due to fastener failure). Fastener failure for the specimens tested without sealant always occurred at the fastener head, through the tri-wing recess. Fastener failures for the -1 specimen, however, occurred at the opposite end near the first thread.
