Miscellaneous Paper GL-96-19  
August 1996

# **Airfield Pavement Evaluation, Butts Army Airfield, Fort Carson, Colorado**

*by Jeb S. Tingle*

## **Final report**

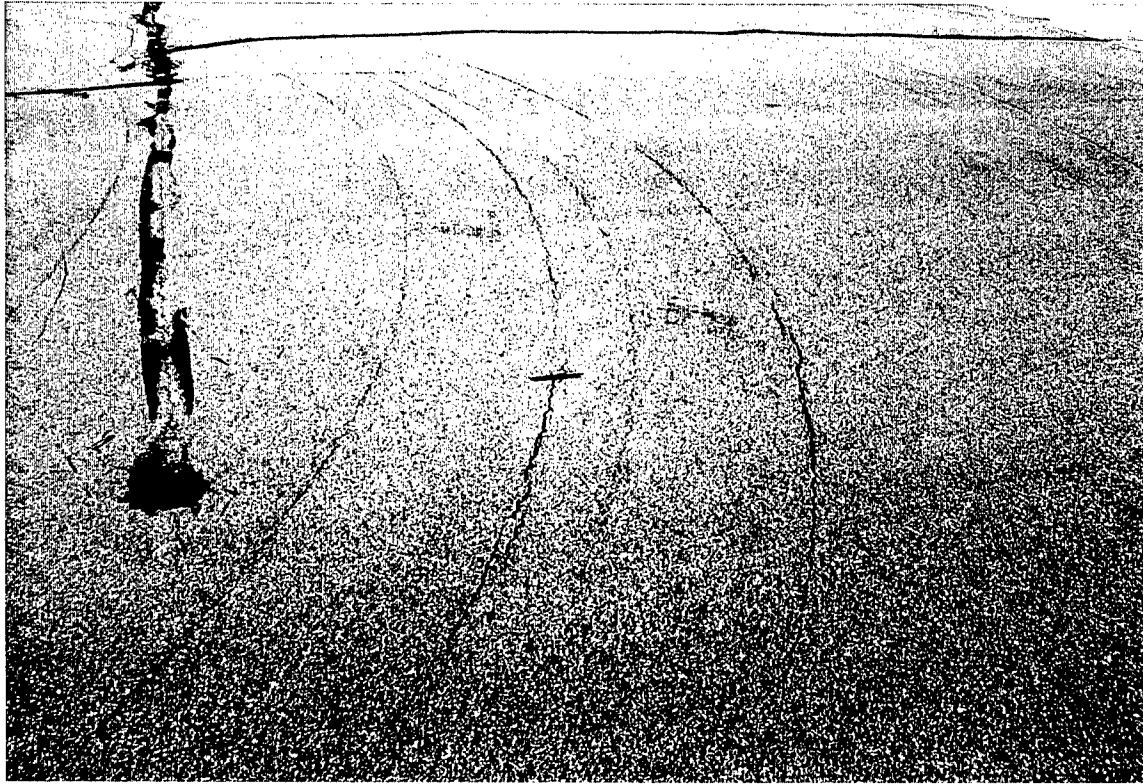
Photo C1. Cracks caused by turning C-130 on Runway 13-31

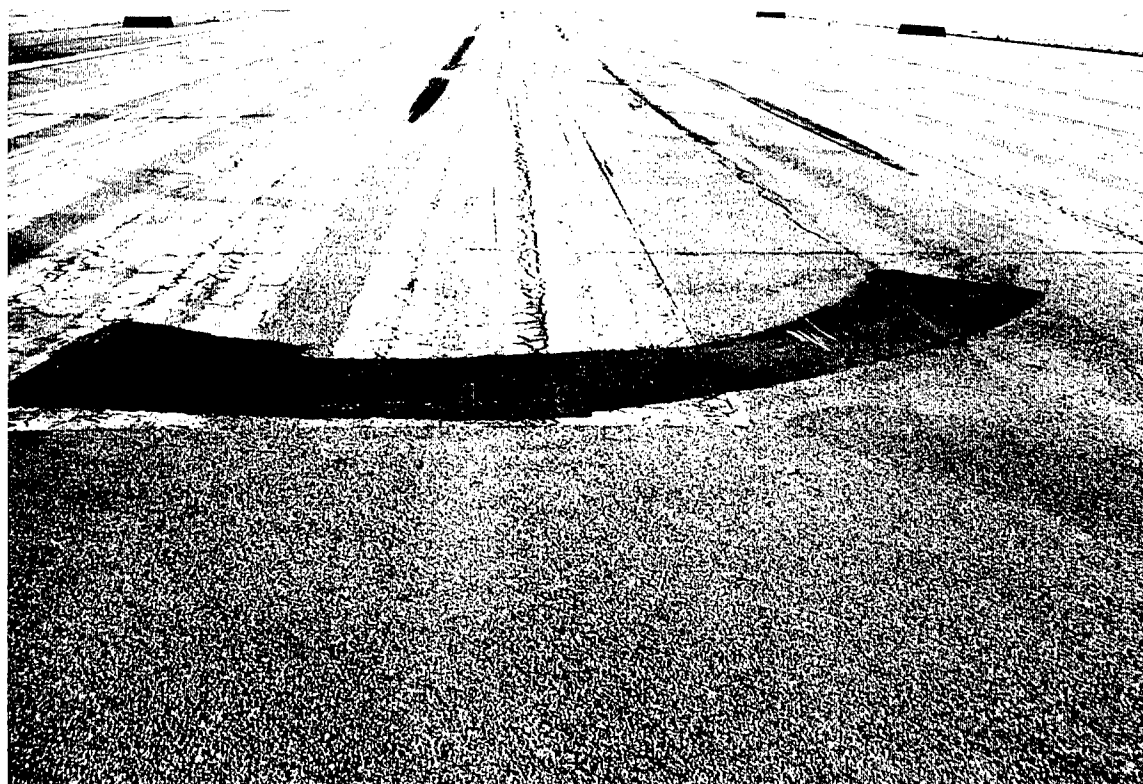
Photo C2. Patch of slippage crack on Runway 13-31

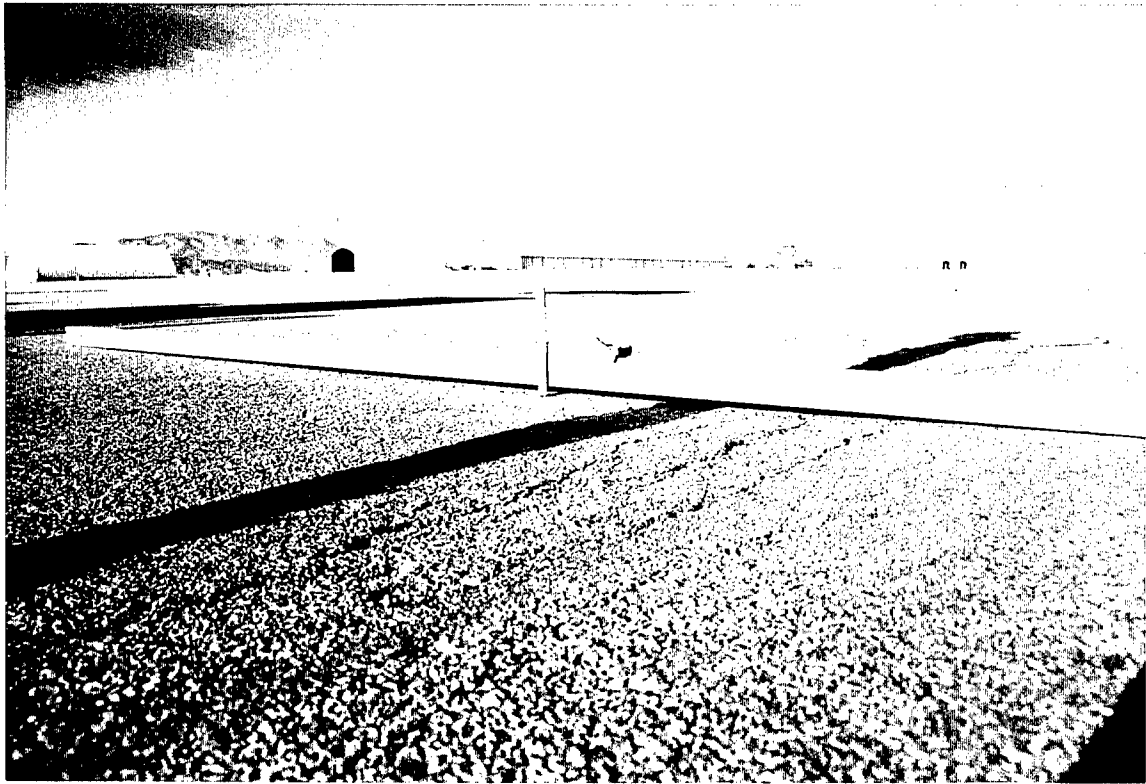
Photo C3. Medium-severity rutting and alligator cracking on Runway 13-31

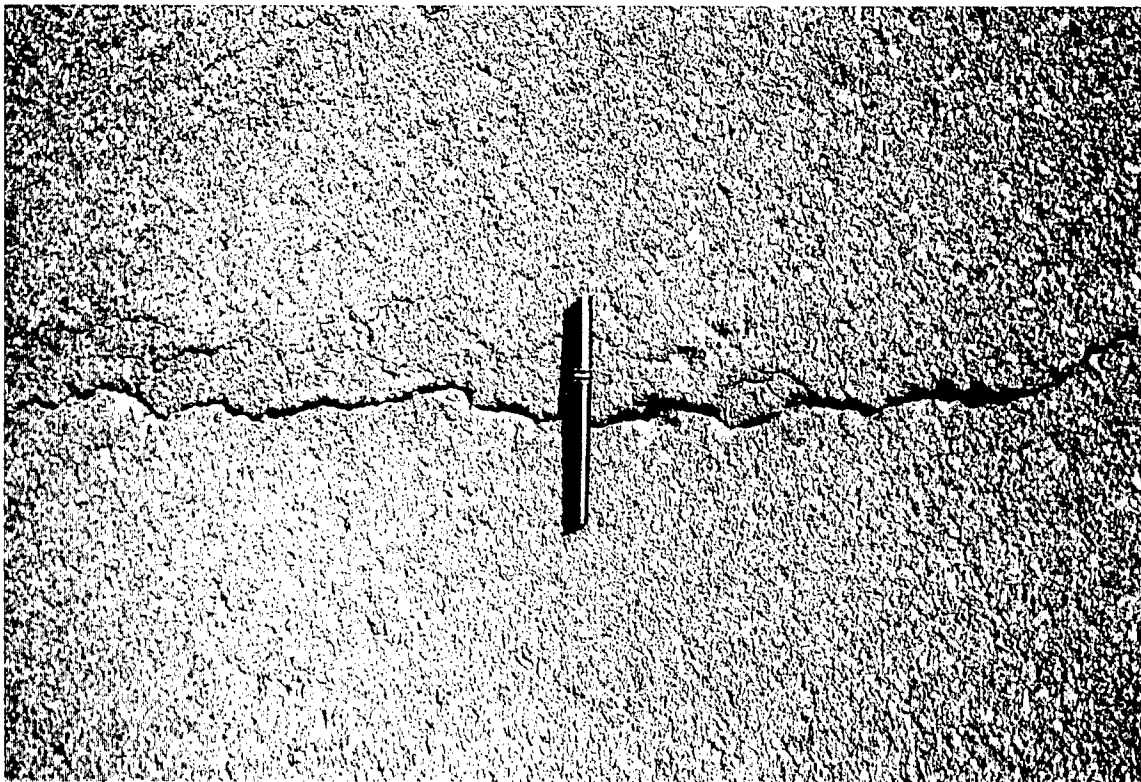
Photo C4. Medium-severity longitudinal and transverse crack

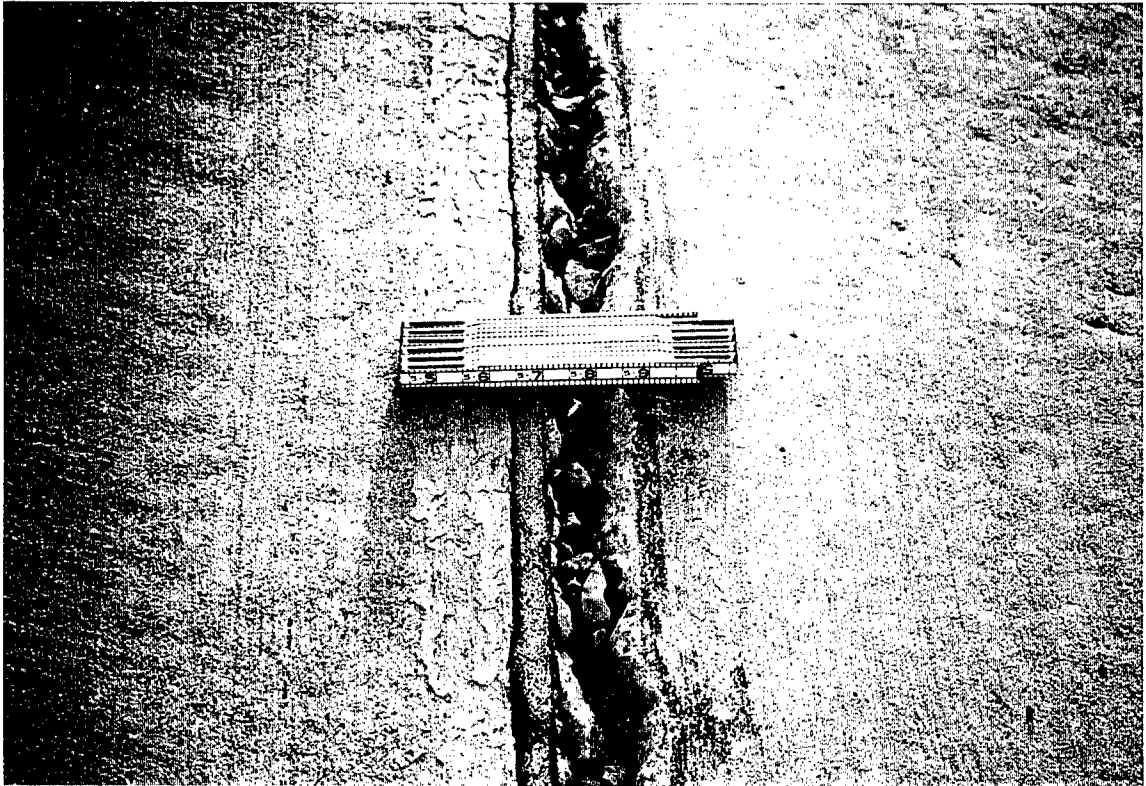
Photo C5. High-severity joint sealant on the Midfield Taxiway

| Table 3-2<br>(Continued) | | Maintenance and Repair Alternatives for Existing Surfaces | | | |
|---|---|---|---|---|---|
| T3A | 2,330<br>(25,083) | 102(4.0) | 152 (6.0) | 152 (6.0) | Remove, clean, and replace old joint sealant with high quality joint sealant <sup>2</sup> . Clean spalls and repair with epoxy concrete. Clean medium- and low-severity cracks and seal with a high quality crack sealant <sup>2</sup> . Partial- or full-depth patching is required to repair medium- and high-severity spalls. Overlay as required. |

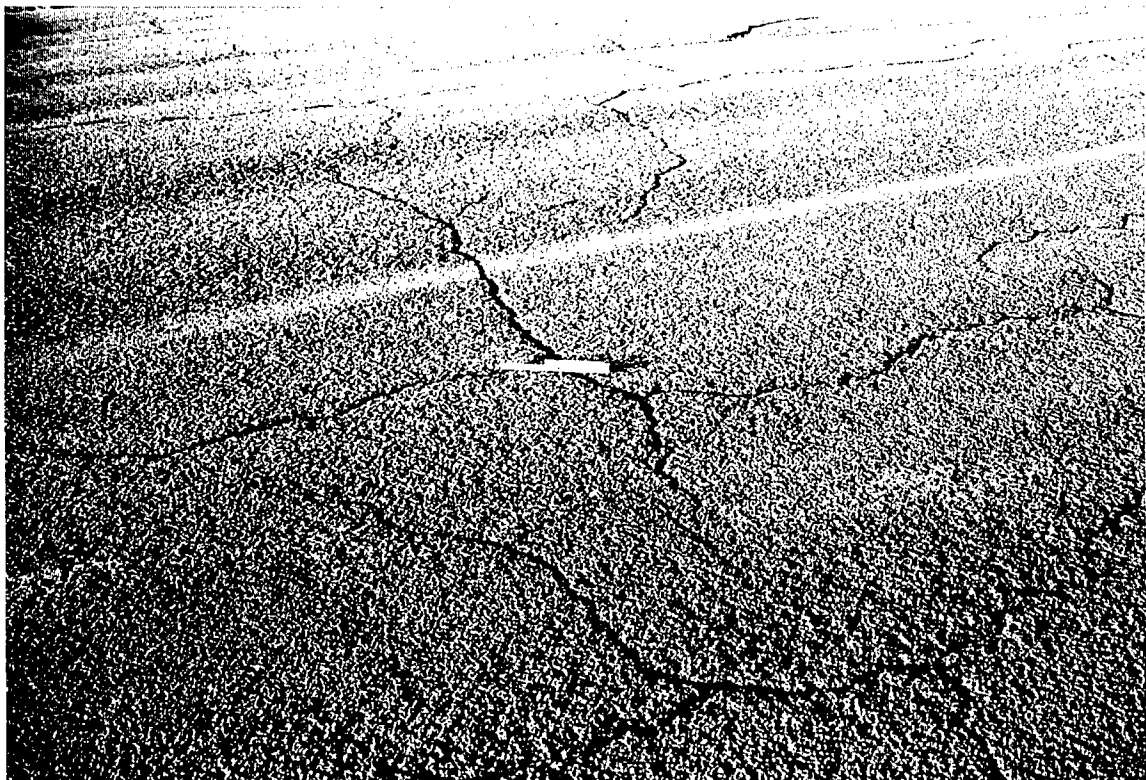
accomplished within the next 2 years in order to prevent further deterioration. Due to the severity of the block cracking and weathering on the surfaces of features R1A, T1A, T2A, T5A, A1B, A2B, and A3B, Foreign Object Damage (FOD) is a problem for aircraft operating with engines running.

Photo C6. High-severity block cracking on the Alpha Lane (Old Runway 4-22)

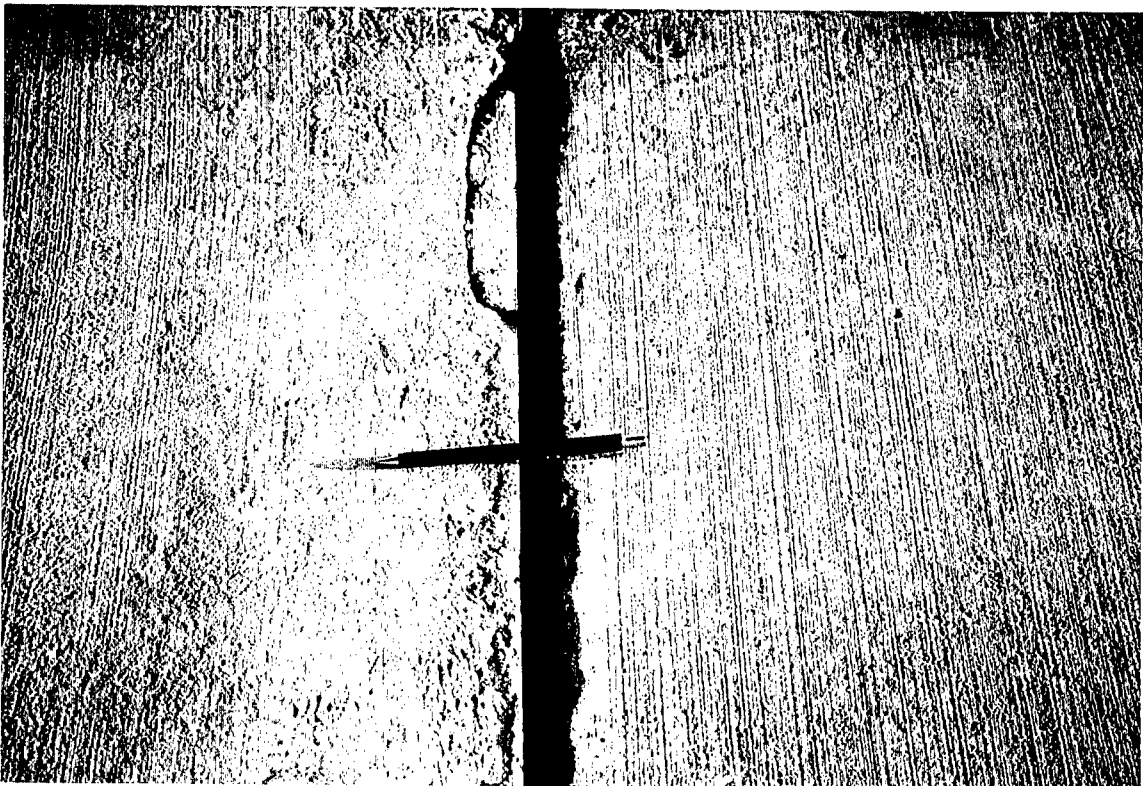
Photo C8. Typical low-severity joint spall on the Avum Hanger Apron

| Table 3-2<br>(Concluded) | | | | | | |
|---|---|---|---|---|---|--|
| A13B | --- | 0.0 | 0.0 | 0.0 | Clean low-severity cracks and seal with high quality crack sealant <sup>2</sup> . Clean cracks around patches and seal with high quality crack sealant <sup>2</sup> . Partial-depth patching or epoxy concrete should be used to repair spalls. | |

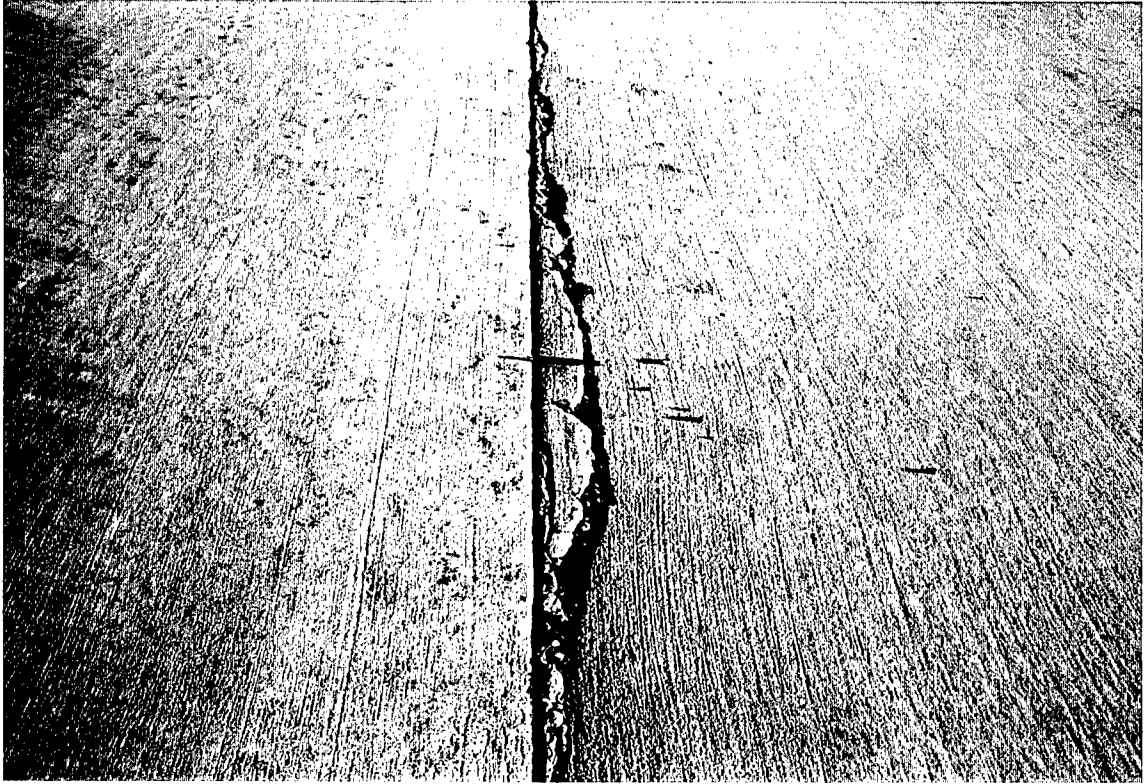
Photo C9. High-severity joint spall on the Parking Apron

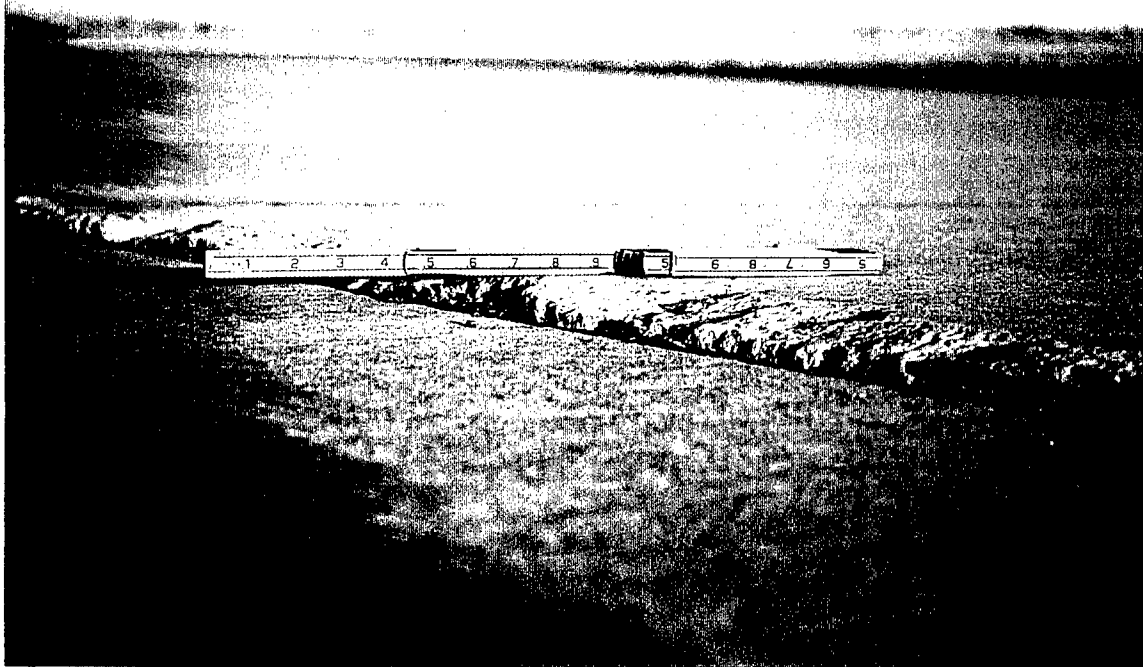
Photo C10. High-severity faulting on the Parking Apron
