Technical Report CERC-96-5
September 1996

Periodic Inspection of Nawiliwili Harbor Breakwater, Kauai, Hawaii

Report 1 Base Conditions

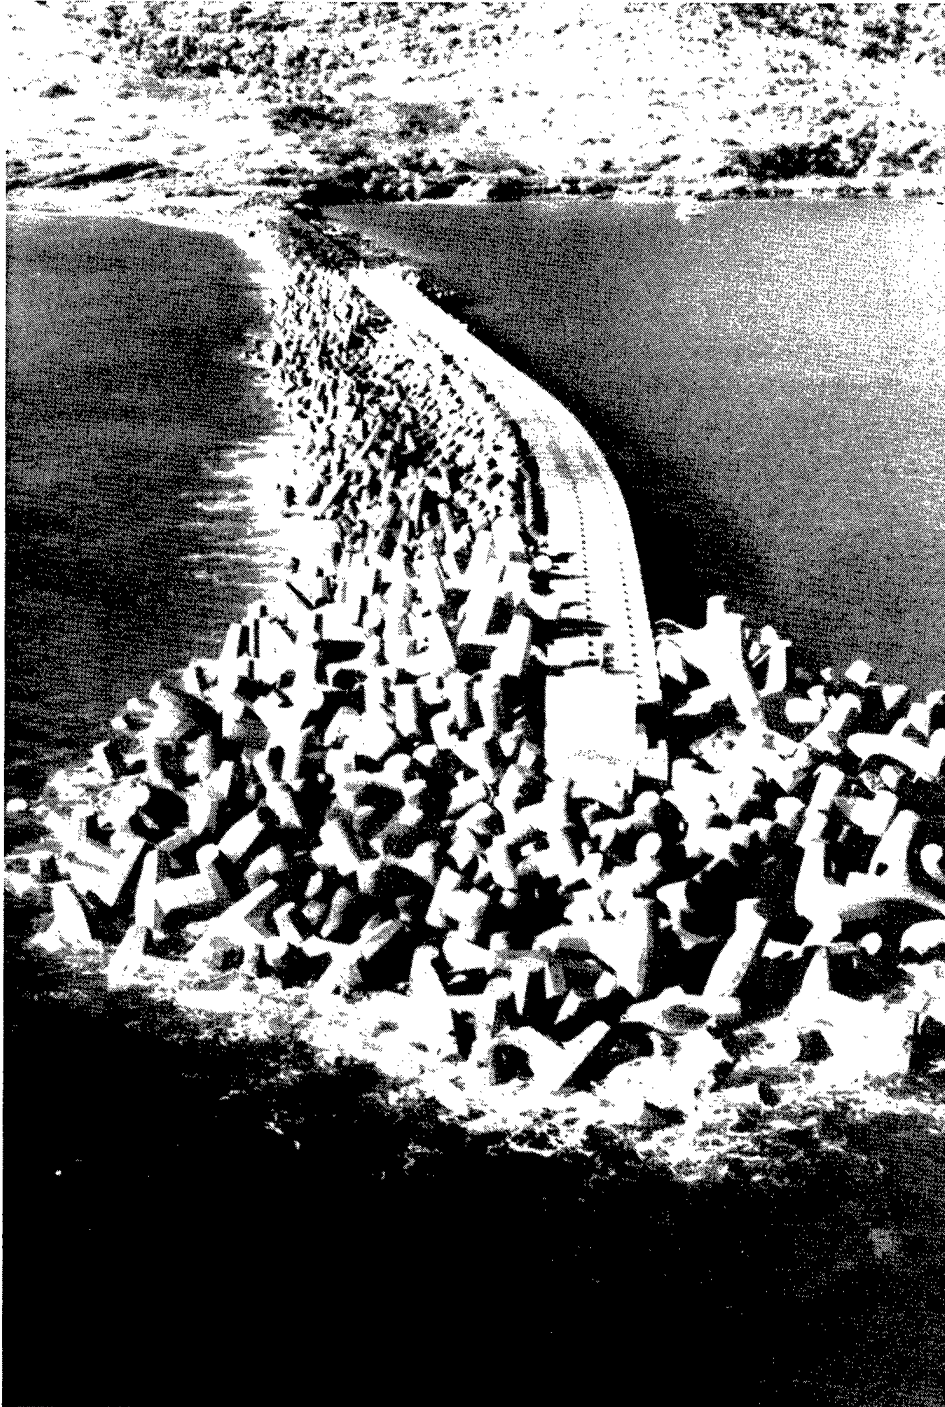
Figure 7. Aerial photograph of Nawiliwili breakwater (1995)

Hurricane Iniki struck the island of Kauai in 1992 with Nawiliwili almost directly in its path. Eyewitness accounts indicated that seas outside the harbor reached 10 m (33 ft) during the storm and over 3 m (10 ft) inside the harbor. Storm surge exceeded 5 m (16 ft) along much of the southern island coast. A survey revealed that three 20,865-kg (23-ton) dolosse, seven 9,980-kg (11-ton) dolosse, and six 16,150-kg (17.8-ton) tribars had broken as a result of the hurricane. A survey of the structure in 1994 revealed a total of 54 broken concrete armor units on the structure above the waterline. An aerial photo of Nawiliwili breakwater in 1995 is shown in Figure 7.

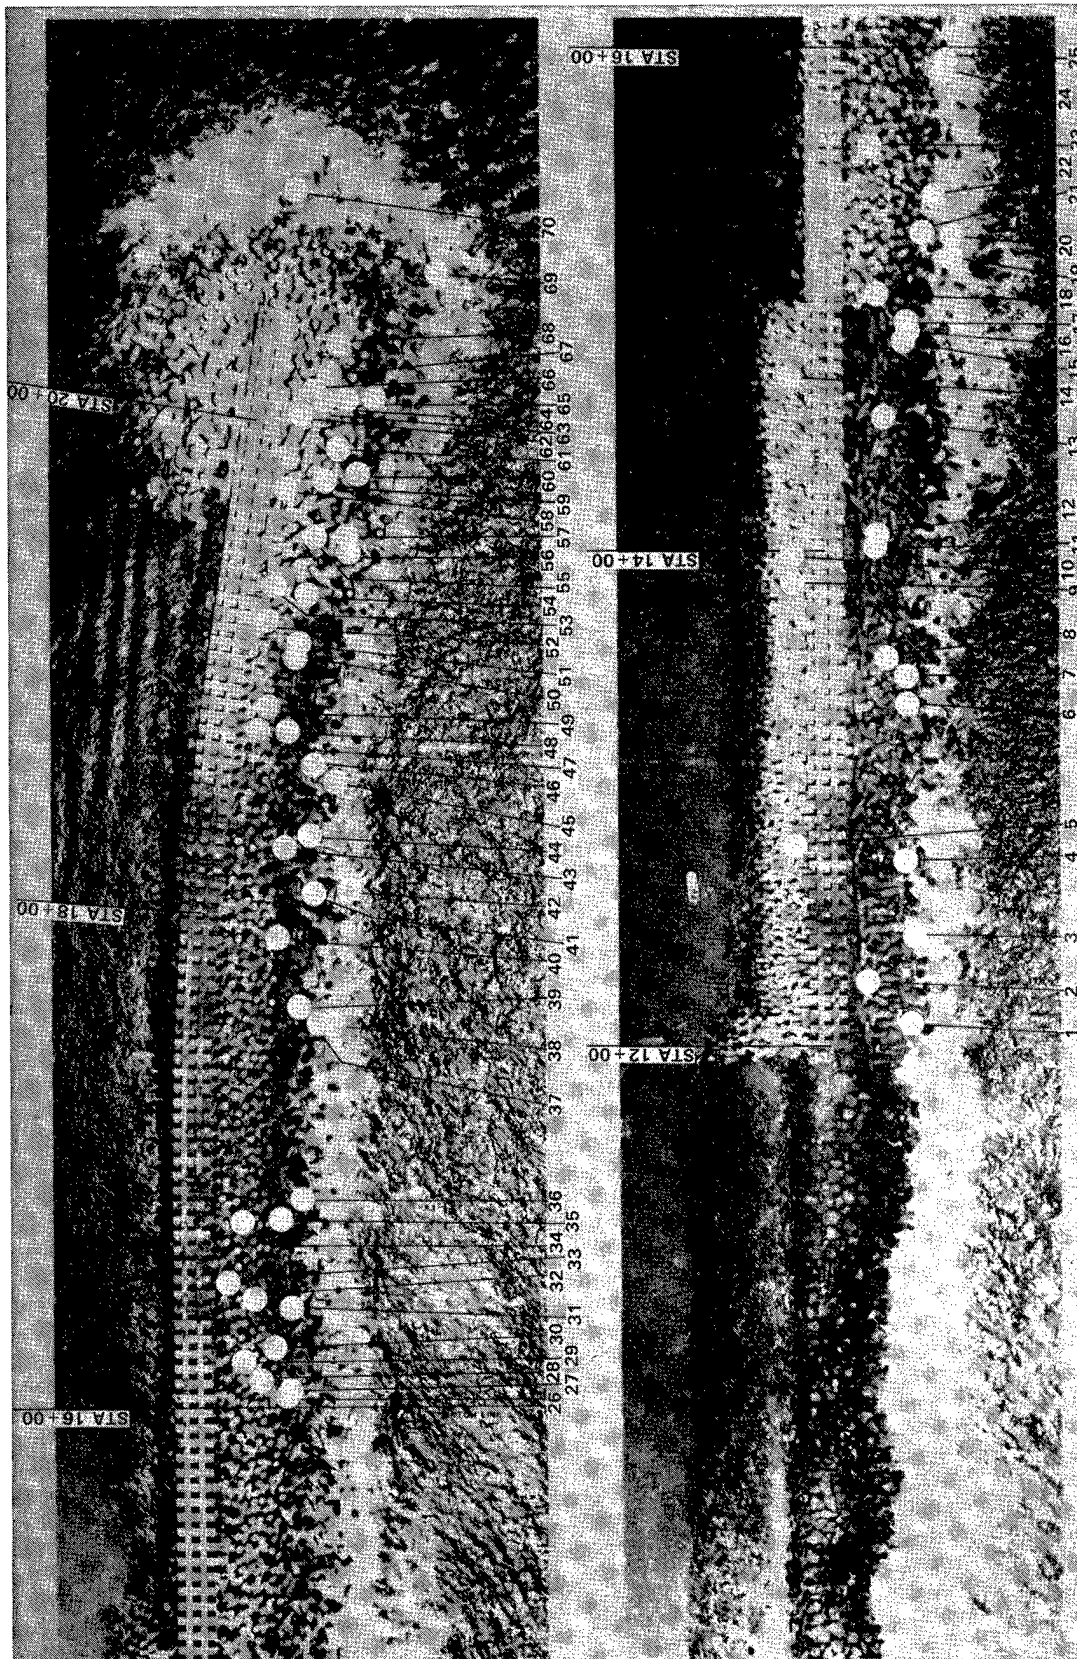
Figure 14. Approximate locations of broken/cracked armor units along outer portion of Nawiliwili Harbor breakwater

The approximate locations of broken/cracked armor units along the outer portion of the breakwater are shown in Figure 14, and detailed data obtained during the broken armor unit inventory are shown in Table 3. Armor unit numbers identified in Figure 14 correspond to those listed in Table 3. As shown, broken units occur along the entire length on the sea side of the structure, but in general, are more concentrated along the

seaward end of the breakwater. Sixty-one percent of the broken units are located on the outer half of the structure (sta 16+00 - 20+50), and about one third of the broken units are situated on the outer 45.7-m (150-ft) length of the breakwater (sta 19+00 - 20+50). With regard to distance from baseline, the majority of broken units (71 percent) are located between 7.6 and 16.8 m (25 and 55 ft) seaward of the baseline. These units are in the active wave zone.

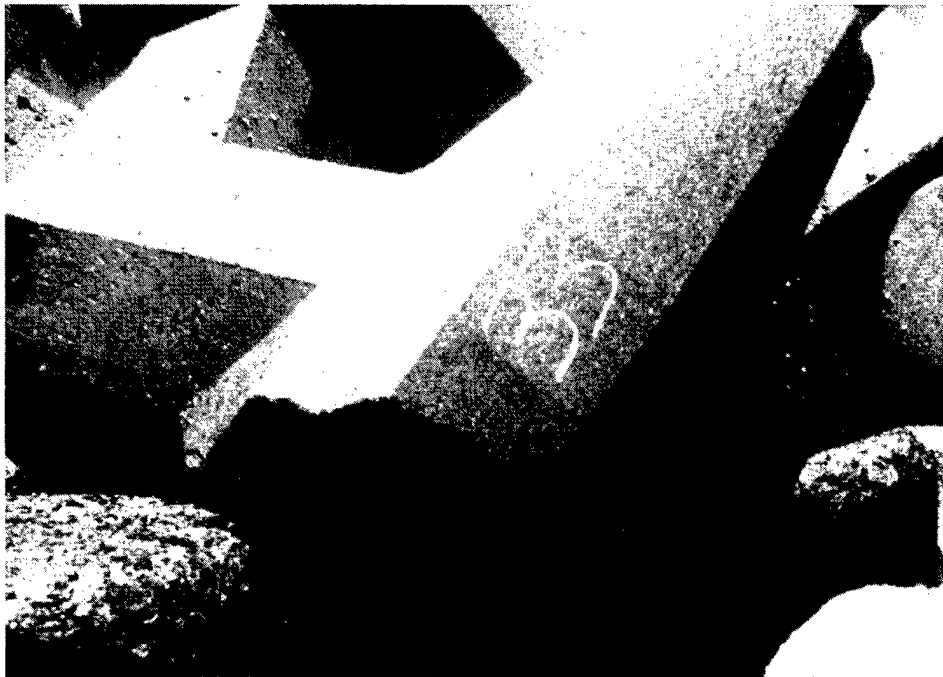
Types of breaks for the dolosse included shank and fluke breaks. These were characterized as mid-shank, shank-fluke (shank broken in vicinity of fluke), and fluke-shank (fluke broken off at junction with shank). Also recorded were straight breaks (broken straight across) and angled breaks (broken at some angle to the dolos limb). For the tribars, types of breaks included those through the center section of the unit where one or more legs were separated from the unit, and those in which just a portion of one of the legs was broken off. Views of representative types of breaks for the armor units are shown in Figures 15-18. Armor units with hairline cracks on one side were not counted; only those that were cracked all the way through were considered a break for recording purposes.

Figure 16. Dolos with fluke-shank break

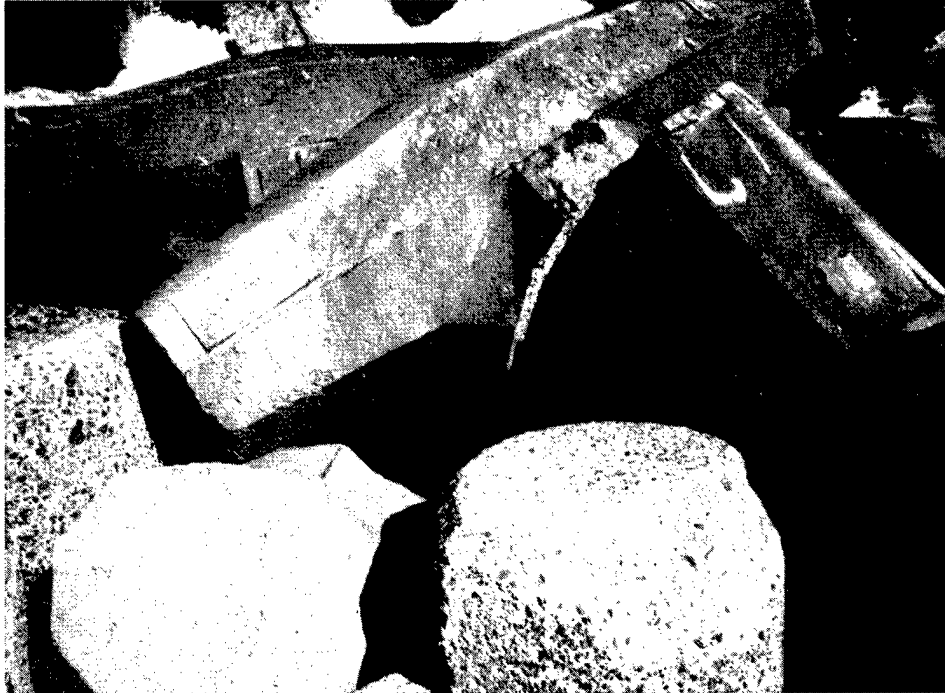
Figure 17. Dolos with shank-fluke break

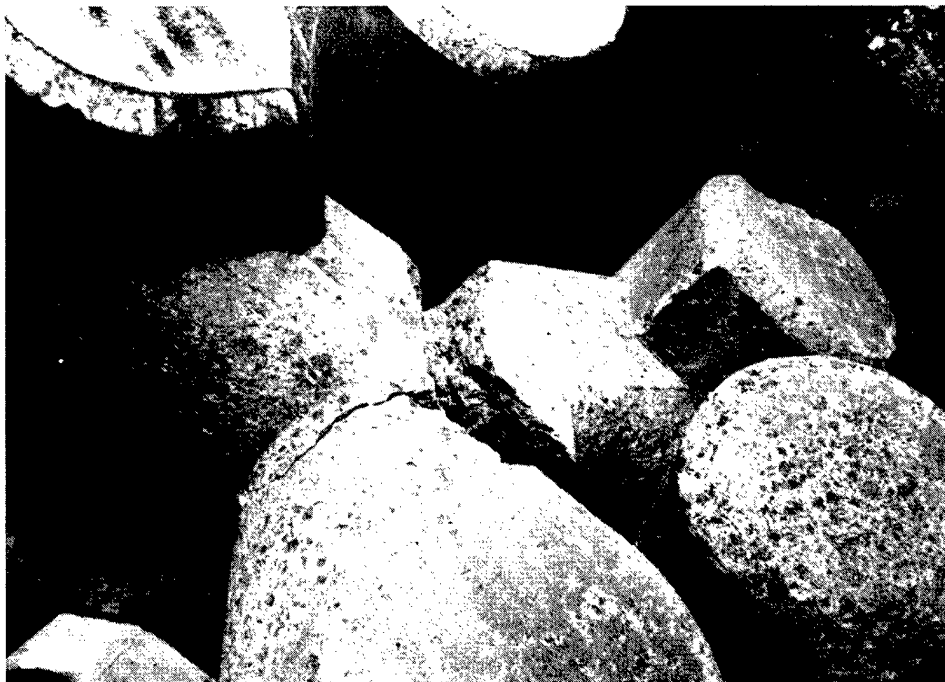
Figure 18. Tribar with break through center section of unit
