AL/OE-TR-1996-0117

FAILURE MECHANISMS IN AIRCREW HELMET VISORS

September 1996

Final Technical Report for the Period 1 September 1993 to 29 March 1995

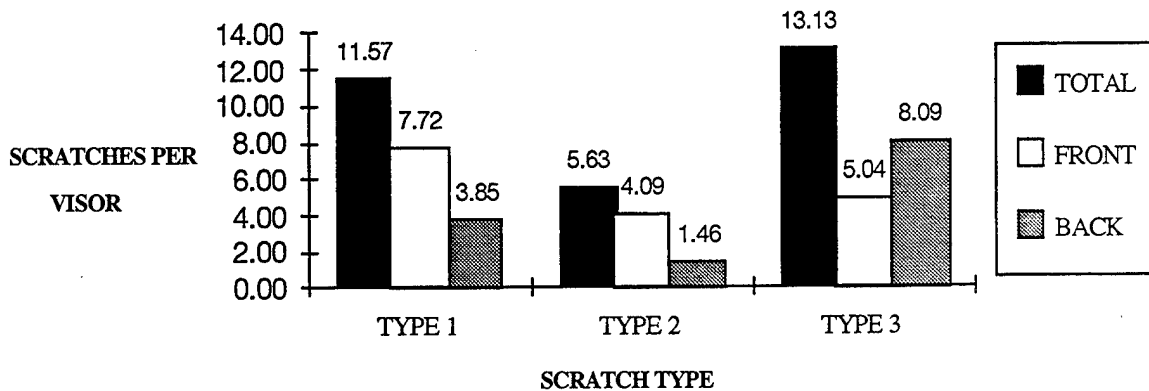
AVERAGE NUMBER OF SCRATCHES PER VISOR

Table 1: Average Number of Scratches per Visor per Type of Scratch by Location

Type 1 scratch	11.57 total	7.72 front	3.85 back
Type 2 scratch	5.63 total	4.09 front	1.46 back
Type 3 scratch	13.13 total	5.04 front	8.09 back

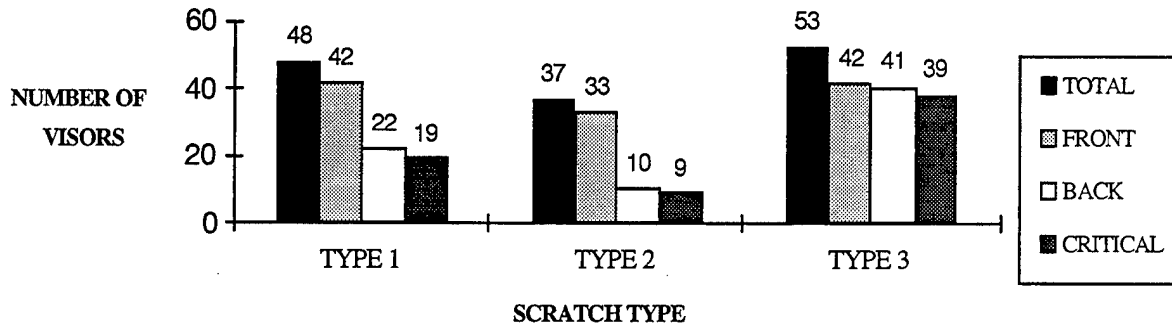
NUMBER OF VISORS vs TYPE OF SCRATCH
53 VISORS MEASURED

Table 2: Number of Visors Evidencing Each Type of Scratch by Location

Type 1 scratch	48 total	42 front	22 back	19 critical area
Type 2 scratch	37 total	33 front	10 back	9 critical area
Type 3 scratch	53 total	42 front	41 back	39 critical area

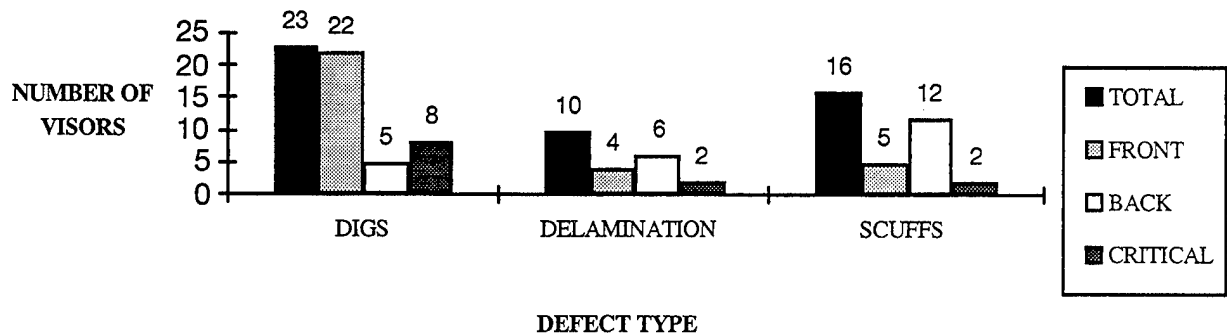
NUMBER OF VISORS vs TYPE OF DEFECT
53 VISORS MEASURED

Table 3: Number of Visors Evidencing Each Type of Defect by Location

Digs	23 total	22 front	5 back	8 in critical area
Delamination	10 total	4 front	6 back	2 in critical area
Scuffs	16 total	5 front	12 back	2 in critical area
