# Failure Analysis and Mechanical Tests of Failed Aluminum Alloy 7277 Rivets on Armored Vehicle Launched Bridges

Howard E. Horner

ARL-TR-1195

September 1996

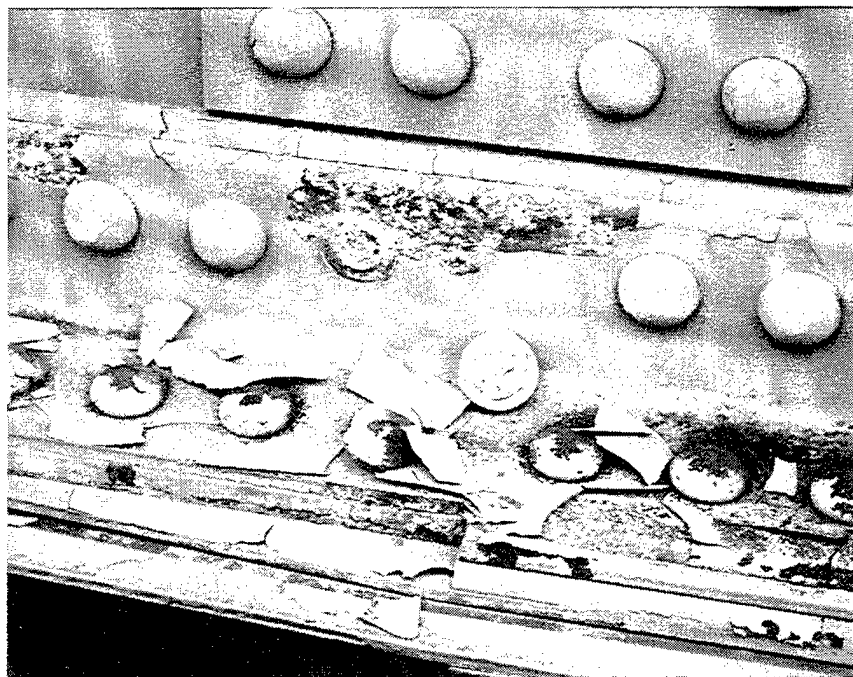
Figure 2. A view of the splice joint in the bottom chord of the AVLB from SWA, showing a failed aluminum rivet with its head already popped off. Note the white areas of the corrosion products formed on the surfaces of the fracture under the failed head as well as on the structural angle where the paint coating had flaked off.

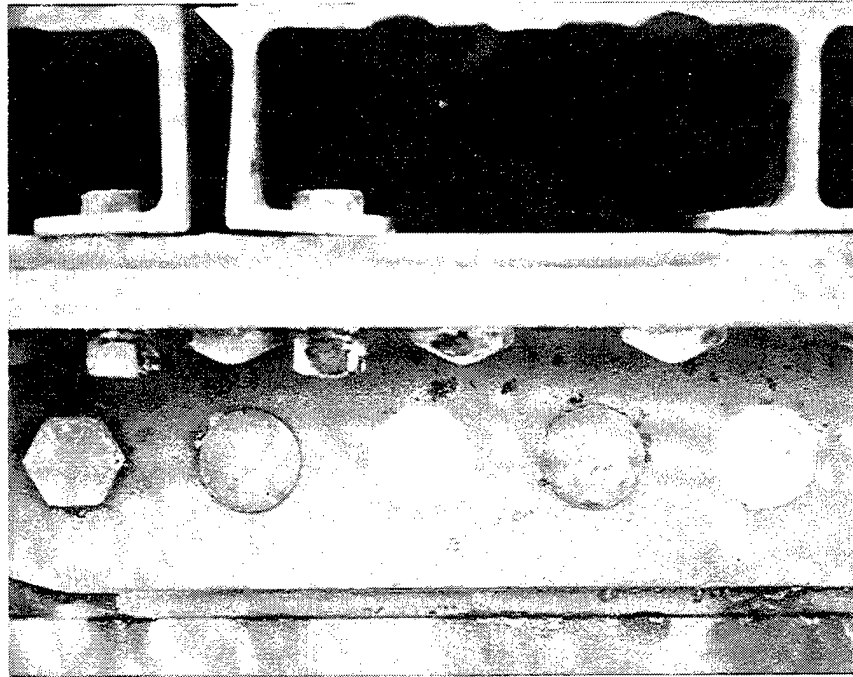
Figure 3. A view of a top chord connector of the AVLB from SWA, showing two failed aluminum rivets with their head already fallen off. The white circular areas are the corrosion products formed under the head at the shoulder and crack fracture. Note the steel bolt at far left which apparently was used to replace the rivet that failed earlier.

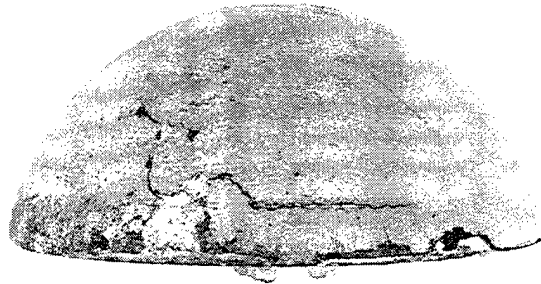
Figure 4. Side view of a failed aluminum rivet head sample received for failure analysis. The rivet shank of the failed rivet was not included for analysis. The white corrosion deposit can be seen in the area where some of the paint was chipped off the surface of the head.

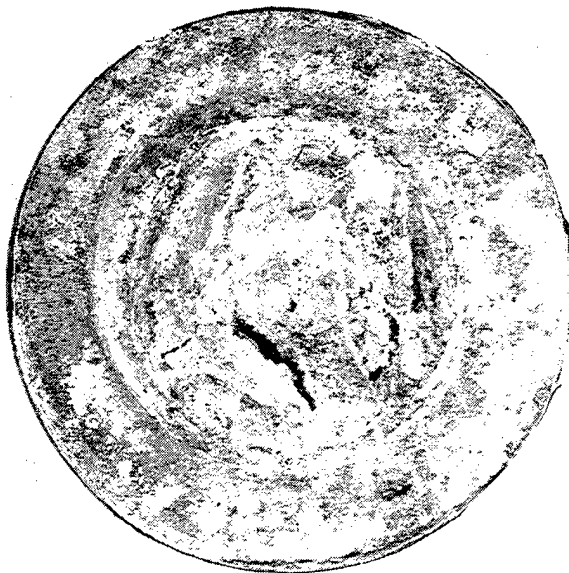
Figure 5. A view of the fracture surface of the same rivet head in Figure 4. The white areas on the fracture surface (center area) and on the head shoulder (outer rim) are the corrosion products that had formed for a period of time before the head fell off the rivet shank.

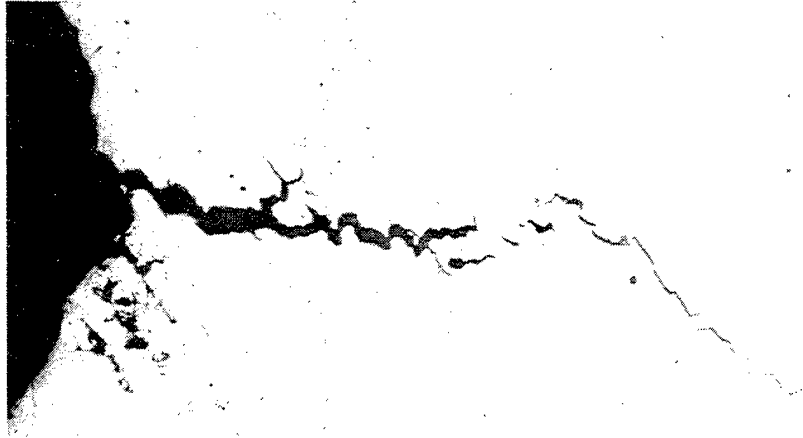
Figure 6. As-polished microstructure of the failed aluminum rivet head showing a small secondary crack in the future. Magnification: 150 $\times$ .

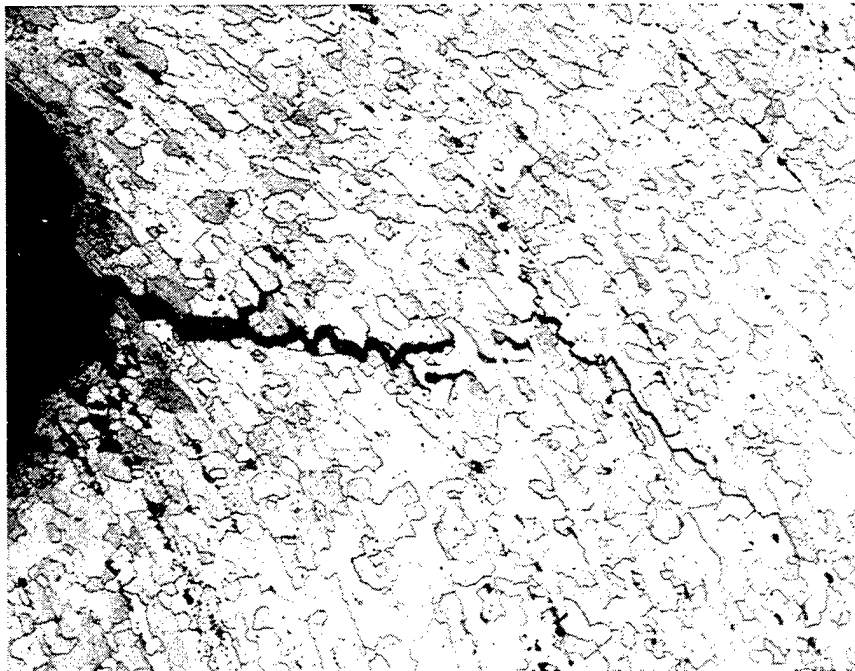
Figure 7. Etched microstructure of the same area in Figure 6 revealing that the crack is predominantly intergranular, indicative of stress corrosion cracking. The tail end of the crack had followed the grain flow formed as the result of the cold head-forming process by the rivet manufacturer. Magnification: 150 $\times$ . Keller's etchant.

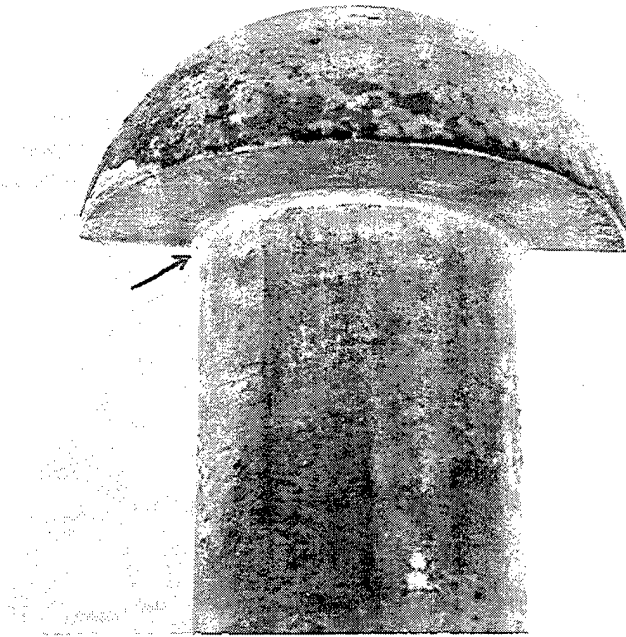
Figure 8. A view of a large aluminum rivet removed from a forged aluminum center hinge of one AVLB from SWA stored at ANAD. A small white corrosion deposit (arrow) can be seen in the head-to-shank fillet. A section of the head and shank with the corroded area was already cut off for microstructural examination. Magnification: 2x.

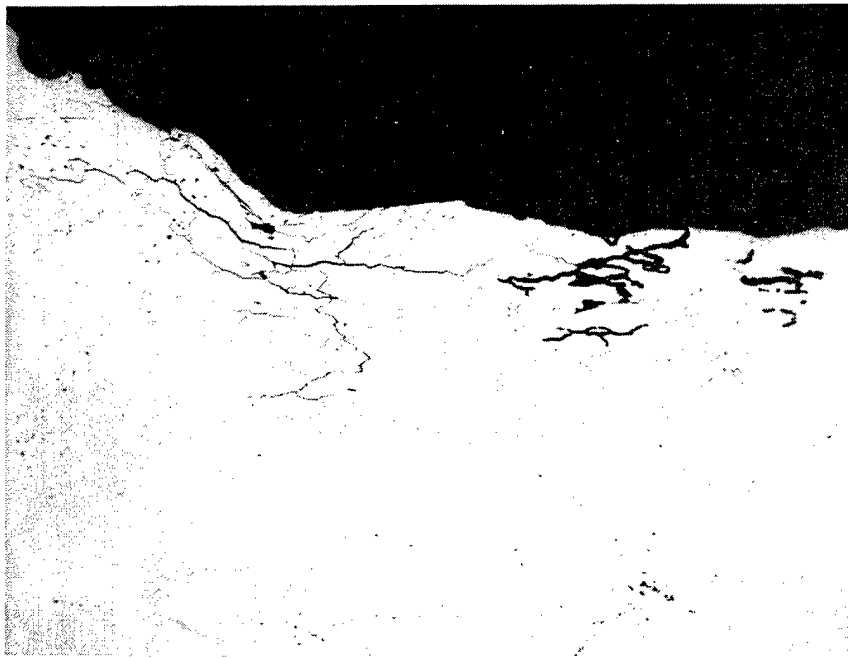
Figure 9. As-polished microstructure of the aluminum rivet in Figure 8. Intergranular corrosion and cracks are present in the small corroded area in head-to-shank fillet, indicative of stress corrosion cracking. Magnification: 170x.

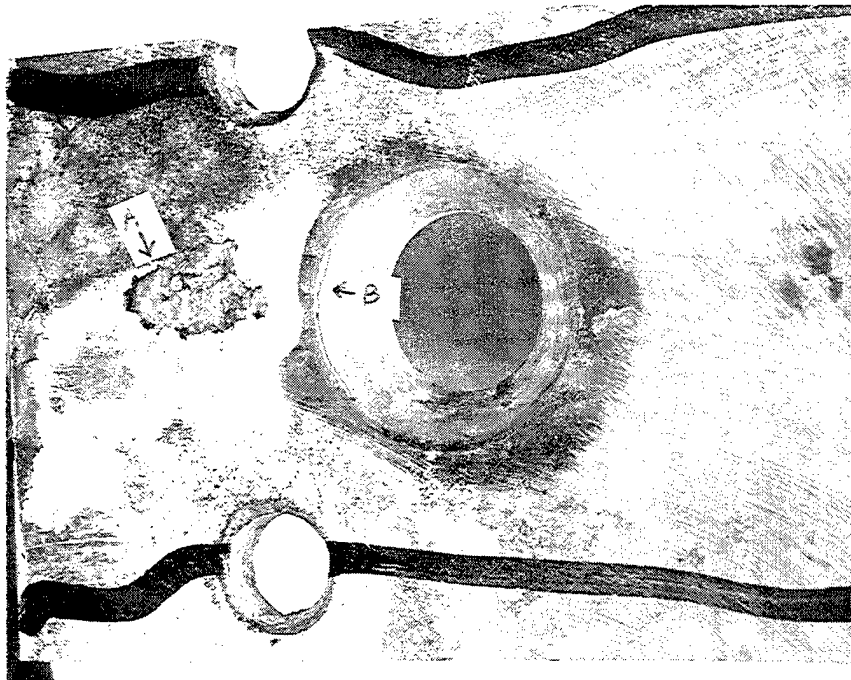
Figure 11. Large corroded hole (A) on top surface of the top chord angle section cut from AVLB center panel dismantled at ANAD. Exfoliation had extended laterally beyond the hole of the corroded area. Delaminated surface crack (B) due to exfoliation was observed near the top of the large countersunk rivet hole. Slightly larger than actual size.

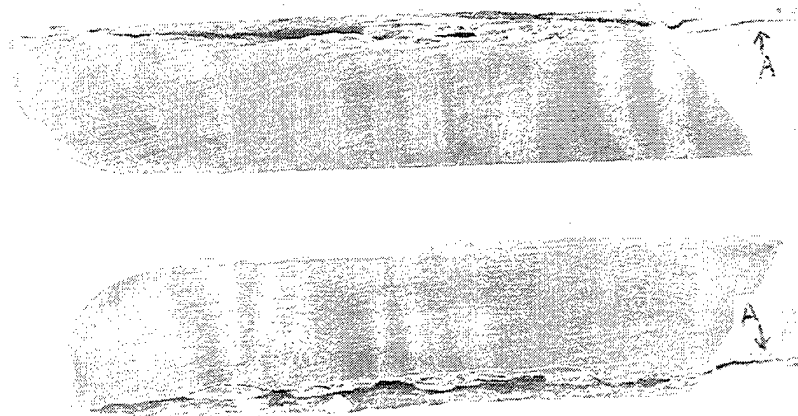
Figure 12. Matched half sections of the corroded sample in Figure 11. It was cut in two through the large corroded hole. Delaminated surface cracks (A) were observed in the countersunk section of the rivet hole on the right, revealing extensive exfoliation beyond the corroded hole. Magnification: approximately 2x.

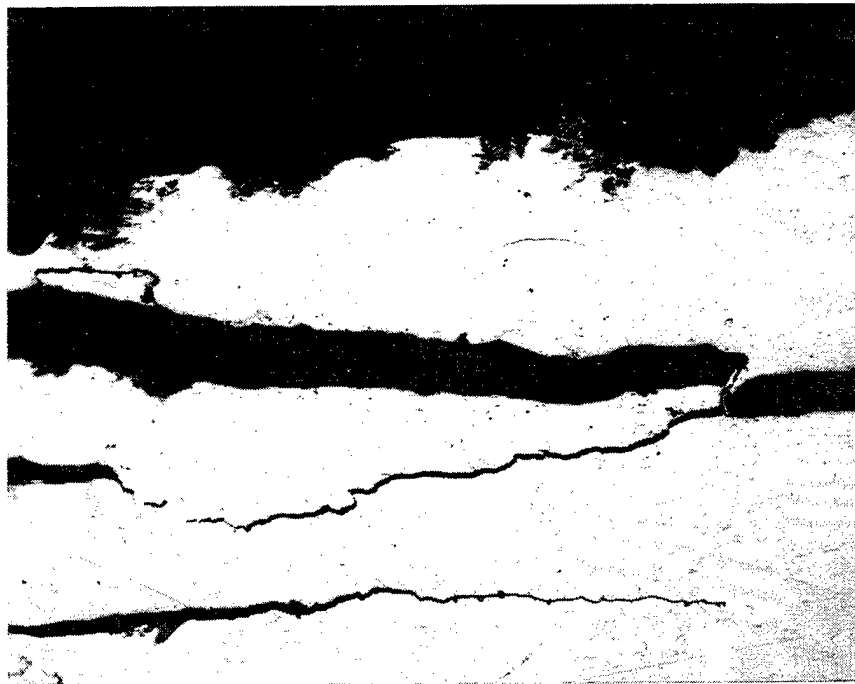
Figure 13. As-polished microstructure at the bottom of the corroded hole in Figure 11. Exfoliation was the primary mode of corrosion on the corroded surface of the angle section of the AVLB top chord. Magnification: 75 $\times$ .

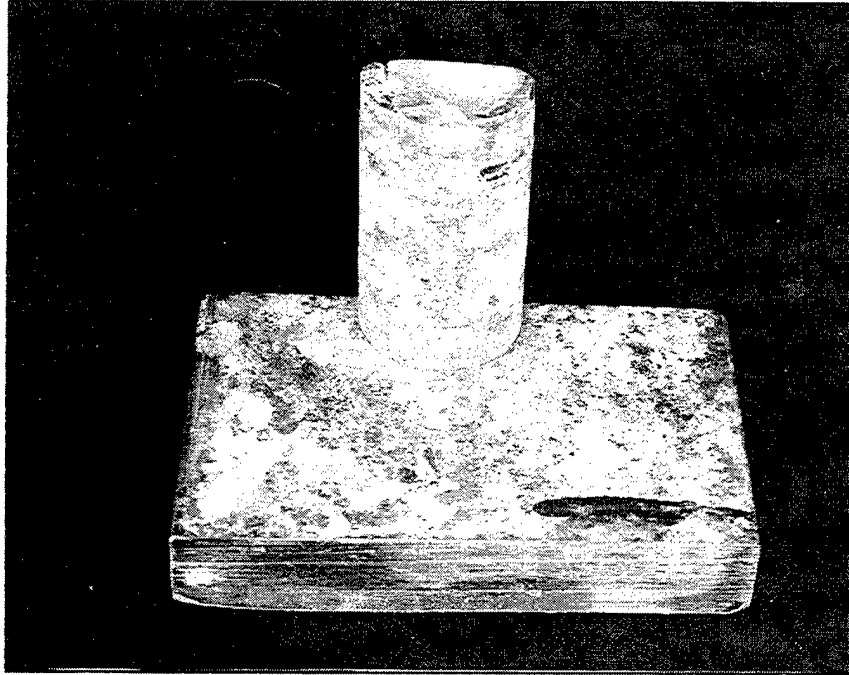
Figure 14. A section of the aluminum rivet shank still in the rivet hole of the spacer bar removed from the AVL B center panel assembly dismantled at ANAD. The bare surfaces of the rivet and bar were heavily covered with the white corrosion products. This sample was already cut in two for metallurgical examination. Magnification: approximately 1.25x.

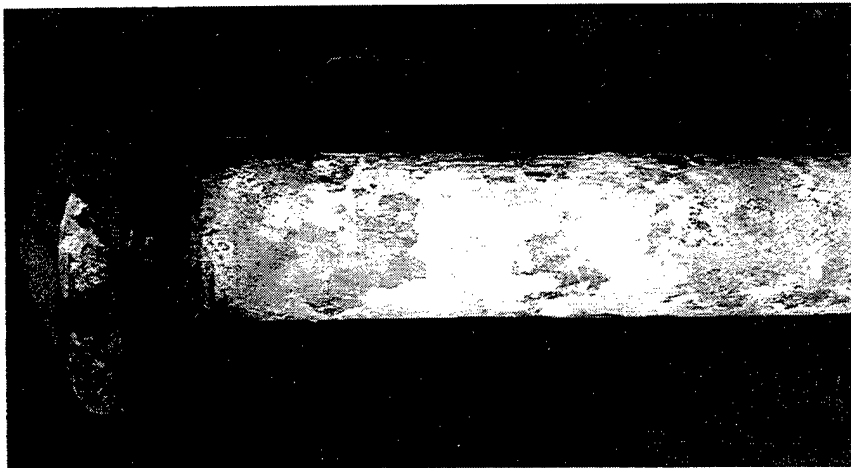
Figure 17. A 4-in-long large aluminum rivet sample with heavy deposits of white corrosion products on the surface of its shank. The driven end of the rivet is on left. Slightly larger than actual size.

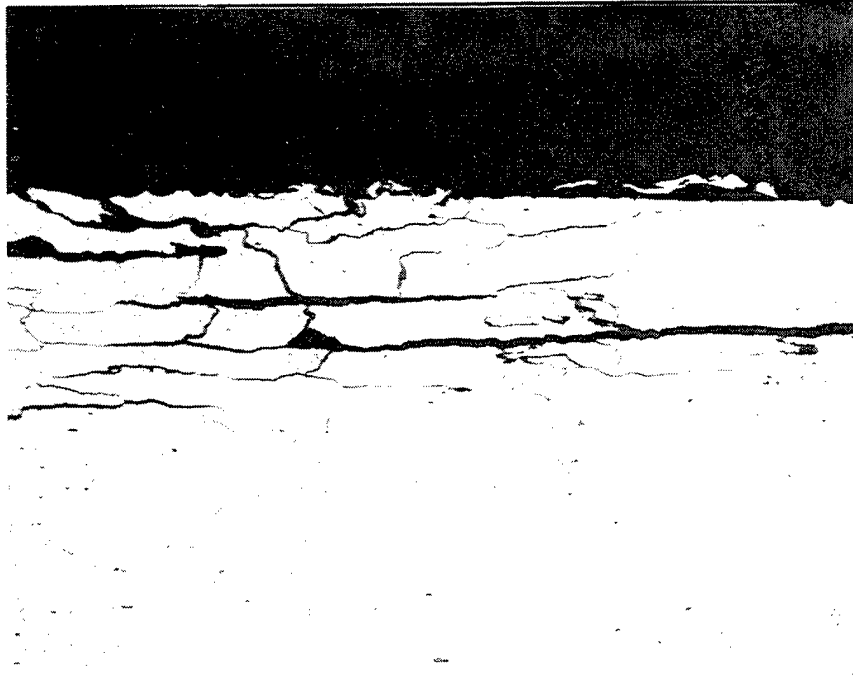
Figure 18. As-polished microstructure of a small corroded area on the surface of the rivet shank in Figure 17 covered with thick corrosion products. Intergranular corrosion and cracks (SCC) were observed at the corroded surface. Magnification: 100 $\times$ .

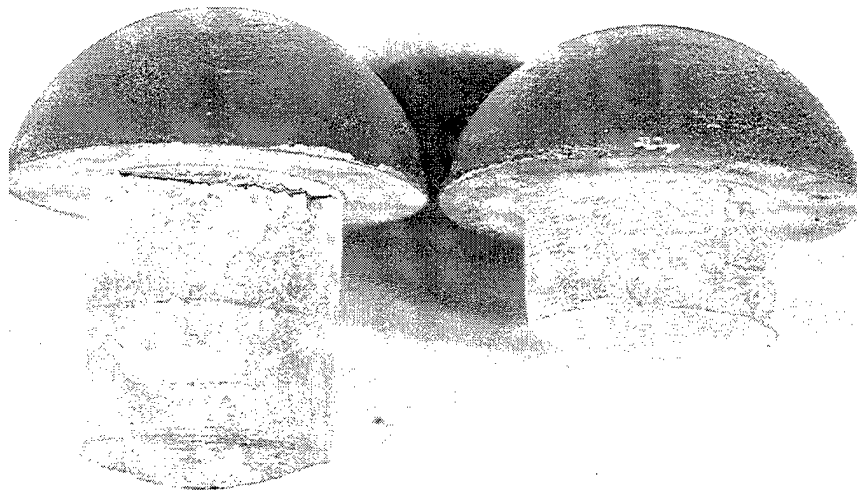
Figure 23. View of "Bad" (left) and "Good" rivets after the shear tests. A large crack is seen in the head-to-shank fillet of the "Bad" rivet. White corrosion products were on the surface of the rivet shank of both rivets. Magnification: approximately 1.33 $\times$ .

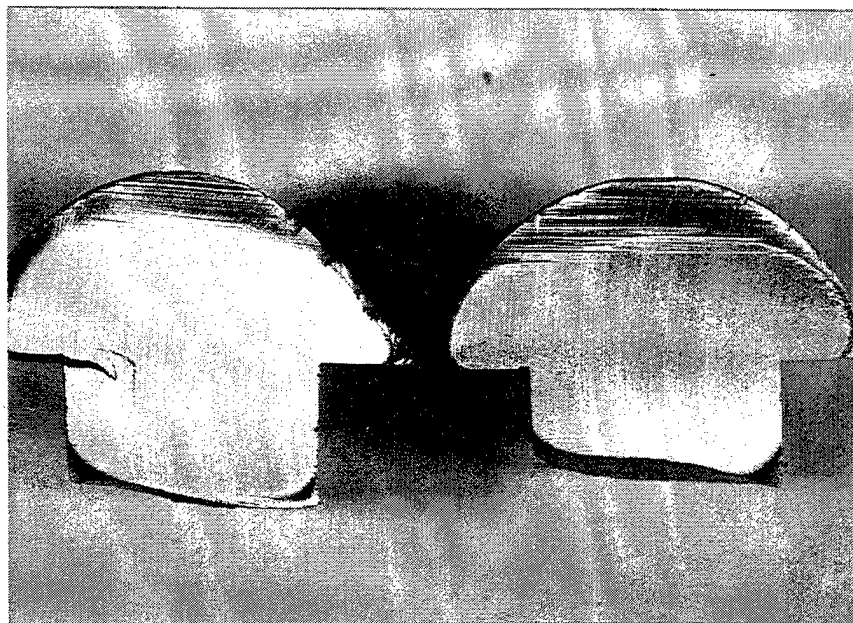
Figure 24. Cross sections of AVLB corroded rivet heads sectioned in two after the shear tests. The "Bad" rivet with large and small cracks in the left fillet under the head on the left. The "Good" rivet on right did not have observable cracks. Magnification: approximately 1.33 $\times$ . Grit 600 surface finish.

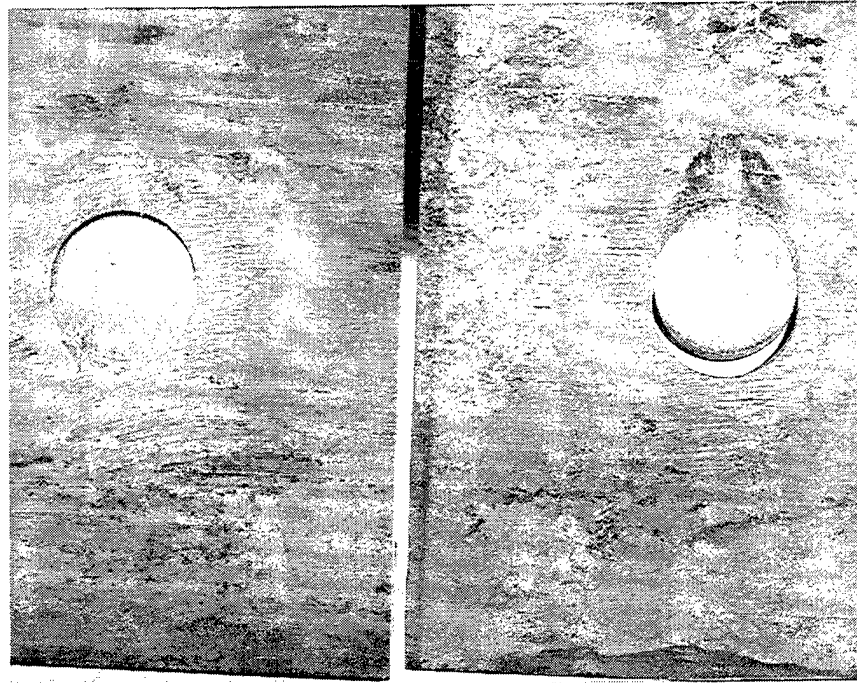
Figure 25. View of the rivet holes in the angle vertical leg on left and in the girder plate plunger on right after the shear test. Elongation of the rivet hole in the plate plunger was greater than the hole in the angle leg as noted by the gap. Sheared sections of the rivet shank remained in the holes. Actual size.

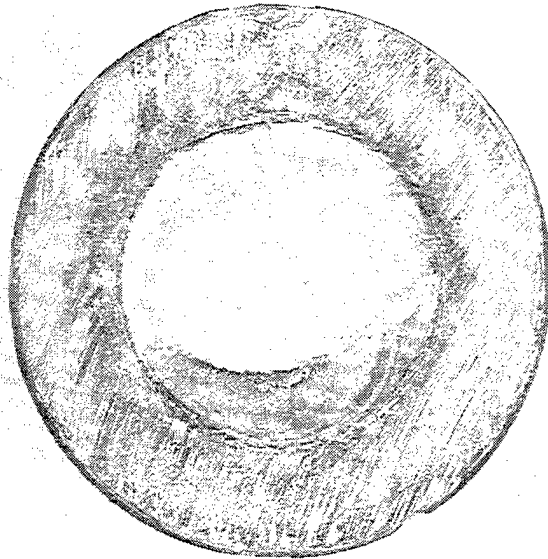
Figure 29. Enlarged view of the fracture surface of the rivet head (specimen C) that broke at the head-to-shoulder fillet after the pull test, revealing the darkened area of the crack because of corrosion (stress corrosion cracking).

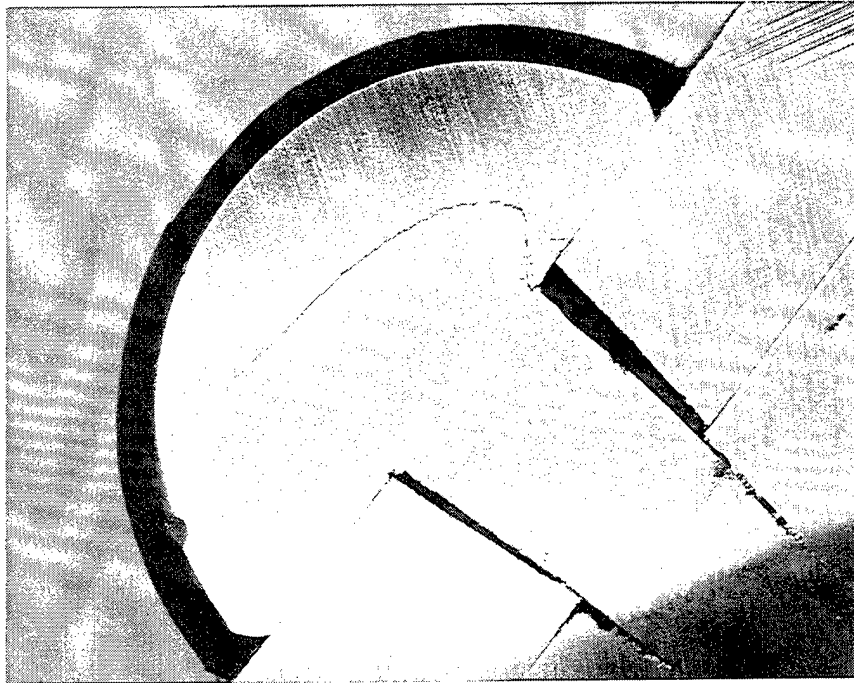
Figure 31. A view of the cross section of the installed rivet showing a large crack in the head. The crack initiated in the fillet. Magnification: 3 $\times$ . As-polished.

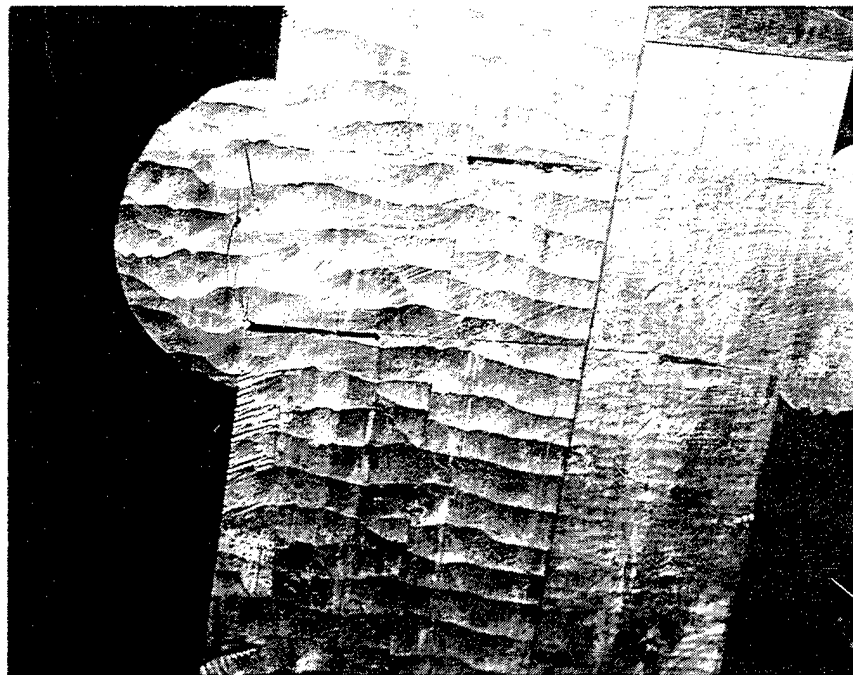
Figure 32. A view of the rivet that was rough cut in half lengthwise in the top connector of the AVL B, thus revealing large cracks in the head. The crack initiated in the fillet. See Figure 33 for polished surface of the same rivet.

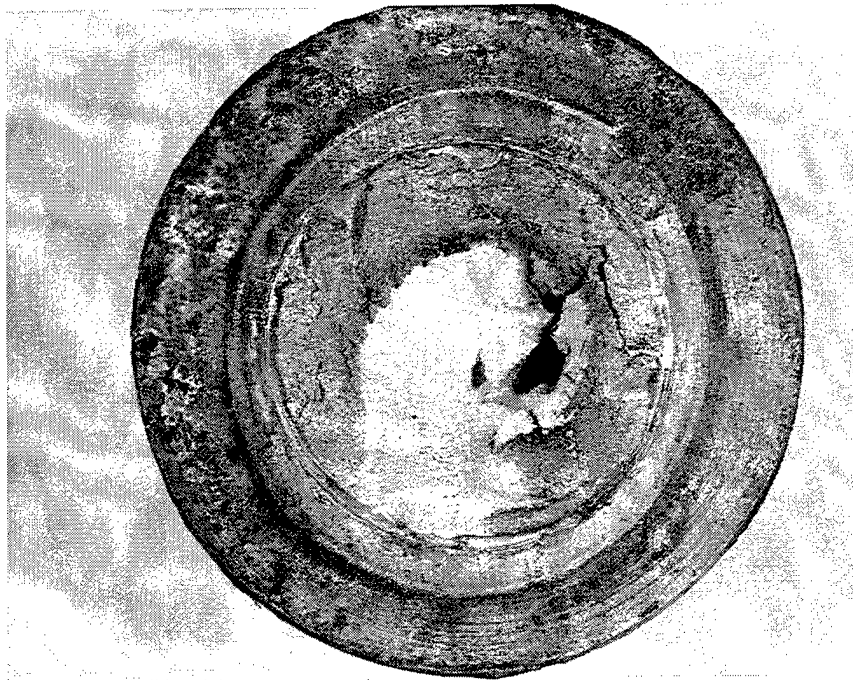
Figure 36. Enlarged view of the fracture surface under the head of specimen C "Bad" rivet after the pull test. The crack (discolored area because of corrosion) covers about 65% of the shank cross section, hence the reason for the low breaking load recorded during the test. Magnification: approximately 3x.

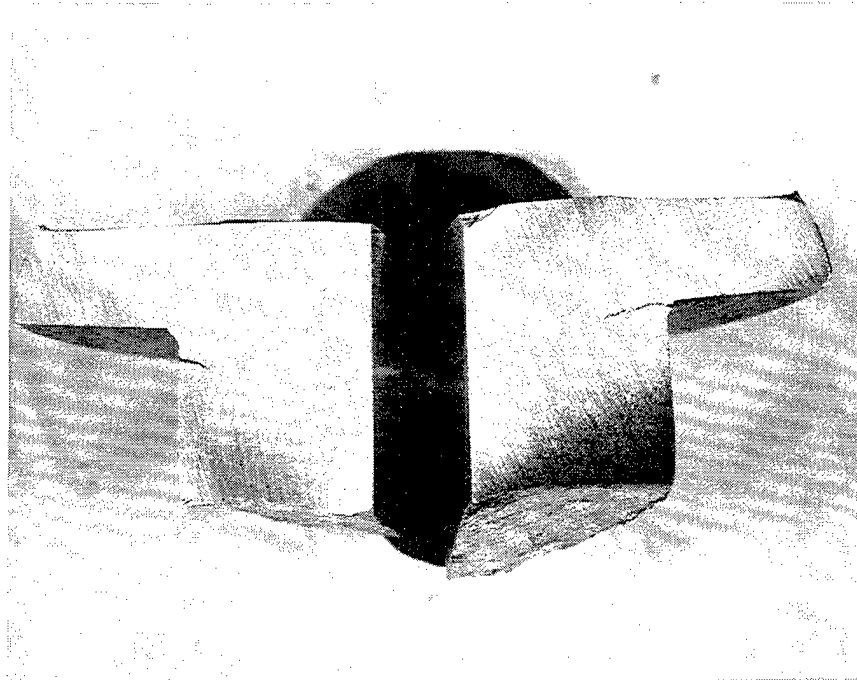
Figure 37. Enlarged view of two quarter sections of specimen D "Bad" rivet in Figure 34. Large cracks can be seen to initiate in the fillet of the right section and in the shank near the fillet of the left section. The crack on right is about 0.140-in deep. Magnification: 3 $\times$ . Surface finish: Grit 600.

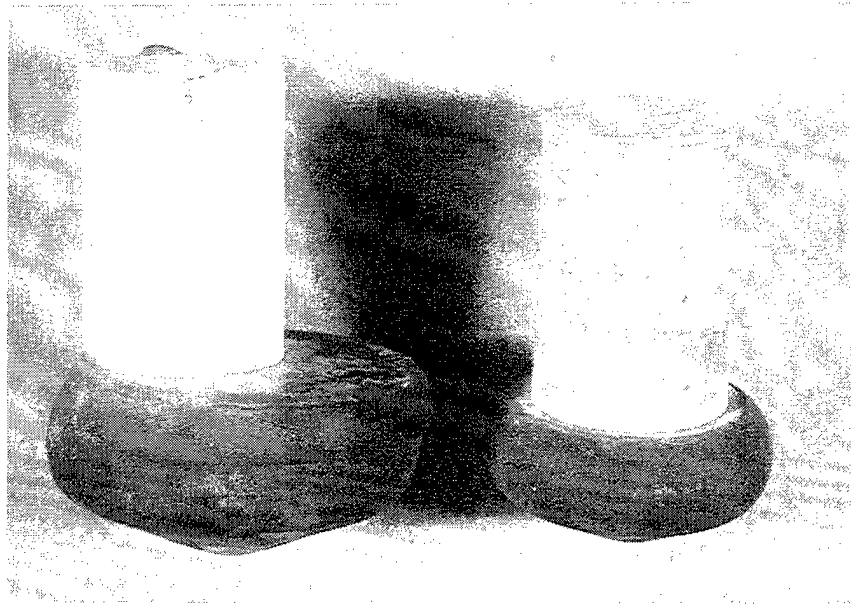
Figure 42. A view of the headless AVLB aluminum rivet samples 10 (left) and 15 after the plunger push tests, revealing the condition of the corroded rivet shanks. A load of 9,880 lb was required to push sample 10 out of the rivet holes as compared to 260 lb for sample 15. Note the complete coverage of thick white corrosion products on the shank surface of sample 10 vs. small corrosion pittings on sample 15. Also, note the larger size, off-center driven end of sample 10 as compared to the normal, centered end 15. This was due to use of incorrect, longer length rivet (sample 10), which probably allowed moisture to enter into the rivet hole at the very narrow flange (left side of sample 10) of the driven end, resulting in extensive formation of corrosion on the rivet shank surface. Magnification: 1.33x.

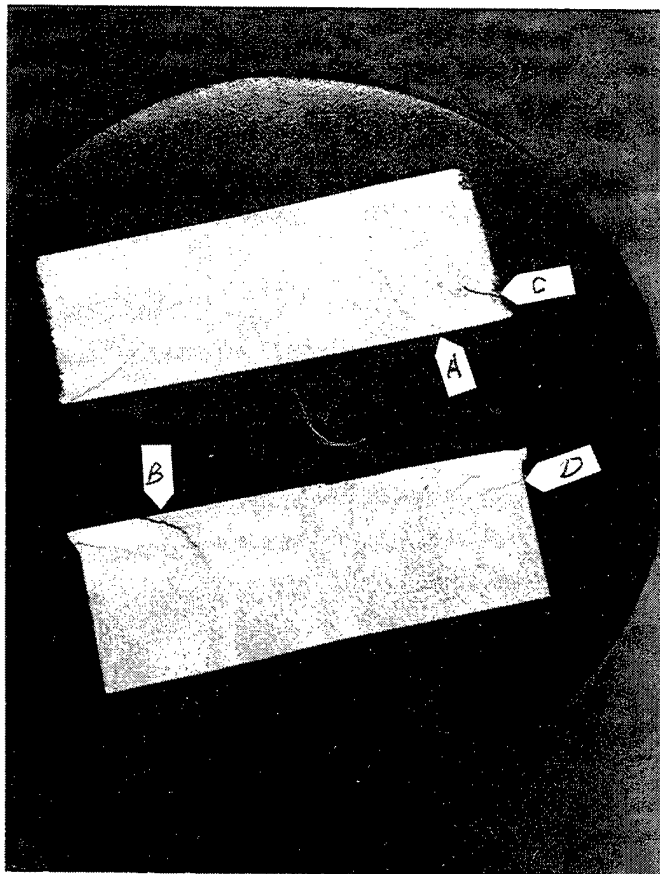
Figure 43. Enlarged view of the etched cross sections of the corroded AVLB rivet samples 10 (top) and 15, revealing stress corrosion cracks (dark curved lines) in the headless ends (arrows A and B) where the rivet buttonheads were sawed off. Most cracks observed were initiated at or near the fillets (partly seen in the photograph) and followed the grain flow caused by the head-forming operation. The microstructure at arrow C is seen in Figures 44 and 45, and that at arrow D in Figures 46 and 47. Magnification: 3.17 $\times$ . Keller's etchant.

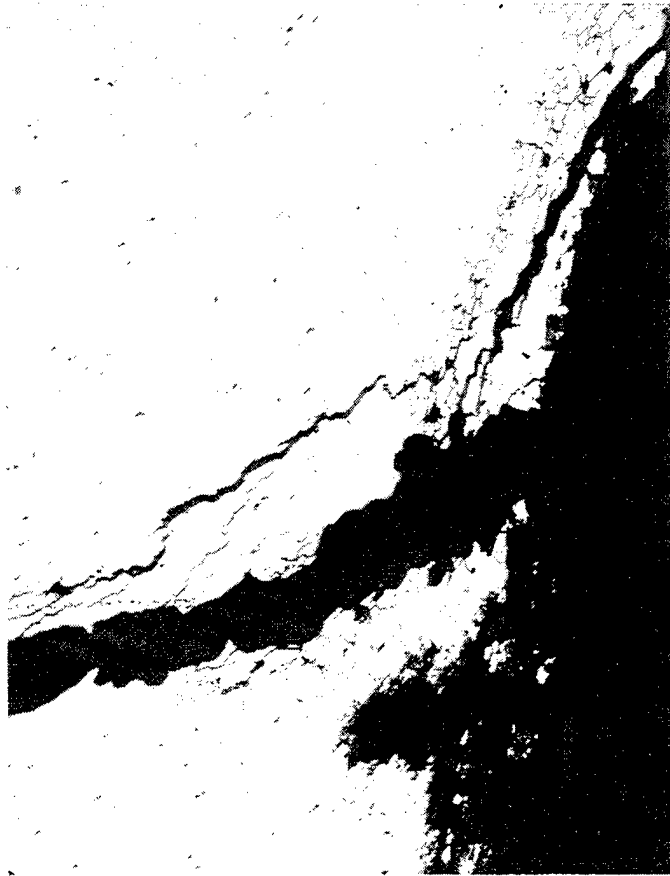
Figure 44. As-polished microstructure of stress corrosion cracks on the shank of corroded rivet sample 10 near the fillet. Note the intergranular corrosion on the surface of the shank (right side) and in the major cracks. Magnification: 100×.

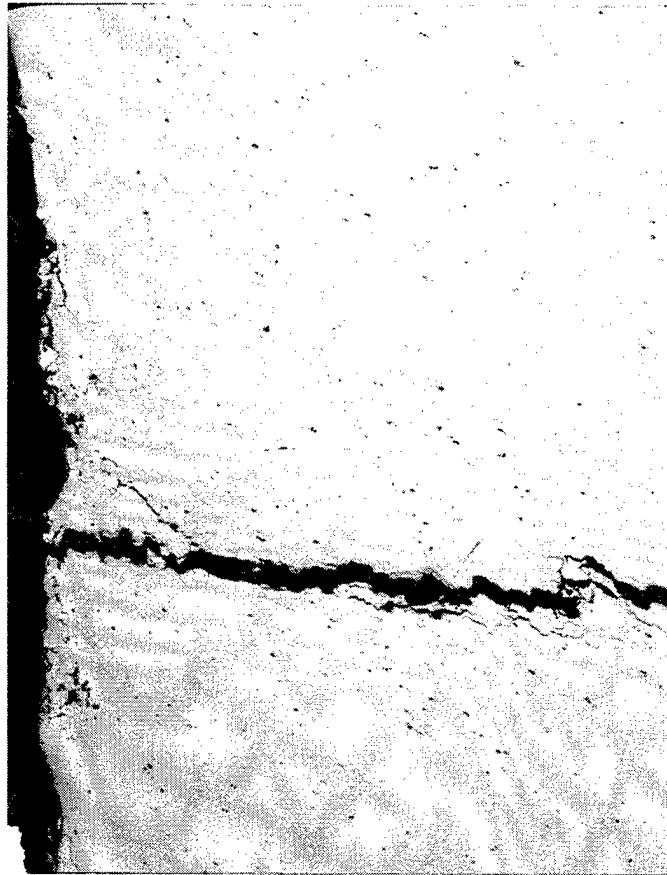
Figure 46. As-polished microstructure of stress corrosion cracks on the shank of the corroded sample 15 near the fillet area. Note the intergranular corrosion (not clearly seen in this photograph) on the surface of the shank (left side) and in the major crack. Magnification: 100x.

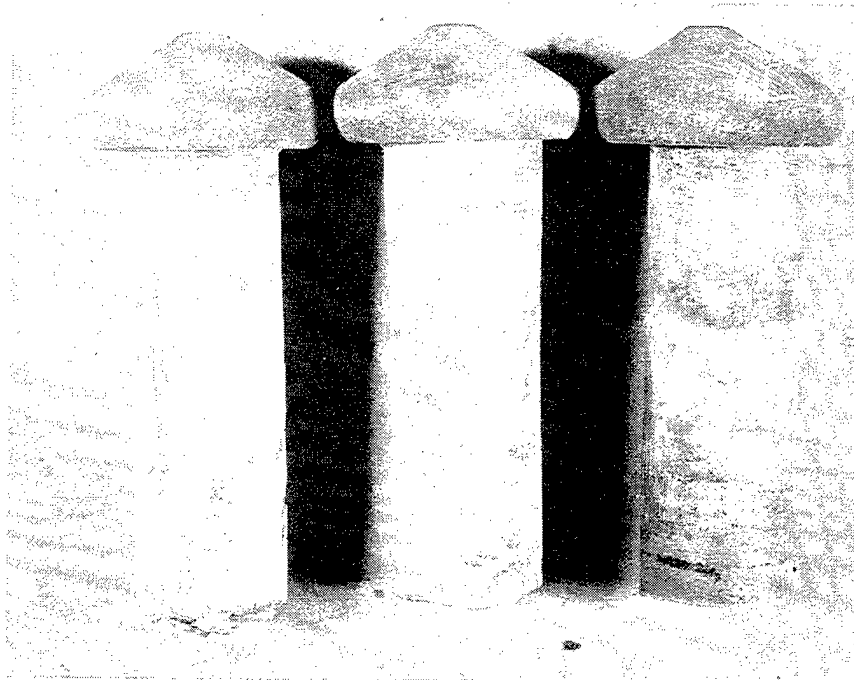
Figure 51. A view of the white corrosion products on the surface of the shank of the no. 1 headless corroded rivet at left, no. 5 rivet in middle, and no. 7 rivet at right. The loads required to break the rivets loose in their rivet holes were 19,000 lb for no. 1; 1,500 lb for no. 5; and 500 lb for no. 7.

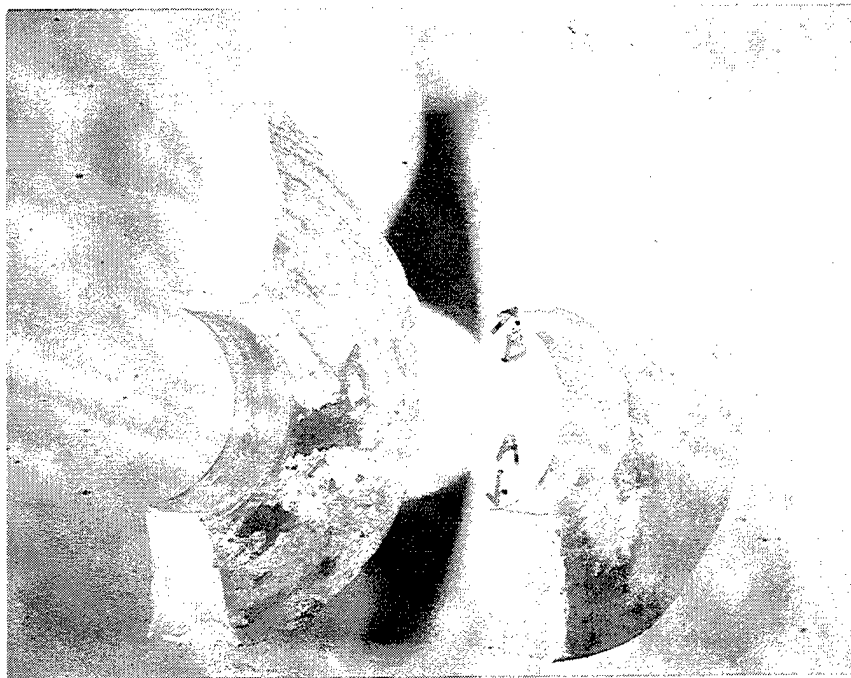
Figure 52. View of broken inboard female center hinge eyes. The piece on left is part of the inner hinge forging, and the other piece is part of the outer hinge forging that broke first at 95-ton load. Small fatigue cracks at A and B are seen in Figures 55 and 56.

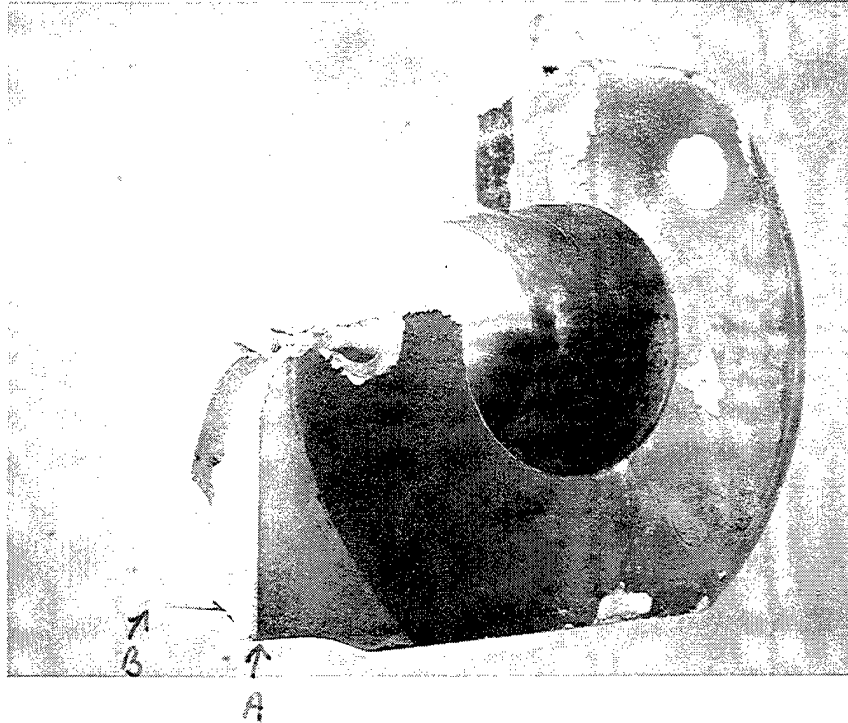
Figure 53. View of broken outboard bottom chord male connector eyes from the female center panel assembly after the failure test. The brittle fractures initiated at A and B because of the sharp machined fillets (straight edges). Closeup views of small fatigue cracks at A and B are seen in Figures 57 and 58.

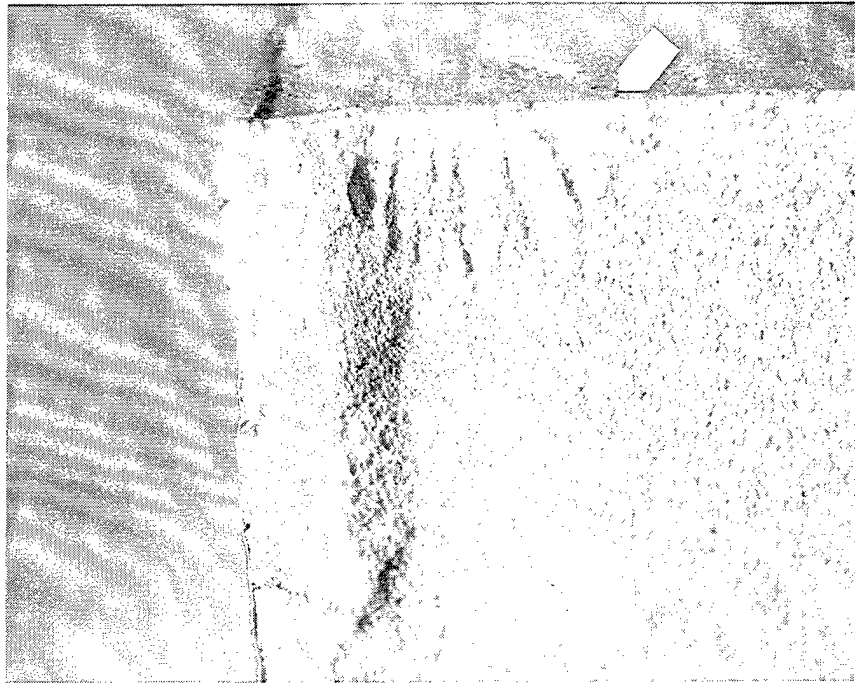
Figure 55. Closeup view of a small fatigue crack (arrow) at A in Figure 52. This eye piece of the forged female center hinge broke first at 95-ton load, initiating at this fatigue crack.

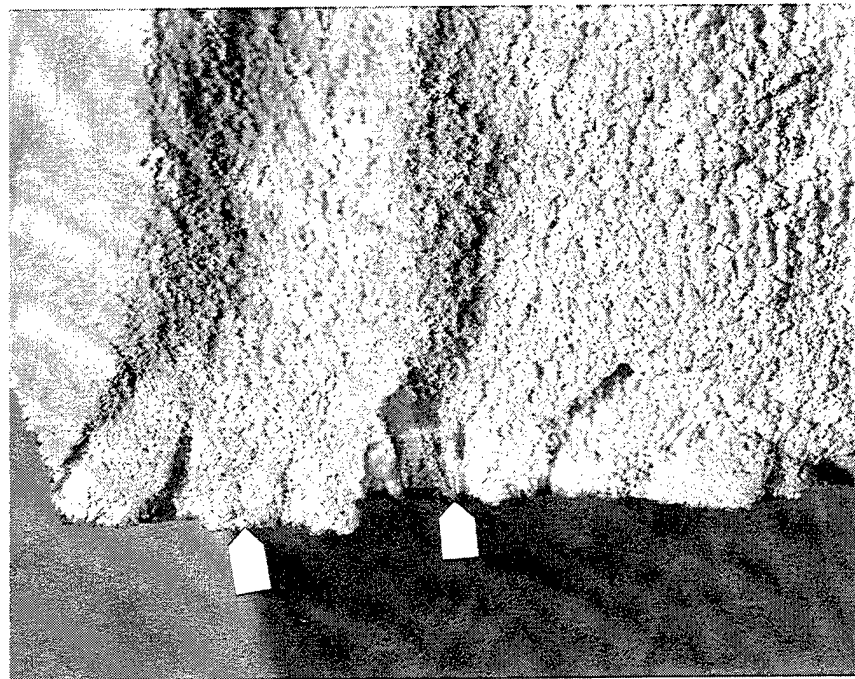
Figure 56. Closeup view of small fatigue crack (top edge) at B in Figure 52 after the eye piece broke from the forged female center hinge at 115-ton load.

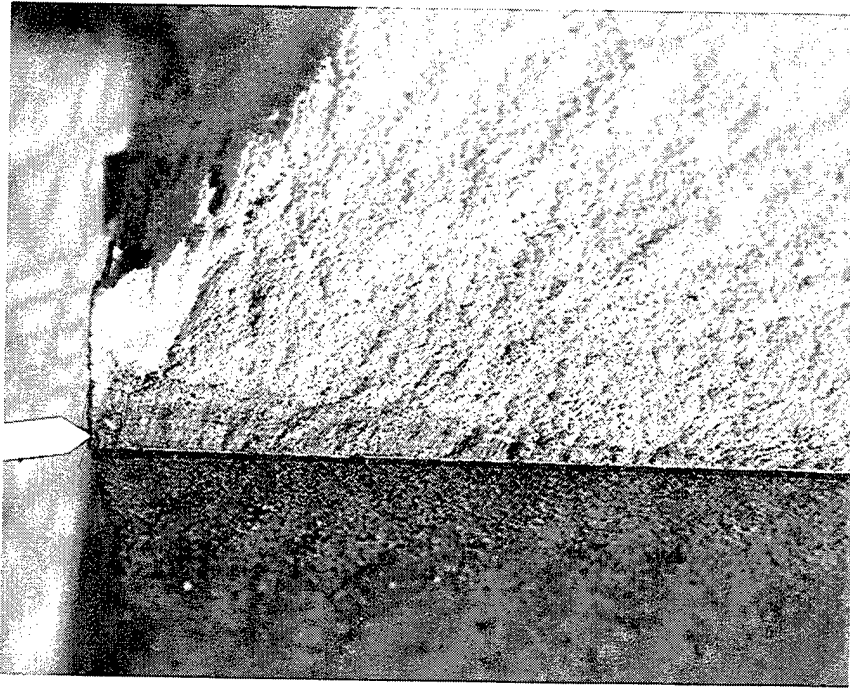
Figure 57. Closeup view of a small fatigue crack (arrow) at A in Figure 53 where it was initiated at the sharp machined fillets (straight edge).

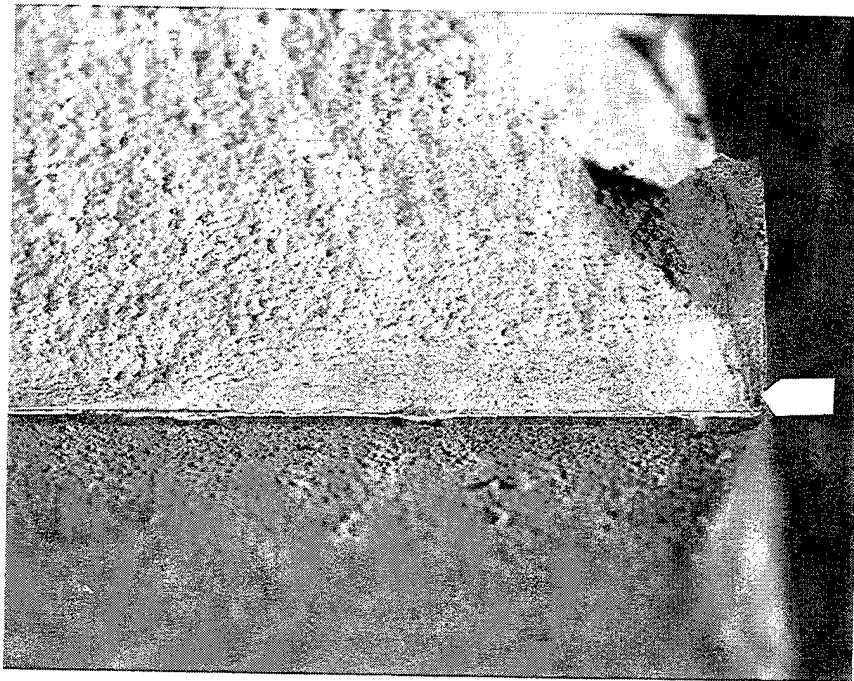
Figure 58. Closeup view of a small fatigue crack (arrow) at B in Figure 53 where it was initiated at the sharp machined fillet (straight edge).
