DSTO-TR-0366

Evaluation of Innovative NDI  
Methods for Detection of  
Widespread Fatigue Damage

P. Khan Sharp,  
D.E. Rowlands and G. Clark

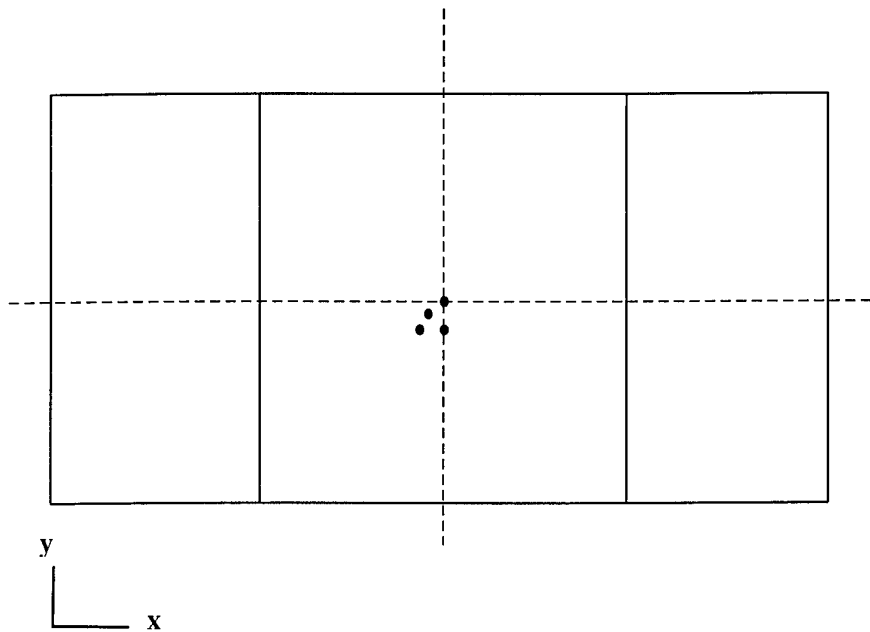
The only indications of cracking after program 23+13493tp, were sites (i) and (ii), the other possible having been confirmed as false positive indications. The lack of apparent development of indications (i) and (ii) between programs 14 and 23+, and the lack of development of any other indications in this period indicates non crack-like behaviour. However, as indicated earlier, it was necessary to continue the test until cracks grew to visible length in order to confirm/reject indications confidently.

Figure 15: Location of possible cracks detected with laser ultrasonics. These possible crack locations could not be confirmed by any other method.

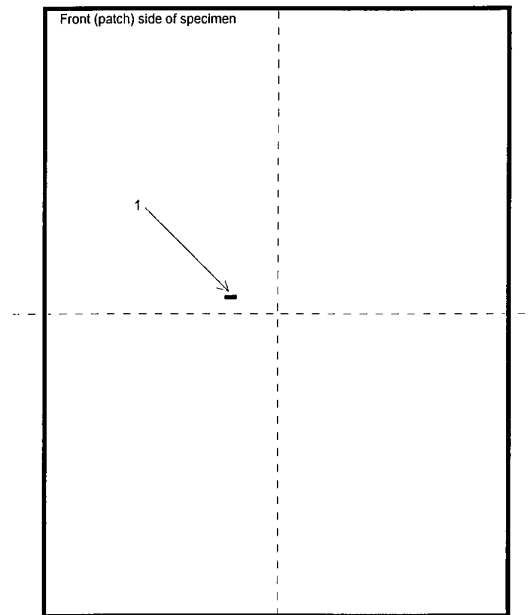
The crack was detected under the patch, though the lag in the system made it difficult to locate the crack precisely. The patch was not removed to confirm the presence of a crack by conventional NDI techniques.

Figure 16: The suspected location of the crack detected, this location was not precise due to the lag in the instrument system.

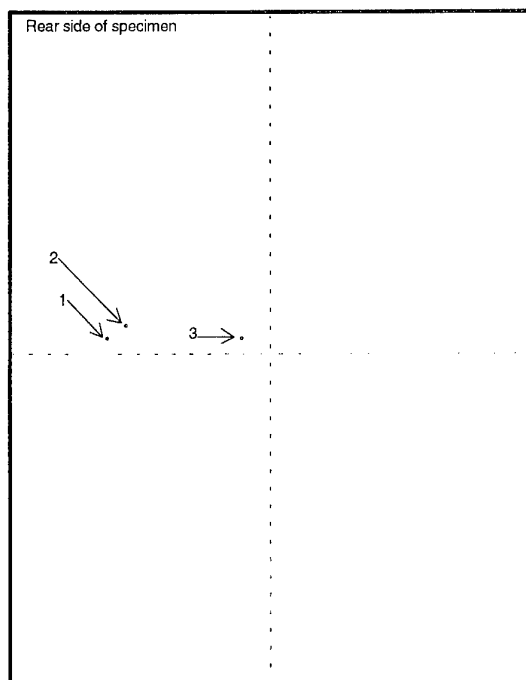
Figure 17: A schematic of the location of the three cracks detected.

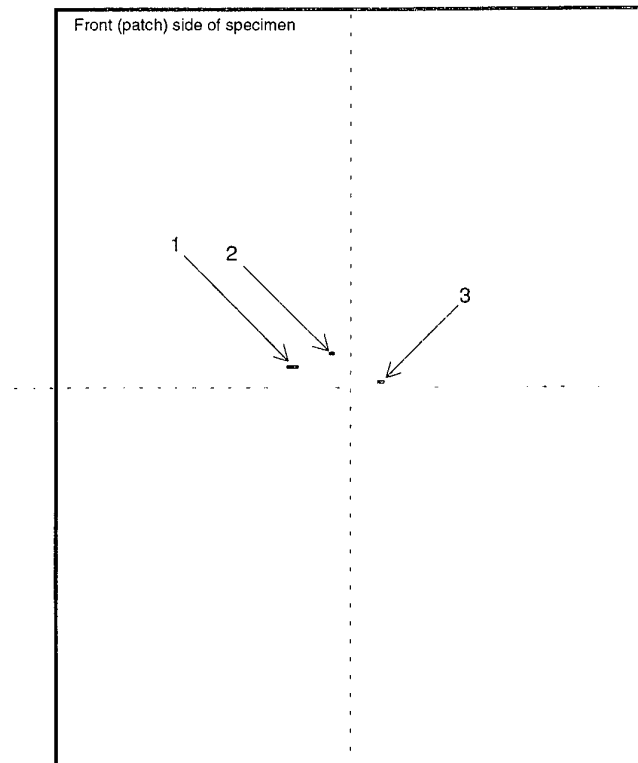
Three possible microcracks were located approximately 56 mm, 62 mm and 75 mm from the left hand edge of the specimen. It was not possible to locate the cracks vertically under the patch.

Figure 19: A schematic of the location of the three cracks detected by the structural integrity monitor (Model 2).

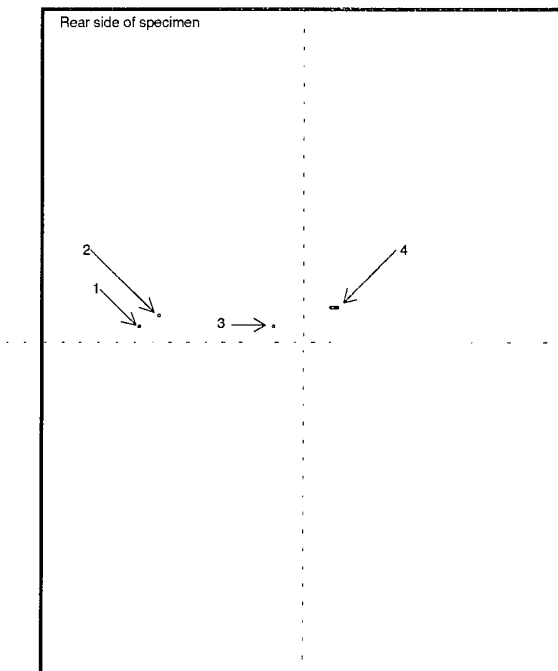
Figure 20: A schematic of the locations of the four cracks now found. Three cracks were found after program 26 (No's 1,2,3) and a new large crack was found at location No. 4.

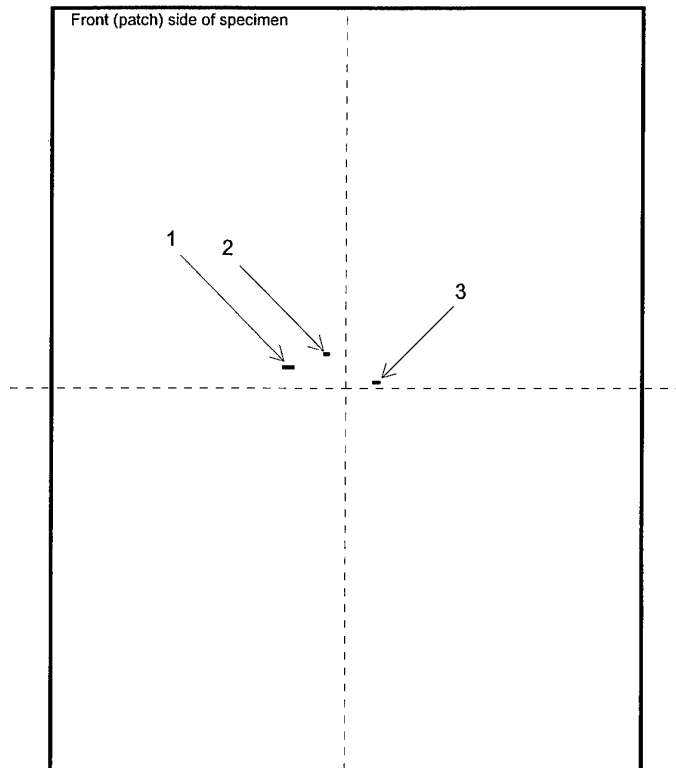
The crack was located approximately 58 mm from the left hand edge. Though there were still indications at approximately 65 mm and 70 mm the signal was being dominated by the crack located 58 mm from the edge. This indicates that there was one large crack at 58 mm and two small cracks at 65 mm and 70 mm. The fact that the zero load differential reading was slowly creeping up also indicated that a crack was present.

Figure 23: A schematic of the location of the three cracks detected by the structural integrity monitor (Model 2). Crack No.1 was large and starting to swamp the signal from cracks No. 2 and No. 3.

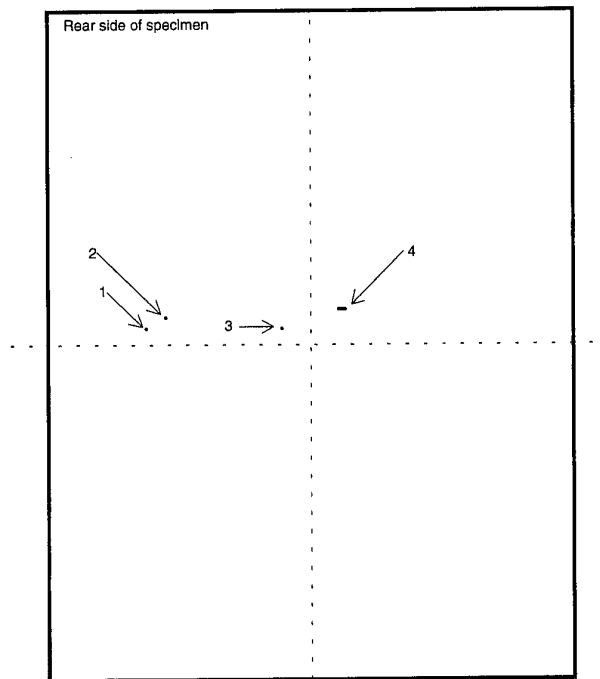
Figure 24: A schematic of the location of the four cracks detected with holographic interferometry.

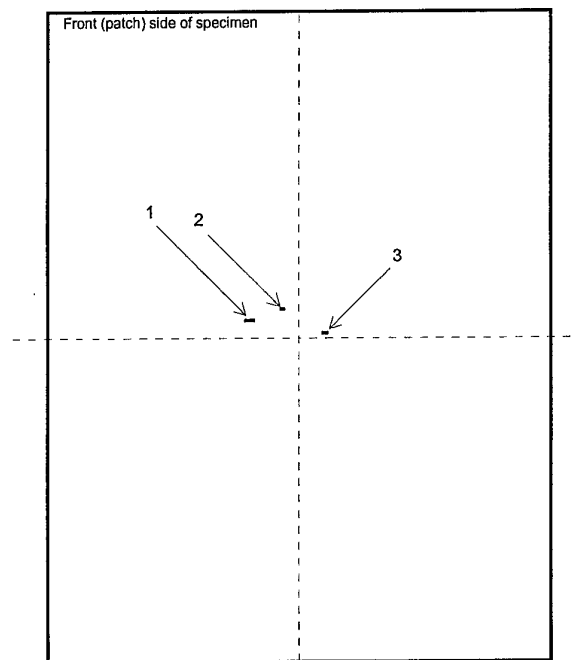
Three cracks had been identified, though the signal from crack No.1 was swamping other indications that may have helped to locate other cracks.

Figure 27: A schematic of the location of the three cracks detected by the structural integrity monitor (Model 2).

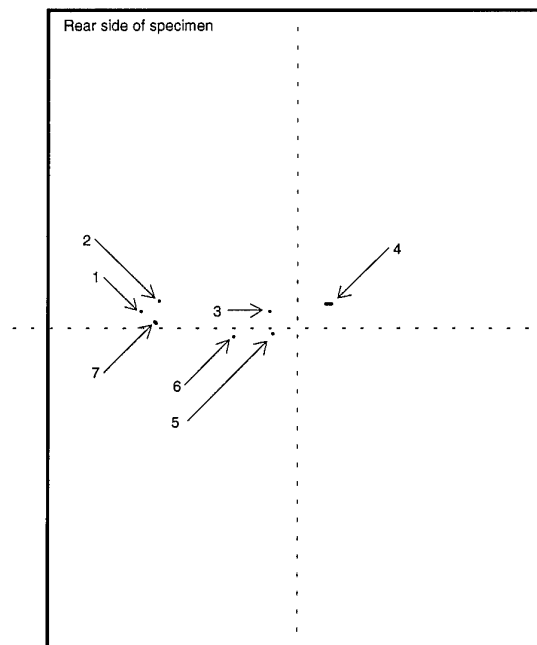
Figure 28 is a schematic of the crack locations observed after program 29. Plate No. 24 clearly shows a number of cracks present, Figure 29.

Figure 28: More cracks were located as shown in this schematic. Note that crack No.4 does not appear on this image.

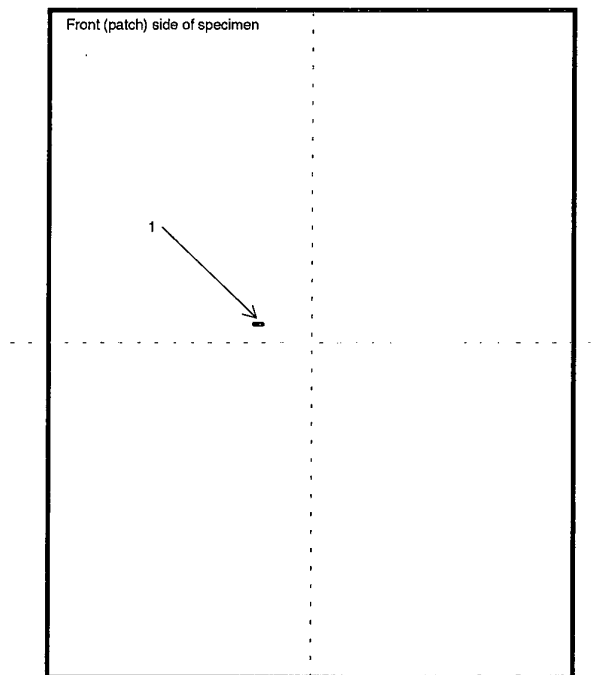
The structural integrity monitor patch was removed from the front of the specimen and a hologram taken of the specimen front. Figure 30 shows the location of the crack found by holographic interferometry, Figure 31. There are indications of three other cracks. The located crack is the main crack found by the structural integrity monitor.

Figure 30: A schematic of the large crack located on the structural integrity monitor side after the patch was removed. The location agrees with the large crack found by the structural integrity monitor.

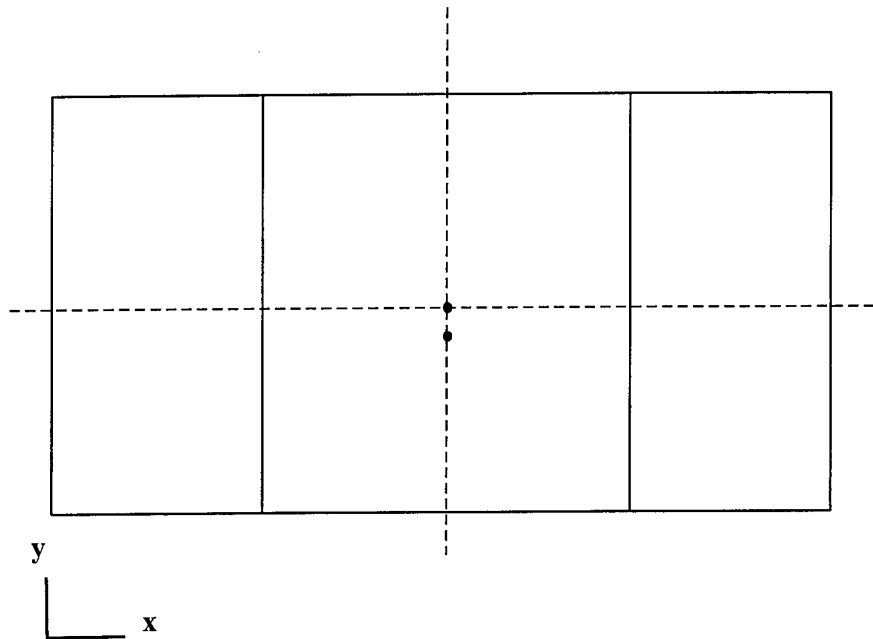
This inspection again showed indications of cracks at (i) and (ii). A final series of consistency checks were made on the data at this stage, including detailed comparison of the transmission results for various "y" values.

Figure 32: A schematic of the location of the two crack indications found with laser ultrasonics

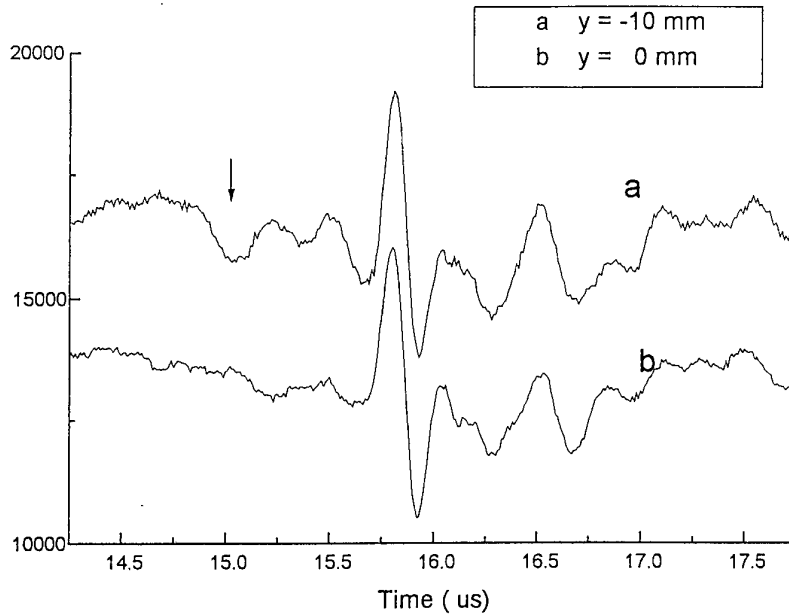
Figure 33: A typical waveform transmission from the test [3]. The difference between the two waveforms is the arrowed peak, which is attributed to a crack.

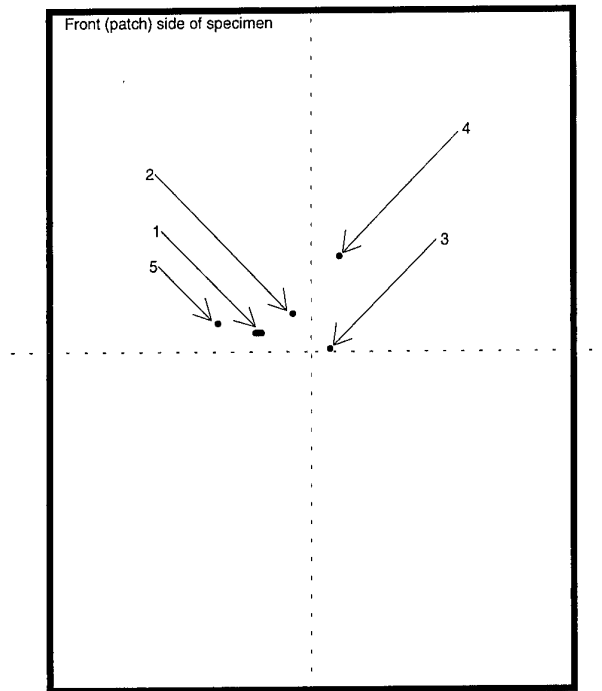
Figure 35: The five cracks located by fluorescent dye penetrant on the front of the specimen (structural integrity monitor side). The visual intensities are a good indication of the crack size and are as follows; crack 1-very bright, crack 2-bright, crack 3-bright, crack 4-weak and crack 5-weak

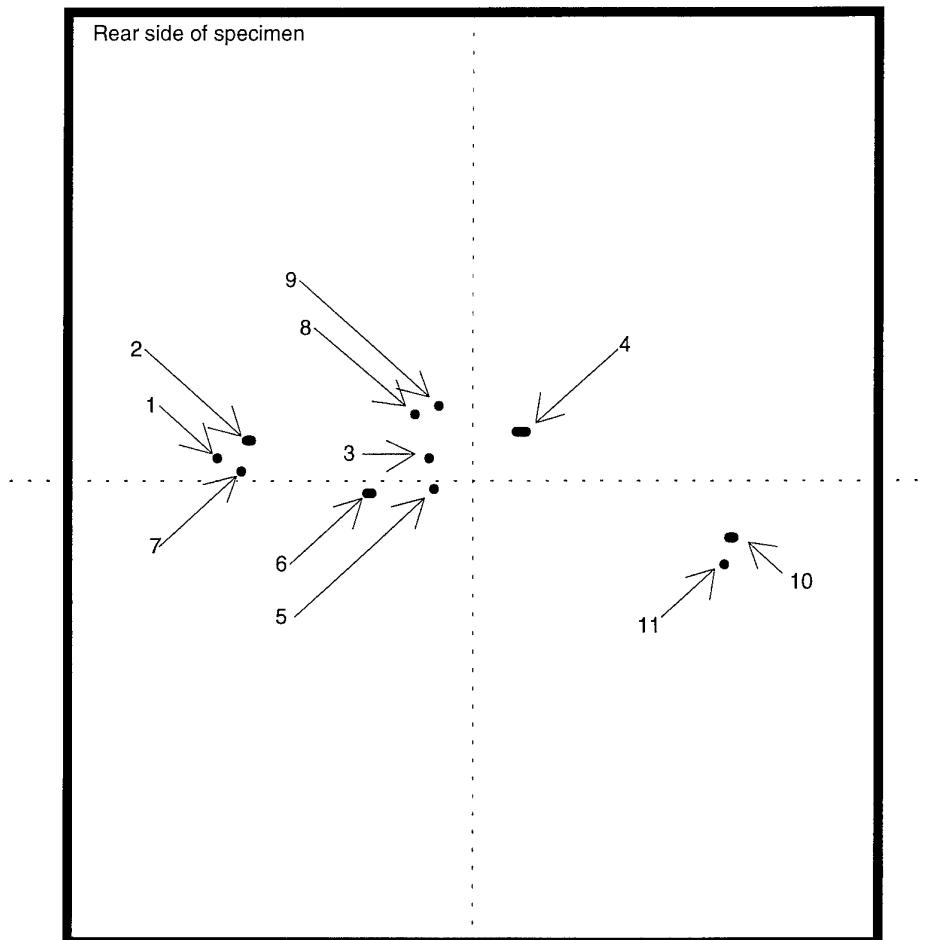
Figure 36: The eleven cracks found by fluorescent dye penetrant on the back of the specimen (holographic interferometry side). The visual intensities are a good indication of the crack size and are as follows; crack 4-very bright, cracks 2, 6, 10-bright and cracks 1,3,5,7,8,9,11-weak.

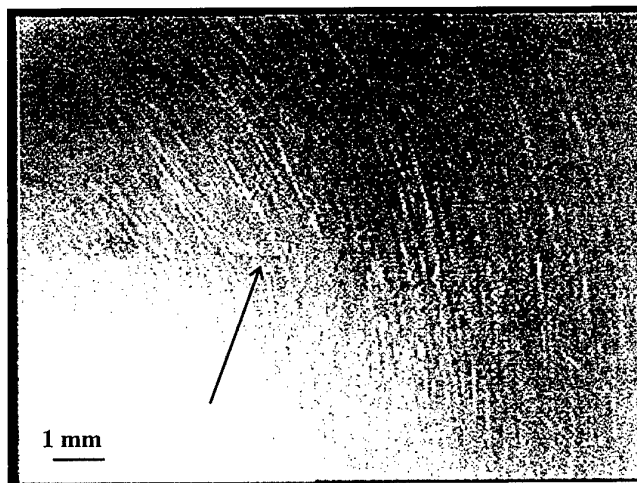
Figure 40: Images of the second crack on the "Davey System" side, observed with the microwatcher (crack No. F2).
