# ***GALLIPOLIS LOCKS AND DAM***

**FOUNDATION REPORT**

**VOLUME 4 PHOTOGRAPHS**

**CONSTRUCTION OF TWO PARALLEL LOCKS AND CANAL**

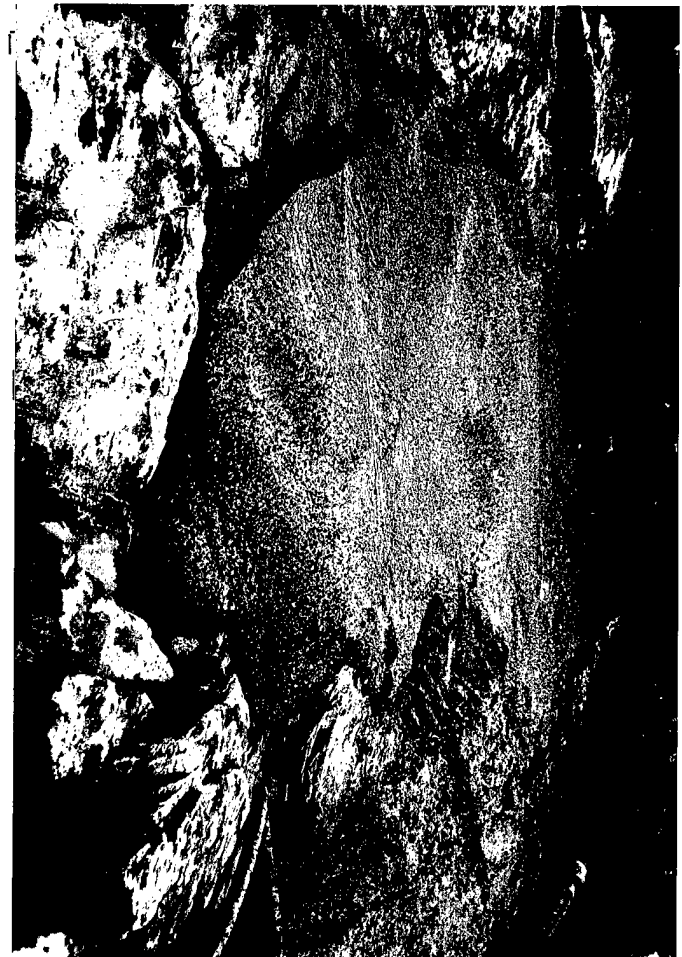
(231) L-14 Invert View looking East after repair
