DSTO-TR-0480

F-111C Lower Wing Skin Bonded  
Composite Repair Substantiation  
Testing

R. Boykett and K. Walker

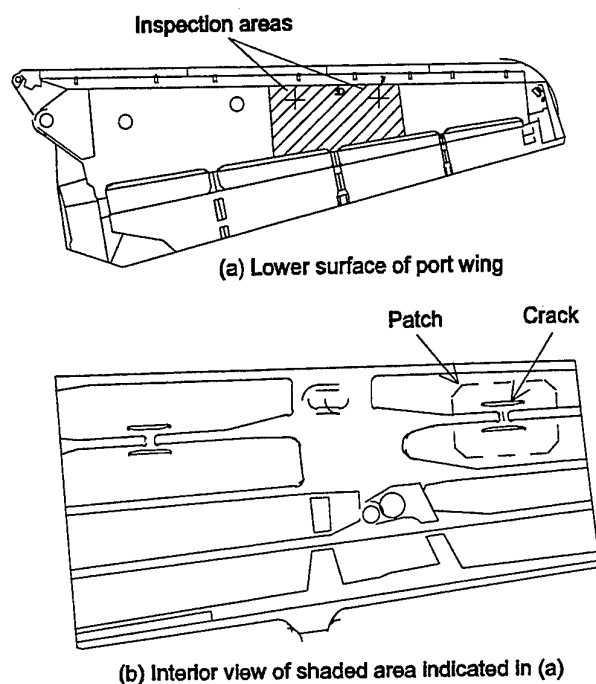
A crack was discovered in the port lower wing skin of a Royal Australian Air Force F-111C aircraft (RAAF tail number A8-145) during a routine visual inspection. The initial indication was fuel seepage at the site of an apparent 40 mm chordwise crack; however, a detailed non-destructive inspection revealed a through-thickness crack, 48 mm long tip-to-tip. Fracture mechanics calculations indicated that the residual strength had been degraded to 150 MPa (21.7 ksi), which is considerably less than the Design Limit Stress of 256 MPa (37.1 ksi) specified for this region of the wing<sup>1</sup>, compromising flight safety.

Figure 1 indicates the location of cracking on the lower wing-skin. Raised portions serve as integral stiffeners and as attachment lands for spars. The cracking occurred in an area lying below the forward auxiliary spar, at the spar station FASS 281.28, where the thickness of the integral stiffener is reduced from approximately 8.2 mm to the nominal skin thickness ( $3.7 \pm 0.1$  mm at this location). The purpose of this depression in the stiffener is to allow full fuel flow and drainage between adjacent bays of the

Figure 1. Crack location on the F-111C lower wing-skin and repair patch outline.

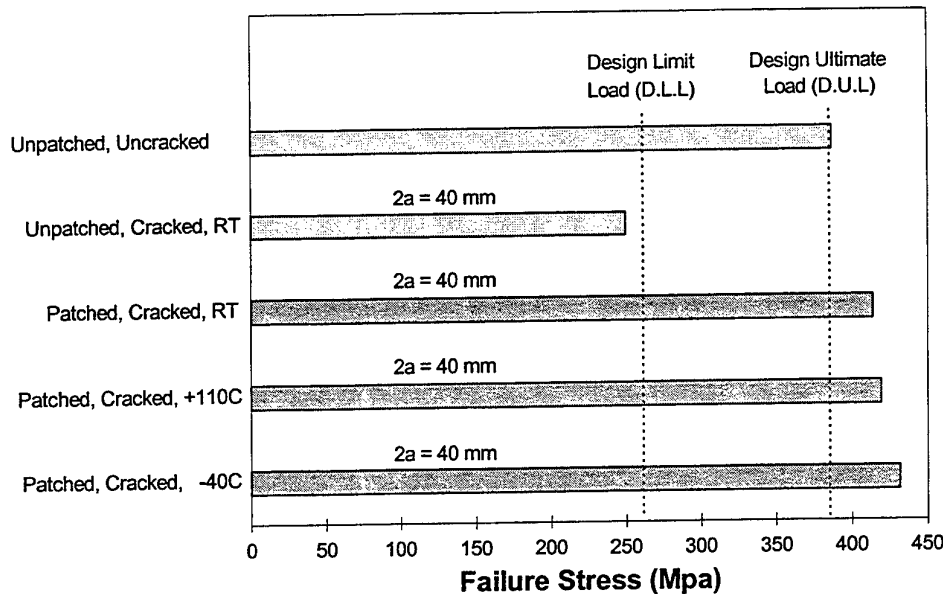
Figure 6. Results of static strength tests on panel specimens.

- 1) The undamaged "baseline" panel fails at DUL but the unrepaired damaged panel does not meet DLL. This was predicted by fracture mechanics calculations<sup>1</sup>.

- 2) The repaired panels all exceed DUL, with little effect noted between the different temperatures. The temperature gradient on the specimen during the hot test (+110°C) ranged from 83.0°C to 119.4°C, and during the cold test (-40°C) from -16.3°C to -42.2°C. The maximum values were at the centre of the specimen due to heat transfer from the ends of the specimen into the grips of the testing machine<sup>14</sup>. However, the hot test was repeated at later date (August 1996) using a new environmental chamber. The specimen *FLTP-17* had already been used for fatigue loading (50,000 simulated flight hours and the crack had grown to 69.4 mm). The temperature range on the specimen was 105°C to 112°C, within the boundary of the boron patch, when it failed by the crack propagating to the edges at a load of 204.7 kN (247 Mpa). Since the Design Ultimate Stress for the high temperature load case<sup>7</sup> is 214.5 Mpa, the specimen *FLTP-17* demonstrated that the repair restores static strength above DUL at high temperature. This is considered to be a remarkable achievement for the FM73 adhesive because 110°C is well above the glass transition temperature,  $T_g$ .

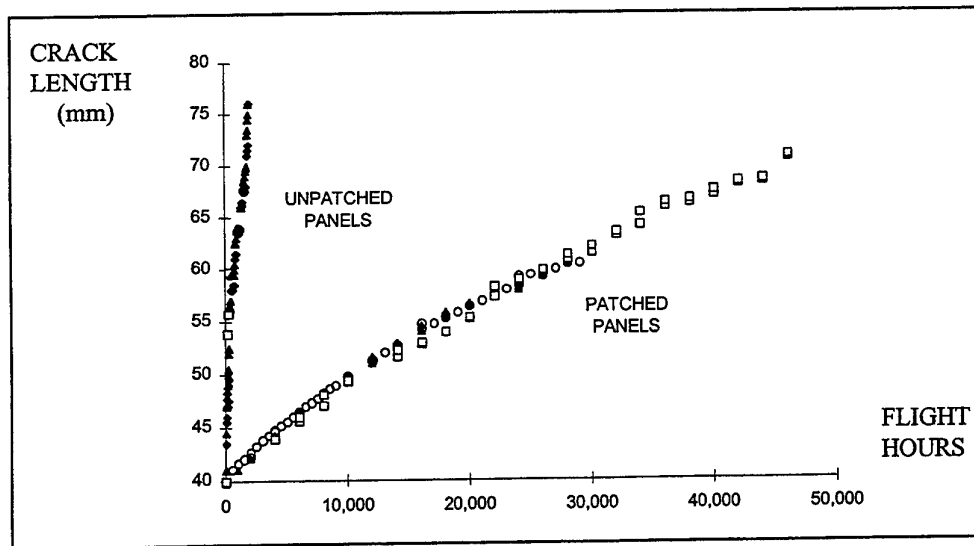
Figure 9. Fatigue crack growth rates using the cycle-by-cycle spectrum

These results indicate a significant improvement in life obtained from the patch repair. 30,000 flight hours approximates 100 years at current RAAF usage rates.

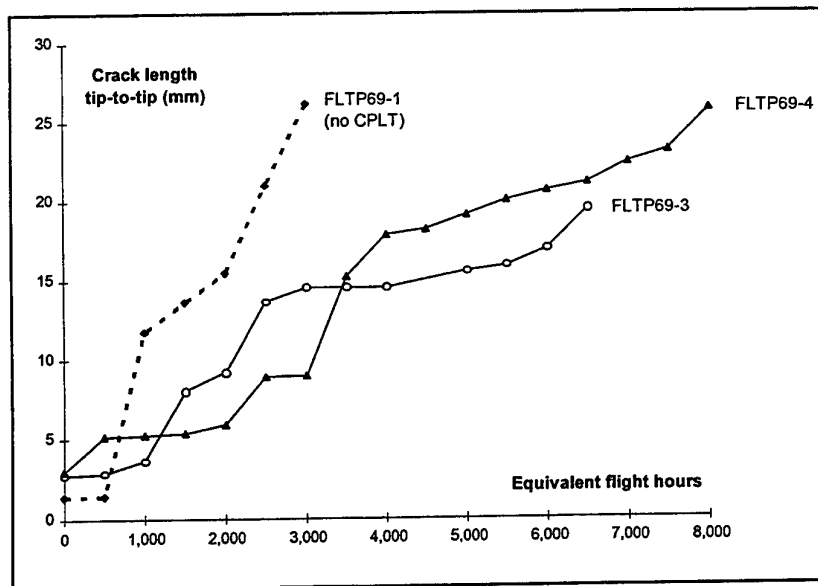
From Figure 10, the average crack growth curve gives a growth time from  $2a = 6 \text{ mm}$  to  $2a = 20 \text{ mm}$  of approximately 2,000 hours. These results therefore support an inspection interval for this region of approximately 1,000 hours.

Figure 10. Crack growth of panel specimens from first initiation under the cycle-by-cycle loading spectrum.

Note that the specimen FLTP69-1 was not loaded quite the same as the others; the CPLT load cases were omitted until the last block (whereupon it failed).

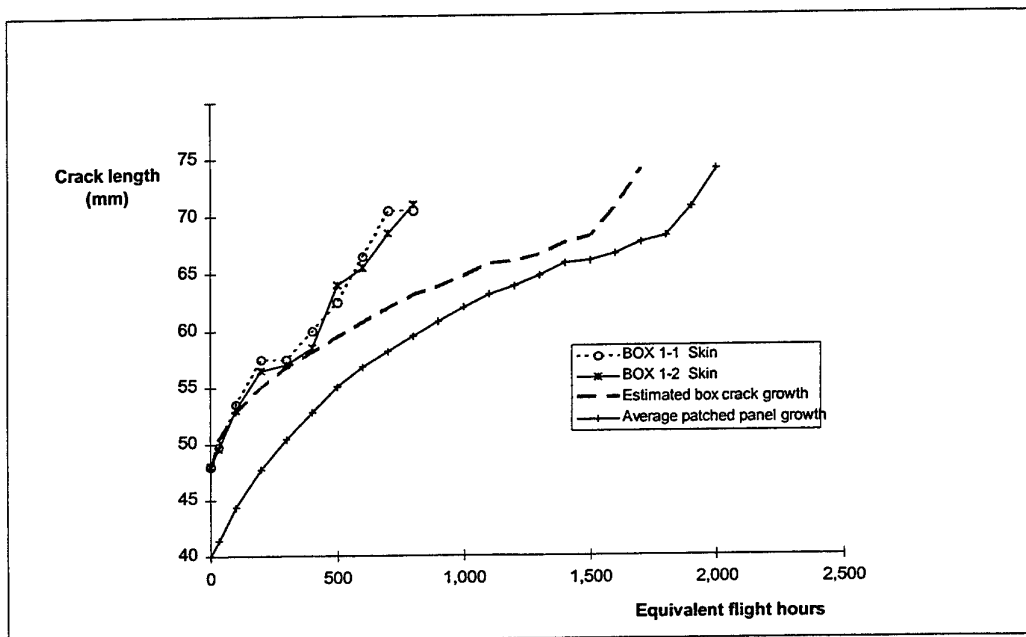
After 800 equivalent flight hours of the blocked loading spectrum, the crack length in each skin was 70.5 and 71 mm. Ultrasonic A-scan NDI carried out in the vicinity of the crack gave "indications" of disbonding for a spanwise distance of about 6 mm and about 70 mm in the chordwise direction. However, subsequent teardown inspections were not conclusive as to whether such a disbond really existed or not. The stress analysis carried out for this repair<sup>9,25</sup> indicates that plastic deformation is expected in the adhesive in the region of the crack. It also indicates that if a disbond was to occur, then the local stresses and strains would be relieved and the disbond would not propagate. The test results are consistent with this analysis.

Figure 19. Specimen crack growth under blocked spectrum loading.

The patched and pre-cracked panel specimens were tested from 40 mm crack lengths (compared to 48 mm in the box specimen), so an equivalent predicted crack growth curve for the box specimen is calculated by translating (horizontally) the average growth curve to the match the values at 48 mm to obtain the dashed curve shown in Figure 19, above.

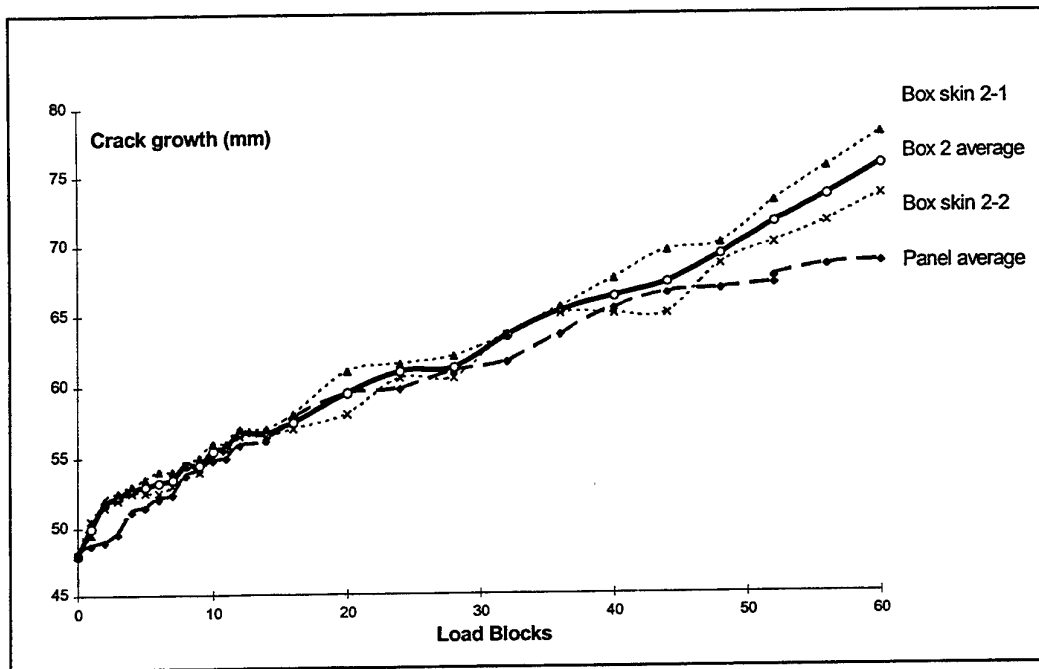
Figure 20. Second Box Specimen post-repair crack growth

The patched and pre-cracked panel specimens were tested with crack lengths starting from 40 mm (compared to 48 mm in the box specimen), so an estimated crack growth curve for the box specimen was calculated as per Figure 9.

- 1) One load block is equivalent to 500 flight hours.
- 2) This crack growth zone extends into the adjacent integral side stiffeners. The crack tips reach the fillet radii when the crack length is approximately 55 mm and reach the lands of the stiffeners at 70 mm.

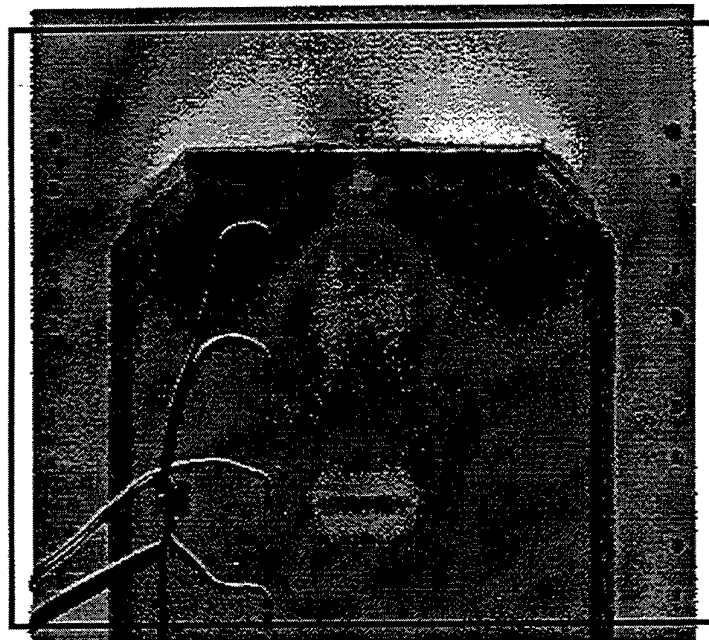
*Figure 23. FAST scan - View onto Box 1, skin 2 repair patch after 800 equivalent flight hours. Spanwise load axis is vertical in this view. Lighter shaded areas have higher levels of surface strain.*

The increased strains are clearly evident in the central region in the lower part of this view, where the crack location is shown by the darker line. The fastener location adjacent to the end of the patch is in an area of unusual strain distribution ; a small
