**Reconnaissance Report of Damage  
to Historic Monuments in Cairo, Egypt  
Following the October 12, 1992 Dahshur Earthquake**

**D. Sykora, D. Look, G. Croci, E. Karaesmen and E. Karaesmen**

Technical Report NCEER-93-0016

**August 19, 1993**

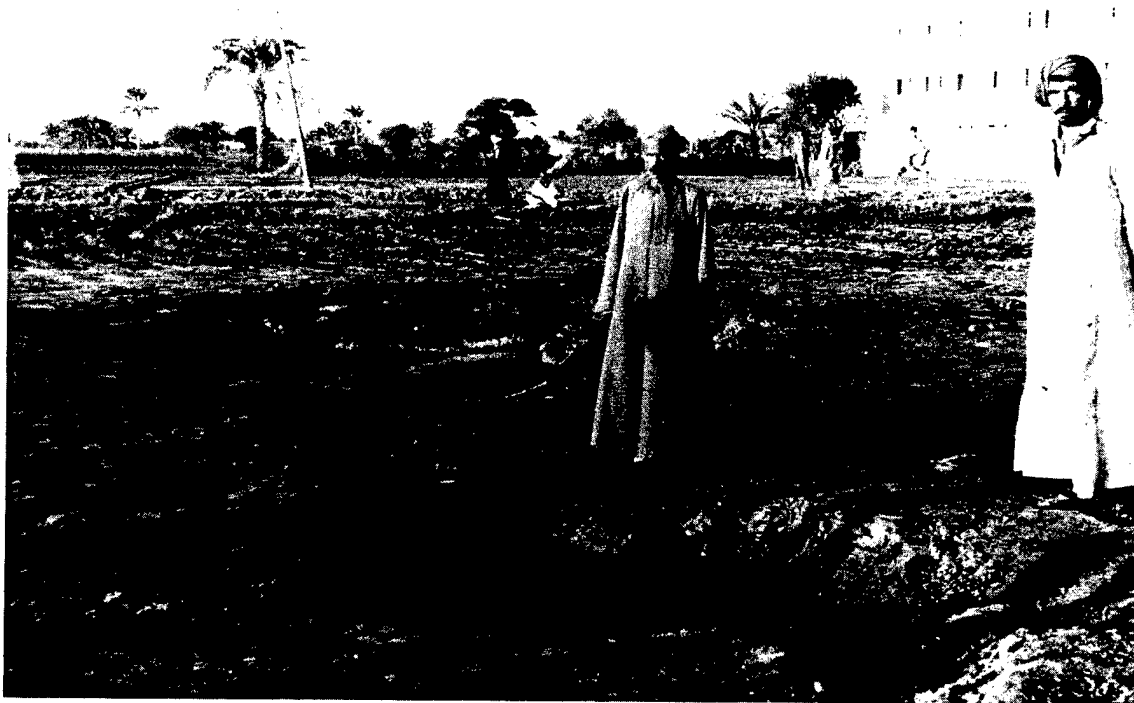
area defined by a seismic intensity of VIII (refer to figure 2-9). These manifestations included sand boils, earthquake-induced settlements of saturated soils, and lateral spreading and were documented shortly after the earthquake by Prof. Mohamed Amer at Cairo University (Elgamal, Amer, and Adalier 1993). An example of a remnant depression from a sand boil is shown in figure 2-10.

**FIGURE 2-10** Remnant craters from sand boils 20 km south of Cairo (courtesy of Ahmed Elgamal, Rensselaer Polytechnic Institute)

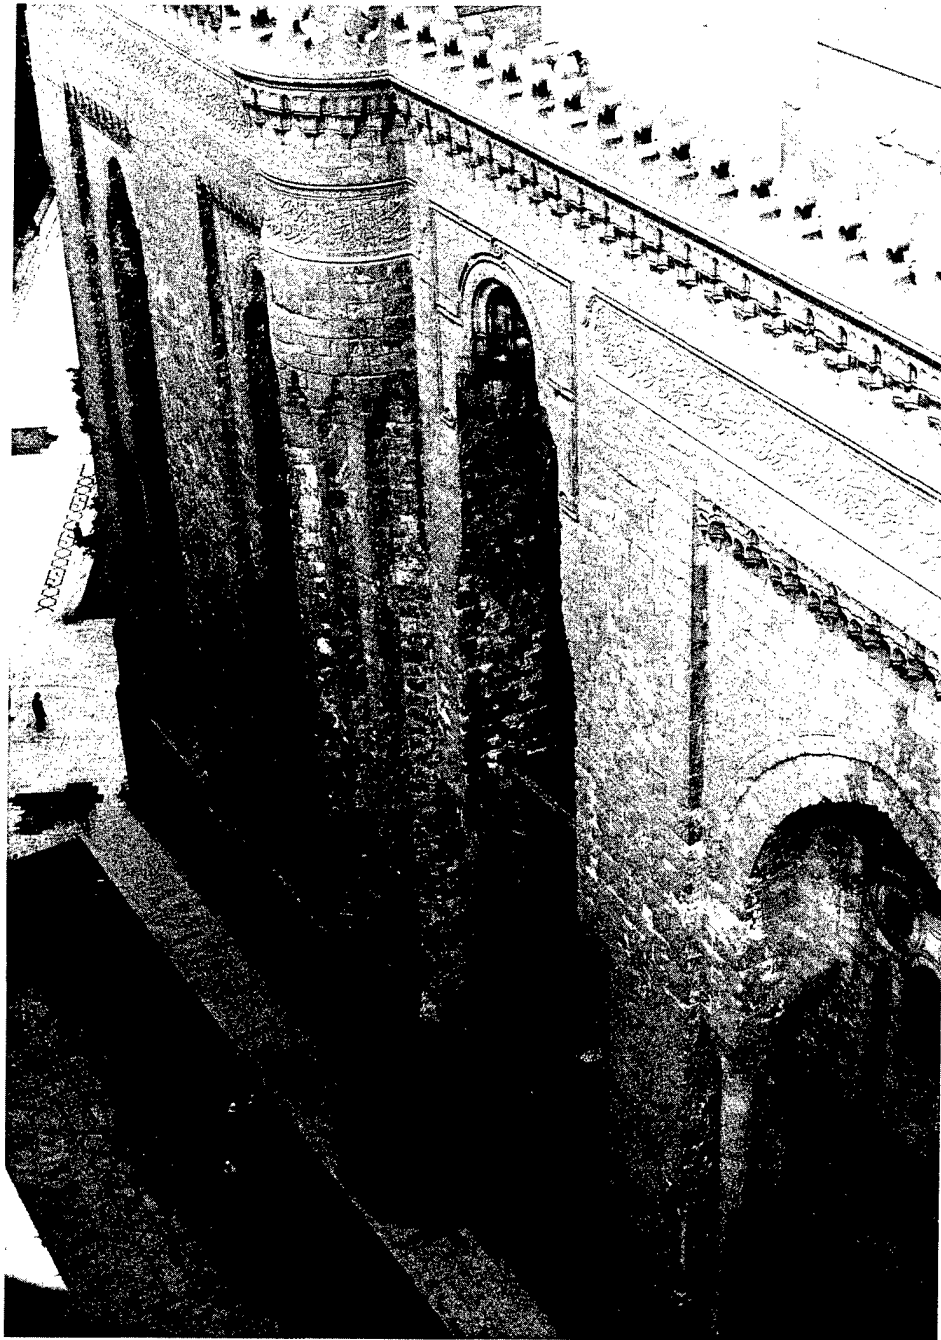
**FIGURE 4-1** Main portal of century-old al-Rifai Mosque looking down from the eastern minaret of the Sultān Hasan Mosque showing deterioration of masonry near arches

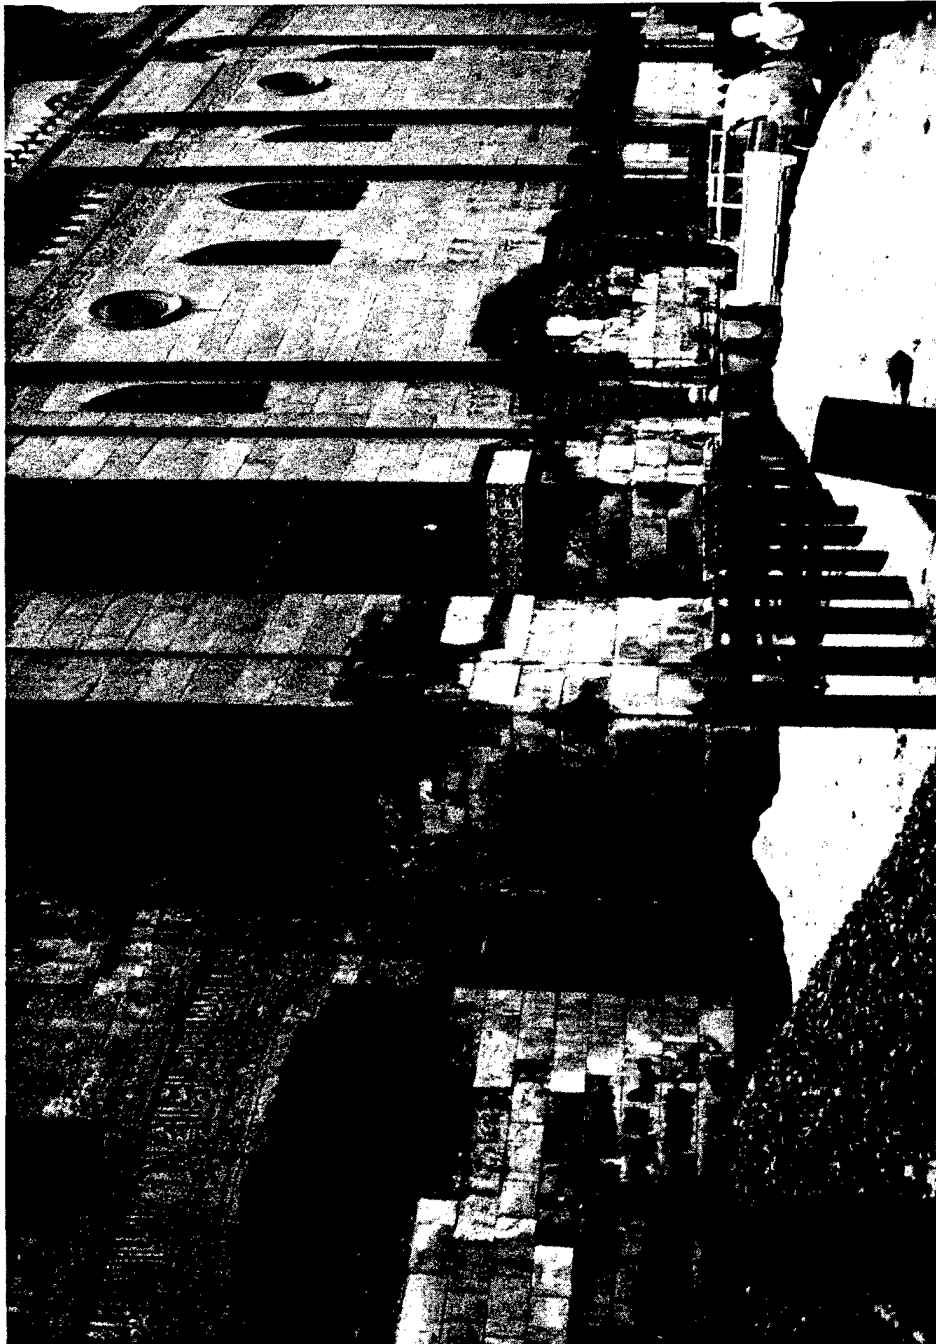
**FIGURE 4-4** Southwest exterior wall of Mosque of Sultān Barqūq looking north showing dampness in masonry and progressive deterioration with height

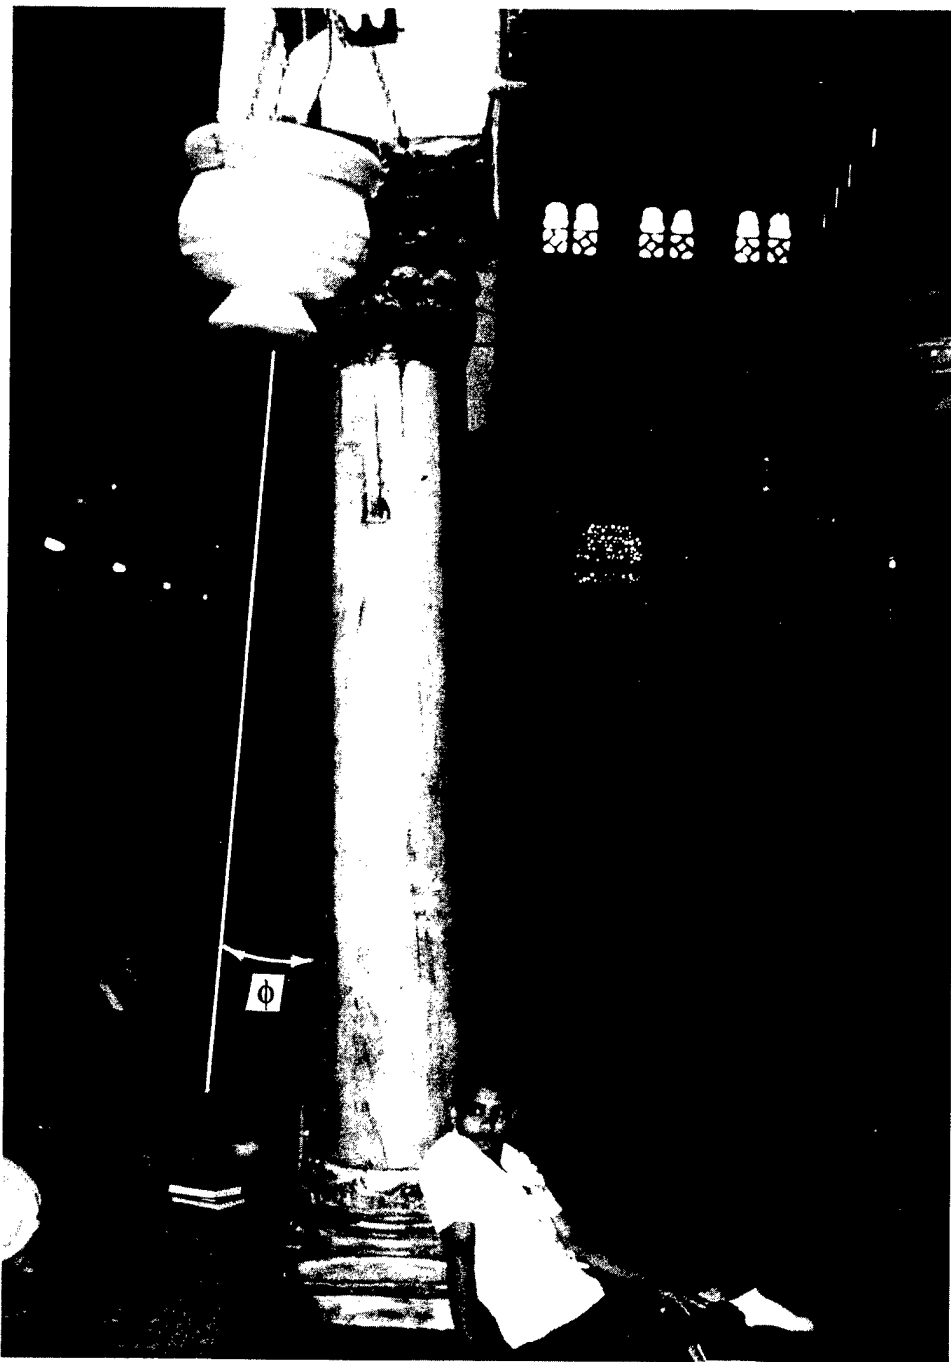
It is not known if thorough records of damage to historic monuments and reports of lessons learned exist anywhere in Egypt. Historic records generally state that mosques have been damaged and destroyed during previous earthquakes (refer to Table 3). Behrens-Abouseif (1985 and 1989) and SPARE (1981a) report that minarets at al-Hākim Bi-Amrillāh and al-Mansūr Qala'ūn mosques were damaged during the 1303 earthquake. The minarets of al-Hākim Bi-Amrillāh were rebuilt using the remaining base. The minaret of al-Mansūr Qala'ūn was repaired. Many of the monuments visited have cracks or other remnants from previous earthquakes. A tilted column remains at al-Azhar as shown in figure 4-6 (even though this monument was restored in 1980).

**FIGURE 4-6** Column of arcade at al-Azhar Mosque showing tilting effect from previous earthquake

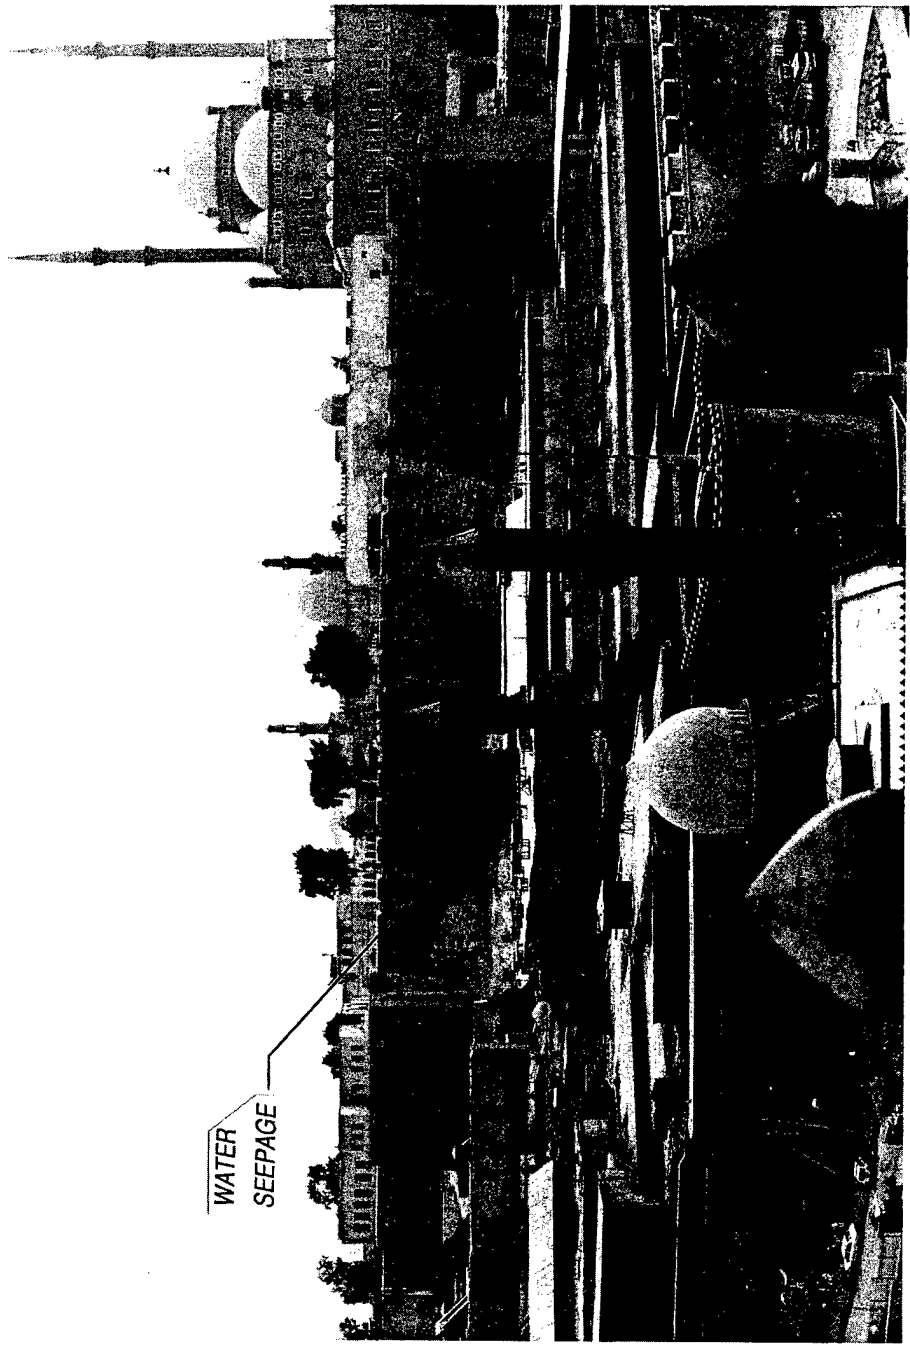
**FIGURE 4-9** Citadel looking east from Mosque of Sultān Hasan showing significant moisture seepage through upper wall

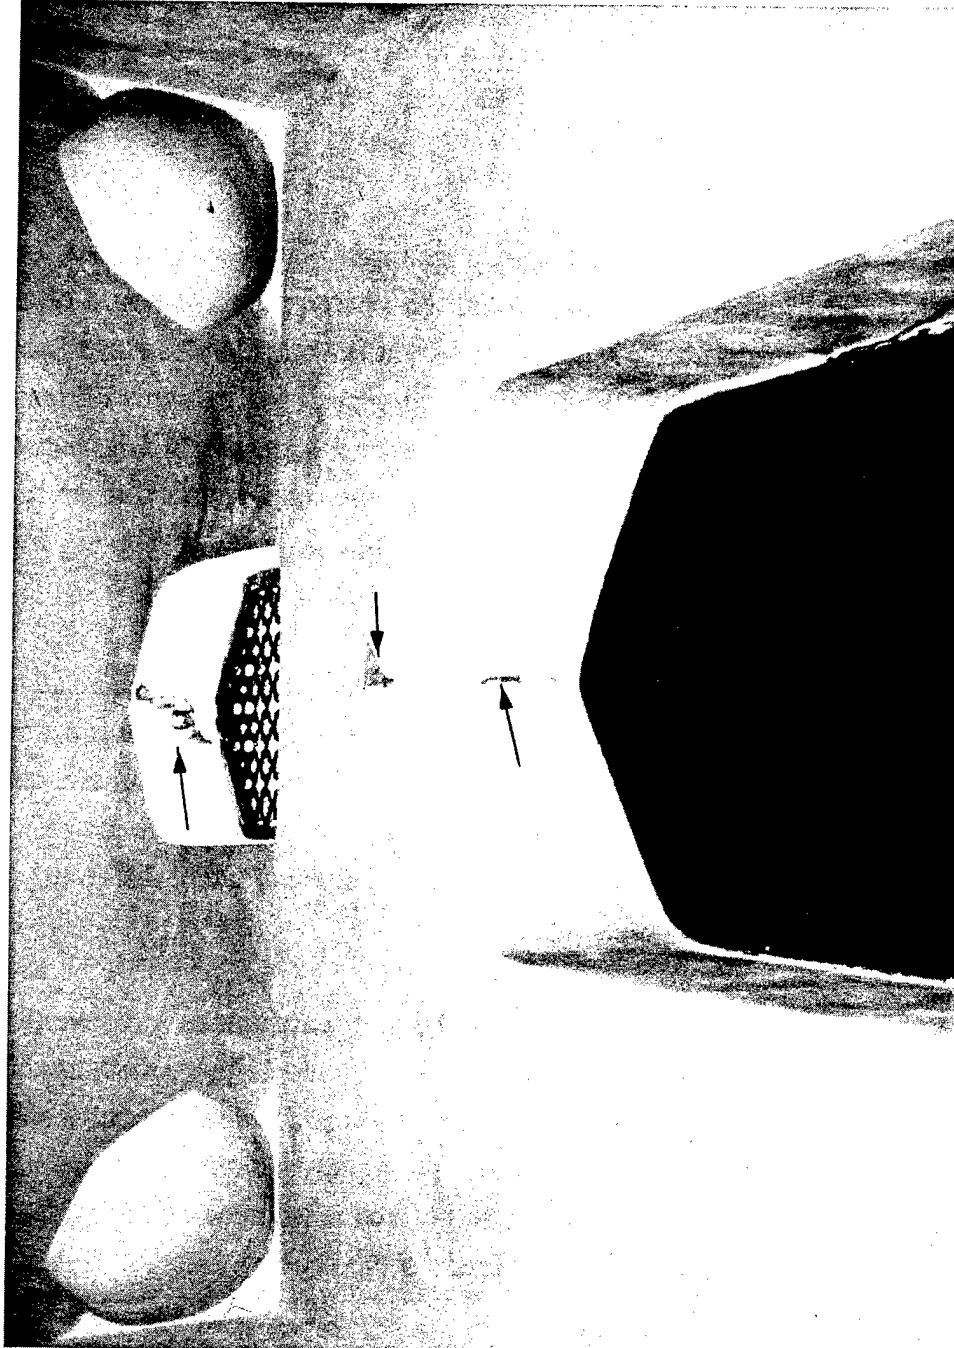
**FIGURE 4-10** Wall and small dome at Abu Sufein Church showing cracks and spalling at top of arches

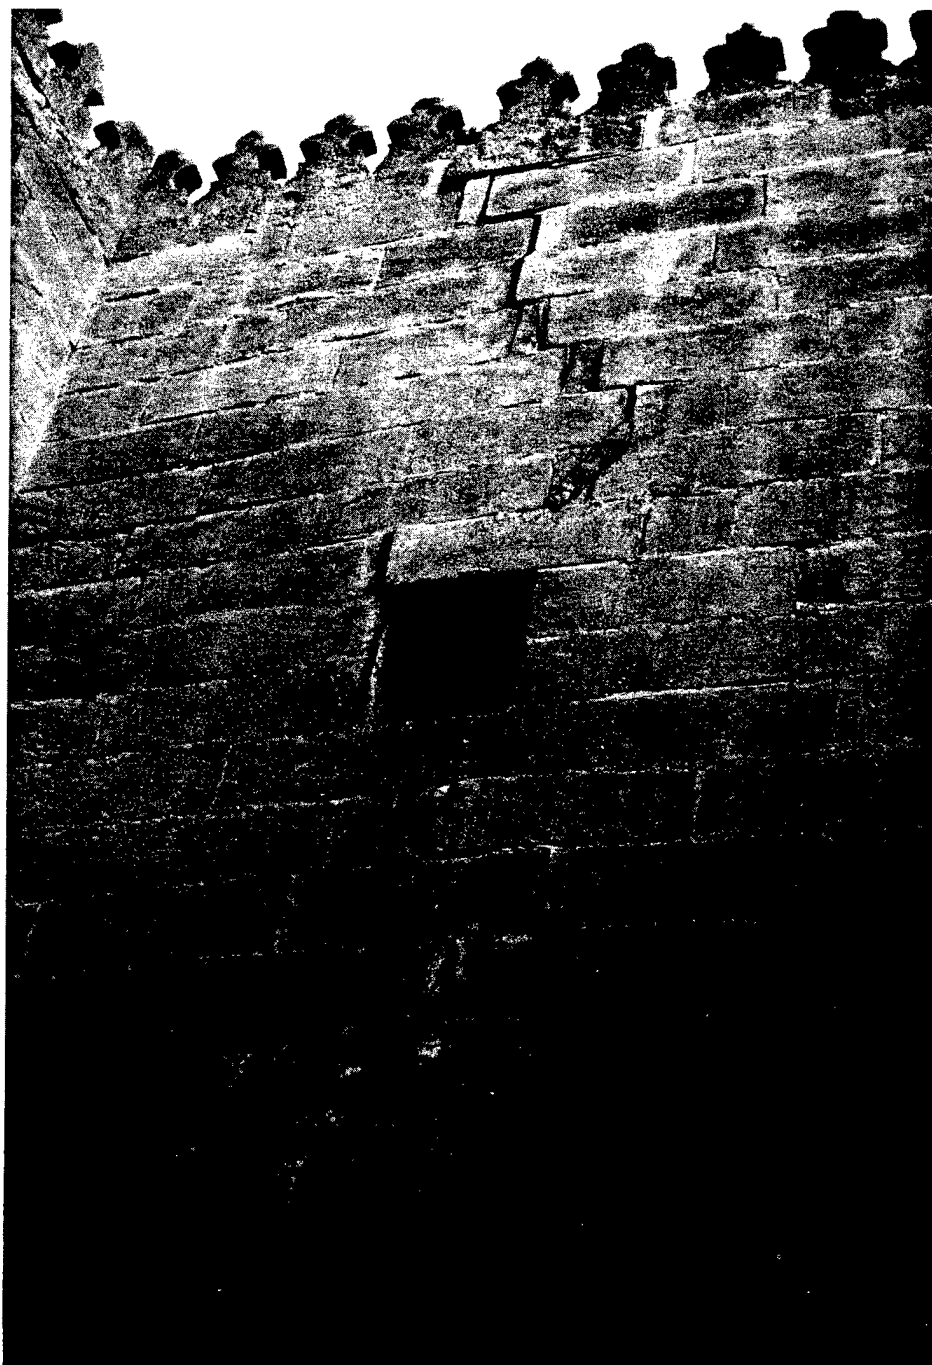
**FIGURE 4-12** Wall near back of Mosque of Sultān Barqūq  
showing extensive crack in southwestern wall

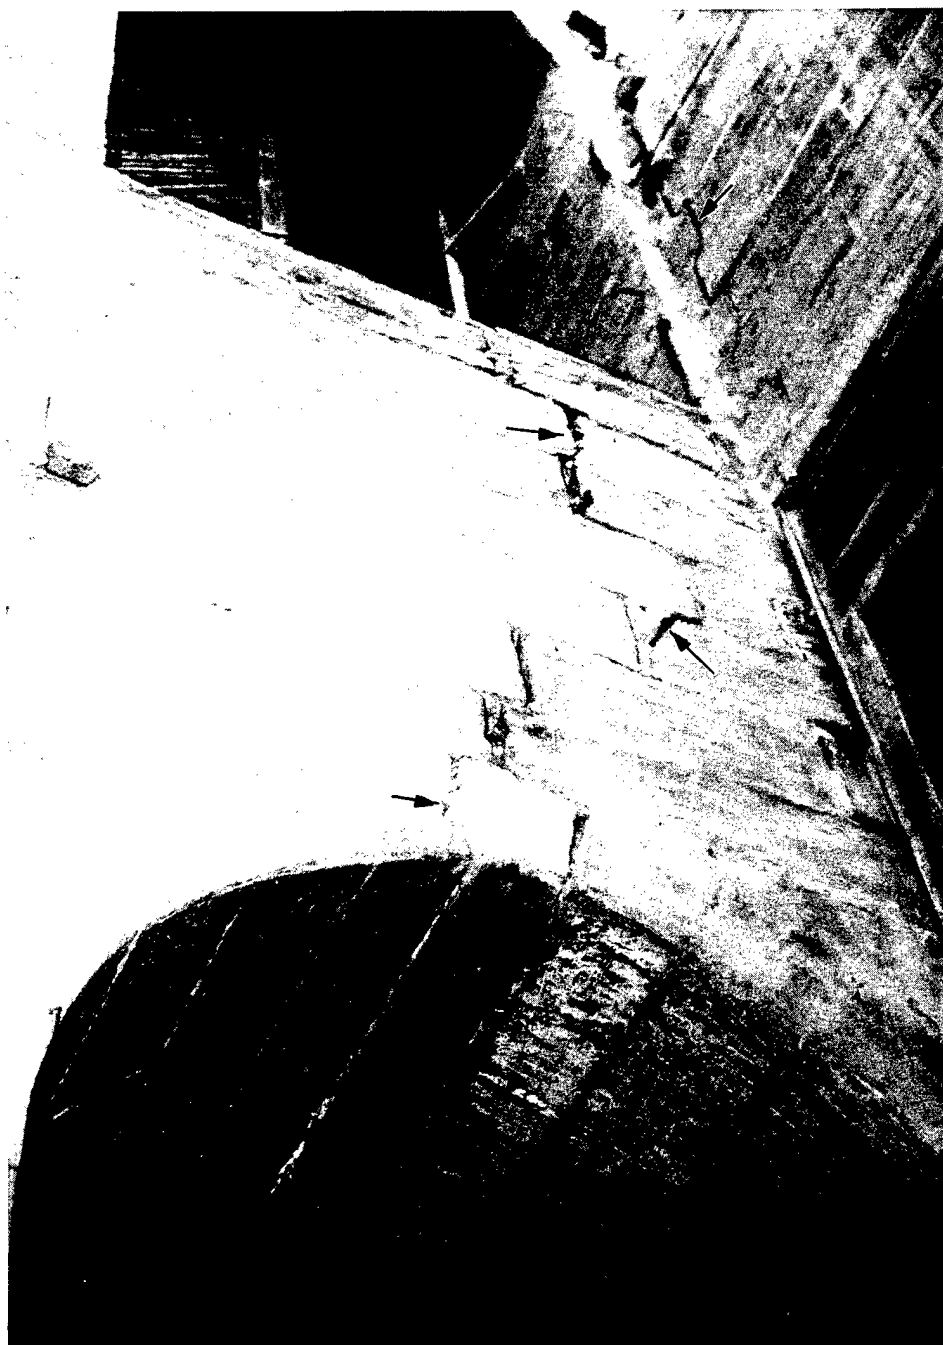
**FIGURE 4-13** Wall at southern corner of inner court of Mosque of Sultān Barqūq showing crack in southwestern wall extending down to arch

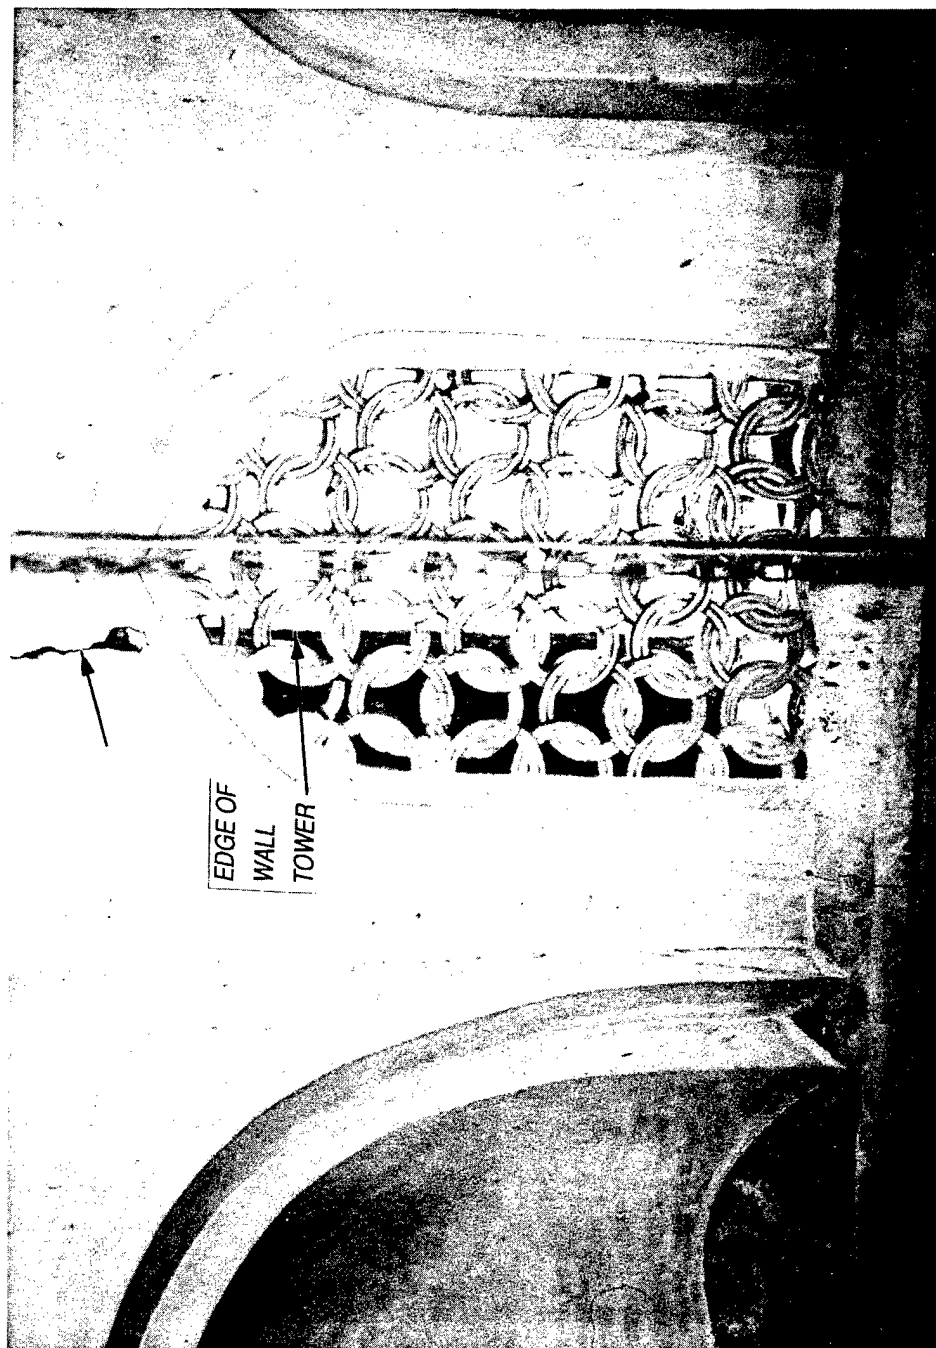
**FIGURE 4-14** Base of dome at eastern corner of al-Hakim Bi-Amrillah Mosque showing crack extending up from window corresponding to wall tower

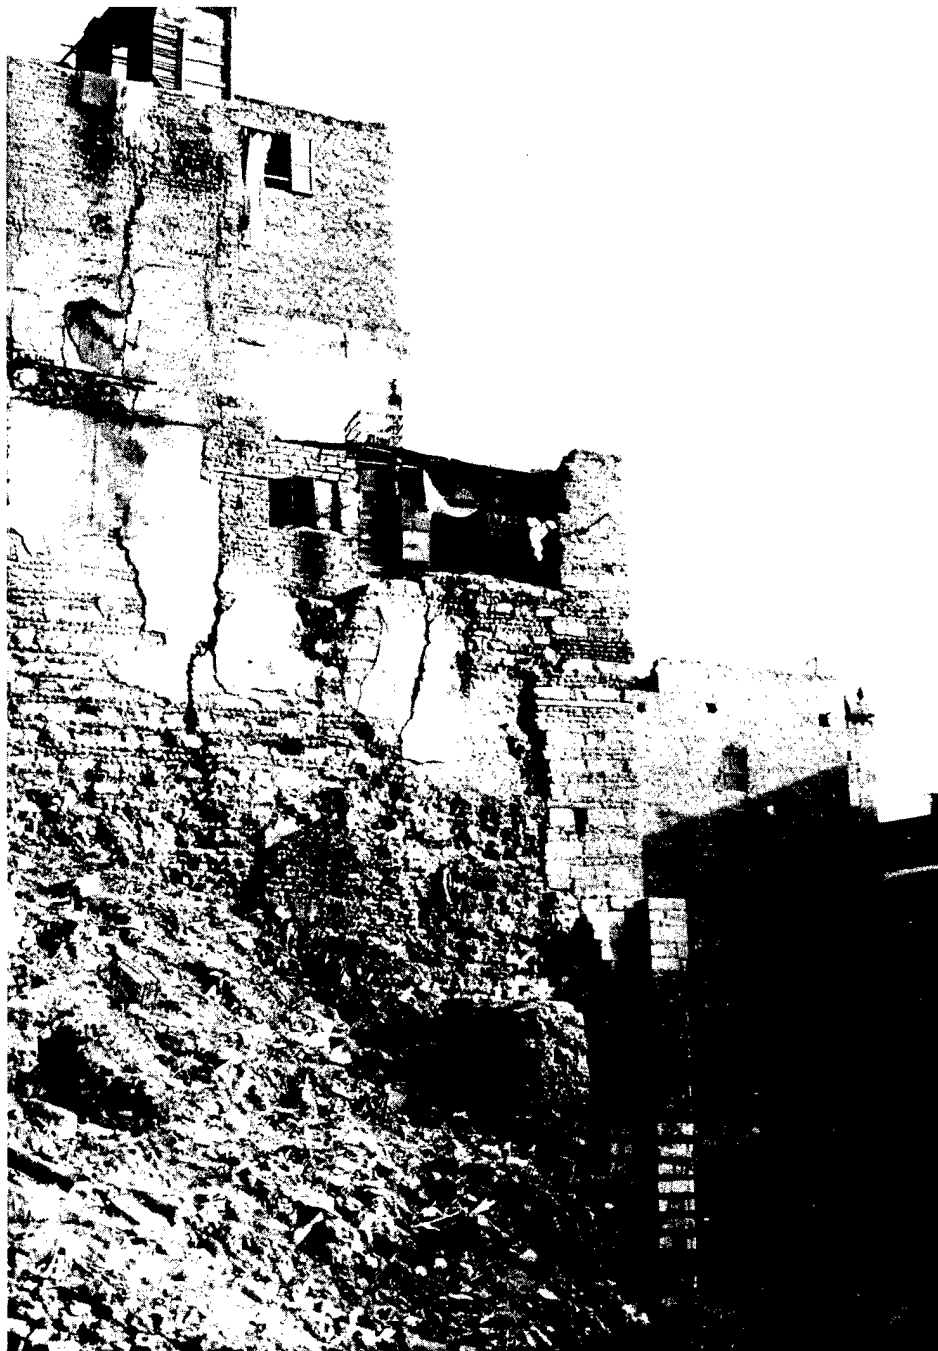
**FIGURE 4-18 Residential housing unit behind remains of Madrasa of as-Sālih Negm ad-Din Ayyub showing significant cracks**

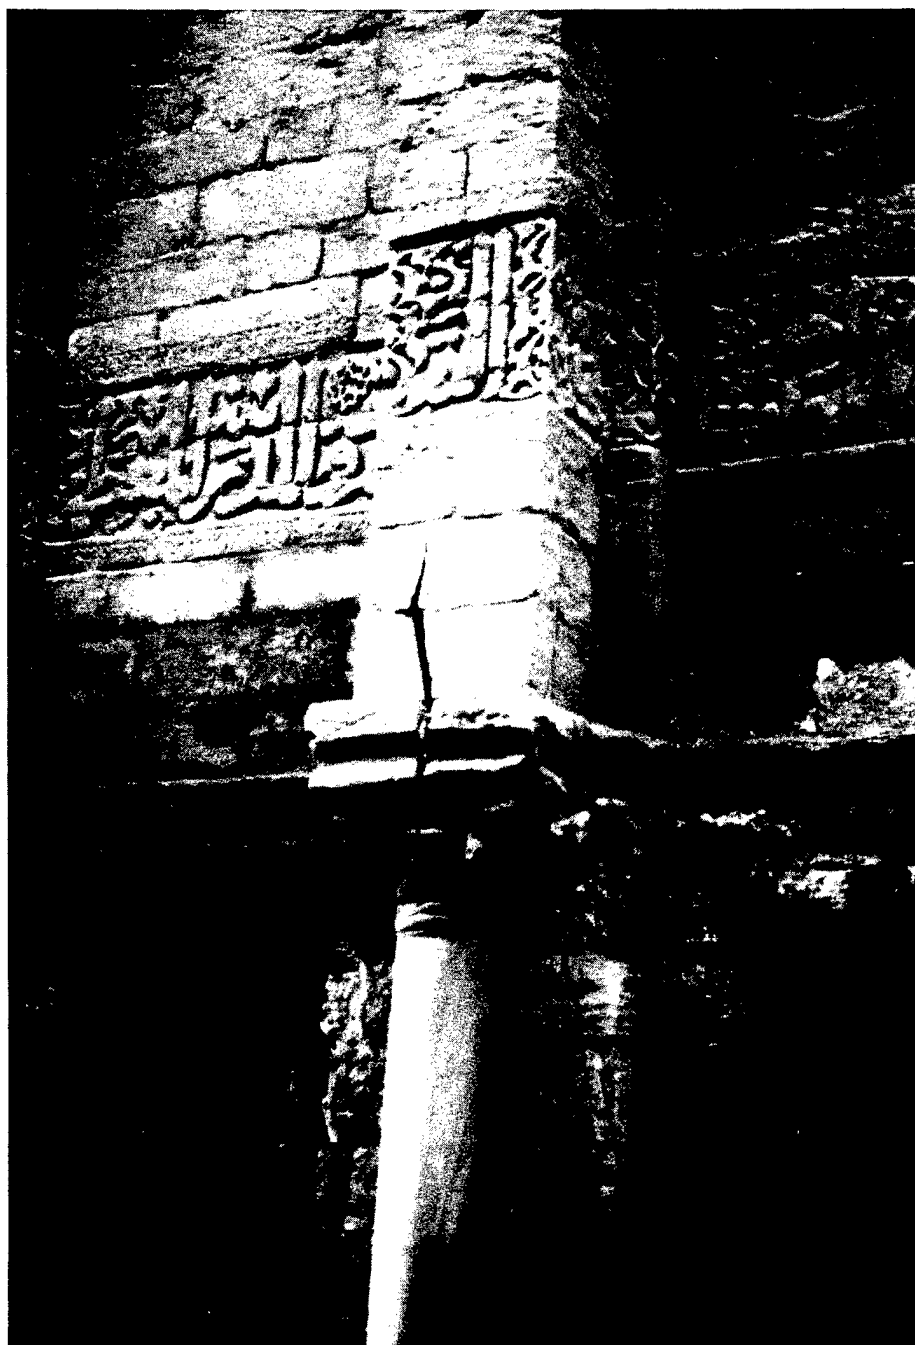
**FIGURE 4-20** Marble column at base of recessed panel at Mausoleum of al-Mansur Qala'un showing large crack

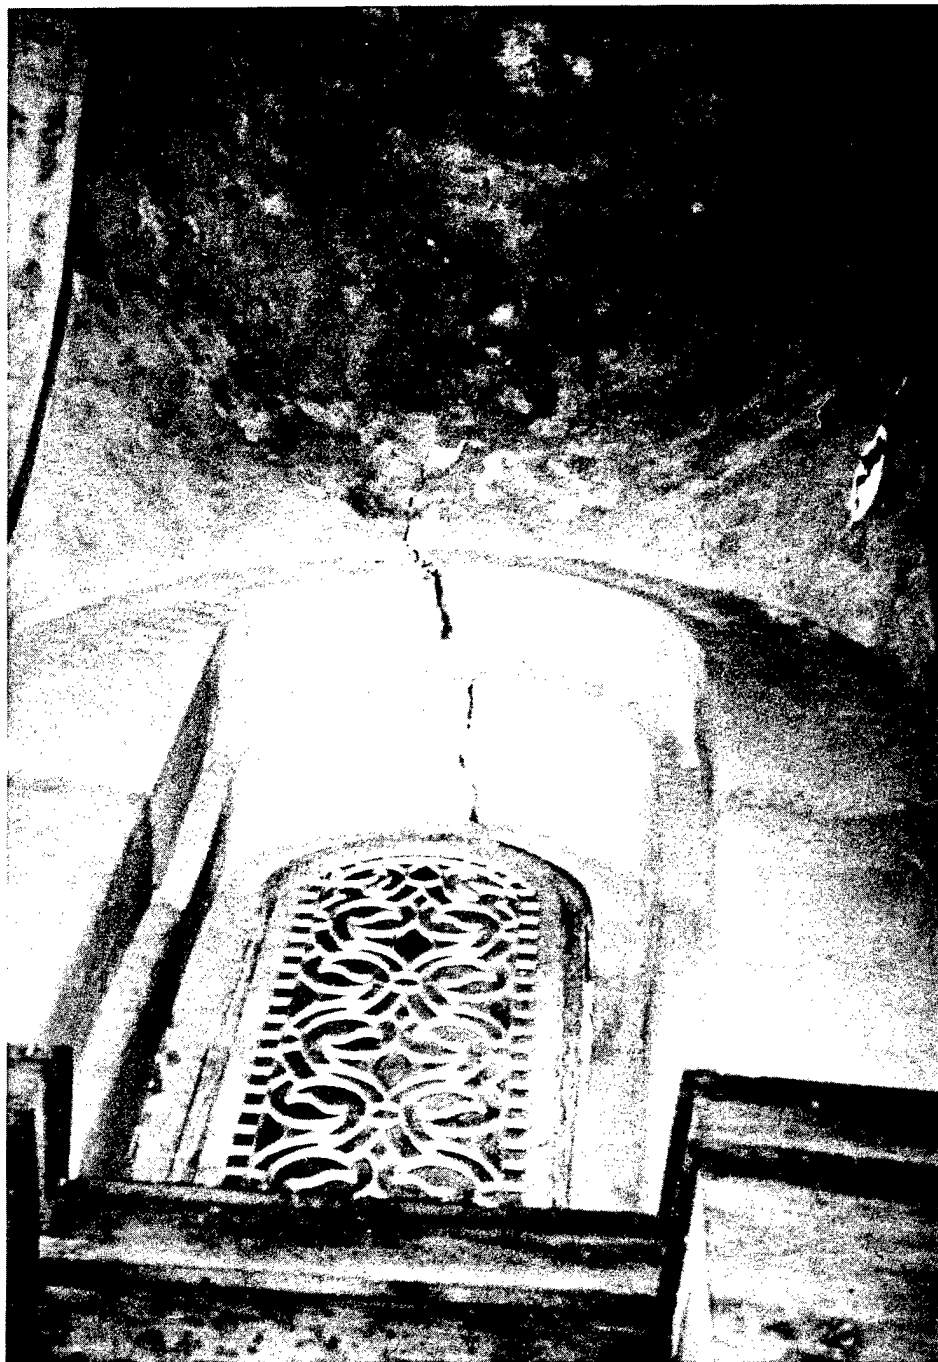
**FIGURE 4-21** Top of arch and minor dome in Mausoleum of al-Mansūr Qala'ūn showing significant cracks

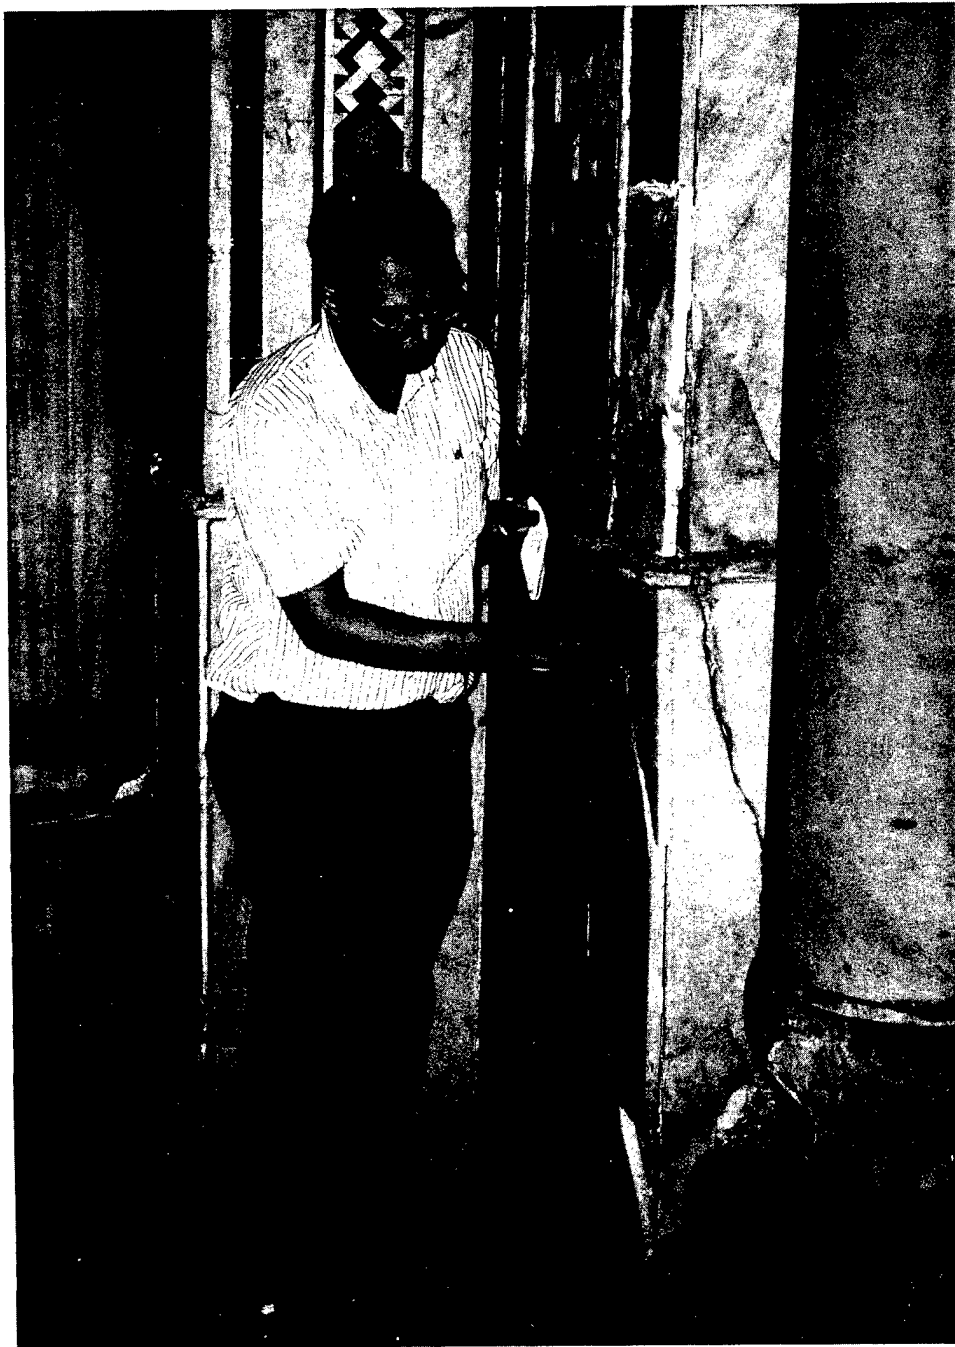
**FIGURE 4-22** Base of pier in Mausoleum of al-Mansūr  
Qala'ūn showing large cracks

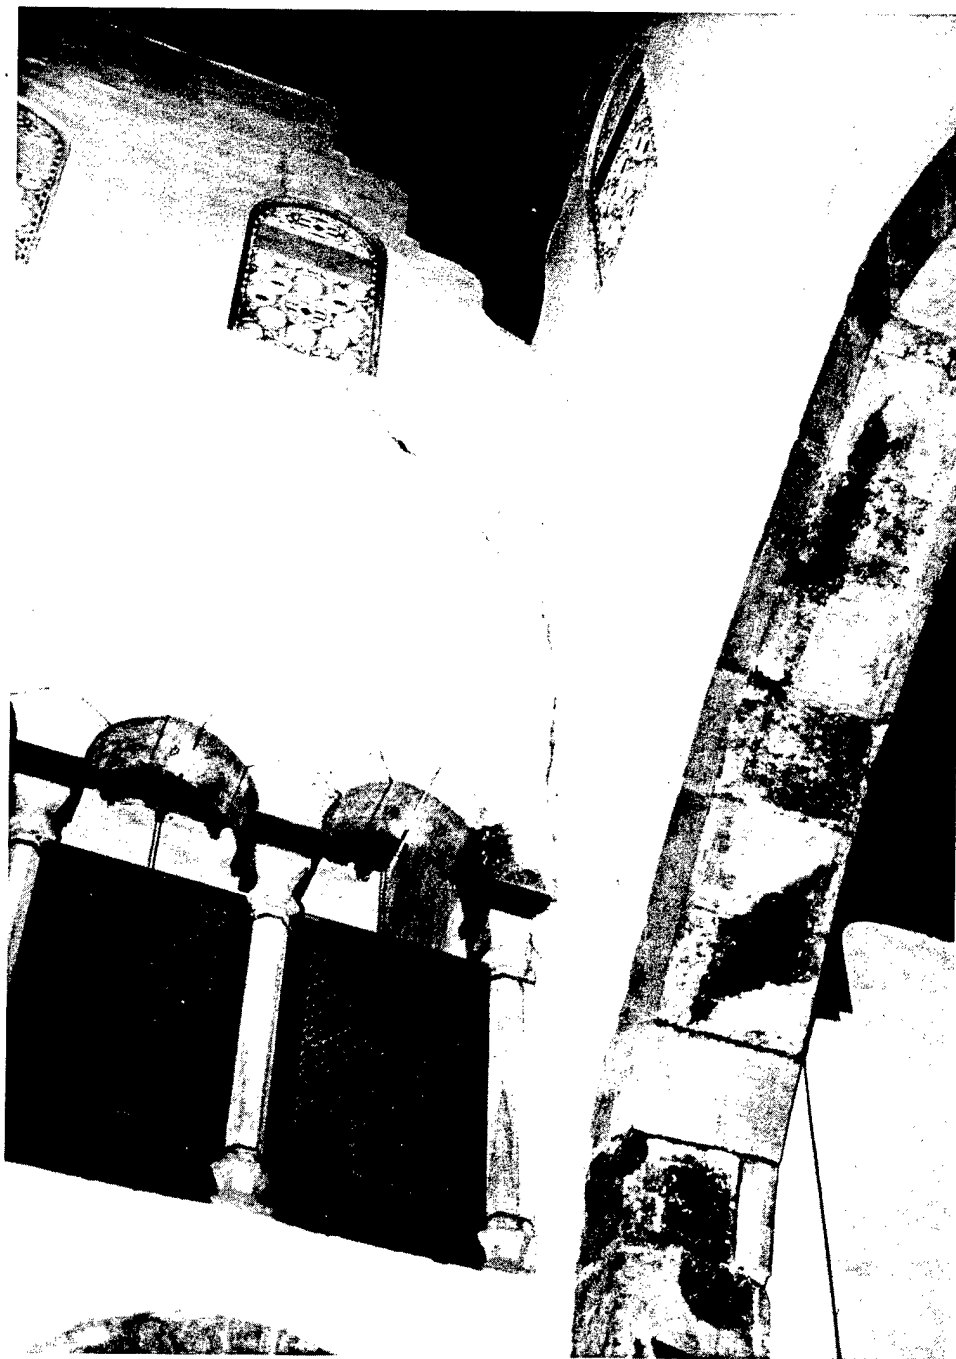
**FIGURE 4-23** Western corner of qa'a at Palace of the Amir  
Beshtak showing large and continuous crack on  
southwest wall emanating from corner

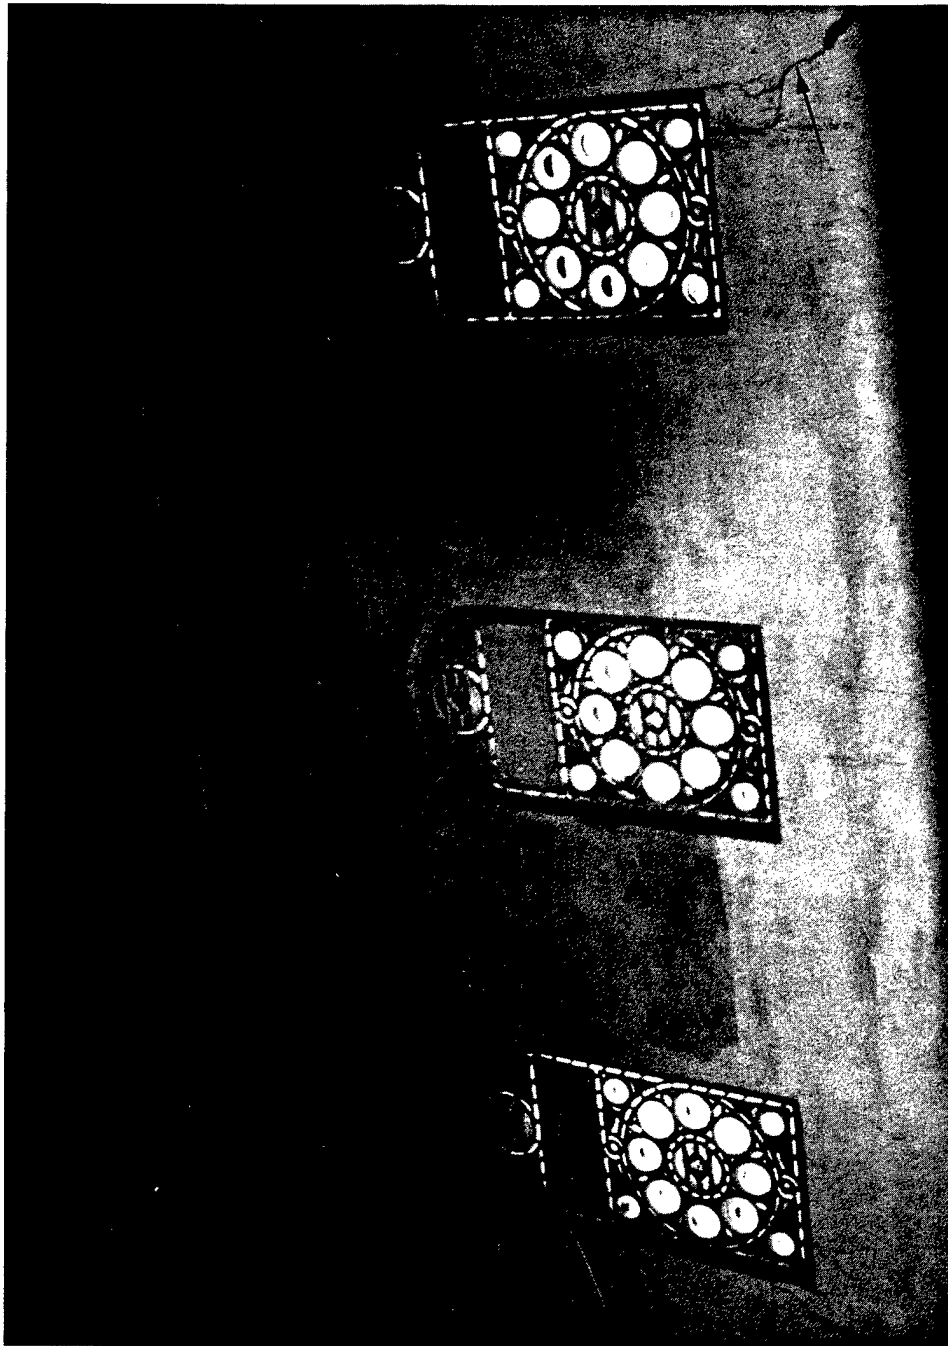
**FIGURE 4-24 Southwest wall of qa'a at Palace of the Amir Beshtak  
showing extent of large and continuous crack**

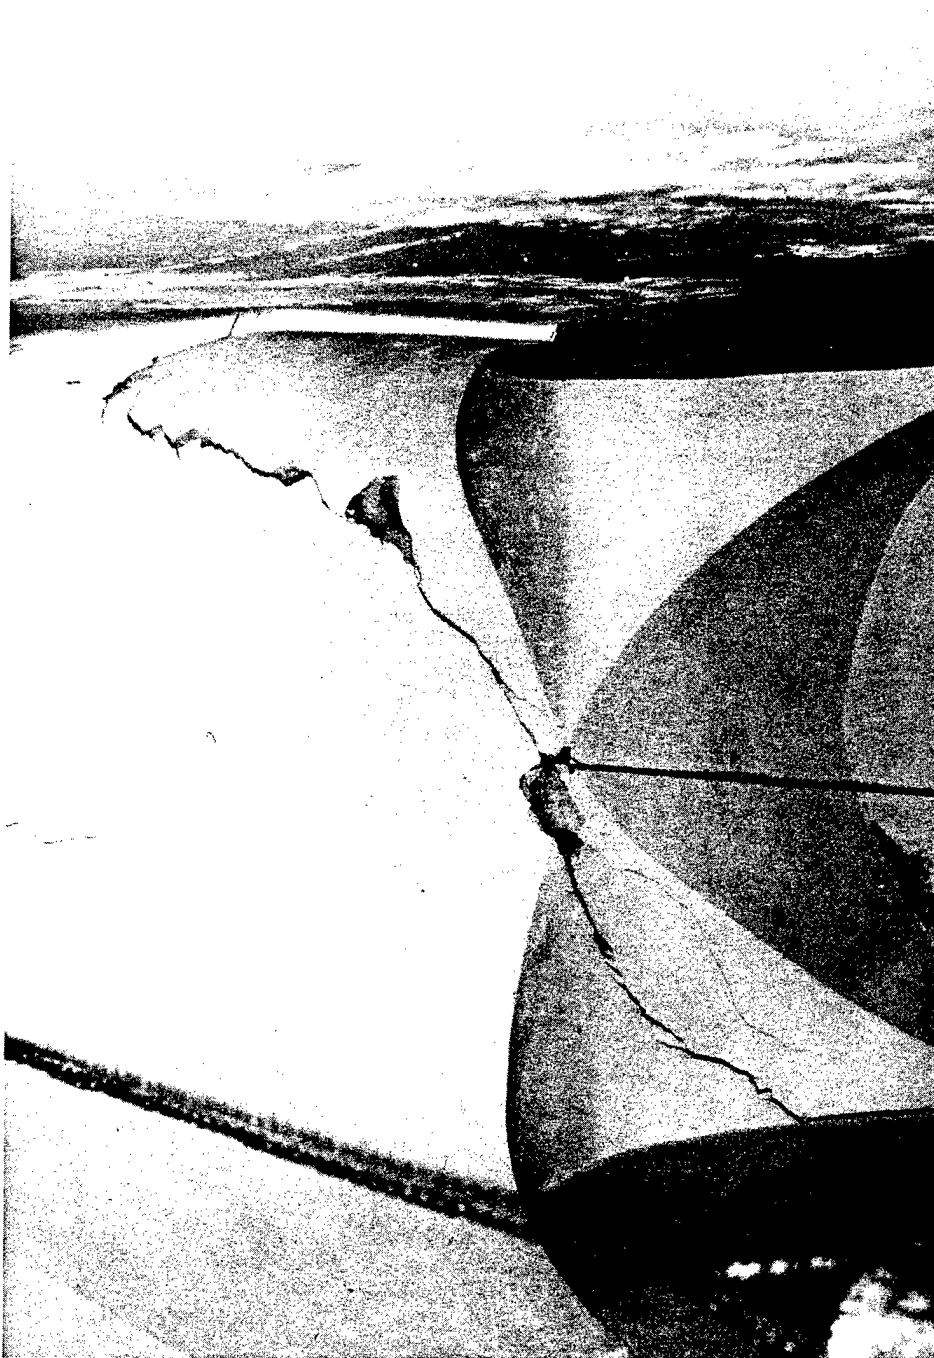
**FIGURE 4-25** Ceiling of hallway on northwest side of Palace of the Amir Beshtāk showing large and extensive cracks

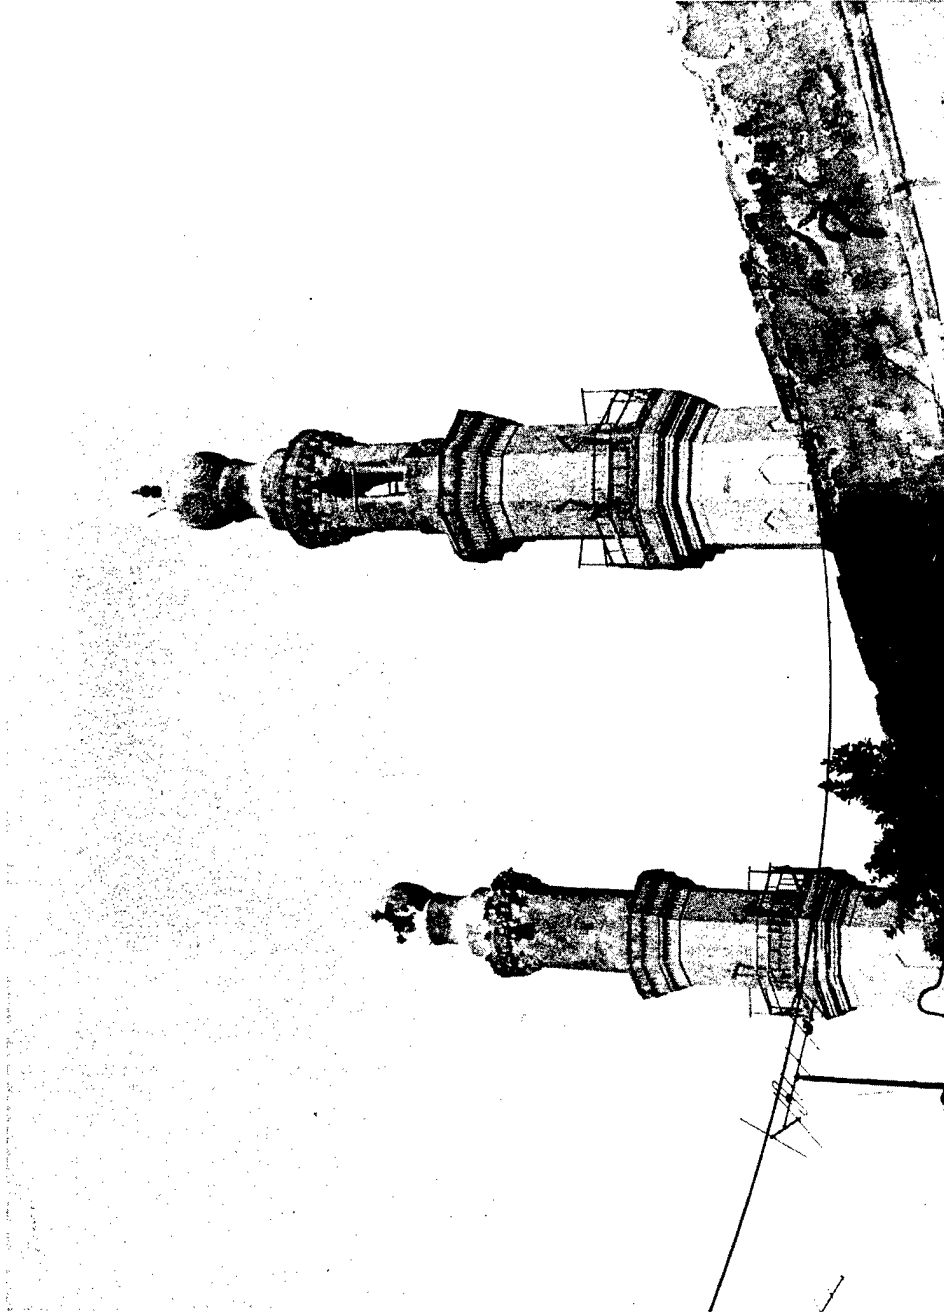
**FIGURE 4-26** Minarets of the Mosque of Amir Shaykhū (left) and the Khanqāh of Amir Shaykhū (right) showing damage to the bulb at the mosque

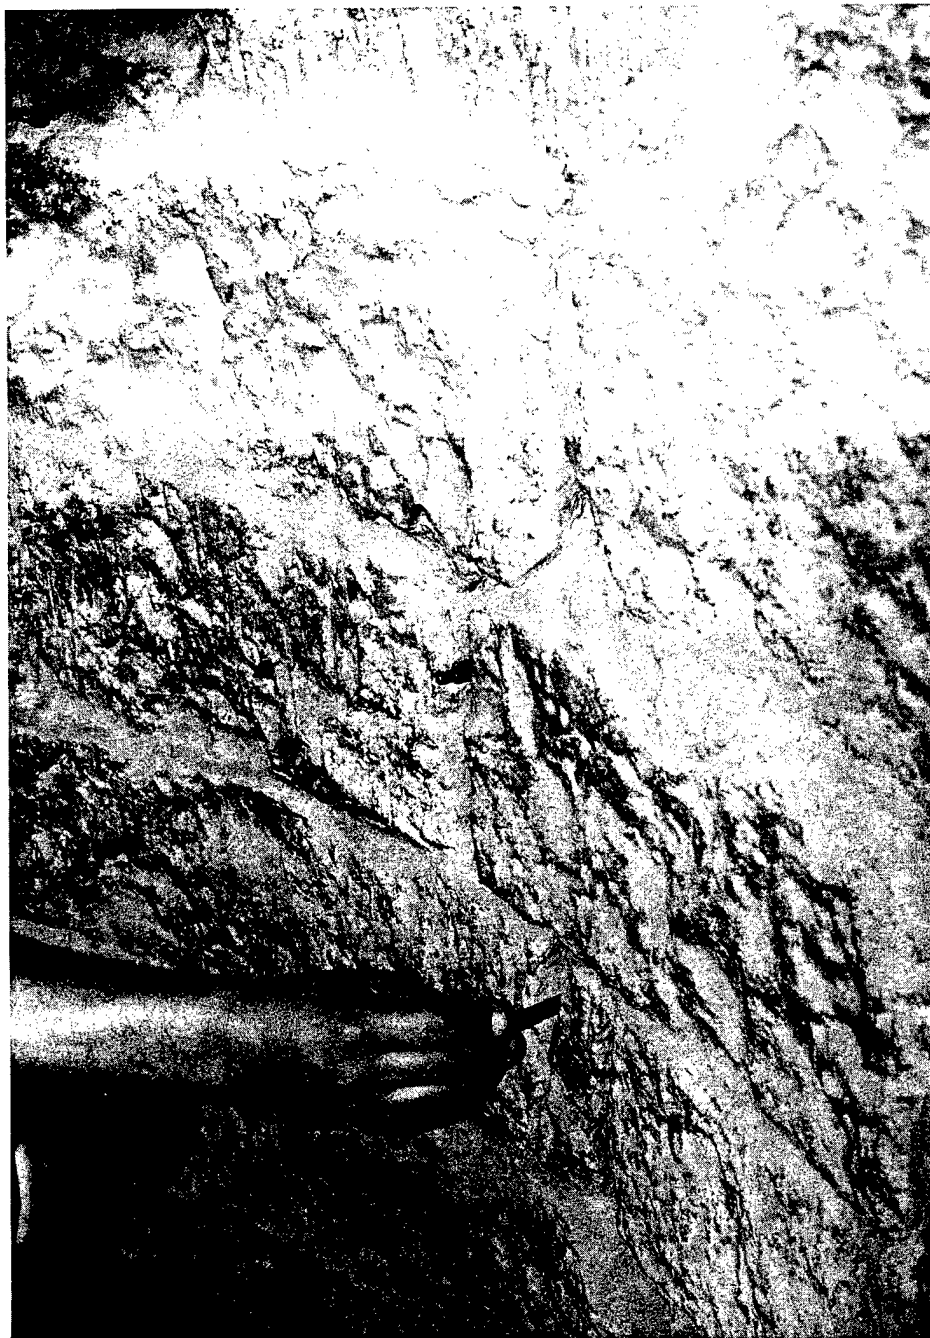
**FIGURE 4-29** Interior of southern minaret wall at Mosque, Mausoleum, and Madrasa of Sultān Hasan showing large vertical crack
