**Reconnaissance Report of Damage  
to Historic Monuments in Cairo, Egypt  
Following the October 12, 1992 Dahshur Earthquake**

**D. Sykora, D. Look, G. Croci, E. Karaesmen and E. Karaesmen**

Technical Report NCEER-93-0016

**August 19, 1993**

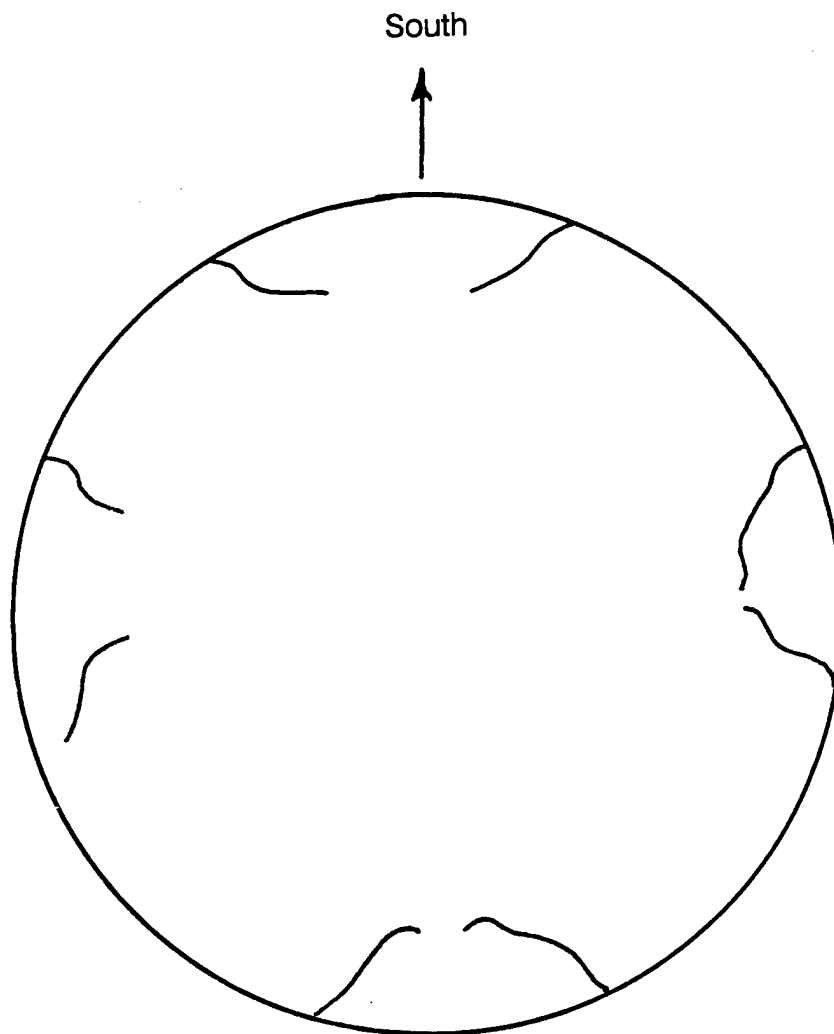
**FIGURE 4-30** Sketch of interior crack pattern in dome of Mausoleum of Sultan Hasan looking up

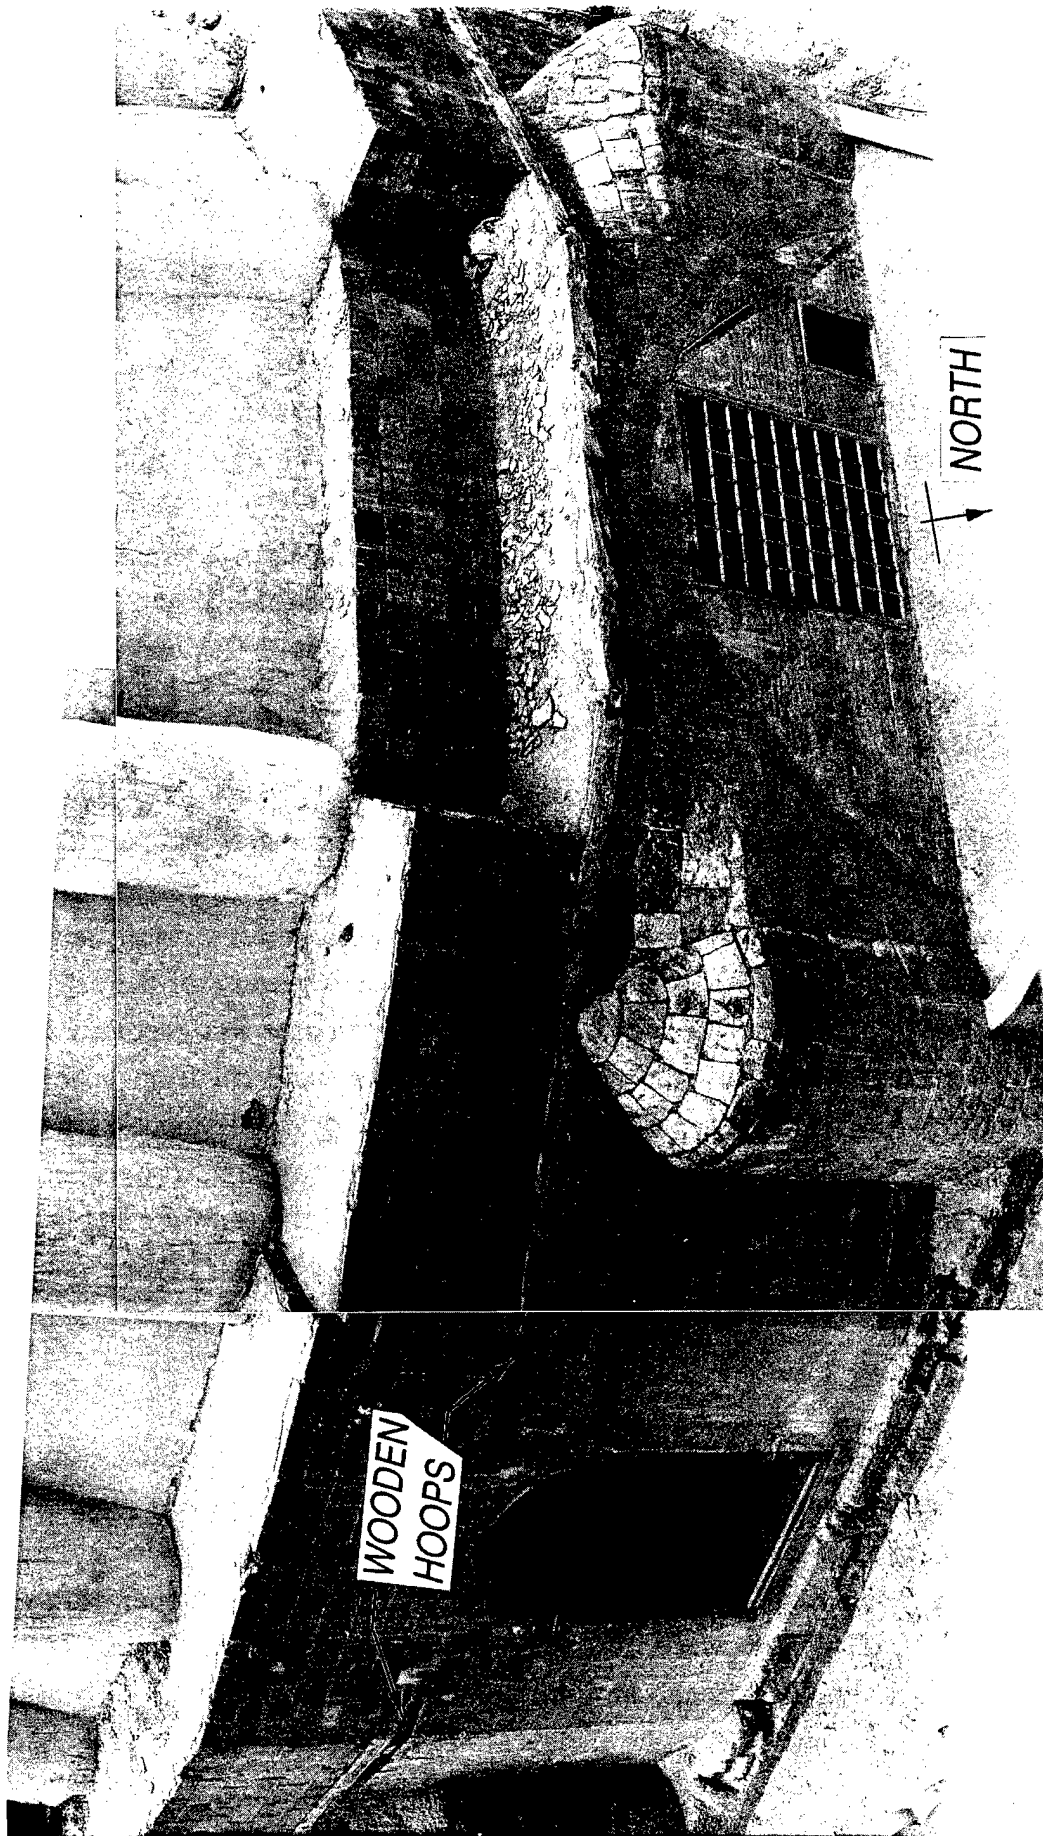
**FIGURE 4-31** Exterior of major dome at Mausoleum of Sultān Hasan looking south  
showing wooden hoop structural support system

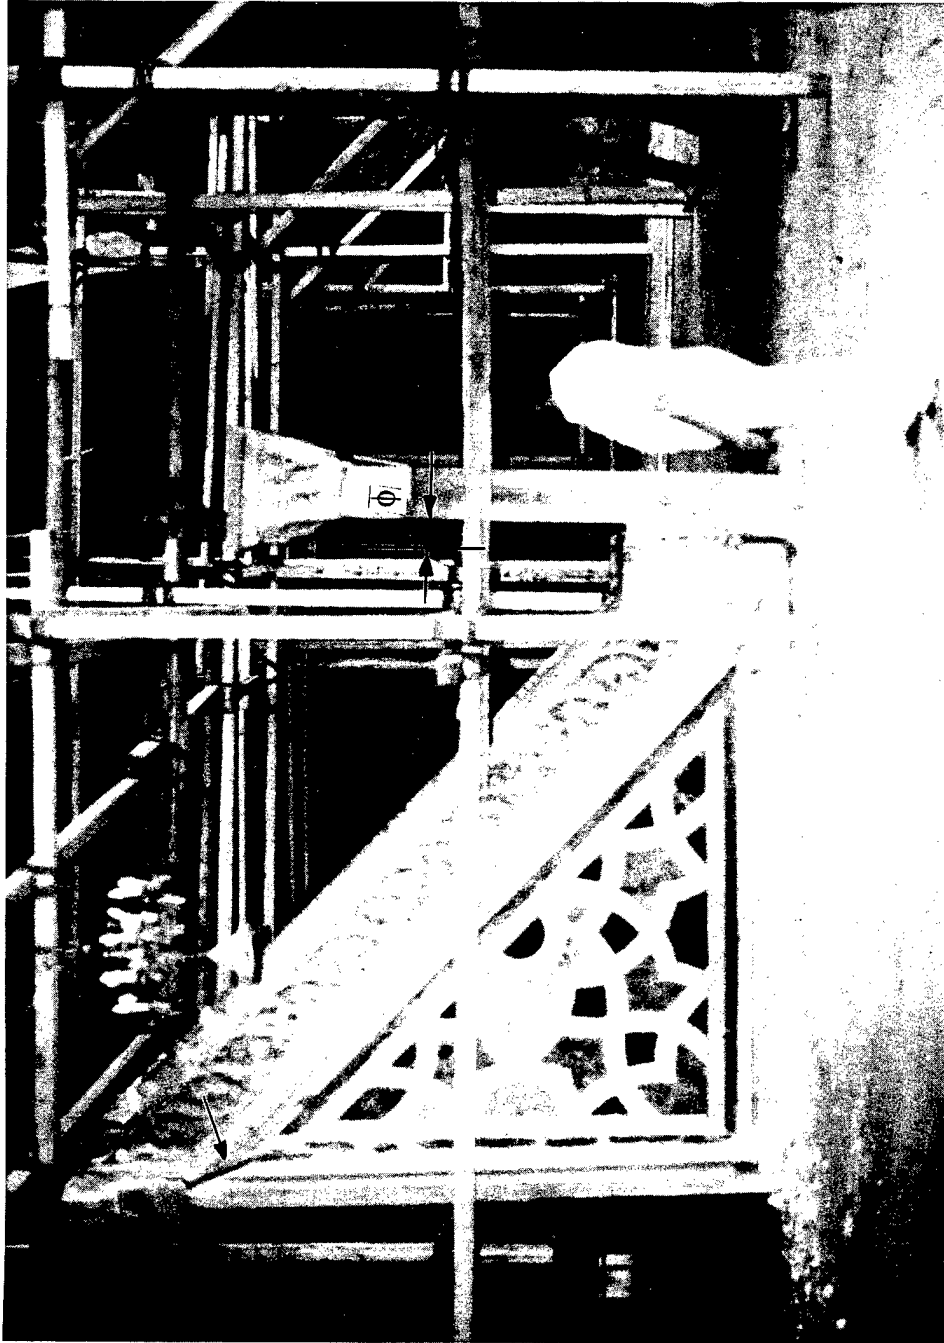
**FIGURE 4-32** Minbar of Mosque of Ibrāhīm Āghā Mustahfizān showing signs of relative displacement

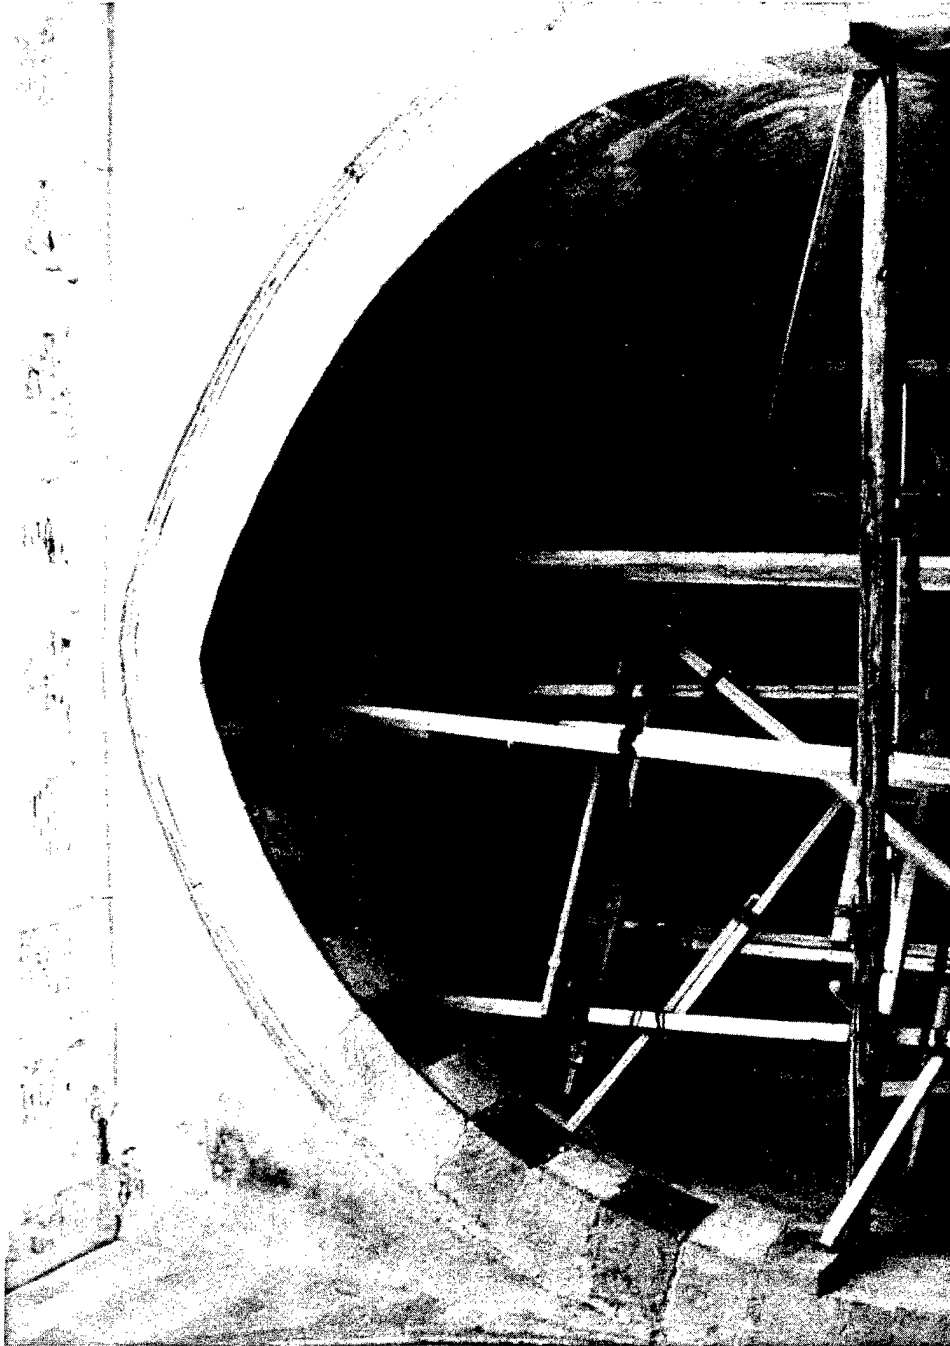
**FIGURE 4-33 Arch at Mosque of Ibrāhim Āghā Mustahfizān showing cracks and bracing**

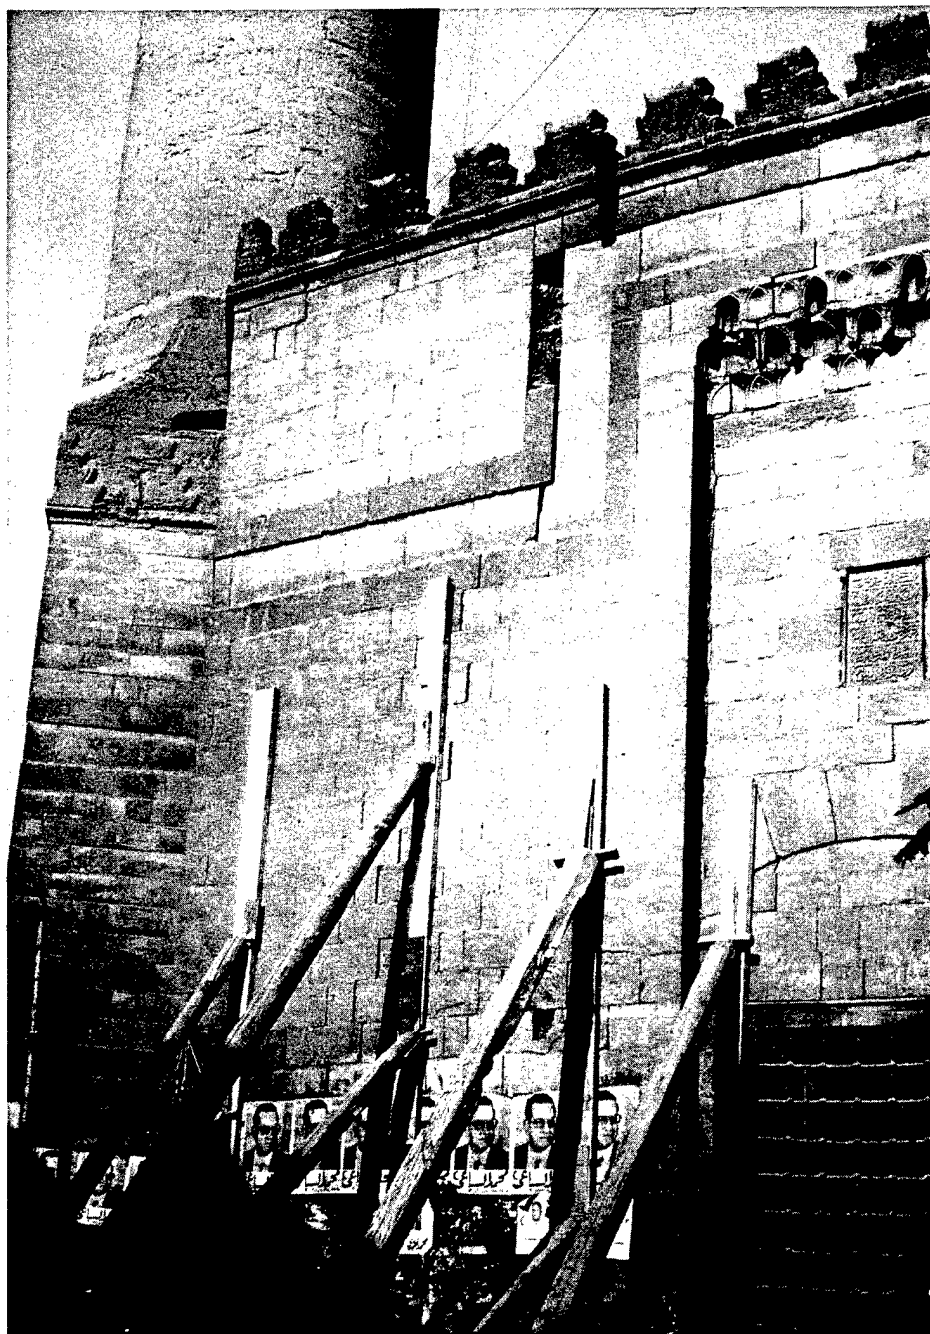
**FIGURE 4-34.** Exterior wall and base of minaret at Mosque of Ibrāhim Aghā Mustahfizān looking northeast showing cracks, distortions, and bracing

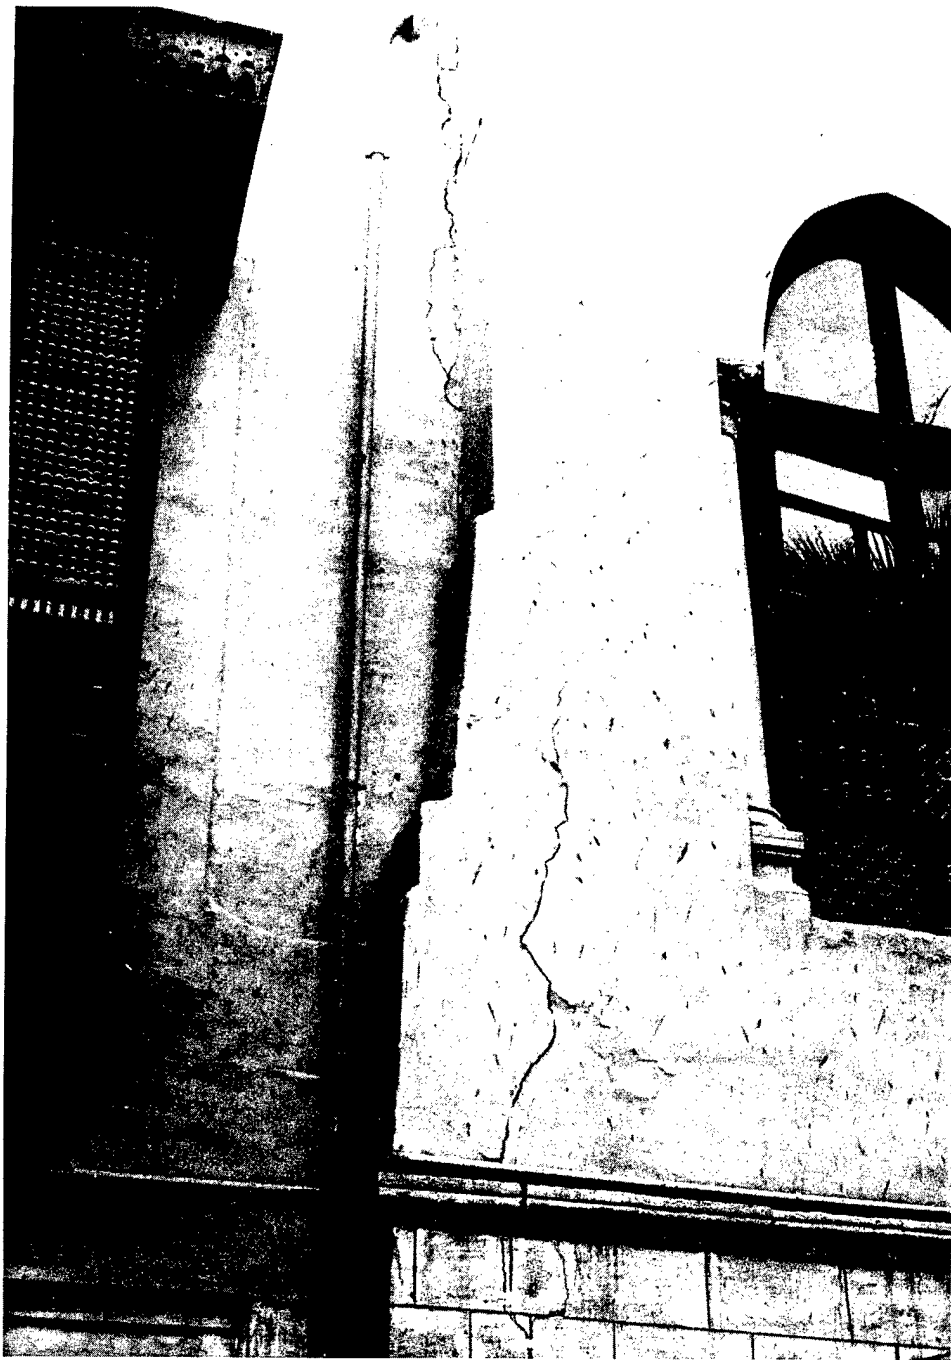
**FIGURE 4-36** Exterior wall of Coptic Museum looking north  
showing large cracks

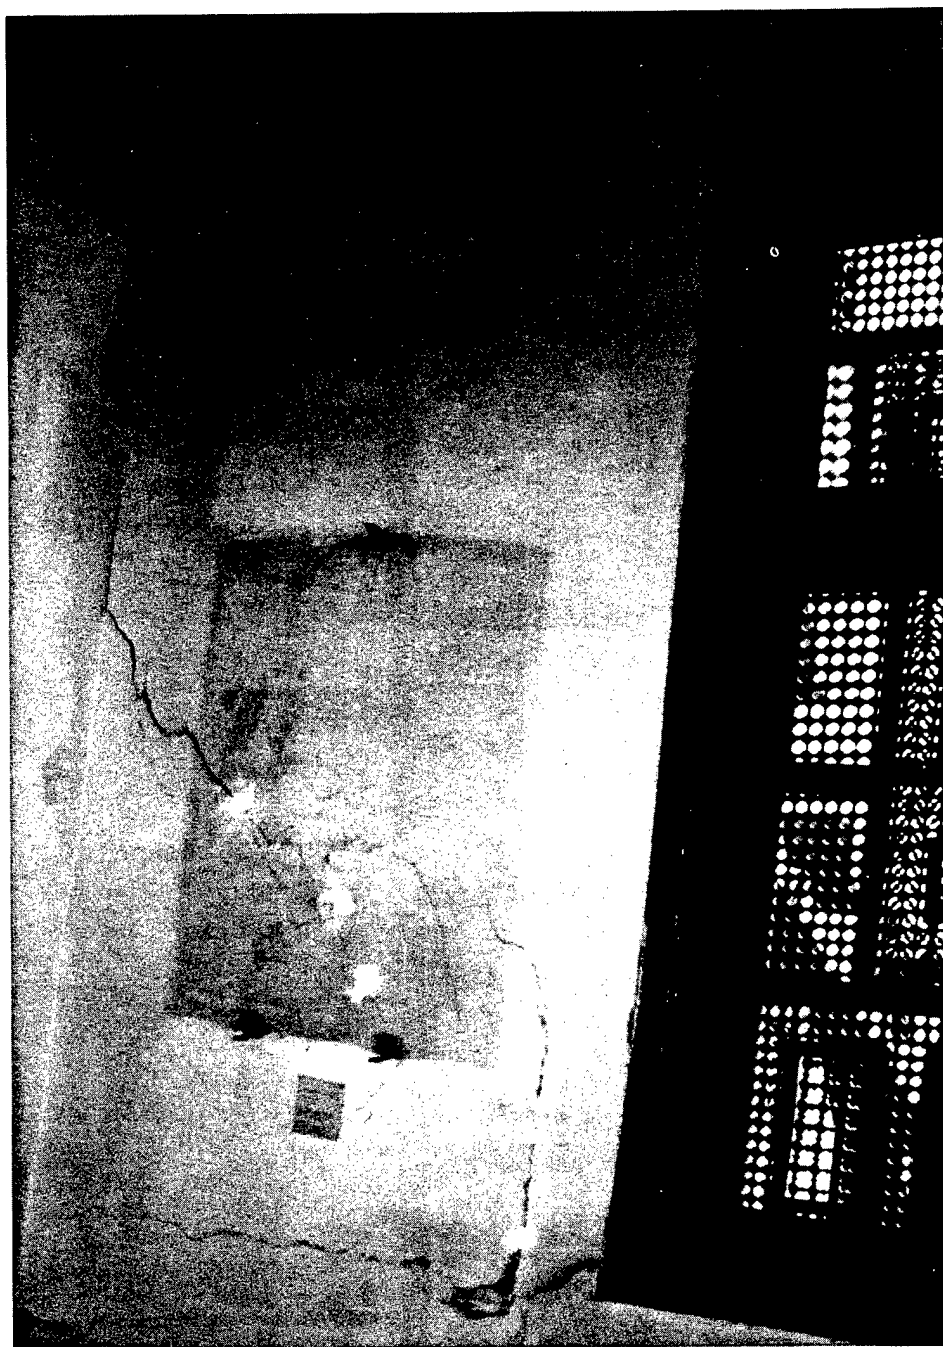
**FIGURE 4-37** Interior wall of Coptic Museum showing large cracks

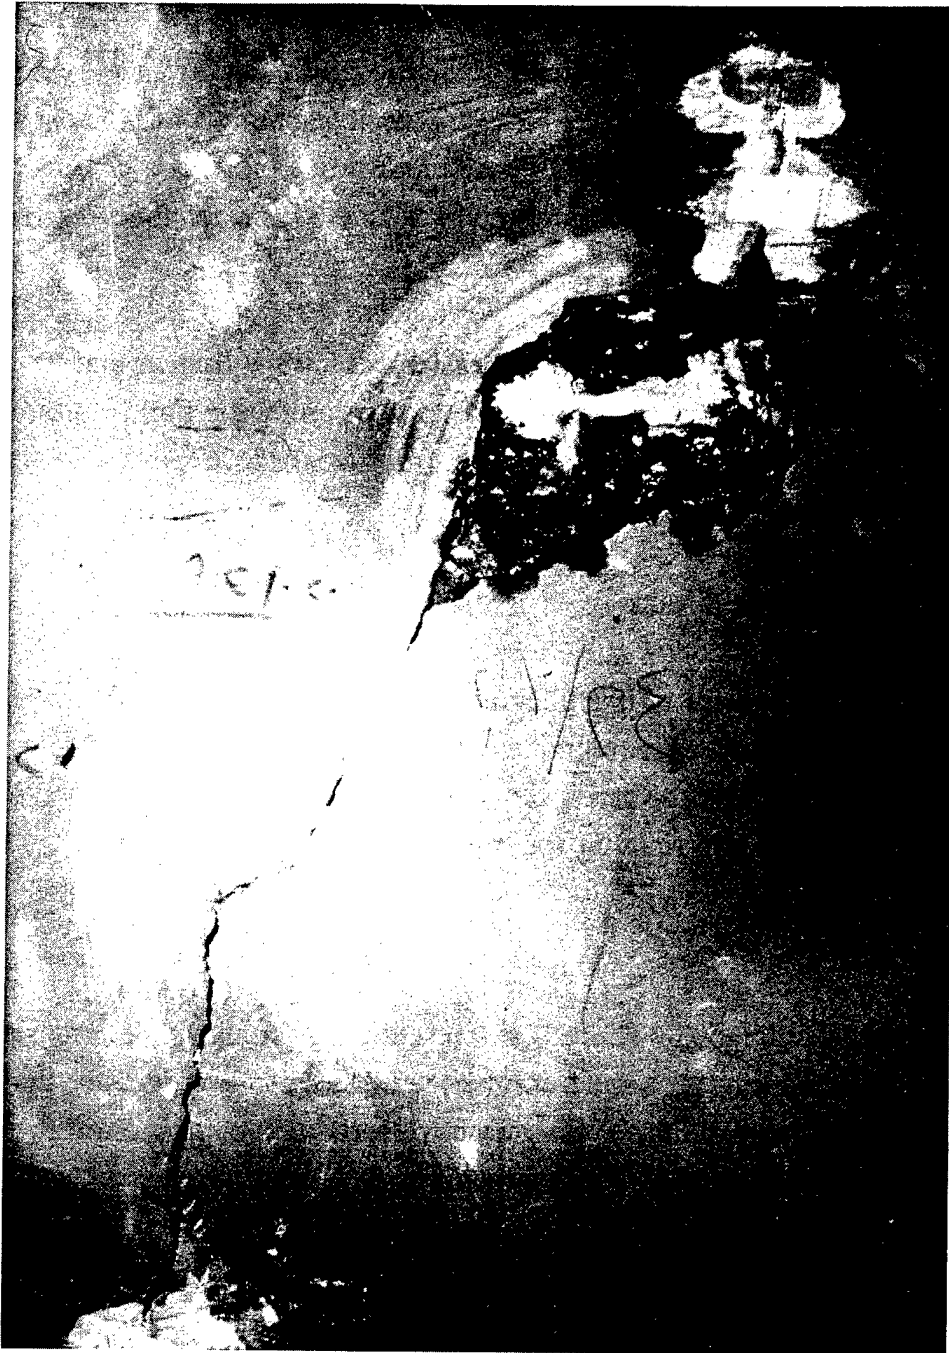
**FIGURE 4-39** Interior wall of el-Moalloqa Church showing cracks and deformations

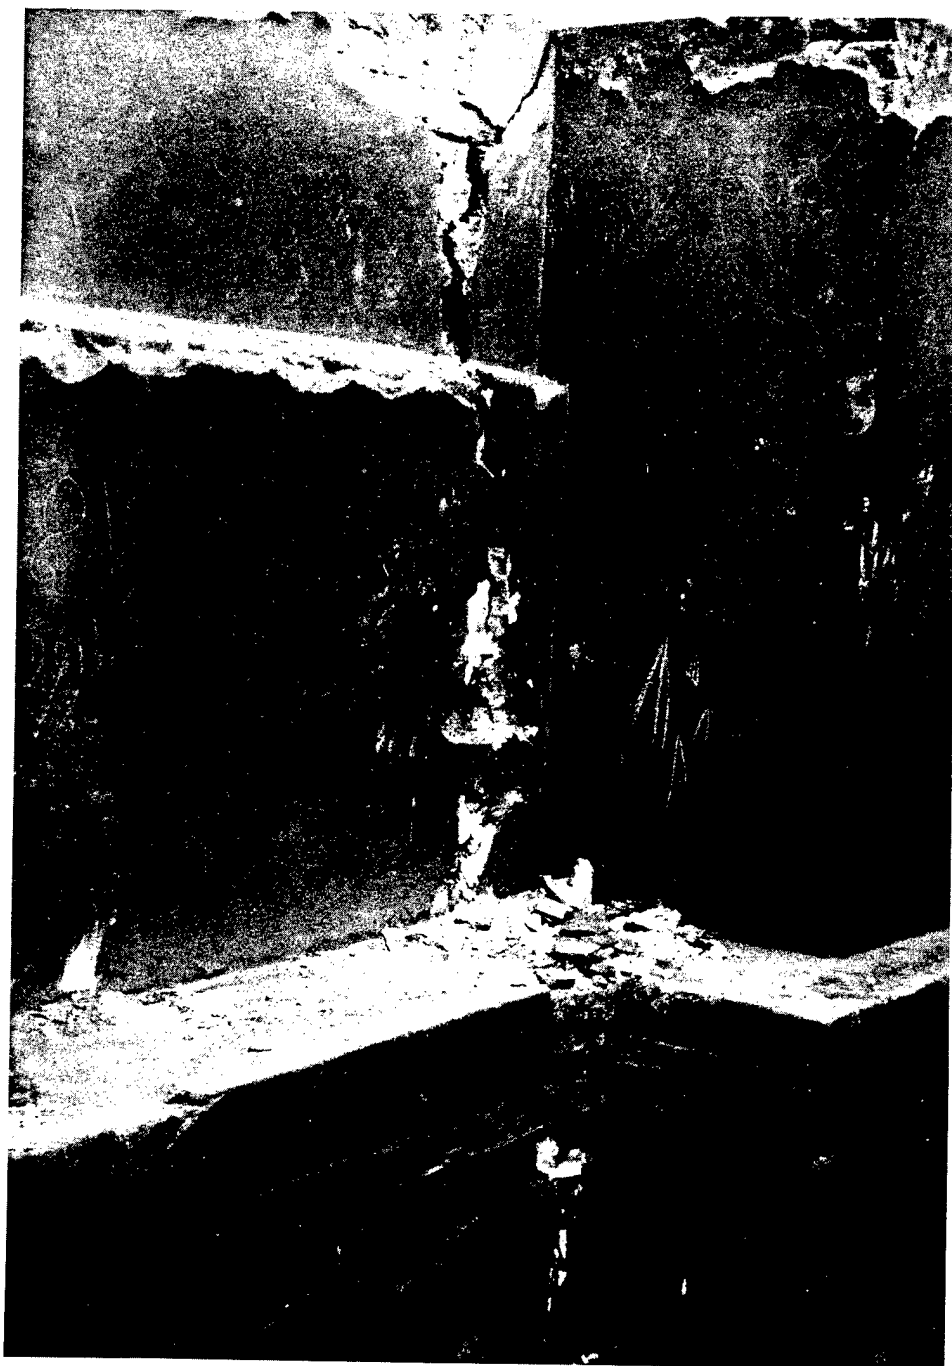
**FIGURE 4-41 Northern parapet wall of el-Moalloqa Church  
looking east showing cracks and deformations**

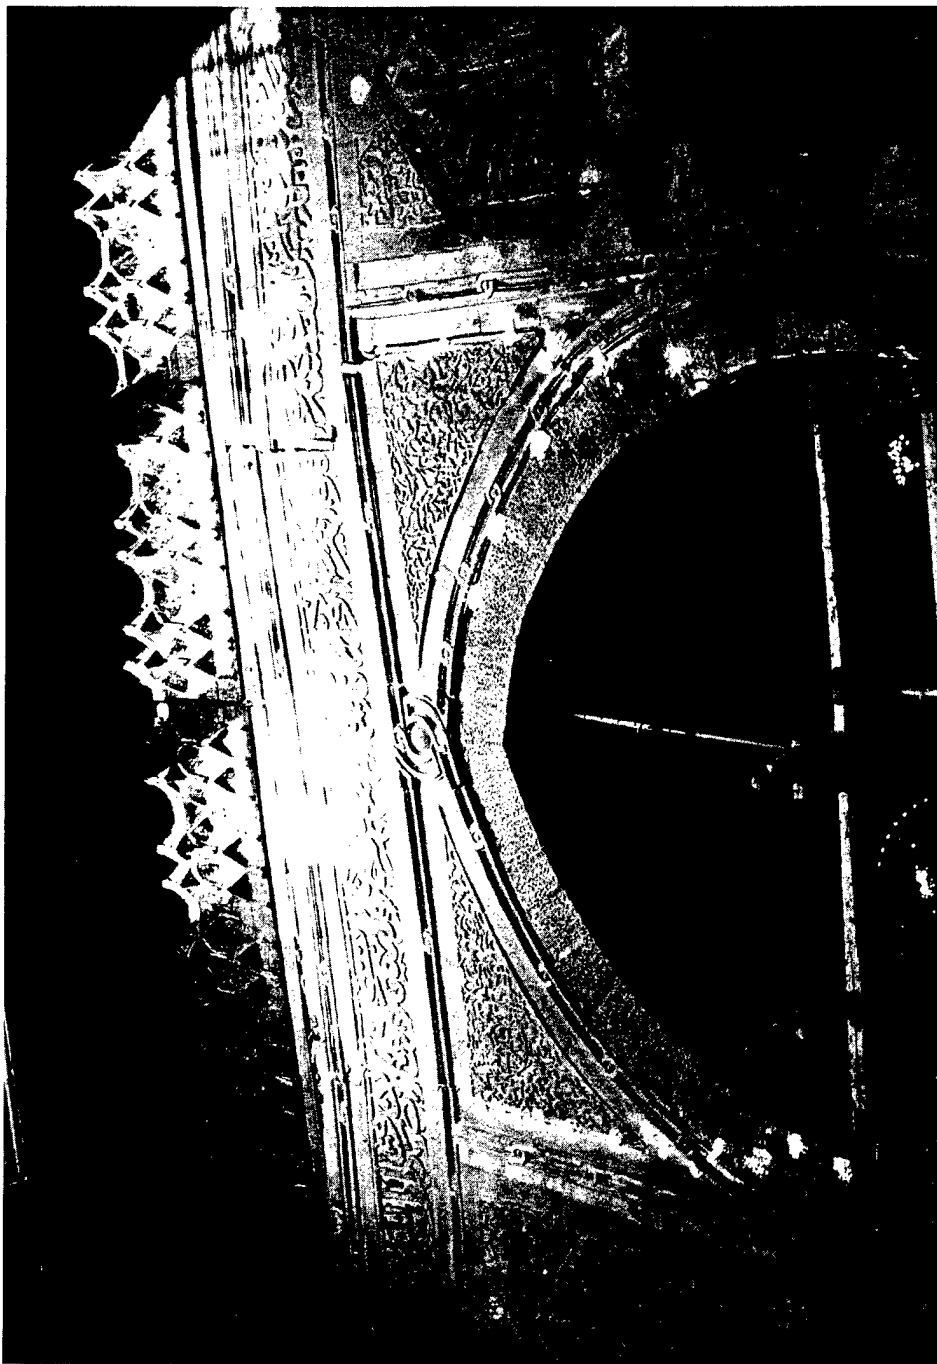
FIGURE 4-44 Main arch of Mosque of al-Ghūri looking northwest showing cracks and distortions

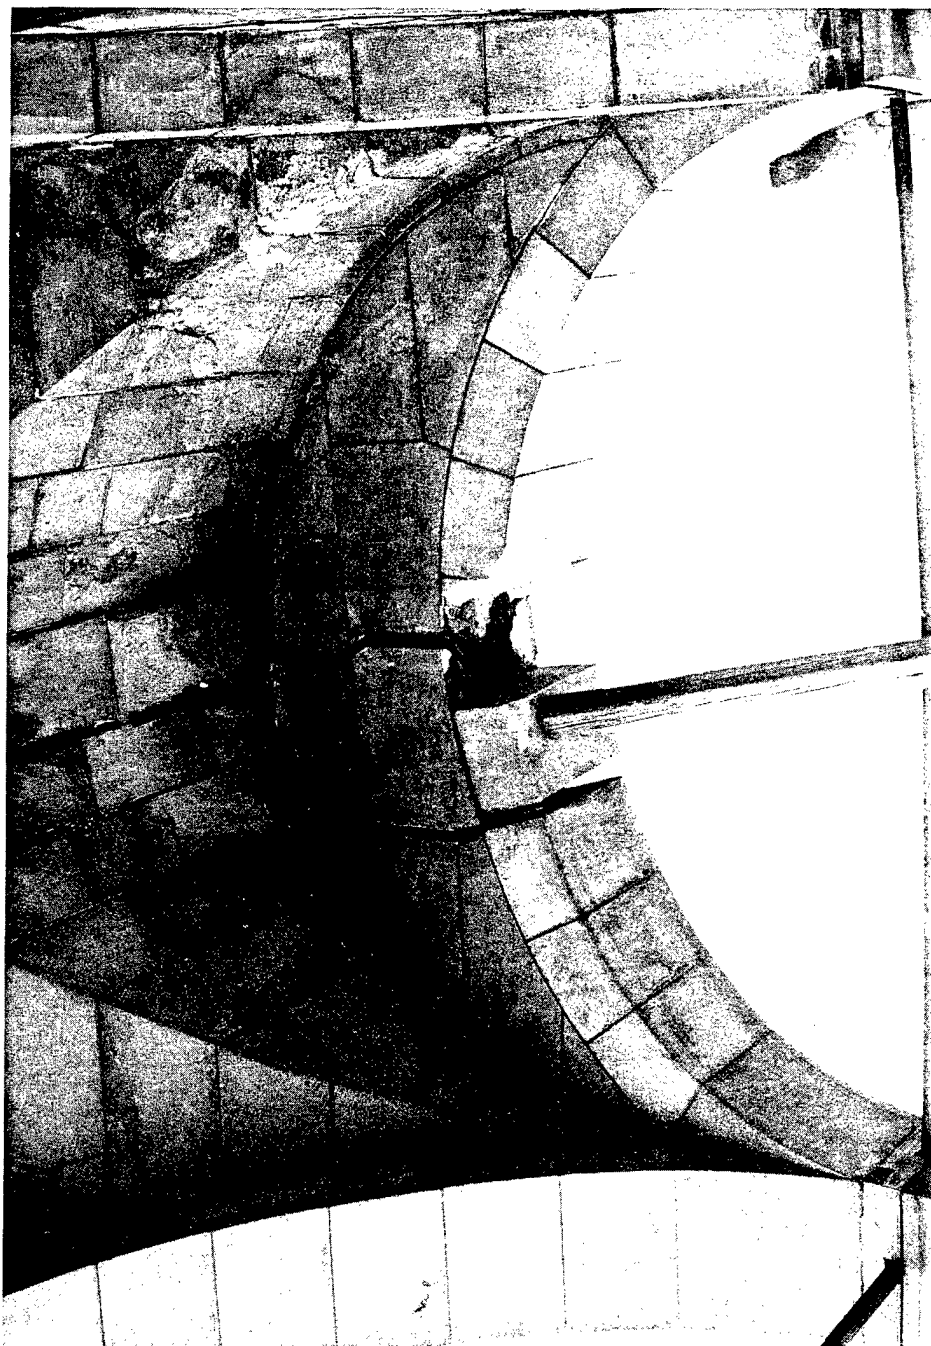
**FIGURE 4-49 Arch of portico to Saraya el-Adl at Citadel showing missing stone, large cracks, separation, and distortion**

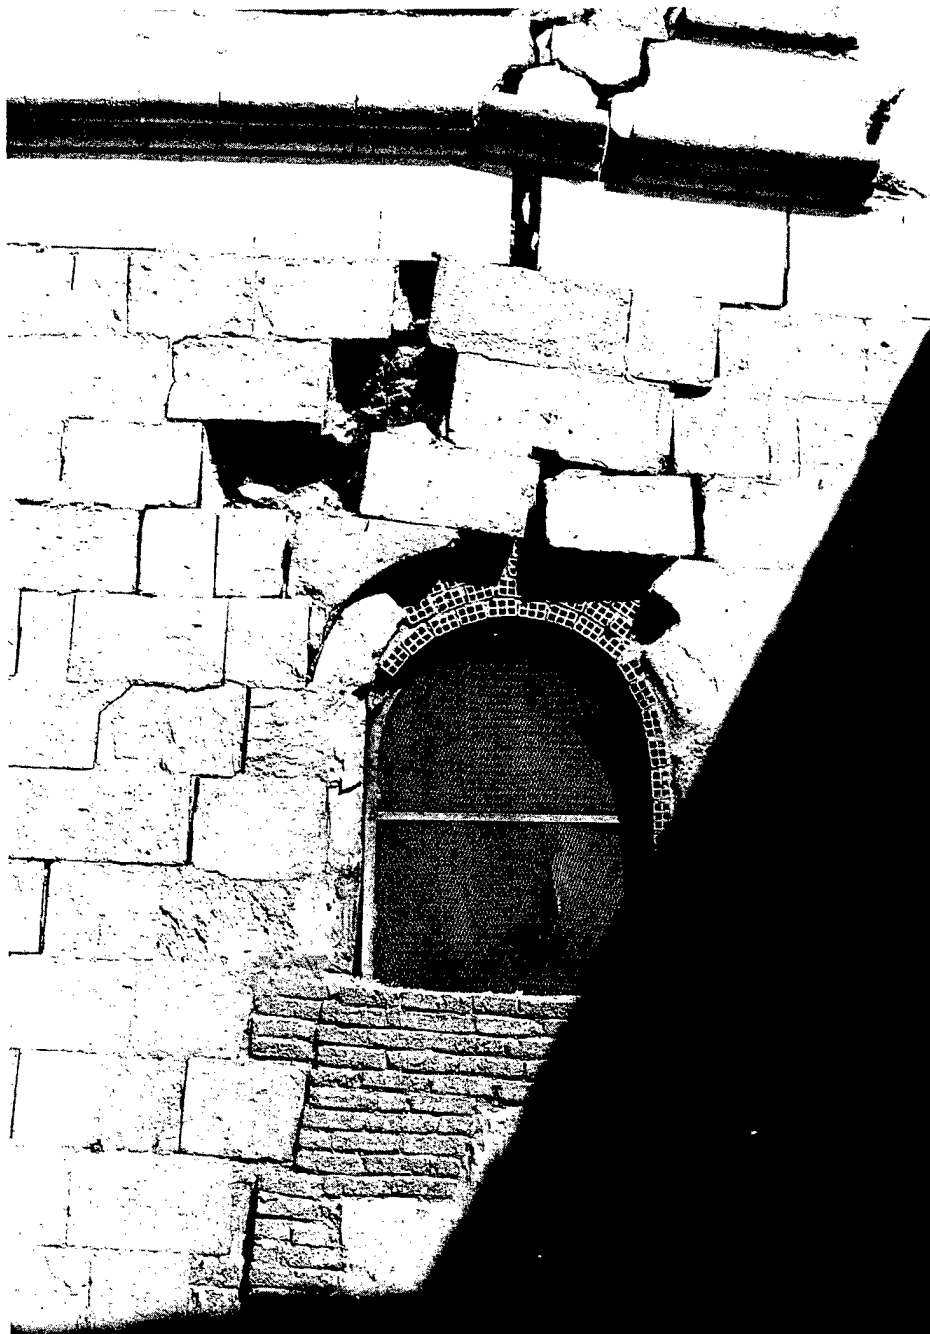
**FIGURE 4-50** Back wall of Saraya el-Adl at Citadel showing missing stones, large cracks and separation

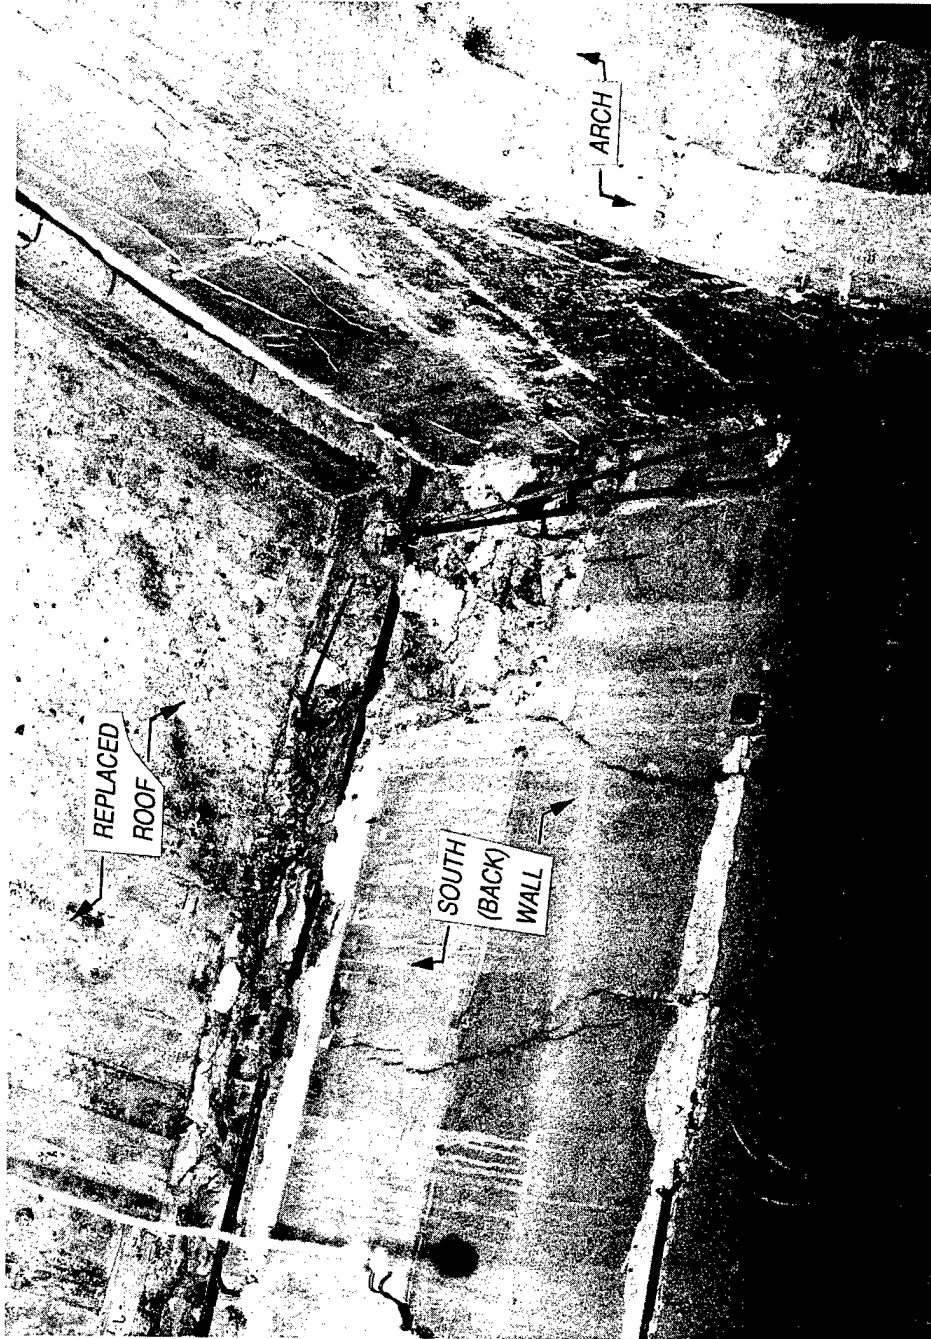
**FIGURE 4-51** Interior south wall of Saraya el-Adl looking up at contact between wall, arch, and concrete ceiling showing cracks, separation, and distortions

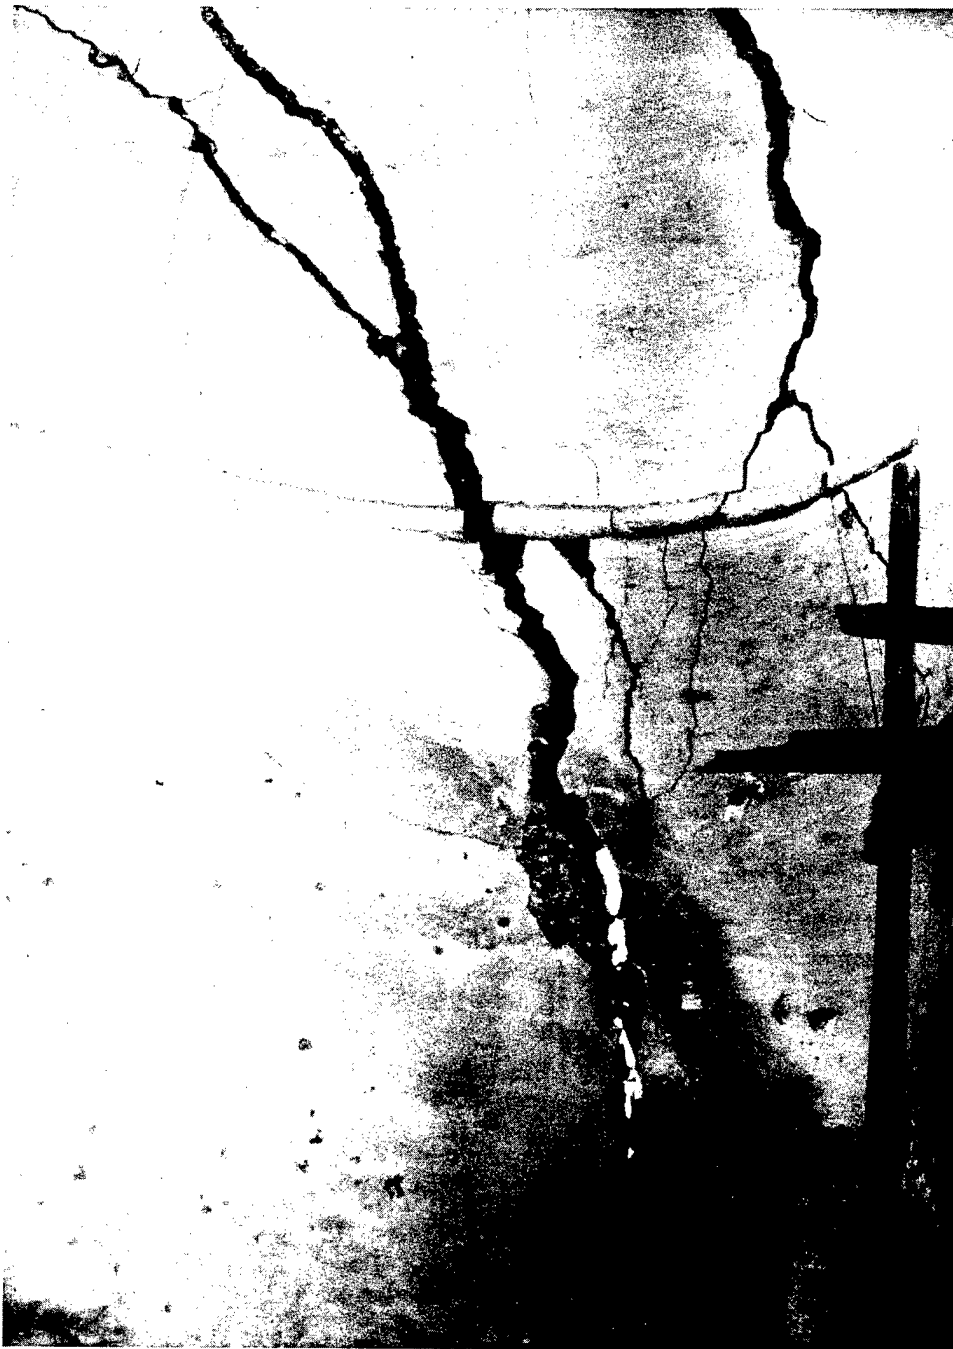
**FIGURE 4-53** Interior minor dome near southwest corner of Mint at Citadel showing large cracks and separation
