**DOT/FAA/AR-95/49**

# **A Study of the Continued Fire Worthiness of Aircraft Seat Cushion Fire-Blocking Layers**

March 1997

Final Report

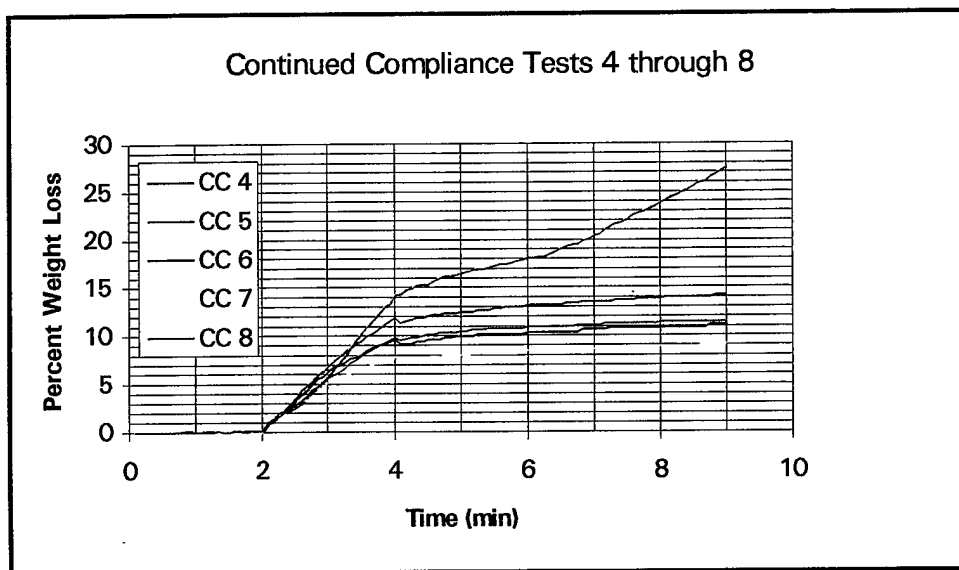
FIGURE 2. PERCENT WEIGHT LOSS PROFILES, TESTS 4 THROUGH 8

Stock Test Results. The weight loss profiles of the stock tests are shown in figures 1 and 2. The eight stock tests resulted in five tests exceeding 10 percent weight loss. The stock cushion tests did result in several instances where burn lengths exceeded the 17 inch (43.2 cm) requirement. In either case, the standard pass/fail criteria has no relevance in the stock configuration tests, which are expected to have higher test values. The data scatter was wide for both stock test series A and B, as seen in tables 4 and 5. Excluding test number five, no unusual fire behavior was observed during the testing.

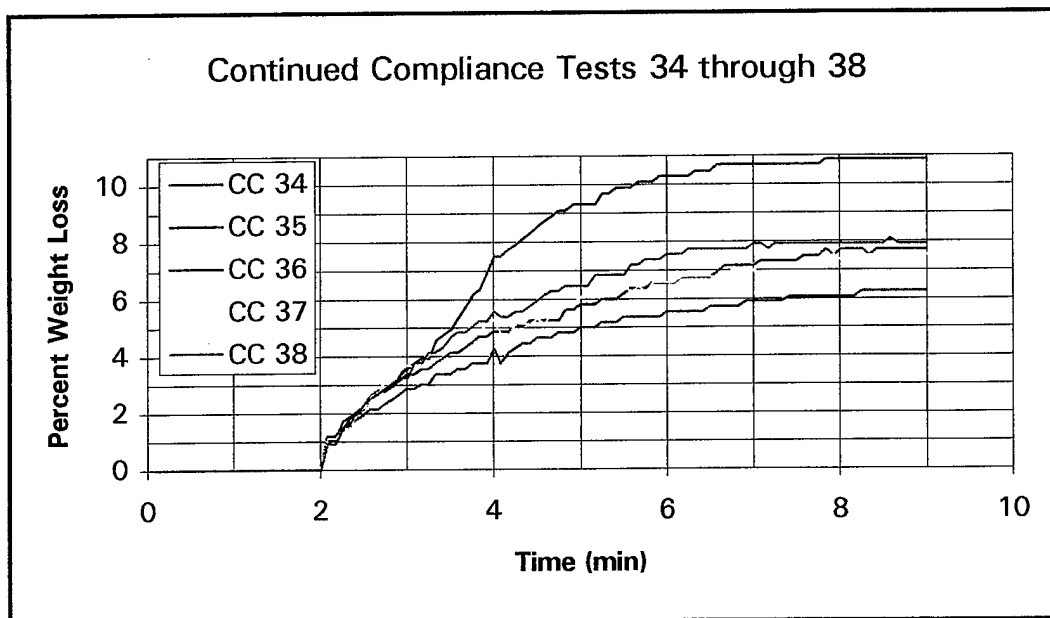
FIGURE 9. PERCENT WEIGHT LOSS PROFILES, TESTS 34 THROUGH 38

The percent weight loss was 10.87 for test number 36. This test was one of the final four tests performed which had reused vertical cushions. In review of this test, the final weight loss was mainly affected by the involvement of the reused vertical cushion. Had the vertical cushion been in an untested condition, the entire cushion set would have been expected to pass in the same manner as the other 29 tests.
