Report to the Chairman, Subcommittee
on Readiness, Committee on Armed
Services, U.S. Senate

AFLC PREPOSITIONING

Not All Equipment Meets the Army's Readiness Goal

B-277122

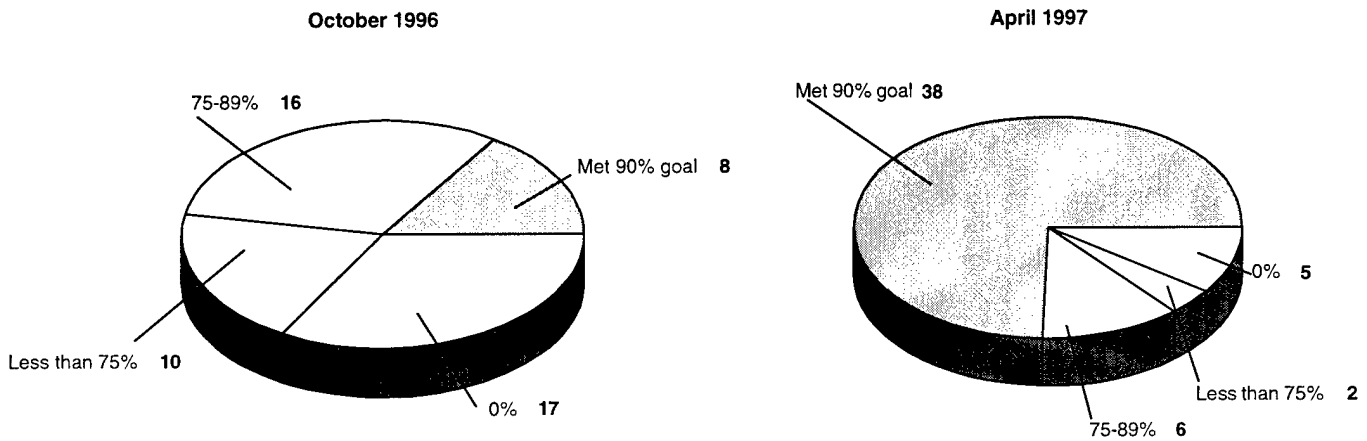
Figure 1: Number of Equipment Sets That Did Not Meet the Army's Readiness Goal in October 1996 and April 1997

As of April 1997, 13 of the 51 unit sets of equipment that are assigned to Army prepositioning ships and considered for readiness reporting, or about 25 percent, did not meet the Army's readiness goal that 90 percent of available war reserve equipment be fully mission capable. Equipment in two unit sets was less than 75 percent fully mission capable, and five unit sets had a fully mission capable rating of zero because they did not have on hand any authorized primary weapon systems or equipment considered critical for accomplishing and sustaining a unit's mission. For example, one unit set designated to support a heavy equipment transport company did not have any of its authorized trucks or trailers.

The status of the equipment in April 1997 had significantly changed from October 1996, when 43 of the 51 unit sets did not meet the Army's goal. At that time, equipment in 10 unit sets was less than 75 percent fully mission capable, and 17 unit sets had a fully mission capable rating of zero because they did not have any of their authorized reportable equipment on hand.

Note: The unit sets that had a fully mission capable rating of zero did not have any reportable equipment on hand.

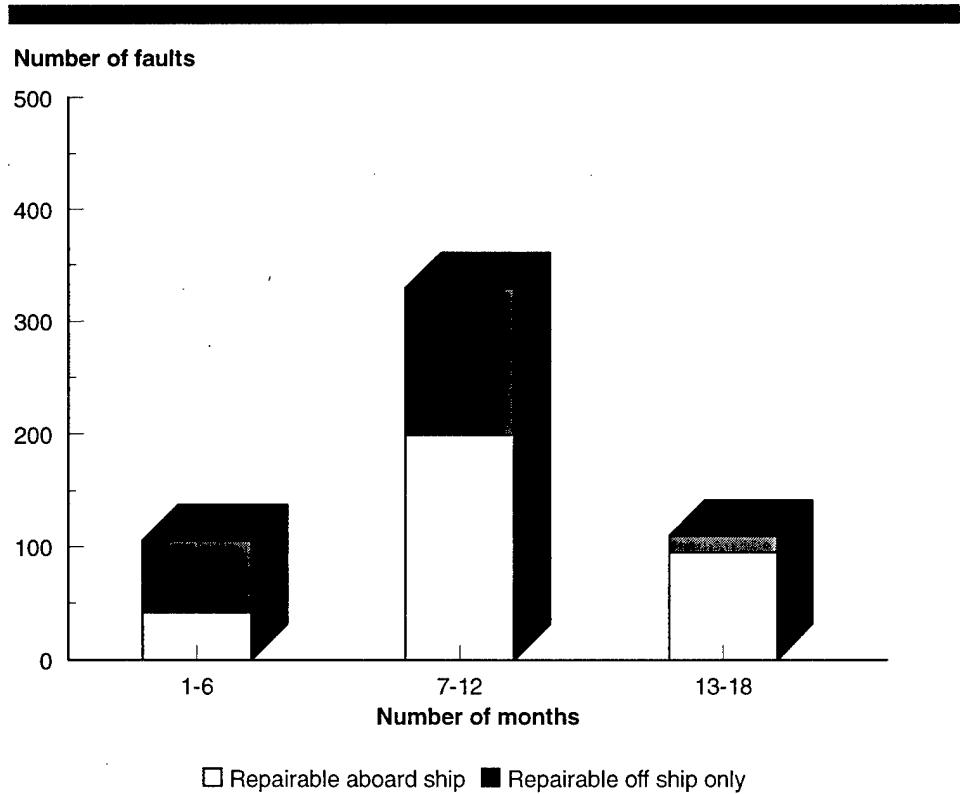
Figure 2: Amount of Time That Uncorrected Faults Have Rendered Equipment Non-Mission Capable (as of Apr. 1997)

The Army's equipment status data, as of April 1997, showed that faults rendering specific pieces of equipment non-mission capable had remained uncorrected since September 1995. Figure 2 shows the amount of time that uncorrected faults have rendered equipment prepositioned afloat non-mission capable and the portion of those faults that the Army considered to be repairable while in storage aboard prepositioning ships.

Note: Data reflects all ships as of April 1997 with the exception of one for which data was only available as of January 1997.

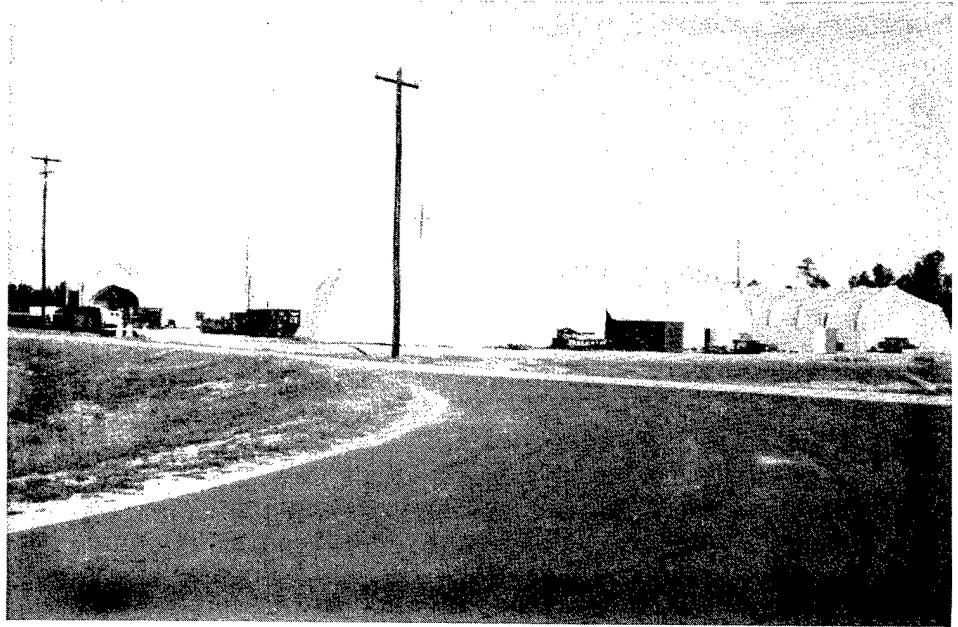
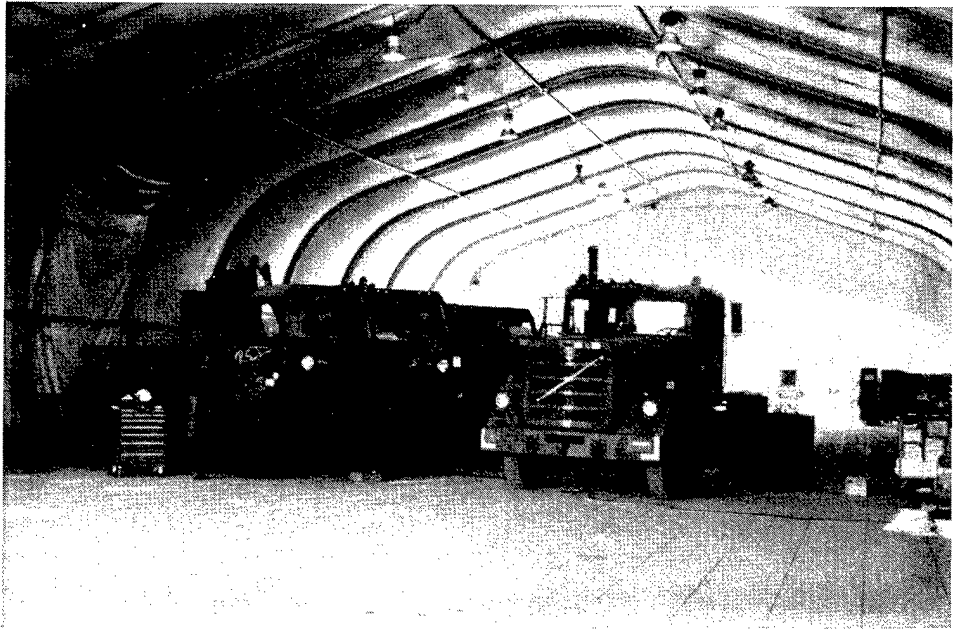
Figure 3: Temporary Maintenance Shelters at the Charleston, South Carolina, Site

The Army received a total of \$45.7 million in fiscal year 1995 and 1996 appropriations for construction of a maintenance facility at Charleston, South Carolina. The site preparation and the initial phase of construction were originally scheduled to be completed before October 1996—in time for the facilities to be used to conduct maintenance on the first full shipload of the brigade set of equipment, which is prepositioned afloat. However, contractors did not complete scheduled construction and renovation projects in time. As a result, the maintenance contractor had to continue to rely on temporary shelters instead (see fig. 3) and had to develop less efficient maintenance processes.

According to Army officials, the construction delays were primarily due to poor soil conditions and the removal of unanticipated hazardous waste, such as asbestos and pigeon droppings, from existing structures.⁹ The officials said that the continued reliance on temporary maintenance facilities did not delay the successful upload of fully mission capable equipment. They also said that the only discernable impact of these less efficient working conditions was a slight but unquantifiable increase in the amount of overtime charged to the contract. The Army plans to complete the transition of maintenance operations from the temporary shelters to the permanent facilities in fall 1997. In accordance with the original facility funding plan, the Army requested \$7.7 million in fiscal year 1998 for further construction at the site, making the total estimated cost for the facility \$53.4 million.
